**Flood Control Project Maintenance
Levee Inspections**

Maintenance Issue Types Only, Levee Inspection Report By Mile - Spring 2019

Reclamation District No. 0784 Plumas Lake

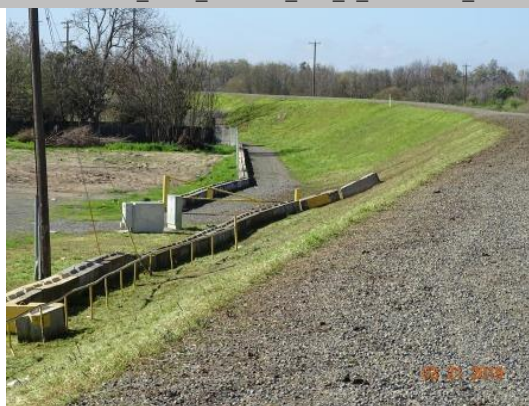
Photo 1 of 1 : SP_2019_RD0784_178_2_20190325_00008.jpg

View looking downstream landside at the well maintained annual vegetation, Spring 2019.

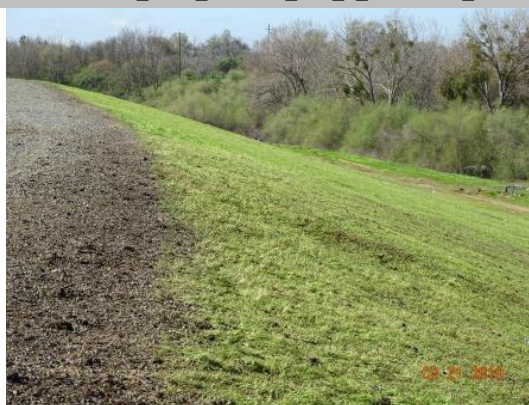
Photo 1 of 1 : SP_2019_RD0784_178_3_20190325_00009.jpg

View looking downstream waterside at the well maintained annual vegetation, Spring 2019.

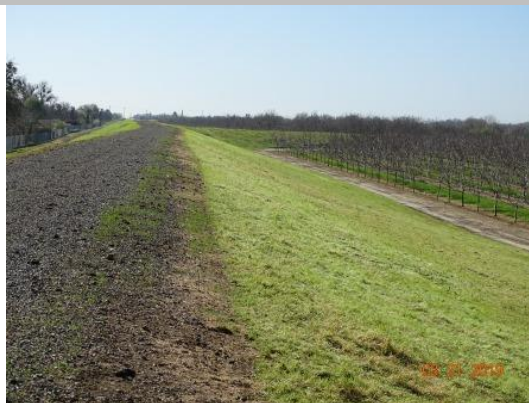
Photo 1 of 1 : SP_2019_RD0784_531_2_20190325_00002.jpg

View looking downstream waterside at the well maintained annual vegetation, Spring 2019.

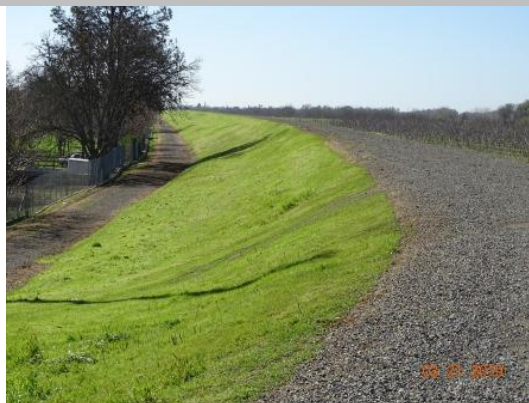
Photo 1 of 1 : SP_2019_RD0784_531_1_20190325_00001.jpg

View looking downstream landside at the well maintained annual vegetation, Spring 2019.

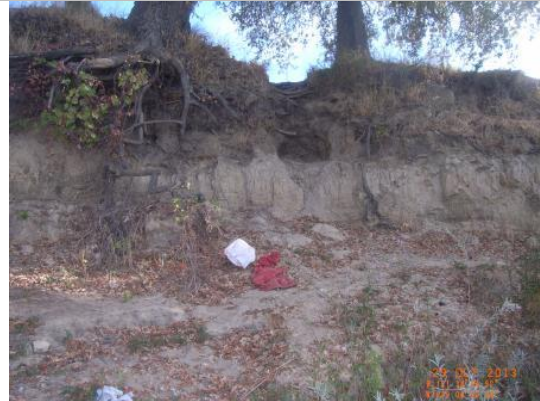
Photo 1 of 1 : SP_2019_RD0784_532_1_20190305_00001.jpg

| Site History: 2003 - Bank is near vertical. Identified as a Potentially Critical site. 2004 - Eddy flow off downstream end of Modesto formation eroding the fluvial sediments. 2005 - Some new slumping. Actively eroding but berm width is greater than 50 ft. 2006 - Downgraded to regular erosion site. Still actively eroding. Large old rotational failures in high bank on the downstream end. 2008 - Removed from inventory due to wide berm width does not meet criteria for an erosion site. 2010 - Added back to the inventory after 10 ft of bank erosion in the winter 2009 storm. Steep vertical face. 2011 - Bank has retreated an additional 2.5 ft from last year. New tree popouts and erosion throughout the site. 2012 - Site continues to worsen with new tree popouts and many sections of new erosion. | | | | | |

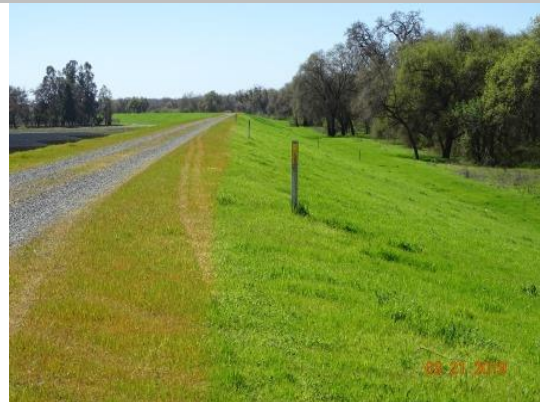
Photo 1 of 1 : SP_2019_RD0784_532_3_20190415_00006.jpg

View looking downstream waterside at the well maintained annual vegetation, Spring 2019.

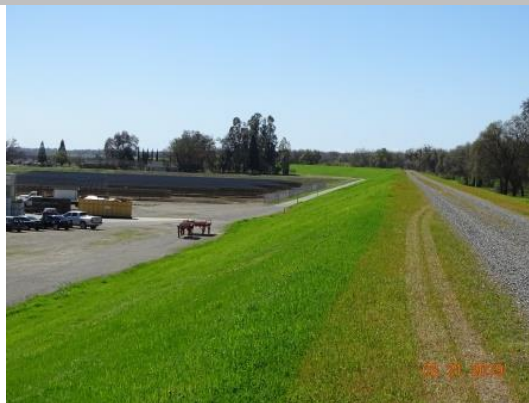
Photo 1 of 1 : SP_2019_RD0784_532_2_20190415_00007.jpg

View looking downstream landside at the well maintained annual vegetation, Spring 2019.

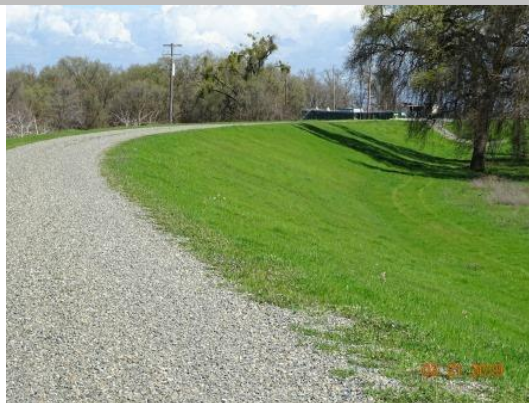
Photo 1 of 1 : SP_2019_RD0784_533_2_20190325_00002.jpg

View looking upstream waterside at the well maintained annual vegetation, Spring 2019.

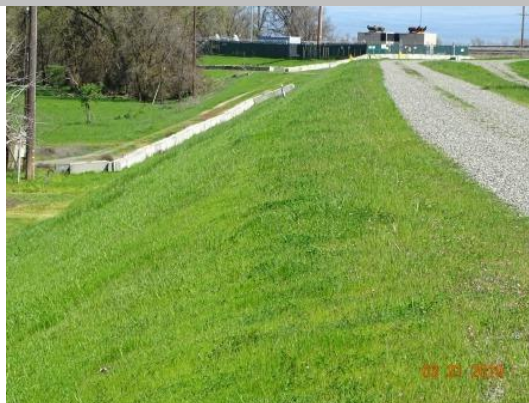
Photo 1 of 1 : SP_2019_RD0784_533_1_20190325_00001.jpg

View looking upstream landside at the well maintained annual vegetation, Spring 2019.

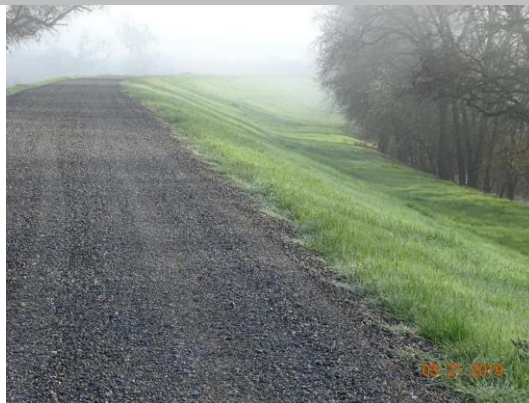
Photo 1 of 1 : SP_2019_RD0784_534_5_20190325_00007.jpg

View Looking upstream waterside of well maintained annual vegetation, Spring 2019.

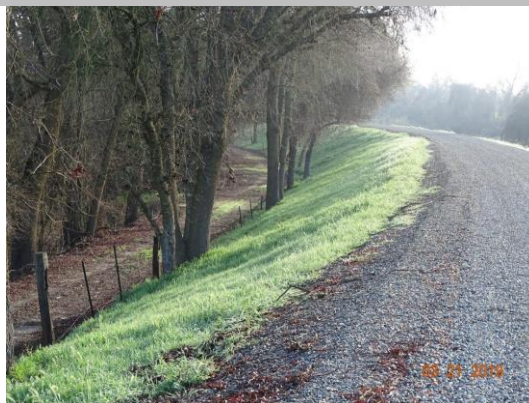
Photo 1 of 1 : SP_2019_RD0784_534_4_20190325_00005.jpg

View Looking upstream landside of well maintained annual vegetation, Spring 2019.

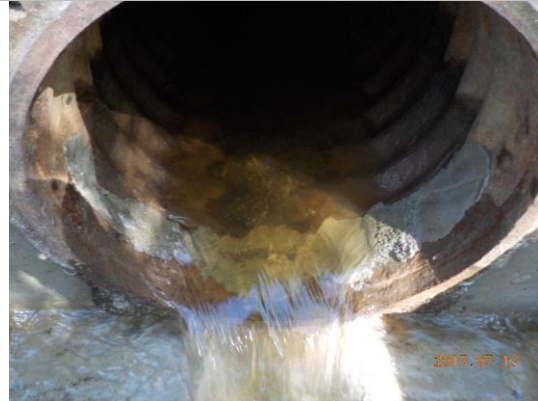
Photo 1 of 3 : UCIP_SP_2019_53072_77114.jpg

FS_ID:53072
DS_ID:18627
EP_NO: N/A
Repair Type: Urgent
Crossing Status: Found
UCIP Comments: 10/16/2018 Internal video inspection was completed recently and the inspection is being evaluated by the District Engineer. Waiting for internal inspection results to determine the internal condition of this crossing. Crossing remains Urgent due to the unknown condition of the pipe through the levee. (O. Magana - DWR UCIP) 11/30/2017 Crossing remains Urgent due to uncertainty of pipe condition through levee -- recommend an internal inspection of the pipe through the levee as a precaution measure to determine integrity of pipe. Repair of the rusted out collar (void) found at the WS pipe outlet has been repaired by the LMA. Received additional photos from DWR levee inspector, S. York, of the WS concrete headwall installed and vegetation cleared from WS. (O. Magana - DWR UCIP)07/13/2017 - The rusted out collar at the bottom of the waterside flap gate has been sealed with concrete. Internal pipe inspections still pending. (P.Meagher-RD784).04/13/2017 - Spoke to LMA representative, P. Meagher, regarding the status of this crossing. The report has been updated to indicate vegetation has been cleared from WS outlet and LS inlet. The crossing remains Urgent--WS pipe collar is rusted out on the bottom. Recommend internal pipe inspection to determine pipe integrity through the levee. Owner will need to coordinate with the CVFPB to address issue. (O. Magana - DWR UCIP) 01/16/2017 - Landowner who utilizes this pipe reported to RD784 staff on 1/11/2017 that he suspected this pipe at the waterside flap gate ring area was rusted out at the bottom. After investigating, we could see what was reported is correct. Sandbags have been temporarily placed around the 2" +/- gapped area underneath the flap gate ring. A permanent solution is anticipated to be completed in the next 3 to 6 months. The plan is to pour a concrete ring / headwall around the open corroded pipe end. Photos attached. (P. Meagher - RD784).11/04/2016 - Flap gate on waterside has been cleared again as of 10/17/2016. The LS inlet area has been cleared as of 9/21/2016. See updated photos attached. (P.Meagher - RD784)09/22/2016 - vegetation at inlet of pipe has been cleared by owner. photos added showing pipe inlet. (T. Hatch - DWR UCIP)08/09/2016 - vegetation partially obscuring outlet on WS. Heavy vegetation on landside (LS) limiting inspection of inlet. Owner asked by RD0784 to clear vegetation and debris. (T. Hatch - DWR UCIP)11/1/2015 - Flap Gate has been cleared as of 12/9/2014 and again during summer of 2015 (P. Meagher/RD0784)2/27/2013 - Flap gate blocked by vegetation on WS toe. Unable to locate inlet. (W. Wylie - DWR UCIP)

Close up photo of concrete seal where the rusted out void used to be. Farmer irrigation was currently flowing at the time the photo was taken.

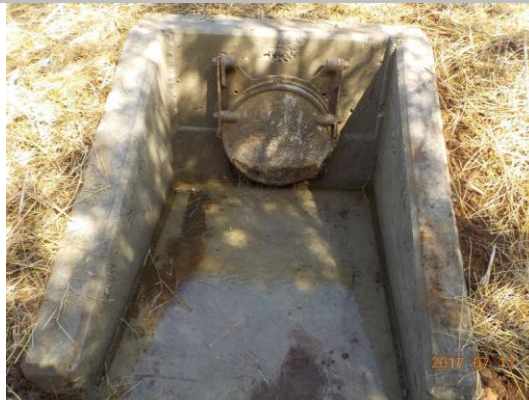
Photo 2 of 3 : UCIP_SP_2019_53072_77115.jpg

Concrete collar completed around the waterside exterior flap gate section.

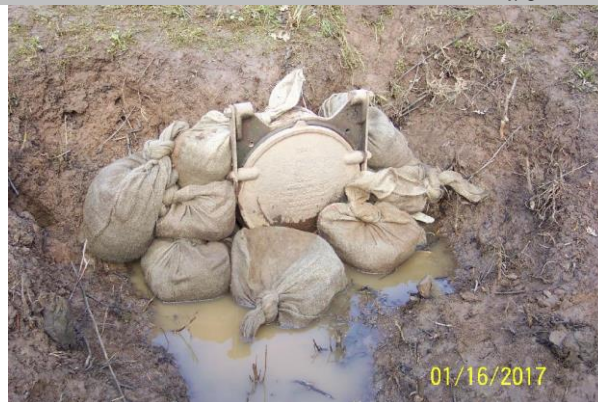
Photo 3 of 3 : UCIP_SP_2019_53072_76618.jpg

Sandbags temporarily placed in front of flapgate.

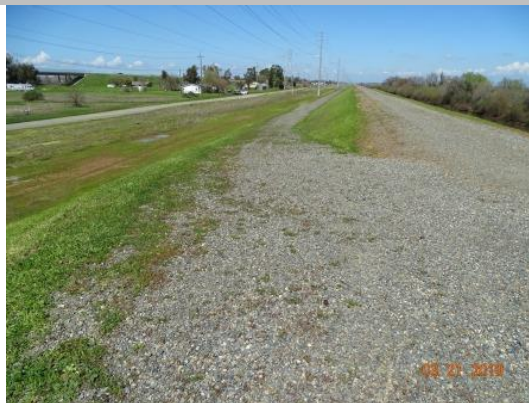
Photo 1 of 1 : SP_2019_RD0784_181_2_20190325_00009.jpg

View Looking upstream landside of well maintained annual vegetation, Spring 2019.

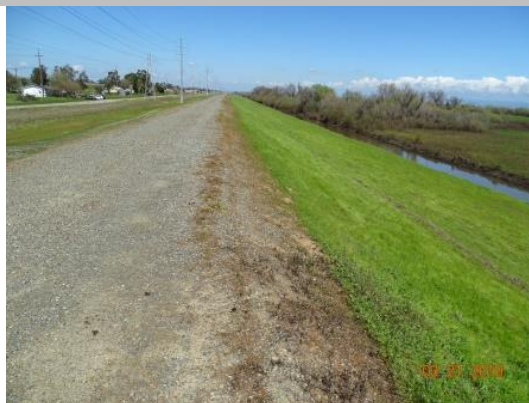
Photo 1 of 1 : SP_2019_RD0784_181_3_20190325_00008.jpg

View Looking upstream waterside of well maintained annual vegetation, Spring 2019.

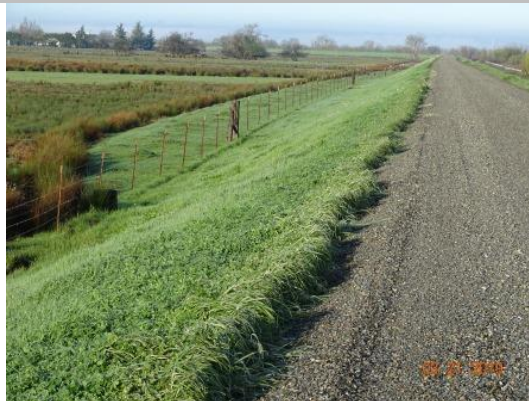
Photo 1 of 1 : SP_2019_RD0784_182_14_20190325_00034.jpg

View looking downstream landside of well maintained annual vegetation, Spring 2019.

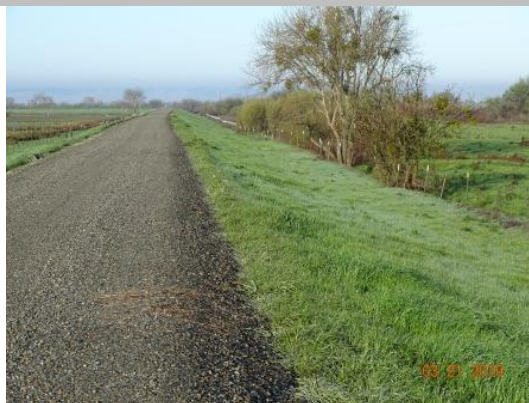
Photo 1 of 1 : SP_2019_RD0784_182_15_20190325_00033.jpg

View looking downstream waterside of well maintained annual vegetation, Spring 2019.

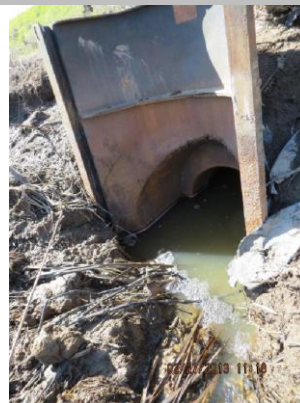
Photo 1 of 3 : UCIP_SP_2019_53544_16552.jpg

inlet control structure on LS toe.

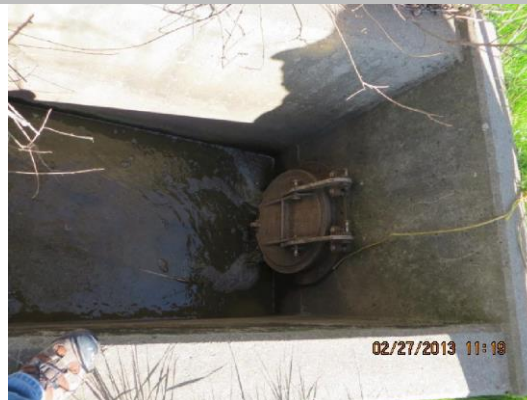
Photo 2 of 3 : UCIP_SP_2019_53544_16555.jpg

Concrete U-shaped outlet with flap gate on WS toe.

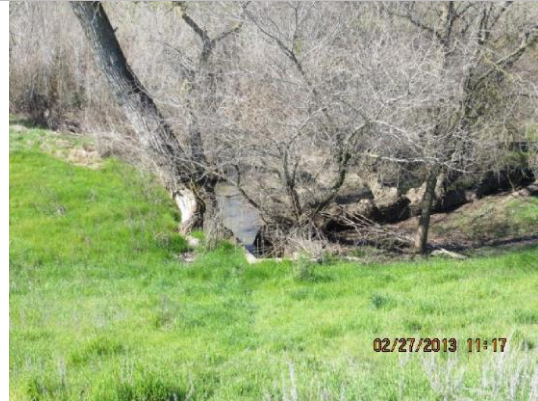
Photo 3 of 3 : UCIP_SP_2019_53544_16554.jpg

Concrete U-shaped outlet on WS toe.

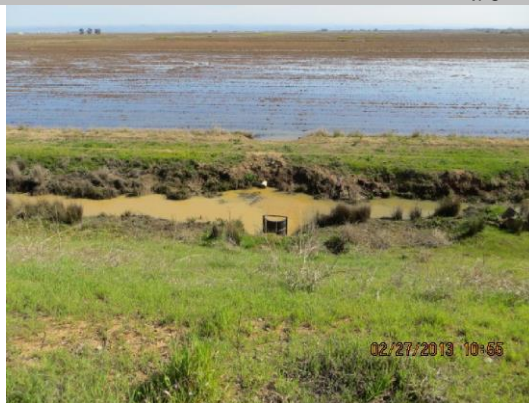
Photo 2 of 3 : UCIP_SP_2019_53547_16563.jpg

Pvc weir on inlet at LS toe.

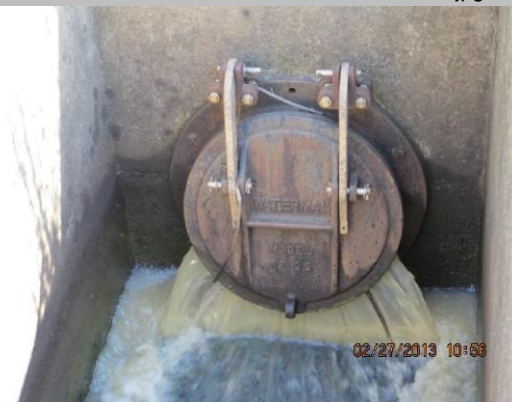
Photo 3 of 3 : UCIP_SP_2019_53547_16562.jpg

Concrete U-shaped headwall and flap gate on WS toe.

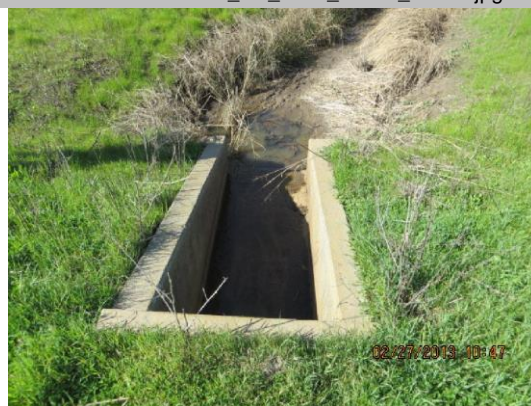
Photo 1 of 3 : UCIP_SP_2019_53548_54247.jpg

Concrete U-shaped outlet and flap-gate on WS toe.

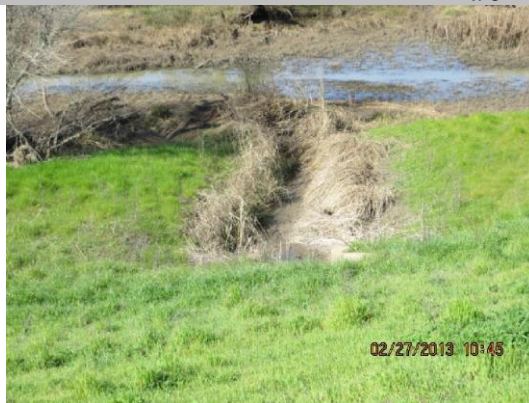
Photo 3 of 3 : UCIP_SP_2019_53548_54249.jpg

Drainage outlet on WS toe.

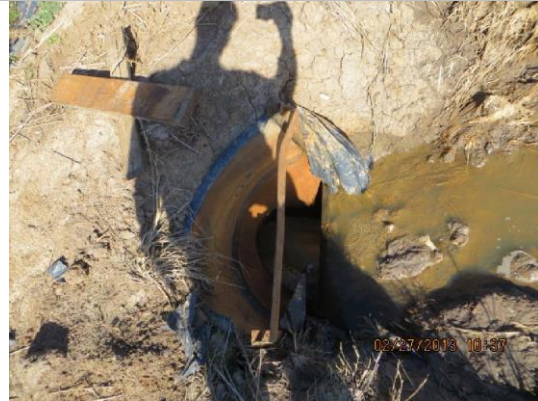
Photo 1 of 3 : UCIP_SP_2019_53557_54250.jpg

Inlet with PVC weir on LS toe.

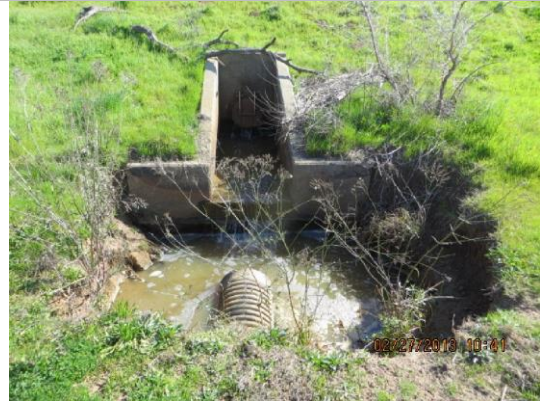
Photo 2 of 3 : UCIP_SP_2019_53557_54253.jpg

FS_ID:53557
DS_ID:18587
EP_NO: N/A
Repair Type: Non-Urgent
Crossing Status: Found
UCIP Comments: 2-1-2019 - The pipe crossing was video inspected on 8/14/2018. New photos of the landside toe added. In August 2017 a sinkhole was noticed at the bottom of the landside toe shelf area. The sinkhole developed as a result of the landowner who extended the existing pipe in order to complete a new unauthorized concrete flashboard structure replacement. The pipe owner was mailed a letter from RD784 with a Cc to CVFPB and DWR dated 10/23/2017 acknowledging the owner's completion of an attempted repair. The sinkhole has since returned. On 1/31/2017 The waterside excess pipe end was discovered to be floating to the surface due to landside water runoff through the pipe. Because of the floating pipe, the water was not draining all the way through the pipe. Instead, the water was overtopping the levee shelf area. In order to resolve this issue, the excess portion of the pipe was cut off. After doing so, the water immediately started draining properly again. (P. Meagher, RD784 2/3/2017). Erosion at outlet may or may not be an issue.

Concrete U-shaped headwall on WS toe with Flap gate showing erosion at outlet.

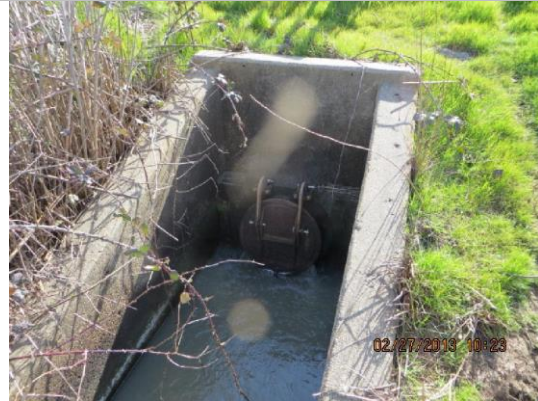
Photo 1 of 3 : UCIP_SP_2019_53540_54258.jpg

Concrete U-shaped headwall and flap gate on WS toe.

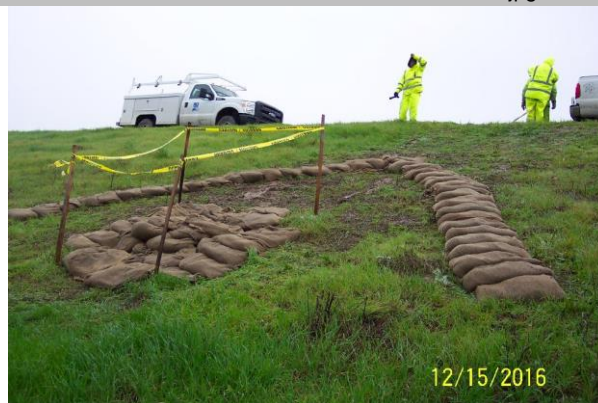
Photo 2 of 3 : UCIP_SP_2019_53540_76309.jpg

10/16/2018 - Pipe remains Urgent due to internal pipe failure. Diversion dam on the WS slope is still present. Mr. Meagher is monitoring the progress of the erosion on the LS. Flag markers have been added just above the erosion site on the LS to monitor the progress of the slope failure. LMA is working with the District Engineer on proposed repair and CVFPB to obtain approval for a pipe replacement. Crossing is listed as DMP Phase 1 eligible crossing. (O. Magana - DWR UCIP)

12/15/2016 - Coordination email was received from RD0784 this afternoon. Patrick Meagher with Reclamation District is closely monitoring the eroded pipe area at the Horseshoe Levee due to periodic rainstorms and unpredictable water flow elevations. To avoid further damage at this location, Mr. Meagher has coordinated with LMA Consultant Sean Minard at MHM Engineering and DWR Levee Inspector Sterling York to address further deterioration at site. As a proactive measure by RD784, sandbags were used to fill in the sink hole on the WS. A "V" shape diversion dam was also built of sandbags above the sinkhole area to help divert running rainwater coming down the slope around the fill area. RD0784 used approximately 100 sandbags at the site to fill in sink hole and create the "V" shaped diversion dam. (O. Magana - DWR UCIP) 07/29/2016 - Erosion scarp on LS cut into levee shoulder starting at inlet headwall. Cavity failure on WS shoulder approximately 2-feet in diameter and several feet in depth. (T. Hatch/UCIP) 11/01/2015 - The concrete box weir structure on the landside inlet has slumped off the end of the pipe. DWR Chief inspector George Willie inspected the site on 8/13/2015 with Steve Fordice, General Manager of RD784. (P. Meagher - RD784)

WS view: Sink hole filled in with sandbags and "V" shaped diversion dam built to help divert rainwater.

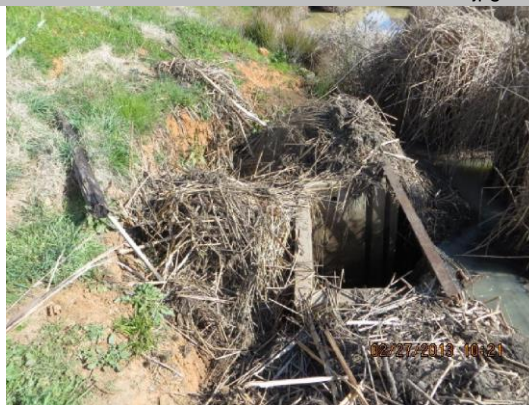
Photo 3 of 3 : UCIP_SP_2019_53540_54254.jpg

Erosion and debris from Beaver activity.

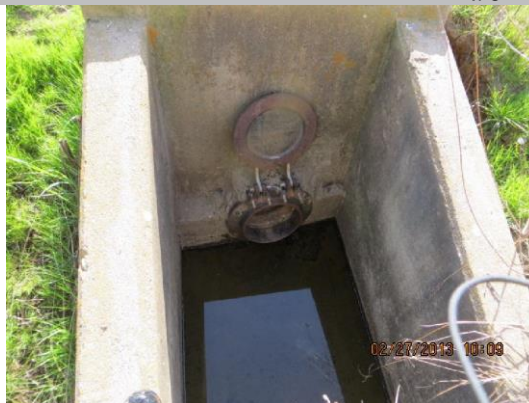
Photo 1 of 3 : UCIP_SP_2019_53553_54259.jpg

Concrete U-shaped headwall and flap gate on WS toe.

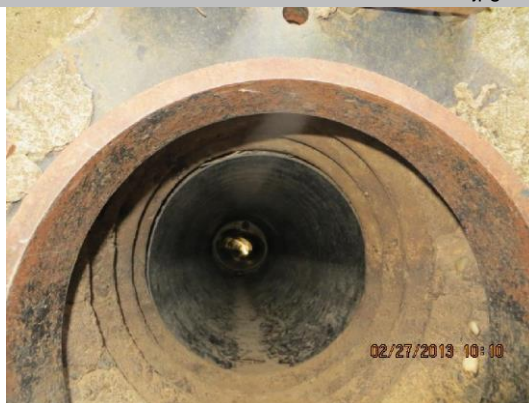
Photo 2 of 3 : UCIP_SP_2019_53553_54262.jpg

| FS_ID:53553 DS_ID:18596 EP_NO: N/A Repair Type: Non-Urgent Crossing Status: Found UCIP Comments: 2-1-2019 - Pipe crossing was video inspected on 8/15/2018. (P. Meagher)02/27/2013 Pipe has been sliplied with PVC, but the liner appears to be eroding at outlet and may be disjointed internal to the levee. See pic. Good candidate for video inspection. (W. Wylie - DWR UCIP) FIELD_STRUCT_DESC: 12-inch corrugated metal drainage pipe through the levee, 12 feet below the crown. Flap gate and concrete U-shaped headwall on the waterside (WS). Polyvinyl chloride weir on inlet at the landside (LS) toe. [Additional Reference(s): DWR Levee Log, 2005. USACE Sacramento O&M Manual 145, August 1955 (Station 44+96)]. FS Date: 9/11/2015 9:26:00 AM | | | | | |

Pipe showing sliplied PVC insert. some erosion of PV at outlet and it may be disjointed internally.

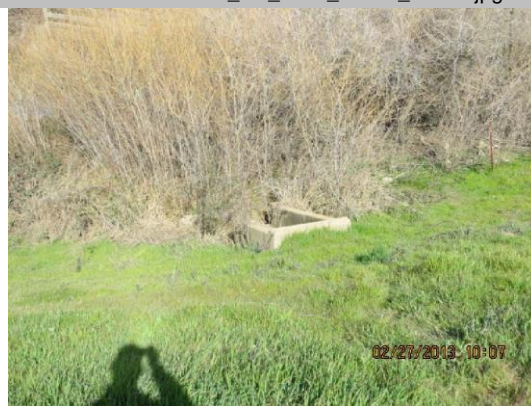
Photo 3 of 3 : UCIP_SP_2019_53553_54261.jpg

Concrete U-shaped headwall on WS toe.

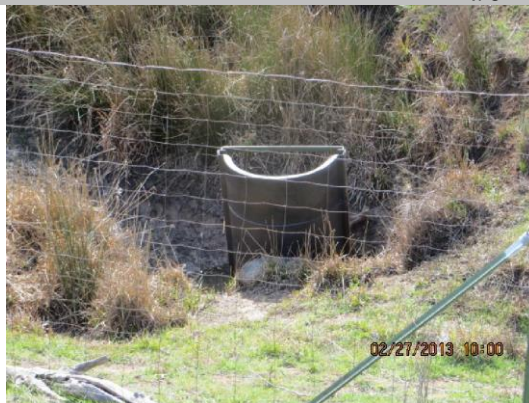
Photo 1 of 2 : UCIP_SP_2019_53552_16594.jpg

PVC weir inlet on LS toe.

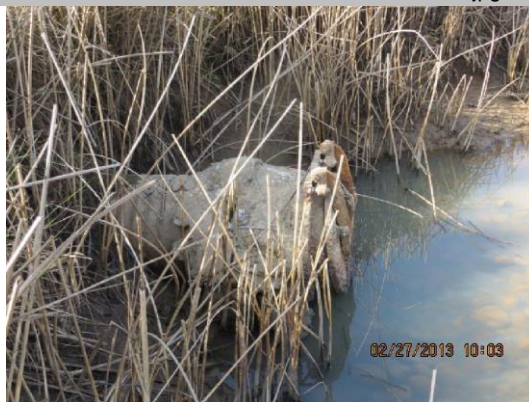
Photo 2 of 2 : UCIP_SP_2019_53552_16593.jpg

Flap gate at WS toe.

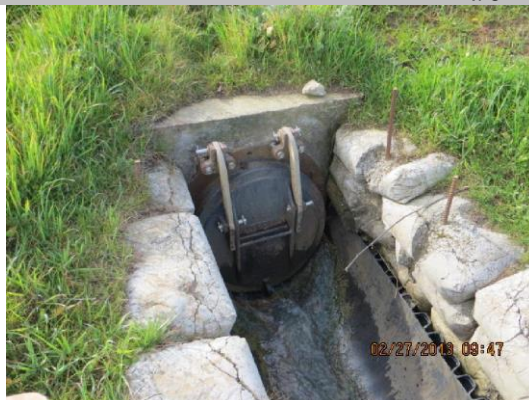
Photo 1 of 3 : UCIP_SP_2019_53551_16590.jpg

Concrete outlet and flap gate on WS toe.

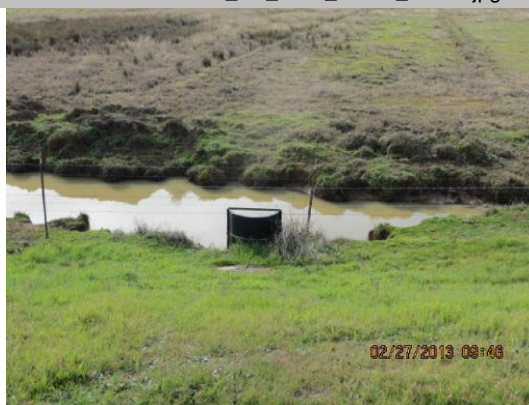
Photo 2 of 3 : UCIP_SP_2019_53551_16591.jpg

PVC weir at inlet on LS toe.

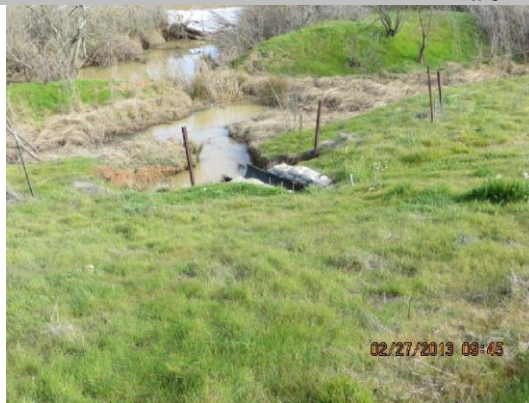
Photo 3 of 3 : UCIP_SP_2019_53551_16592.jpg

Concrete outlet on WS toe.

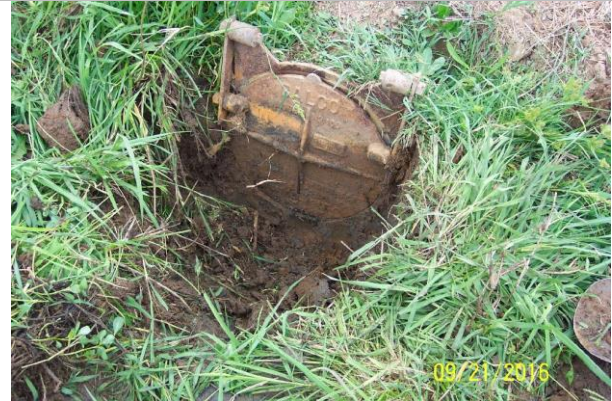
Photo 1 of 3 : UCIP_SP_2019_53550_76147.jpg

| FS_ID:53550 DS_ID:18593 EP_NO: N/A Repair Type: Non-Urgent Crossing Status: Found UCIP Comments: 2/1/2019 - An attempt was made to video inspect this pipe crossing on 8/15/2018 but conditions were too muddy inside the pipe. (P. Meagher)11/14/2016 - Photos added of exposed flap gate on WS and possible inlet location on LS. Condition remains as Non-Urgent because of inlet not being fully operable. Unknown if pipe will operate as designed during high water or if it is full of sediment.11/01/2015 - Waterside Flap Gate Uncovered. Photo sent to DWR Matt Hoffman on 3/3/2014. Fresh photo sent to DWR Pavel Kazi on 9/9/2015. Landside toe has never been able to be located. Requesting DWR inspector to change the status of this issue to "No Action Needed". (P.Meagher - RD784).Pipe buried on LS toe and flap gate is blocked by soil on WS toe. (W. Wylie - UCIP Inspector). FIELD_STRUCT_DESC: 18-inch corrugated metal drainage pipe through the levee, 10 feet below the crown. Flap gate on the waterside (WS) end. [Additional Reference(s): DWR Levee Log, 2005. USACE Sacramento O&M Manual 145, August 1955 (Station 91+50)]. FS Date: 10/9/2015 | | | | | | |

Flap gate on the WS toe is exposed

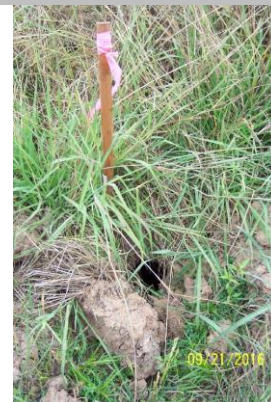
Photo 2 of 3 : UCIP_SP_2019_53550_76148.jpg

Possible location of the inlet on the LS toe

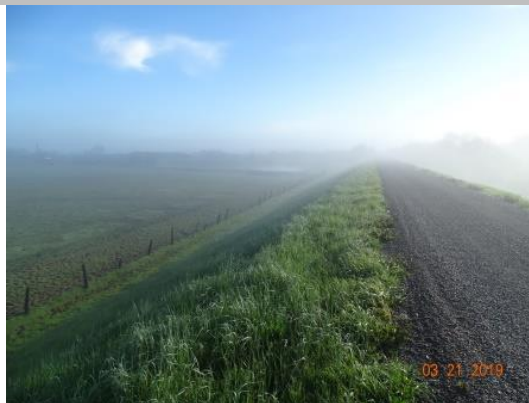
Photo 1 of 1 : SP_2019_RD0784_183_2_20190325_00006.jpg

View looking upstream landside at the well maintained annual vegetation, Spring 2019.

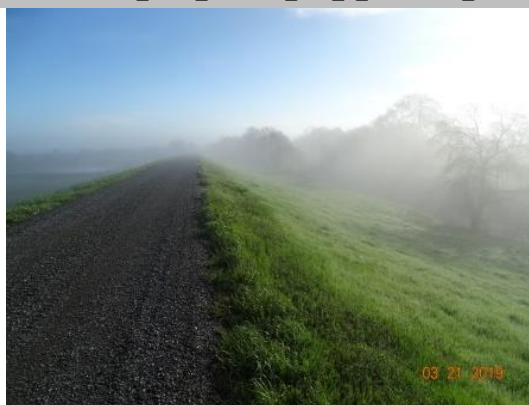
Photo 1 of 1 : SP_2019_RD0784_183_3_20190325_00007.jpg

View looking upstream waterside at the well maintained annual vegetation, Spring 2019.

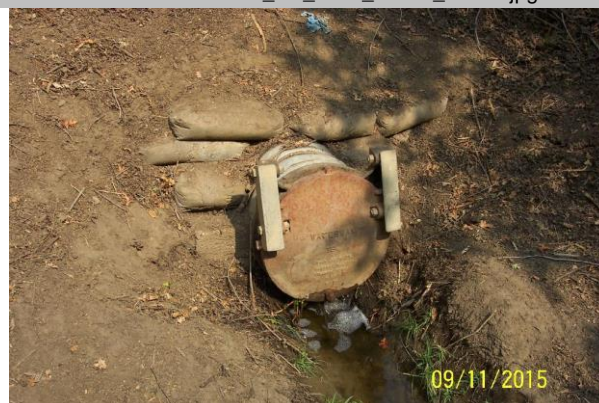
Photo 1 of 3 : UCIP_SP_2019_53542_74682.jpg

Flap Gate is clear as of 9/11/15.

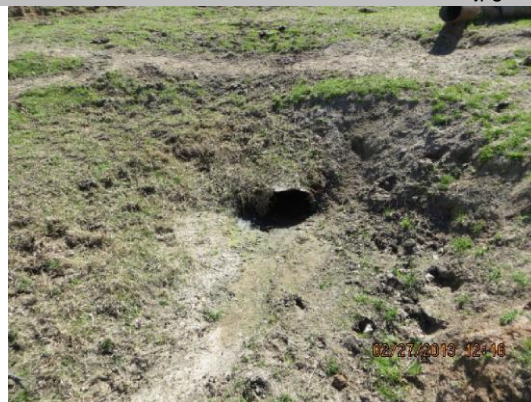
Photo 2 of 3 : UCIP_SP_2019_53542_54268.jpg

Partially clogged inlet pipe at LS toe.

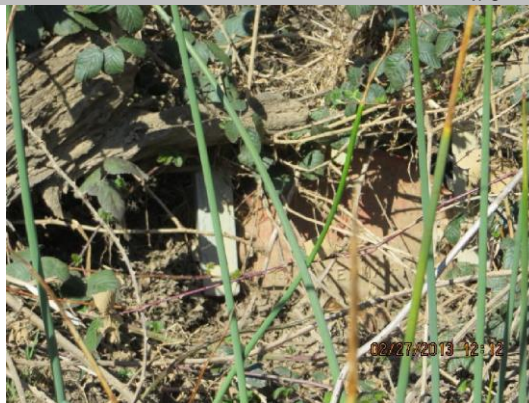
Photo 3 of 3 : UCIP_SP_2019_53542_54265.jpg

Flap gate blocked by vegetation at WS.

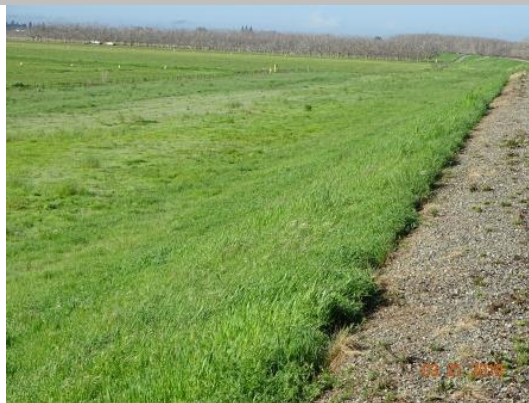
Photo 1 of 1 : SP_2019_RD0784_184_1_20190325_00001.jpg

View looking downstream landside at the well maintained annual vegetation, Spring 2019.

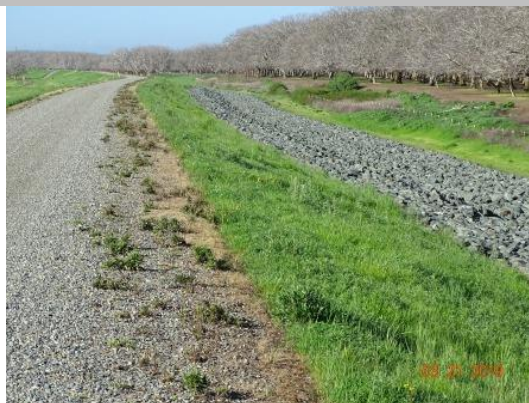
Photo 1 of 1 : SP_2019_RD0784_184_2_20190325_00002.jpg

View looking downstream waterside at the well maintained annual vegetation, Spring 2019.

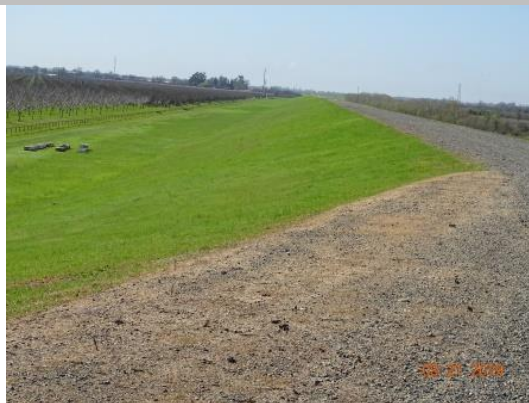
Photo 1 of 1 : SP_2019_RD0784_530_1_20190325_00001.jpg

View looking downstream landside at the well maintained vegetation, Spring 2019.

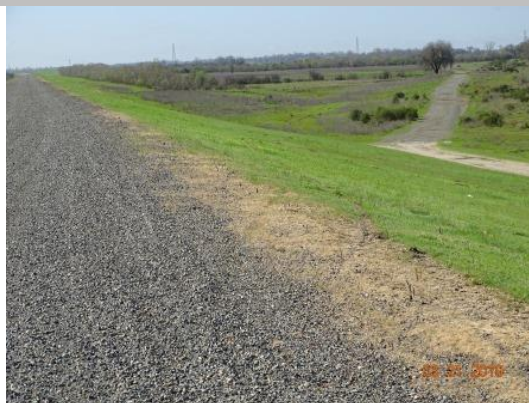
Photo 1 of 1 : SP_2019_RD0784_530_2_20190325_00002.jpg

View looking downstream waterside at the well maintained vegetation, Spring 2019.
