**Flood Control Project Maintenance
Levee Inspections**

Maintenance Issue Types Only, Levee Inspection Report By Mile - Spring 2020

Reclamation District No. 0784 Plumas Lake

Waterway	Bank	Unit Miles	Inspection Start/End	Inspector
Unit No. 01 Yuba River	Left	2.21	03/09/2020 03/09/2020	Sterling York

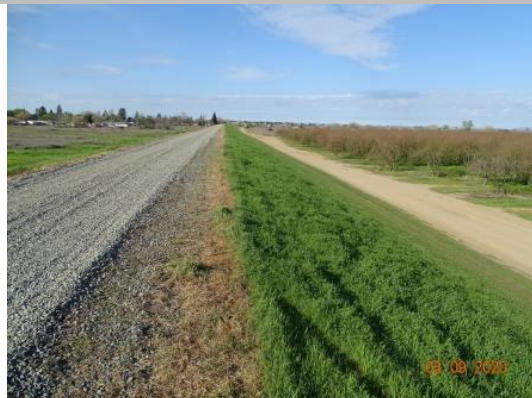
Photo 1 of 1 : SP_2020_RD0784_178_3_20200310_00005.jpg

LM Start	0.04	Rating **	A	Issue No.	3
LM End	2.21	Issue Type +	Ma	Location *	WS
Category	Earthen Levee			GPS Latitude/Longitude	
				Start	End
Item	Vegetation			39.134404 °	39.125840 °
				-121.552729 °	-121.588658 °
DWR ID	DWR_RD0784_01_s_2020_3				
Comment Code					
V1 : Control annual grass and weeds on the levee slopes and easements.					
Inspector Comment					
The annual vegetation is well maintained, Spring 2020.

View looking downstream waterside at the well maintained annual vegetation, Spring 2020.

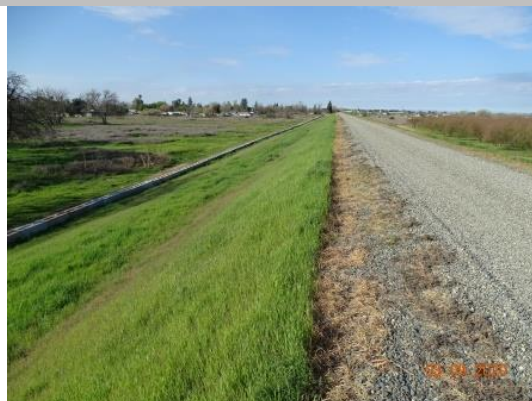
Photo 1 of 1 : SP_2020_RD0784_178_2_20200310_00006.jpg

LM Start	0.04	Rating **	A	Issue No.	2
LM End	2.21	Issue Type +	Ma	Location *	LS
Category	Earthen Levee			GPS Latitude/Longitude	
				Start	End
Item	Vegetation			39.134404 °	39.125840 °
				-121.552729 °	-121.588659 °
DWR ID	DWR_RD0784_01_s_2020_2				
Comment Code					
V1 : Control annual grass and weeds on the levee slopes and easements.					
Inspector Comment					
The annual vegetation is well maintained, Spring 2020.

View looking downstream landside at the well maintained annual vegetation, Spring 2020.

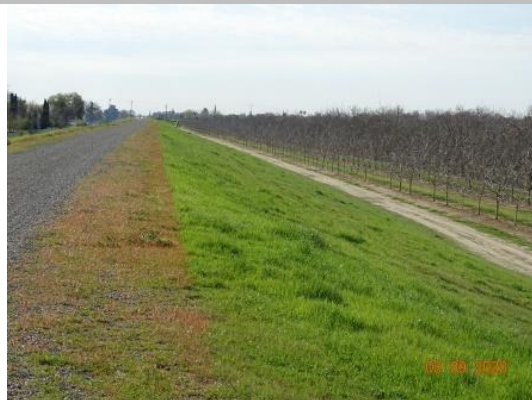
Photo 1 of 1 : SP_2020_RD0784_531_1_20200310_00001.jpg

LM Start	0.00	Rating **	A	Issue No.	1
LM End	2.54	Issue Type +	Ma	Location *	WS
Category	Earthen Levee			GPS Latitude/Longitude	
				Start	End
Item	Vegetation			39.125841 °	39.090345 °
				-121.588659 °	-121.584731 °
DWR ID	DWR_RD0784_02A_s_2020_1				
Comment Code					
V1 : Control annual grass and weeds on the levee slopes and easements.					
Inspector Comment					
The annual vegetation is well maintained, Spring 2020.

View looking downstream waterside at the well maintained annual vegetation, Spring 2020.

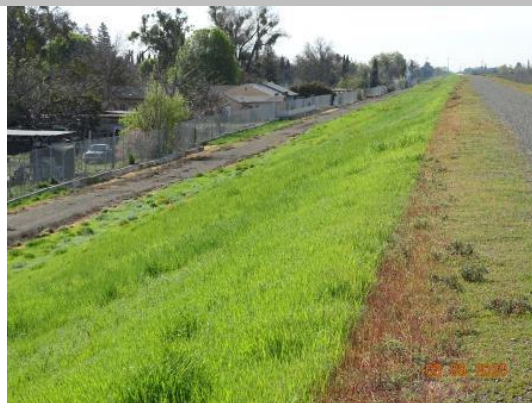
Photo 1 of 1 : SP_2020_RD0784_531_2_20200310_00002.jpg

LM Start	0.00	Rating **	A	Issue No.	2
LM End	2.54	Issue Type +	Ma	Location *	LS
Category	Earthen Levee			GPS Latitude/Longitude	
				Start	End
Item	Vegetation			39.125841 °	39.090345 °
				-121.588659 °	-121.584731 °
DWR ID	DWR_RD0784_02A_s_2020_2				
Comment Code					
V1 : Control annual grass and weeds on the levee slopes and easements.					
Inspector Comment					
The annual vegetation is well maintained, Spring 2020.

View looking downstream landside at the well maintained annual vegetation, Spring 2020.

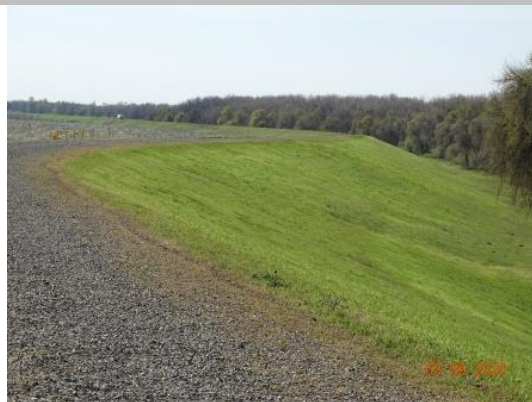
Photo 1 of 1 : SP_2020_RD0784_532_3_20200310_00003.jpg

LM Start	8.97	Rating **	A	Issue No.	3
LM End	12.86	Issue Type +	Ma	Location *	WS
Category	Earthen Levee			GPS Latitude/Longitude	
				Start	End
Item	Vegetation			39.009873 °	38.954664 °
				-121.579154 °	-121.574697 °
DWR ID	DWR_RD0784_02B_s_2020_3				
Comment Code					
V1 : Control annual grass and weeds on the levee slopes and easements.					
Inspector Comment					
The annual vegetation is well maintained, Spring 2020.

View looking downstream waterside at the well maintained annual vegetation, Spring 2020.

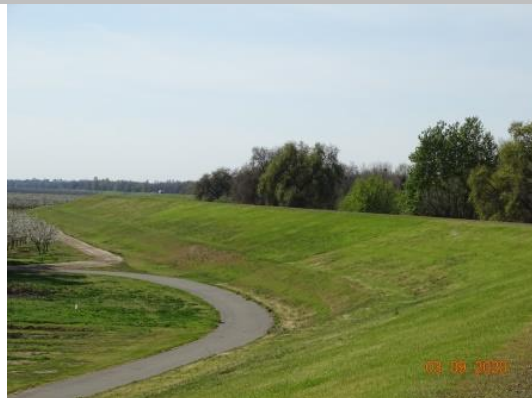
Photo 1 of 1 : SP_2020_RD0784_532_2_20200310_00004.jpg

View looking downstream landside at the well maintained annual vegetation, Spring 2020.

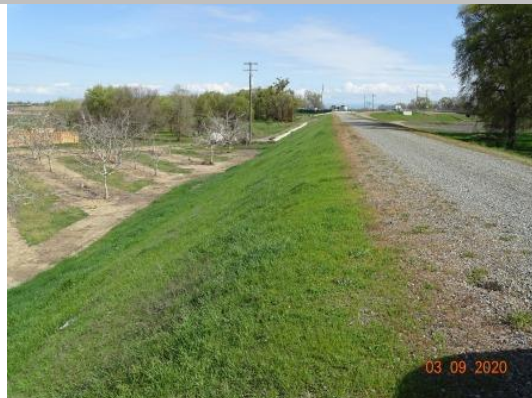
Photo 1 of 1 : SP_2020_RD0784_533_2_20200310_00001.jpg

View looking downstream landside at the well maintained annual vegetation, Spring 2020.

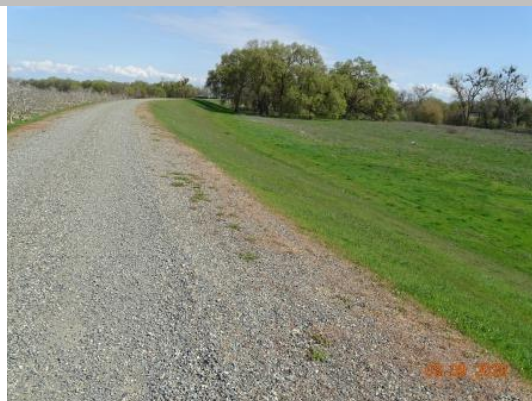
Photo 1 of 1 : SP_2020_RD0784_533_1_20200310_00002.jpg

LM Start	2.43	Rating **	A	Issue No.	1
LM End	3.19	Issue Type +	Ma	Location *	WS
Category	Earthen Levee			GPS Latitude/Longitude	
				Start	End
Item	Vegetation			38.970601 °	38.974692 °
				-121.547555 °	-121.535502 °
DWR ID	DWR_RD0784_03A_s_2020_1				
Comment Code					
V1 : Control annual grass and weeds on the levee slopes and easements.					
Inspector Comment					
The annual vegetation is well maintained, Spring 2020.

View looking downstream waterside at the well maintained annual vegetation, Spring 2020.

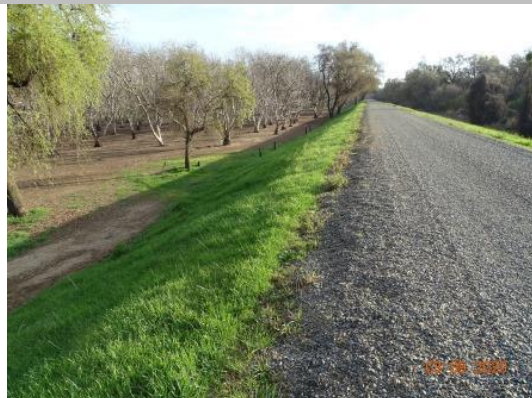
Photo 1 of 1 : SP_2020_RD0784_534_4_20200310_00006.jpg

View looking downstream landside at the well maintained annual vegetation, Spring 2020.

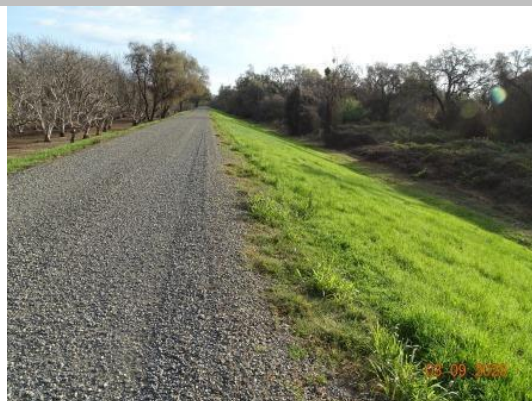
Photo 1 of 1 : SP_2020_RD0784_534_5_20200310_00007.jpg

LM Start	3.22	Rating **	A	Issue No.	5
LM End	4.69	Issue Type +	Ma	Location *	WS
Category	Earthen Levee			GPS Latitude/Longitude	
				Start	End
Item	Vegetation			38.974446 °	38.985475 °
				-121.532407 °	-121.510663 °
DWR ID	DWR_RD0784_03B_s_2020_5				
Comment Code					
V1 : Control annual grass and weeds on the levee slopes and easements.					
Inspector Comment					
The annual vegetation is well maintained, Spring 2020.

View looking downstream waterside at the well maintained annual vegetation, Spring 2020.

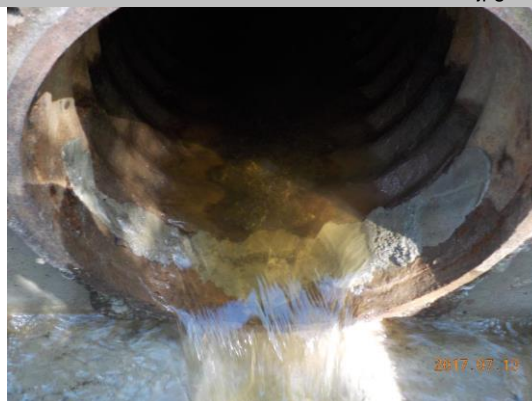
Photo 1 of 3 : UCIP_SP_2020_56110_77114.jpg

DS_ID:18627
FS_ID:56110
EP_NO: N/A
Repair Type: Urgent
Crossing Status: Found
UCIP Comments: 12/16/2019 Pipe crossing was hydroflushed and video inspected (again) in October 2019. Pending final review and recommendations from the RD784 District Engineer and DWR. (P.Meagher RD784)10/16/2018 Internal video inspection was completed recently and the inspection is being evaluated by the District Engineer. Waiting for internal inspection results to determine the internal condition of this crossing. Crossing remains Urgent due to the unknown condition of the pipe through the levee. (O. Magana - DWR UCIP)
11/30/2017 Crossing remains Urgent due to uncertainty of pipe condition through levee -- recommend an internal inspection of the pipe through the levee as a precaution measure to determine integrity of pipe. Repair of the rusted out collar (void) found at the WS pipe outlet has been repaired by the LMA. Received additional photos from DWR levee inspector, S. York, of the WS concrete headwall installed and vegetation cleared from WS. (O. Magana - DWR UCIP)

Close up photo of concrete seal where the rusted out void used to be. Farmer irrigation was currently flowing at the time the photo was taken.

07/13/2017 - The rusted out collar at the bottom of the waterside flap gate has been sealed with concrete. Internal pipe inspections still pending. (P.Meagher-RD784).
04/13/2017 - Spoke to LMA representative, P. Meagher, regarding the status of this crossing. The report has been updated to indicate vegetation has been cleared from WS outlet and LS inlet. The crossing remains Urgent--WS pipe collar is rusted out on the bottom. Recommend internal pipe inspection to determine pipe integrity through the levee. Owner will need to coordinate with the CVFPB to address issue. (O. Magana - DWR UCIP)
01/16/2017 - Landowner who utilizes this pipe reported to RD784 staff on 1/11/2017 that he suspected this pipe at the waterside flap gate ring area was rusted out at the bottom. After investigating, we could see what was reported is correct. Sandbags have been temporarily placed around the 2" +/- gapped area underneath the flap gate ring. A permanent solution is anticipated to be completed in the next 3 to 6 months. The plan is to pour a concrete ring / headwall around the open corroded pipe end. Photos attached. (P. Meagher - RD784).

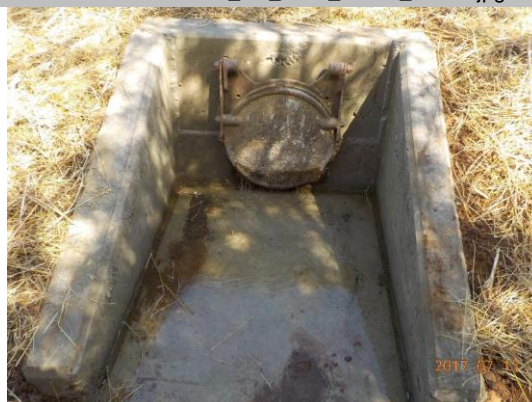
Photo 2 of 3 : UCIP_SP_2020_56110_77115.jpg

Concrete collar completed around the waterside exterior flap gate section.

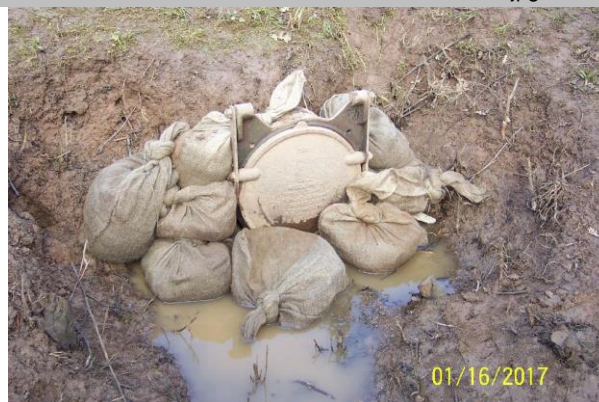
Photo 3 of 3 : UCIP_SP_2020_56110_76618.jpg

Sandbags temporarily placed in front of flapgate.

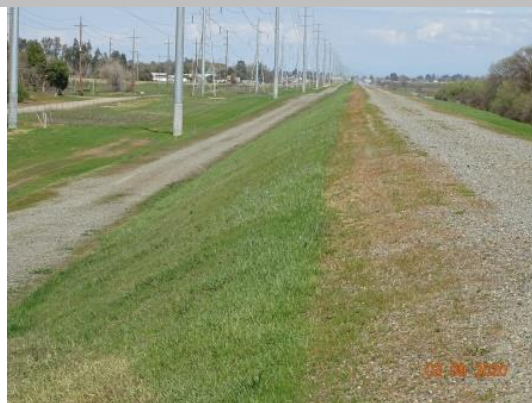
Photo 1 of 1 : SP_2020_RD0784_181_2_20200310_00007.jpg

View looking downstream landside at the well maintained annual vegetation, Spring 2020.

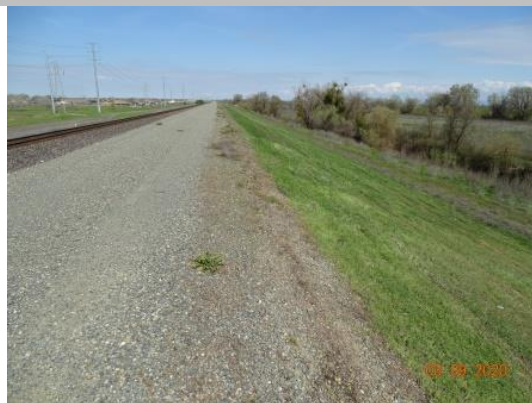
Photo 1 of 1 : SP_2020_RD0784_181_3_20200310_00006.jpg

LM Start	0.00	Rating **	A	Issue No.	3
LM End	6.30	Issue Type +	Ma	Location *	WS
Category	Earthen Levee			GPS Latitude/Longitude	
				Start	End
Item	Vegetation			38.974780 °	39.059261 °
				-121.535082 °	-121.550806 °
DWR ID	DWR_RD0784_04_s_2020_3				
Comment Code					
V1 : Control annual grass and weeds on the levee slopes and easements.					
Inspector Comment					
The annual vegetation is well maintained, Spring 2020.

View looking downstream waterside at the well maintained annual vegetation, Spring 2020.

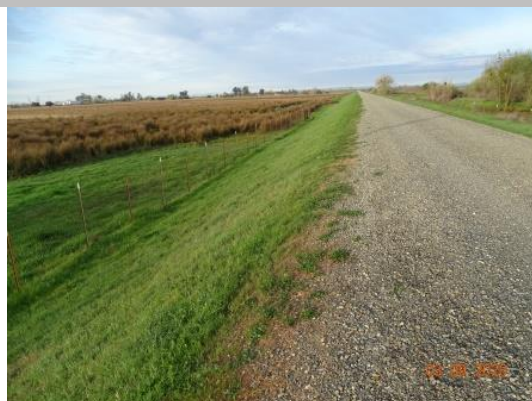
Photo 1 of 1 : SP_2020_RD0784_182_13_20200310_00029.jpg

View looking downstream landside at the well maintained annual vegetation, Spring 2020.

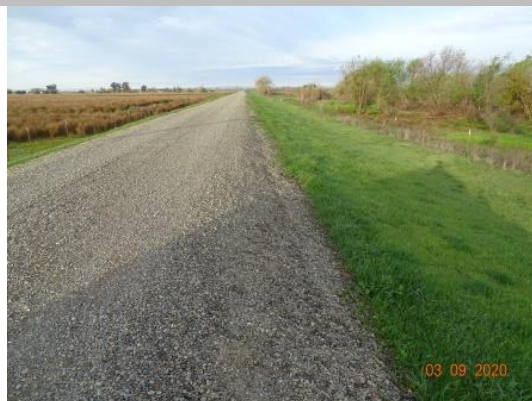
Photo 1 of 1 : SP_2020_RD0784_182_14_20200310_00030.jpg

LM Start	0.01	Rating **	A	Issue No.	14
LM End	4.20	Issue Type +	Ma	Location *	WS
Category	Earthen Levee			GPS Latitude/Longitude	
				Start	End
Item	Vegetation			38.974546 °	39.020572 °
				-121.532548 °	-121.509015 °
DWR ID	DWR_RD0784_05_s_2020_14				
Comment Code					
V1 : Control annual grass and weeds on the levee slopes and easements.					
Inspector Comment					
The annual vegetation is well maintained, Spring 2020.

View looking downstream waterside at the well maintained annual vegetation, Spring 2020.

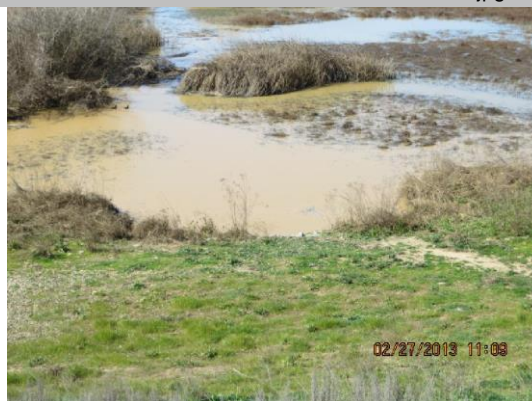
Photo 2 of 2 : UCIP_SP_2020_56112_54245.jpg

Outlet with riprap on WS toe.

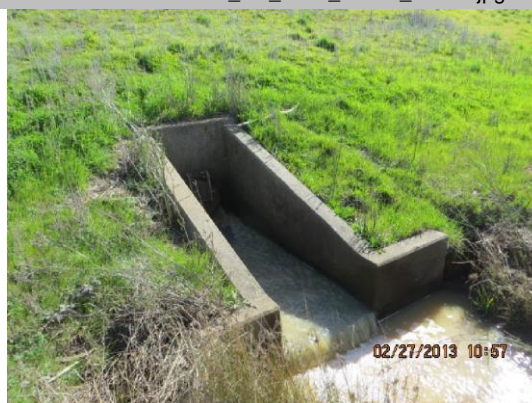
Photo 1 of 3 : UCIP_SP_2020_56119_16565.jpg

DS_ID:18590
 FS_ID:56119
 EP_NO: N/A
 Repair Type: No Action Needed
 Crossing Status: Found
 UCIP Comments: 12/16/2019 Pipe crossing was hydroflushed and video inspected in October 2019. Pending final review by RD784 District Engineer and DWR. (P.Meagher - RD784)2-1-2019 - Pipe crossing was video inspected on 8/14/2018. (P. Meagher)02/26/2013 Good candidate for video inspection. (W. Wylie - DWR UCIP)
 FIELD_STRUCT_DESC: 18-inch corrugated metal drainage pipe through the levee, 14.5 feet below the crown. Flap gate on the waterside (WS) end. Concrete U-shaped headwall on the WS. Polyvinyl chloride weir on inlet. (See Drawing No. 2-4-106, Sheet 5). [Additional Reference(s): DWR Levee Log, 2005. USACE Sacramento O&M Manual 145, August 1955 (Station 103+23)].
 FS Date: 2/26/2013

Concrete U-shaped headwall and flap gate on WS toe.

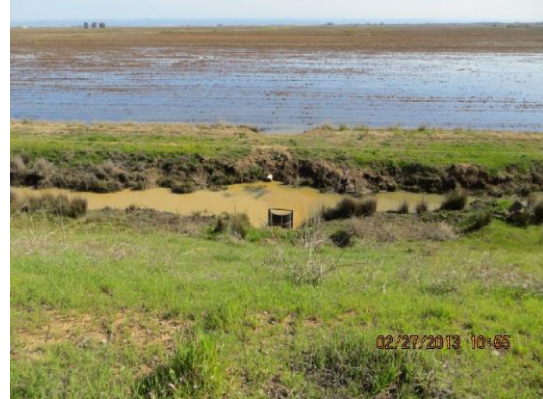
Photo 2 of 3 : UCIP_SP_2020_56119_16563.jpg

Pvc weir on inlet at LS toe.

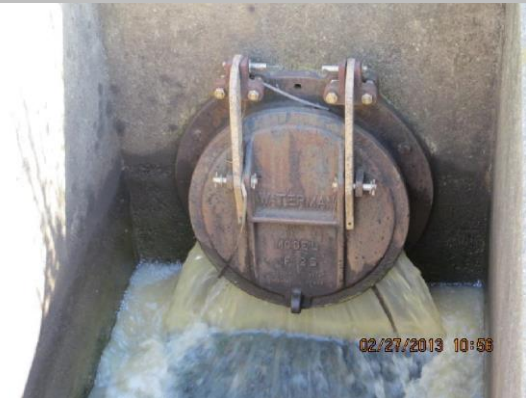
Photo 3 of 3 : UCIP_SP_2020_56119_16562.jpg

Concrete U-shaped headwall and flap gate on WS toe.

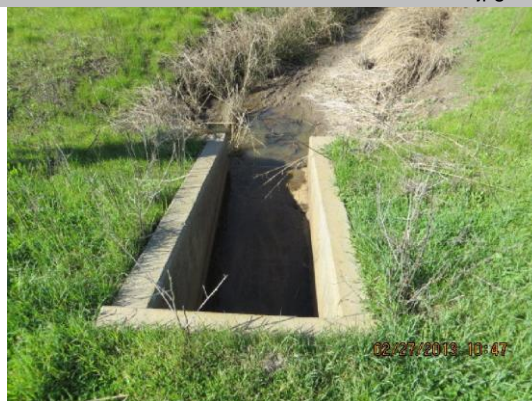
Photo 1 of 3 : UCIP_SP_2020_56113_54247.jpg

Comment Code					
Inspector Comment					
DS_ID:18588 FS_ID:56113 EP_NO: N/A Repair Type: Non-Urgent Crossing Status: Found UCIP Comments: 12/16/2019 Pipe crossing was hydroflushed and video inspected in October 2019. Pending final review by RD784 District Engineer and DWR. (P.Meagher - RD784)2-1-2019 - Pipe crossing was video inspected on 8/14/2018. (P. Meagher)09/11/2015 Inlet buried. Good candidate for video inspection as pipe is corroded. (G. Wylie - FPIIB) FIELD_STRUCT_DESC: 18-inch corrugated metal drainage pipe through the levee, 14.5 feet below the crown. Flap gate on the waterside (WS) end. Concrete U-shaped headwall on the WS. [Additional Reference(s): DWR Levee Log, 2005. USACE Sacramento O&M Manual 145, August 1955 (Station 116+78)]. FS Date: 9/11/2015 9:36:00 AM

Concrete U-shaped outlet and flap-gate on WS toe.

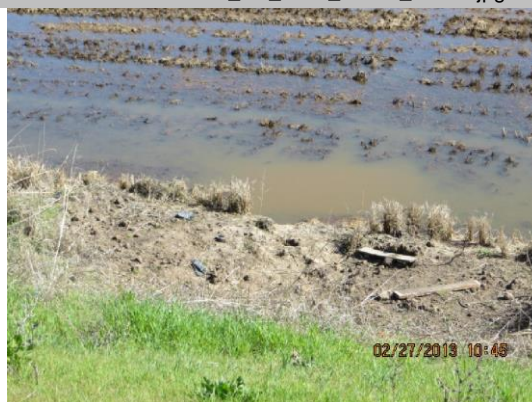
Photo 2 of 3 : UCIP_SP_2020_56113_54248.jpg

Debris covered inlet on LS toe.

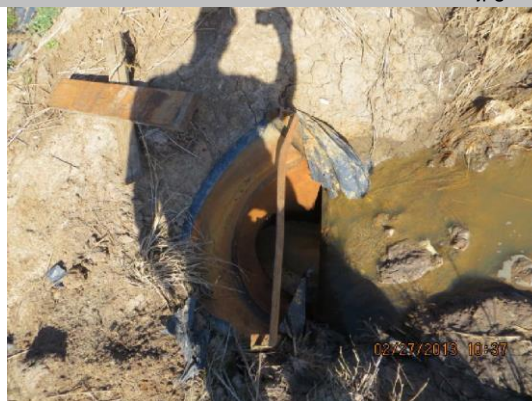
Photo 1 of 3 : UCIP_SP_2020_56111_54250.jpg

UCIP Comments: 12-16-2019 - This pipe crossing was hydroflushed and video inspected (again) in October 2019. Pending final review by RD784 District engineers and DWR. (P.Meagher - RD784)2-1-2019 - The pipe crossing was video inspected on 8/14/2018. New photos of the landside toe added. In August 2017 a sinkhole was noticed at the bottom of the landside toe shelf area. The sinkhole developed as a result of the landowner who extended the existing pipe in order to complete a new unauthorized concrete flashboard structure replacement. The pipe owner was mailed a letter from RD784 with a Cc to CVFPB and DWR dated 10/23/2017 acknowledging the owner's completion of an attempted repair. The sinkhole has since returned.

Inlet with PVC weir on LS toe.

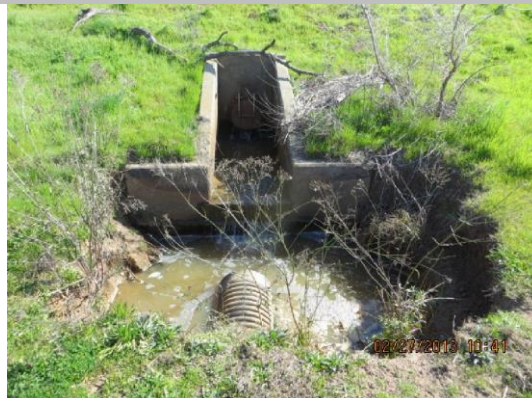
Photo 2 of 3 : UCIP_SP_2020_56111_54253.jpg

Concrete U-shaped headwall on WS toe with Flap gate showing erosion at outlet.

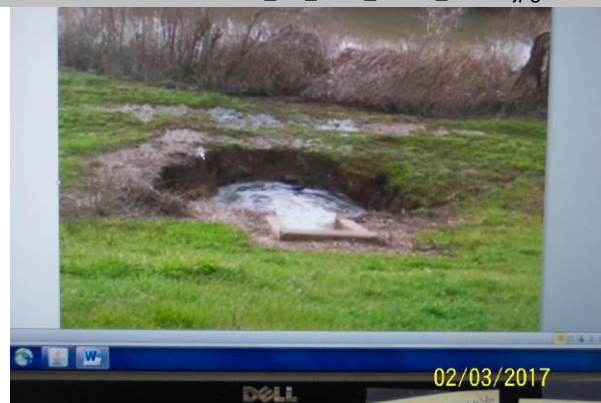
Photo 3 of 3 : UCIP_SP_2020_56111_76774.jpg

After photo after excess pipe was cut off. Actual photo date was 1/31/2017

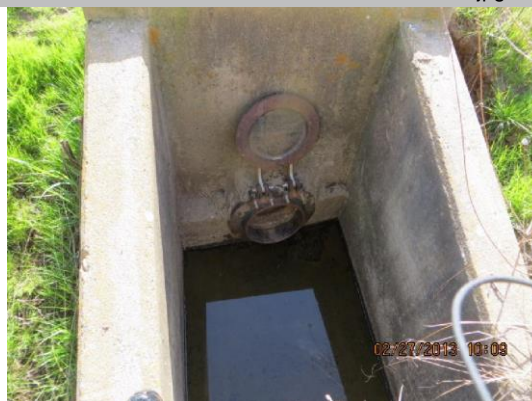
Photo 1 of 3 : UCIP_SP_2020_56114_54259.jpg

Comment Code						
Inspector Comment						
DS_ID:18596 FS_ID:56114 EP_NO: N/A Repair Type: Non-Urgent Crossing Status: Found UCIP Comments: 12/16/2019 Pipe crossing was hydroflushed and video inspected in October 2019. Pending final review by RD784 Engineer and DWR.2-1-2019 - Pipe crossing was video inspected on 8/15/2018. (P. Meagher)02/27/2013 Pipe has been sliplined with PVC, but the liner appears to be eroding at outlet and may be disjointed internal to the levee. See pic. Good candidate for video inspection. (W. Wylie - DWR UCIP) FIELD_STRUCT_DESC: 12-inch corrugated metal drainage pipe through the levee, 12 feet below the crown. Flap gate and concrete U-shaped headwall on the waterside (WS). Polyvinyl chloride weir on inlet at the landside (LS) toe. [Additional Reference(s): DWR Levee Log, 2005. USACE Sacramento O&M Manual 145, August 1955 (Station 44+96)]. FS Date: 9/11/2015 9:26:00 AM

Concrete U-shaped headwall and flap gate on WS toe.

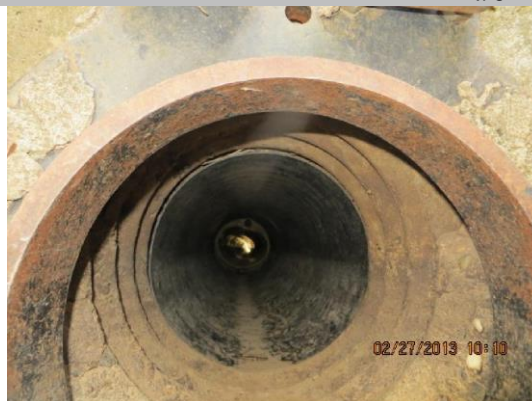
Photo 2 of 3 : UCIP_SP_2020_56114_54262.jpg

Pipe showing sliplined PVC insert. some erosion of PV at outlet and it may be disjointed internally.

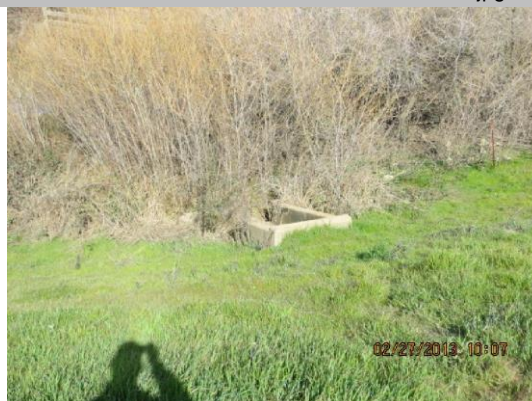
Photo 3 of 3 : UCIP_SP_2020_56114_54261.jpg

Concrete U-shaped headwall on WS toe.

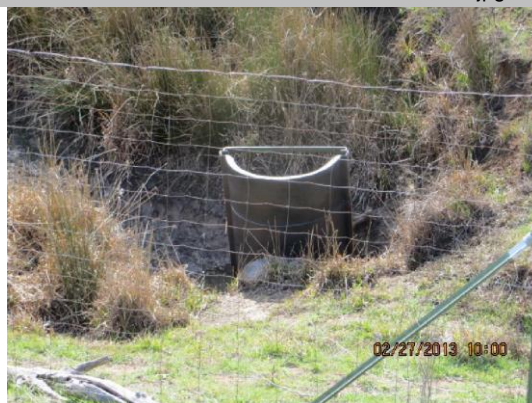
Photo 1 of 2 : UCIP_SP_2020_56115_16594.jpg

DS_ID:18595
 FS_ID:56115
 EP_NO: N/A
 Repair Type: No Action Needed
 Crossing Status: Found
 UCIP Comments: 12/16/2019 - Pipe crossing was hydroflushed and video inspected in October 2019. Pending final review by RD784 District Engineer and DWR.02/01/2019 - Pipe crossing was video inspected on 8/15/2018 (P. Meagher)02/27/2013 Good candidate for video inspection. (W. Wylie - DWR UCIP)
 FIELD_STRUCT_DESC: 18-inch corrugated metal drainage pipe through the levee, 15.8 feet below the crown. Flap gate on the waterside (WS) end. Polyvinyl chloride weir on inlet at the landside (LS) toe. [Additional Reference(s): DWR Levee Log, 2005. USACE Sacramento O&M Manual 145, August 1955, Drawing No. 2-4-106, Sheet 6 (Station 53+86)].
 FS Date: 2/27/2013

PVC weir inlet on LS toe.

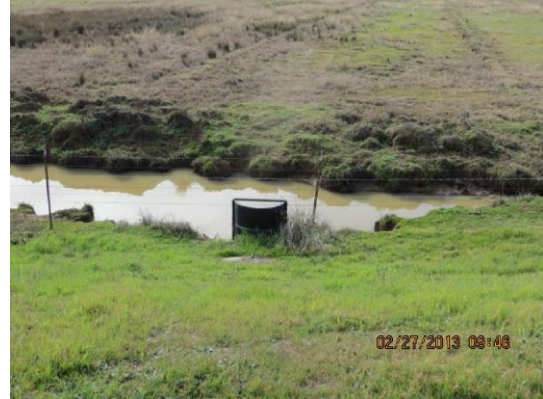
Photo 2 of 3 : UCIP_SP_2020_56117_16591.jpg

PVC weir at inlet on LS toe.

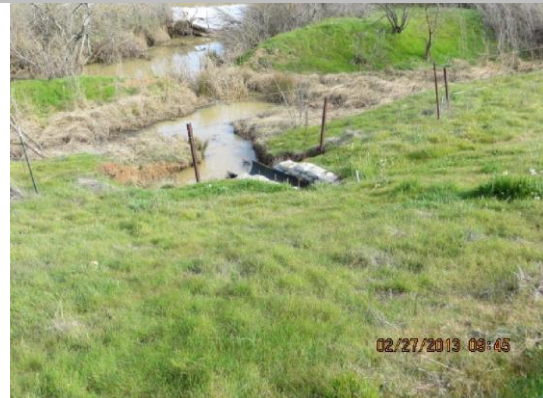
Photo 3 of 3 : UCIP_SP_2020_56117_16592.jpg

Concrete outlet on WS toe.

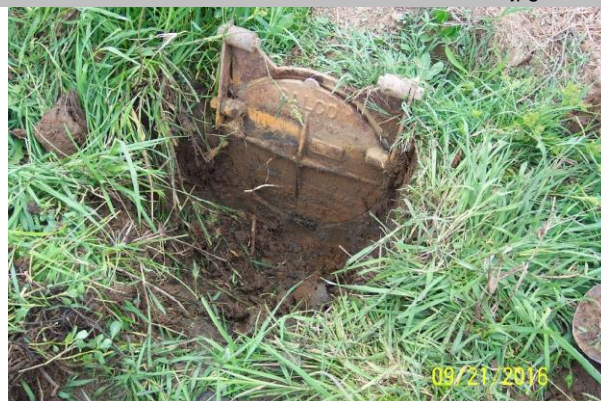
Photo 1 of 3 : UCIP_SP_2020_53550_76147.jpg

Comment Code						
Inspector Comment						
DS_ID:18593 FS_ID:53550 EP_NO: N/A Repair Type: Non-Urgent Crossing Status: Found UCIP Comments: 2/1/2019 - An attempt was made to video inspect this pipe crossing on 8/15/2018 but conditions were too muddy inside the pipe. (P. Meagher)11/14/2016 - Photos added of exposed flap gate on WS and possible inlet location on LS. Condition remains as Non-Urgent because of inlet not being fully operable. Unknown if pipe will operate as designed during high water or if it is full of sediment.11/01/2015 - Waterside Flap Gate Uncovered. Photo sent to DWR Matt Hoffman on 3/3/2014. Fresh photo sent to DWR Pavel Kazi on 9/9/2015. Landside toe has never been able to be located. Requesting DWR inspector to change the status of this issue to "No Action Needed". (P.Meagher - RD784).Pipe buried on LS toe and flap gate is blocked by soil on WS toe. (W. Wylie - UCIP Inspector). FIELD_STRUCT_DESC: 18-inch corrugated metal drainage pipe through the levee, 10 feet below the crown. Flap gate on the waterside (WS) end. [Additional Reference(s): DWR Levee Log, 2005. USACE Sacramento O&M Manual 145, August 1955 (Station 91+50)]. FS Date: 10/9/2015

Flap gate on the WS toe is exposed

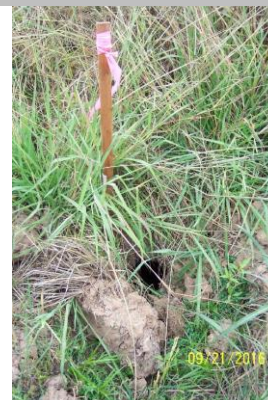
Photo 2 of 3 : UCIP_SP_2020_53550_76148.jpg

Possible location of the inlet on the LS toe

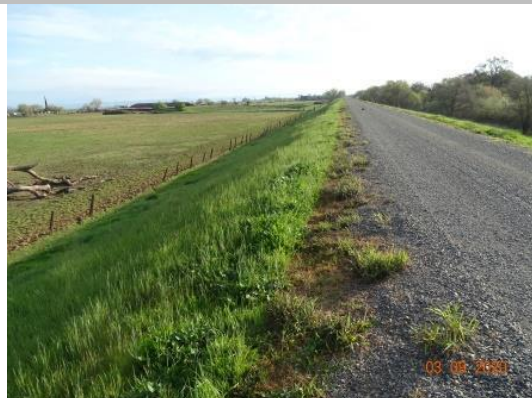
Photo 1 of 1 : SP_2020_RD0784_183_2_20200310_00005.jpg

View looking downstream landside at the well maintained annual vegetation, Spring 2020.

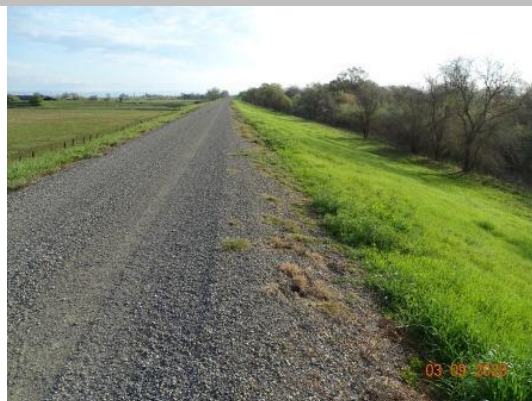
Photo 1 of 1 : SP_2020_RD0784_183_3_20200310_00004.jpg

View looking downstream waterside at the well maintained annual vegetation, Spring 2020.

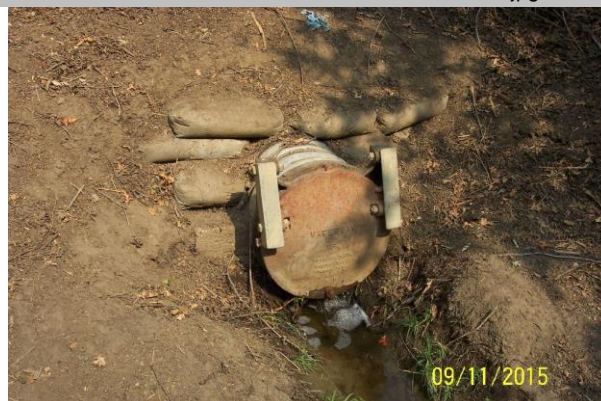
Photo 1 of 3 : UCIP_SP_2020_56120_74682.jpg

Comment Code						
Inspector Comment						
DS_ID:18626 FS_ID:56120 EP_NO: N/A Repair Type: Non-Urgent Crossing Status: Found UCIP Comments: 12/16/2019 Pipe was hydroflushed and video inspected (again) in October 2019. Pending final review by RD784 District Engineer and DWR. (P.Meagher - RD784)2-1-2019 - Pipe was video inspected on 8/13/2018. (P. Meagher)10-30-2015 - Waterside flap gate was cleared in December 2014 and again in September 2015 No LMA access available on Landside (P. Meagher).Pipe partially blocked on LS and flap gate blocked on WS (W. Wylie-UCIP Inspector) FIELD_STRUCT_DESC: 18-inch corrugated metal storm drainage pipe through the levee, 19 feet below the crown. Gate valve on the waterside (WS). [Additional Reference(s): USACE Drawing No. 2-4-106, Sheet 2]. FS Date: 9/11/2015

Flap Gate is clear as of 9/11/15.

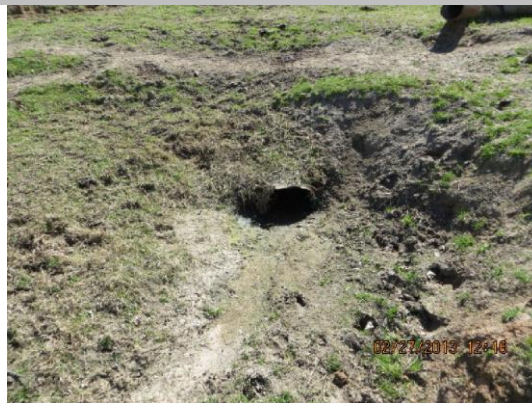
Photo 2 of 3 : UCIP_SP_2020_56120_54268.jpg

Partially clogged inlet pipe at LS toe.

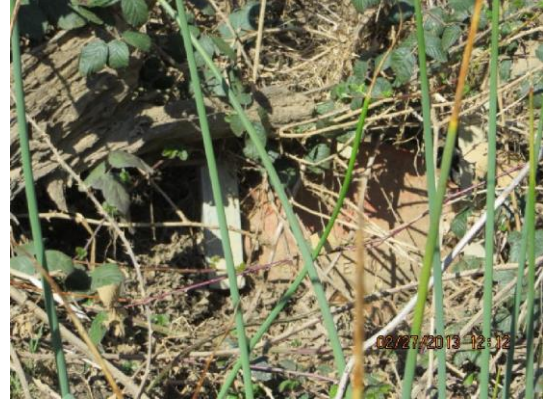
Photo 3 of 3 : UCIP_SP_2020_56120_54265.jpg

Flap gate blocked by vegetation at WS.

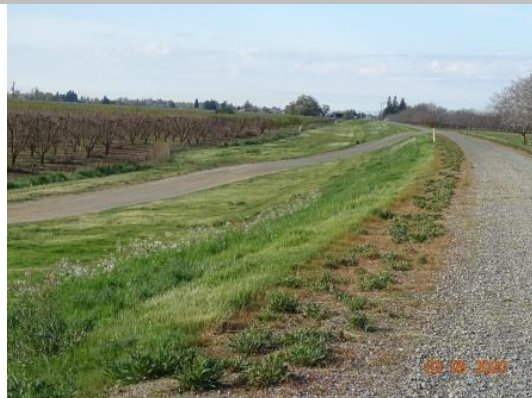
Photo 1 of 1 : SP_2020_RD0784_184_1_20200310_00002.jpg

View looking downstream landside at the well maintained annual vegetation, Spring 2020.

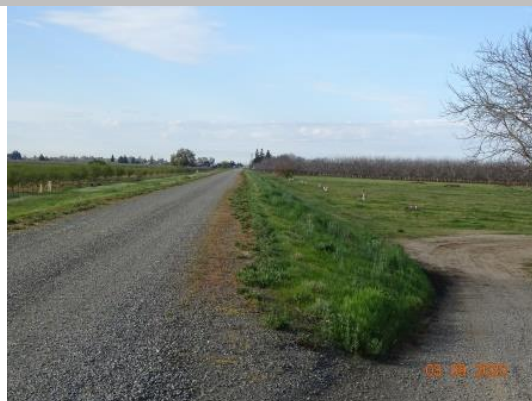
Photo 1 of 1 : SP_2020_RD0784_184_2_20200310_00001.jpg

View looking downstream waterside at the well maintained annual vegetation, Spring 2020.

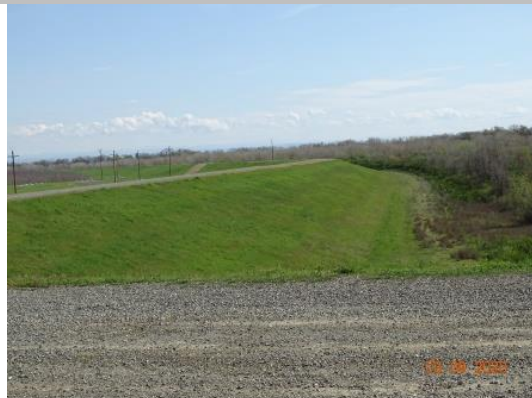
Photo 1 of 1 : SP_2020_RD0784_437_2_20200310_00002.jpg

View looking downstream waterside at the well maintained annual vegetation, Spring 2020.

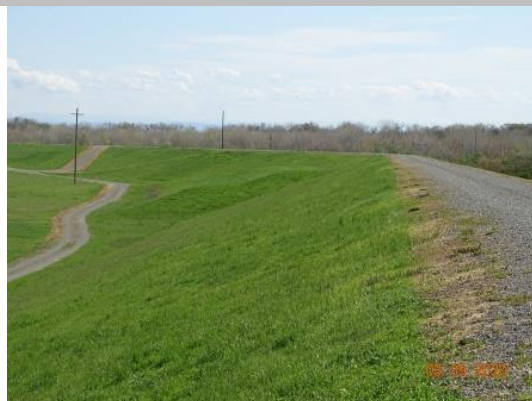
Photo 1 of 1 : SP_2020_RD0784_437_1_20200310_00003.jpg

View looking downstream landside at the well maintained annual vegetation, Spring 2020.

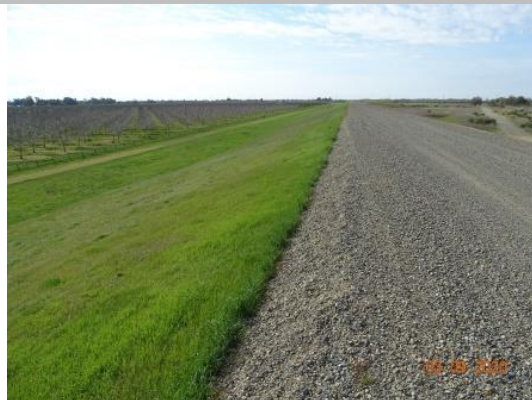
Photo 1 of 1 : SP_2020_RD0784_530_1_20200310_00001.jpg

View looking downstream landside at the well maintained annual vegetation, Spring 2020.

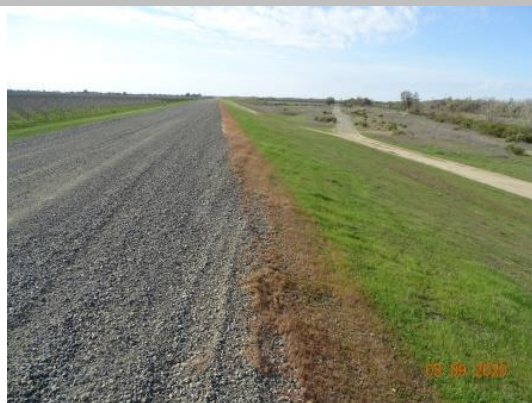
Photo 1 of 1 : SP_2020_RD0784_530_2_20200310_00002.jpg

View looking downstream waterside at the well maintained annual vegetation, Spring 2020.
