**Flood Control Project Maintenance
Levee Inspections**

Maintenance Issue Types Only, Levee Inspection Report By Mile - Spring 2021

Reclamation District No. 0784 Plumas Lake

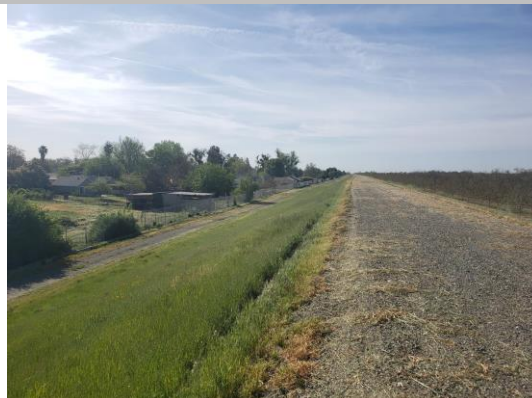
Photo 1 of 1 : SP_2021_RD0784_531_1_20210421_00001.jpg

LM Start	0.33	Rating **	A	Issue No.	1
LM End	2.53	Issue Type +	Ma	Location *	LS
Category	Earthen Levee			GPS Latitude/Longitude	
				Start	End
Item	Vegetation			39.121179 °	39.090432 °
				-121.587160 °	-121.584646 °
DWR ID	DWR_RD0784_02A_s_2021_1				
Comment Code					
V1 : Control annual grass and weeds on the levee slopes and easements.					
Inspector Comment					
Annual vegetation is well maintained, Spring 2021.

View of annual vegetation on landside slope, Spring 2021.

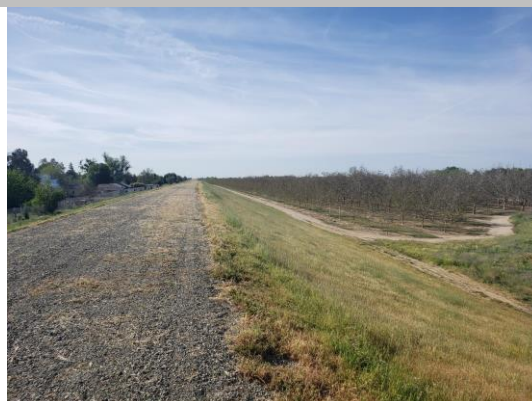
Photo 1 of 1 : SP_2021_RD0784_531_2_20210421_00002.jpg

LM Start	0.33	Rating **	A	Issue No.	2
LM End	2.53	Issue Type +	Ma	Location *	WS
Category	Earthen Levee			GPS Latitude/Longitude	
				Start	End
Item	Vegetation			39.121178 °	39.090432 °
				-121.587155 °	-121.584646 °
DWR ID	DWR_RD0784_02A_s_2021_2				
Comment Code					
V1 : Control annual grass and weeds on the levee slopes and easements.					
Inspector Comment					
Annual vegetation is well maintained, Spring 2021.

View of annual vegetation on waterside slope, Spring 2021.

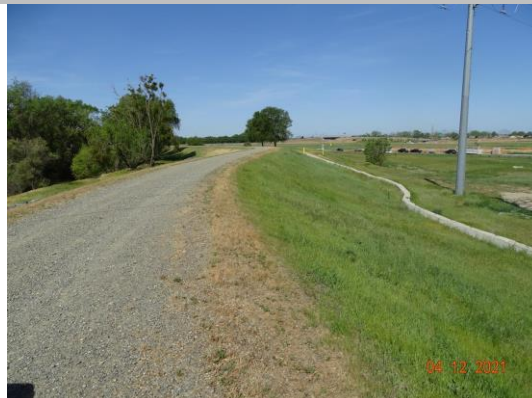
Photo 1 of 1 : SP_2021_RD0784_533_1_20210421_00003.jpg

LM Start	2.43	Rating **	A	Issue No.	1
LM End	3.21	Issue Type +	Ma	Location *	LS
Category	Earthen Levee			GPS Latitude/Longitude	
				Start	End
Item	Vegetation			38.970596 °	38.974707 °
				-121.547528 °	-121.535151 °
DWR ID	DWR_RD0784_03A_s_2021_1				
Comment Code					
V1 : Control annual grass and weeds on the levee slopes and easements.					
Inspector Comment					
Annual vegetation is well maintained, Spring 2021.

View of annual vegetation on landside slope, Spring 2021.

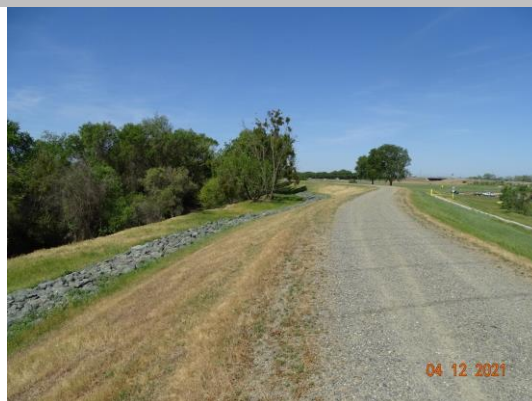
Photo 1 of 1 : SP_2021_RD0784_533_2_20210421_00002.jpg

LM Start	2.43	Rating **	A	Issue No.	2
LM End	3.21	Issue Type +	Ma	Location *	WS
Category	Earthen Levee			GPS Latitude/Longitude	
				Start	End
Item	Vegetation			38.970596 °	38.974707 °
				-121.547528 °	-121.535151 °
DWR ID	DWR_RD0784_03A_s_2021_2				
Comment Code					
V1 : Control annual grass and weeds on the levee slopes and easements.					
Inspector Comment					
Annual vegetation is well maintained, Spring 2021.

View of annual vegetation on waterside slope, Spring 2021.

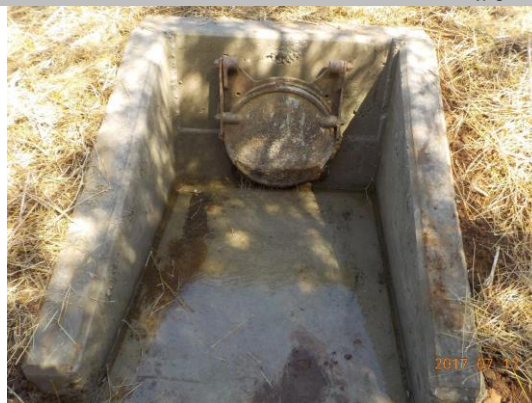
Photo 2 of 3 : UCIP_SP_2021_61742_77115.jpg

Concrete collar completed around the waterside exterior flap gate section.

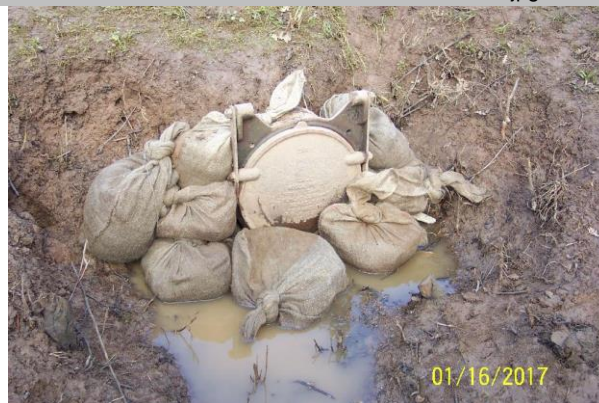
Photo 3 of 3 : UCIP_SP_2021_61742_76618.jpg

Sandbags temporarily placed in front of flapgate.

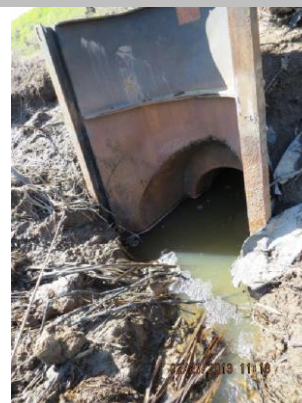
Photo 1 of 3 : UCIP_SP_2021_61747_16552.jpg

inlet control structure on LS toe.

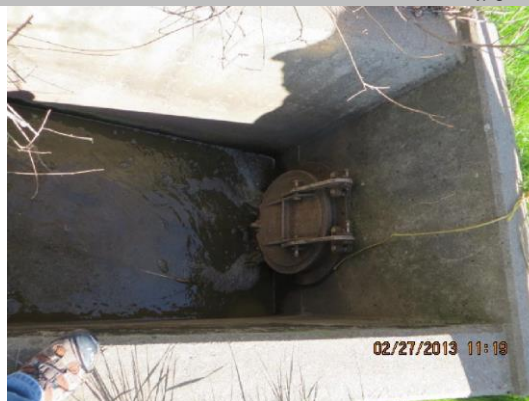
Photo 2 of 3 : UCIP_SP_2021_61747_16555.jpg

Concrete U-shaped outlet with flap gate on WS toe.

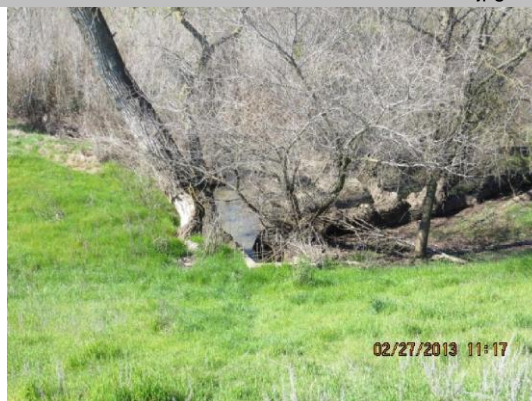
Photo 3 of 3 : UCIP_SP_2021_61747_16554.jpg

Concrete U-shaped outlet on WS toe.

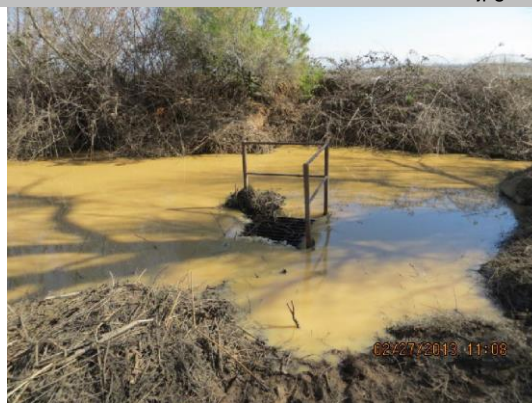
Photo 1 of 2 : UCIP_SP_2021_61748_54246.jpg

FS_ID:61748
DS_ID:18591
EP_NO: N/A
Repair Type: Non-Urgent
Crossing Status: Found
UCIP Comments: 12/16/2019 - Pipe crossing was hydroflushed and video inspected (again) in October 2019. Pending final review by RD784 Engineer and DWR. (P.Meagher - RD784)02/01/2019 - Pipe crossing was video inspected on 8/14/2018. (P. Meagher)02/26/2013 - No handle or access to slide gate on LS toe. (W. Wylie - DWR UCIP)
FIELD_STRUCT_DESC: 30-inch corrugated metal drainage pipe through the levee, 23.7 feet below the crown. Flap gate on the waterside (WS) end. Slide gate inside a concrete drop inlet on the landside (LS). [Additional Reference(s): DWR Levee Log, 2005 (HLM 0.82), listed as a 30-inch CMP. USACE Sacramento O&M Manual, Unit No. 145, August 1955, Revised 6 Aug 2019, (Station 63+00)].
FS Date: 9/11/2015 9:05:00 AM

Concrete drop-inlet at LS toe.

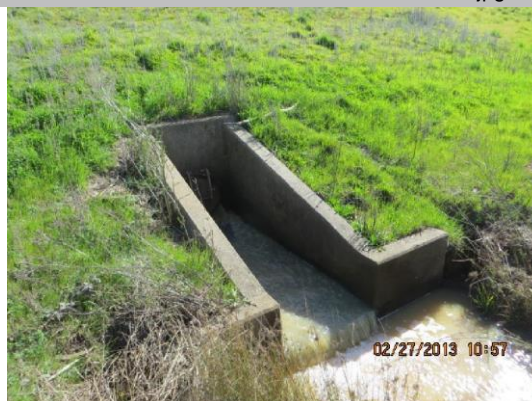
Photo 1 of 3 : UCIP_SP_2021_61749_16565.jpg

FS_ID:61749
DS_ID:18590
EP_NO: N/A
Repair Type: No Action Needed
Crossing Status: Found
UCIP Comments: 12/16/2019 - Pipe crossing was hydroflushed and video inspected in October 2019. Pending final review by RD784 District Engineer and DWR. (P. Meagher - RD784)02/01/2019 - Pipe crossing was video inspected on 8-14-2018. (P. Meagher)02/26/2013 - Good candidate for video inspection. (W. Wylie - DWR UCIP)
FIELD_STRUCT_DESC: 18-inch corrugated metal drainage pipe through the levee, 14.5 feet below the crown. Flap gate on the waterside (WS) end. Concrete U-shaped headwall on the WS. Polyvinyl chloride weir on inlet. [Additional Reference(s): DWR Levee Log, 2005 (HLM 1.60), listed as 18-inch CMP. USACE Sacramento O&M Manual, Unit No. 145, August 1955, Revised 6 Aug 2019, (Station 103+23), Drawing No. 2-4-106, Sheet 5].
FS Date: 2/26/2013

Concrete U-shaped headwall and flap gate on WS toe.

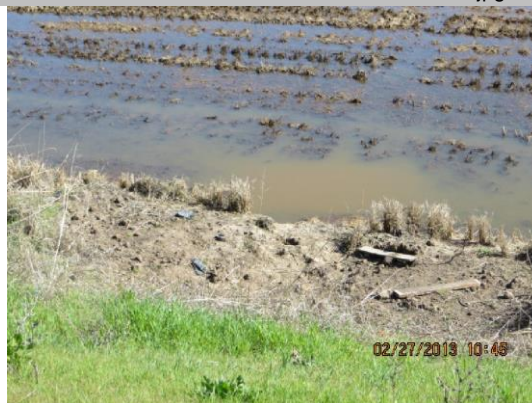
Photo 2 of 3 : UCIP_SP_2021_61750_54248.jpg

Debris covered inlet on LS toe.

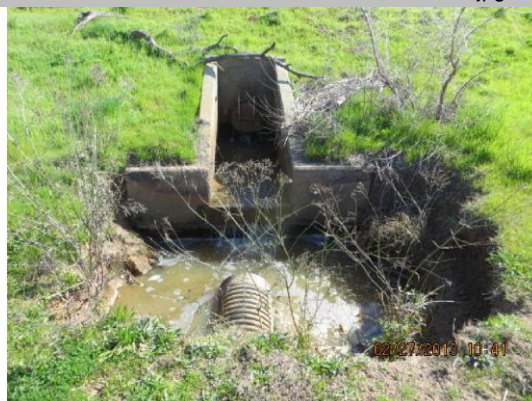
Photo 2 of 3 : UCIP_SP_2021_61751_54253.jpg

Concrete U-shaped headwall on WS toe with Flap gate showing erosion at outlet.

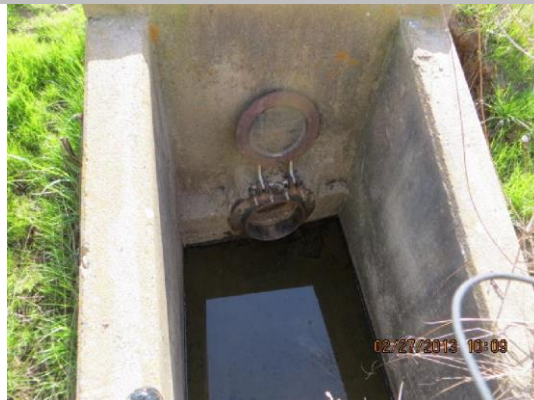
Photo 1 of 3 : UCIP_SP_2021_61754_54259.jpg

FS_ID:61754
DS_ID:18596
EP_NO: N/A
Repair Type: Non-Urgent
Crossing Status: Found
UCIP Comments: 12/16/2019 - Pipe crossing was hydroflushed and video inspected in October 2019. Pending final review by RD784 Engineer and DWR. (P. Meagher - RD784)02/01/2019 - Pipe crossing was video inspected on 8-15-2018. (P. Meagher - RD784)02/27/2013 - Pipe has been sliplined with PVC, but the liner appears to be eroding at outlet and may be disjointed internal to the levee. See pic. Good candidate for video inspection. (W. Wylie - DWR UCIP)
FIELD_STRUCT_DESC: 12-inch corrugated metal drainage pipe through the levee, 12 feet below the crown. Flap gate and concrete U-shaped headwall on the waterside (WS). Polyvinyl chloride weir on inlet at the landside (LS) toe. [Additional Reference(s): DWR Levee Log, 2005 (HLM 3.08), listed as 12-inch CMP. USACE Sacramento O&M Manual, Unit No. 145, August 1955, Revised 6 Aug 2019, (Station 44+96)].

Concrete U-shaped headwall and flap gate on WS toe.

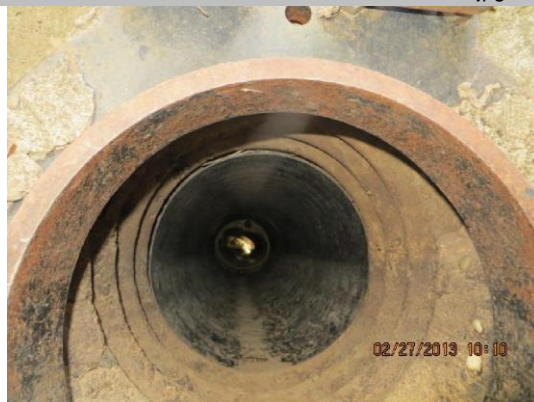
Photo 2 of 3 : UCIP_SP_2021_61754_54262.jpg

Pipe showing sliplined PVC insert. some erosion of PV at outlet and it may be disjointed internally.

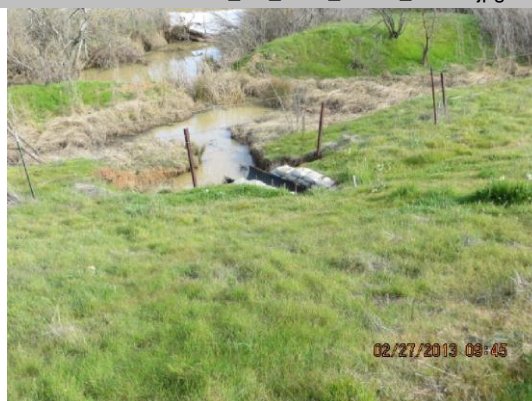
Photo 3 of 3 : UCIP_SP_2021_61756_16592.jpg

Concrete outlet on WS toe.

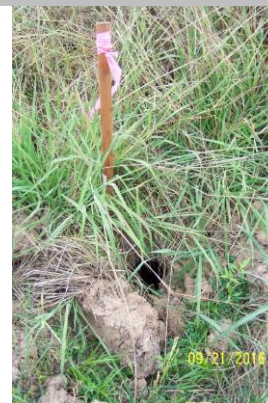
Photo 2 of 3 : UCIP_SP_2021_61757_76148.jpg

Possible location of the inlet on the LS toe

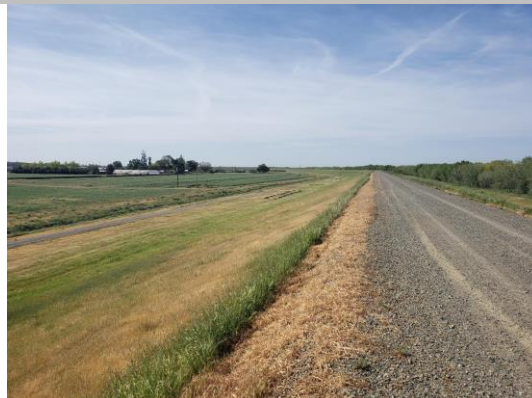
Photo 1 of 1 : SP_2021_RD0784_183_2_20210421_00004.jpg

View of annual vegetation on landside slope, Spring 2021.

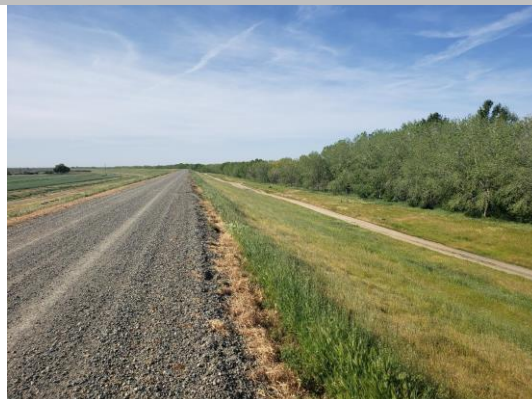
Photo 1 of 1 : SP_2021_RD0784_183_3_20210421_00005.jpg

LM Start	0.00	Rating **	A	Issue No.	3
LM End	0.25	Issue Type +	Ma	Location *	WS
Category	Earthen Levee			GPS Latitude/Longitude	
				Start	End
Item	Vegetation			38.985554 °	38.987575 °
				-121.510470 °	-121.506615 °
DWR ID	DWR_RD0784_06_s_2021_3				
Comment Code					
V1 : Control annual grass and weeds on the levee slopes and easements.					
Inspector Comment					
Annual vegetation is well maintained, Spring 2021.

View of annual vegetation on waterside slope, Spring 2021.

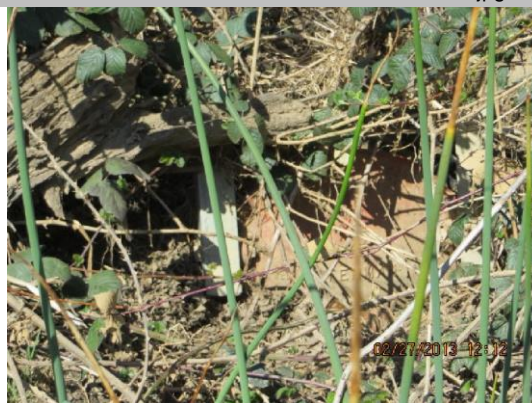
Photo 3 of 3 : UCIP_SP_2021_61758_54265.jpg

Flap gate blocked by vegetation at WS.

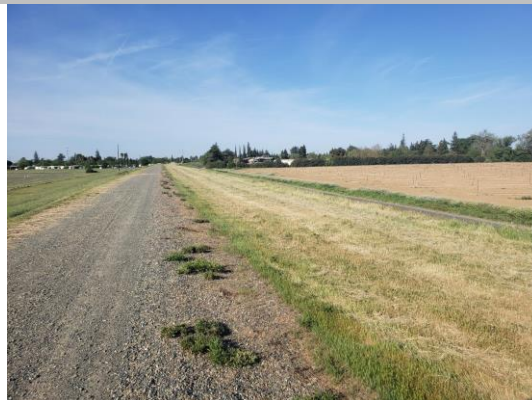
Photo 1 of 1 : SP_2021_RD0784_184_2_20210421_00003.jpg

View of annual vegetation on waterside levee slope, Spring 2021.

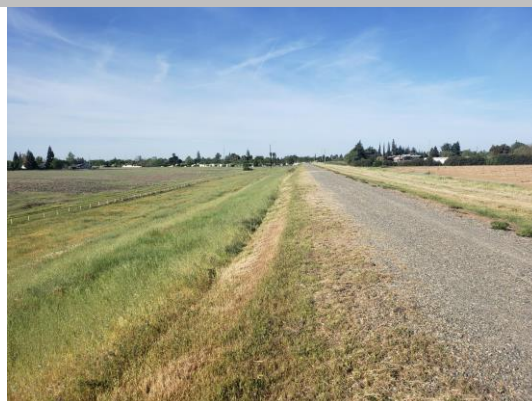
Photo 1 of 1 : SP_2021_RD0784_184_1_20210421_00004.jpg

LM Start	0.00	Rating **	A	Issue No.	1	
LM End	3.61	Issue Type +	Ma	Location *	LS	
Category	Earthen Levee			GPS Latitude/Longitude		
				Start		End
Item	Vegetation			39.134878 °		39.163980 °
				-121.552262 °		-121.498778 °
DWR ID	DWR_RD0784_07_s_2021_1					
Comment Code						
V1 : Control annual grass and weeds on the levee slopes and easements.						
Inspector Comment

View of annual vegetation on landside levee slope, Spring 2021.

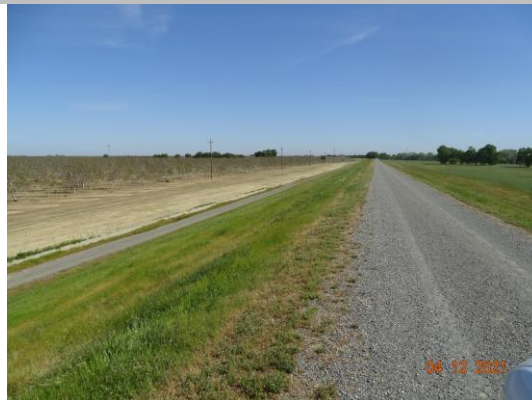
Photo 1 of 1 : SP_2021_RD0784_437_1_20210421_00002.jpg

View of annual vegetation on landside slope, Spring 2021.

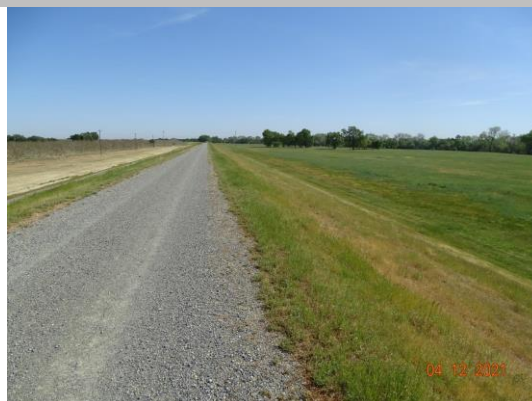
Photo 1 of 1 : SP_2021_RD0784_437_2_20210421_00001.jpg

LM Start	0.00	Rating **	A	Issue No.	2
LM End	1.90	Issue Type +	Ma	Location *	WS
Category	Earthen Levee			GPS Latitude/Longitude	
				Start	End
Item	Vegetation			38.955457 °	38.970199 °
				-121.574954 °	121.547793 °
DWR ID	DWR_RD0784_08_s_2021_2				
Comment Code					
V1 : Control annual grass and weeds on the levee slopes and easements.					
Inspector Comment					
Annual vegetation is well maintained, Spring 2021.

View of annual vegetation on waterside slope, Spring 2021.

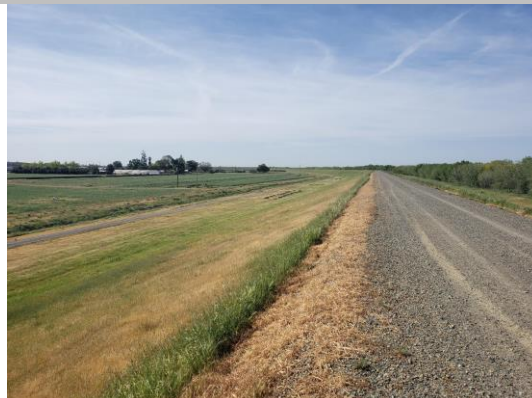
Photo 1 of 1 : SP_2021_RD0784_530_1_20210421_00001.jpg

View of annual vegetation on landside slope, Spring 2021.

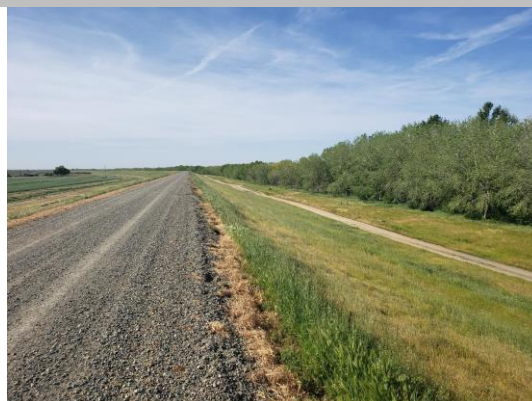
Photo 1 of 1 : SP_2021_RD0784_530_2_20210421_00002.jpg

LM Start	0.00	Rating **	A	Issue No.	2
LM End	5.70	Issue Type +	Ma	Location *	WS
Category	Earthen Levee			GPS Latitude/Longitude	
				Start	End
Item	Vegetation			39.090305 °	39.010236 °
				-121.584686 °	-121.579518 °
DWR ID	DWR_RD0784_09_s_2021_2				
Comment Code					
V1 : Control annual grass and weeds on the levee slopes and easements.					
Inspector Comment					
Annual vegetation is well maintained, Spring 2021.

View of annual vegetation on waterside slope, Spring 2021.
