**Flood Control Project Maintenance  
Levee Inspections**

**Maintenance Issue Types Only, Levee Inspection Report By Mile - Spring 2022**

**Reclamation District No. 0784 Plumas Lake**

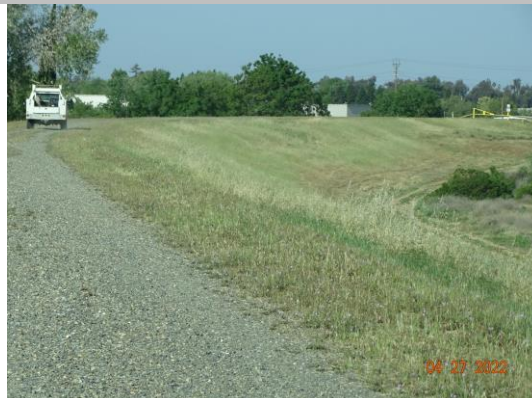
Photo 1 of 1 : SP\_2022\_RD0784\_178\_24\_20220503\_00029.jpg

LM Start	0.04	Rating **	M	Issue No.	24
LM End	2.20	Issue Type +	Ma	Location *	WS
Category	Earthen Levee			GPS Latitude/Longitude	
				Start	End
Item	Vegetation			39.134436 °	39.125944 °
				-121.552701 °	-121.588611 °
DWR ID	DWR_RD0784_01_s_2022_24				
Comment Code					
V1 : Control annual grass and weeds on the levee slopes and easements.					
Inspector Comment					
Annual vegetation on the waterside slope needs to be maintained, Spring 2022.

View of vegetation on the waterside slope, Spring 2022.

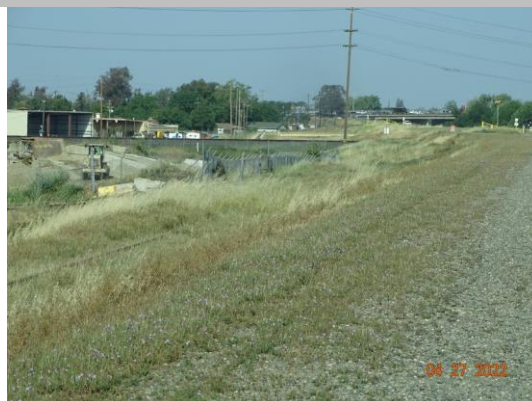
Photo 1 of 1 : SP\_2022\_RD0784\_178\_23\_20220503\_00030.jpg

LM Start	0.04	Rating **	M	Issue No.	23
LM End	2.20	Issue Type +	Ma	Location *	LS
Category	Earthen Levee			GPS Latitude/Longitude	
				Start	End
Item	Vegetation			39.134432 °	39.125943 °
				-121.552698 °	-121.588611 °
DWR ID	DWR_RD0784_01_s_2022_23				
Comment Code					
V1 : Control annual grass and weeds on the levee slopes and easements.					
Inspector Comment

View of annual vegetation on the landside slope, Spring 2022.

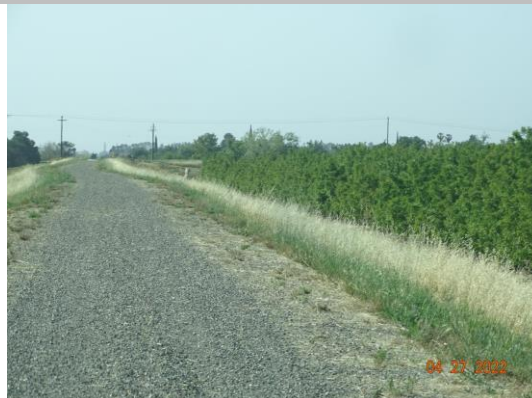
Photo 1 of 1 : SP\_2022\_RD0784\_531\_3\_20220503\_00004.jpg

View of annual vegetation on the waterside slope, Spring 2022.

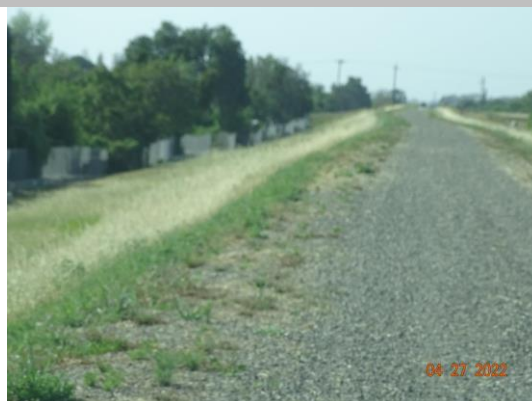
Photo 1 of 1 : SP\_2022\_RD0784\_531\_2\_20220503\_00005.jpg

LM Start	0.10	Rating **	M	Issue No.	2
LM End	2.54	Issue Type +	Ma	Location *	LS
Category	Earthen Levee			GPS Latitude/Longitude	
				Start	End
Item	Vegetation			39.124362 °	39.090305 °
				-121.588318 °	-121.584736 °
DWR ID	DWR_RD0784_02A_s_2022_2				
Comment Code					
V1 : Control annual grass and weeds on the levee slopes and easements.					
Inspector Comment					
Annual vegetation on the landside slope needs to be maintained, Spring 2022.

View of annual vegetation on the landside slope, Spring 2022.

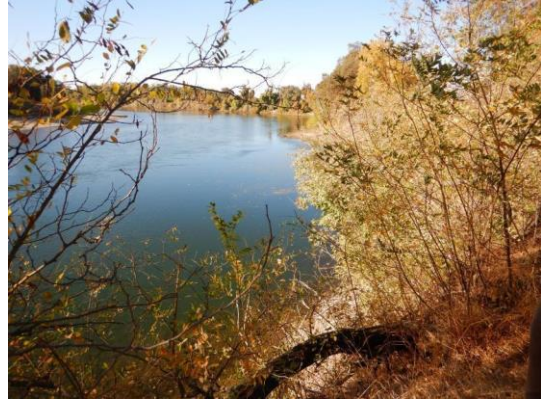
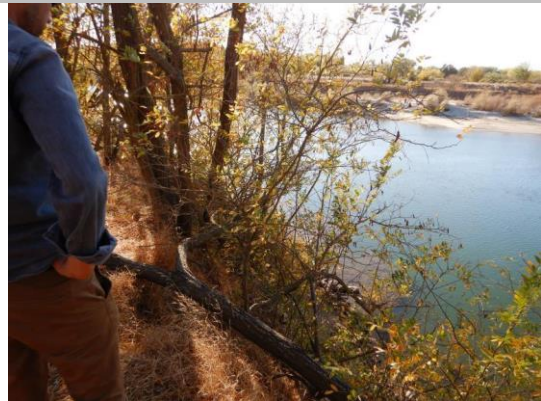
2018 Site ID: FHR 17.8 L  
 Status: Eroding  
 2018 Field Notes: Site continues to erode.  
 Site History: 2003 - Bank is near vertical. Identified as a Potentially Critical site. 2004 - Eddy flow off downstream end of Modesto formation eroding the fluvial sediments. 2005 - Some new slumping. Actively eroding but berm width is greater than 50 ft. 2006 - Downgraded to regular erosion site. Still actively eroding. Large old rotational failures in high bank on the downstream end. 2008 - Removed from inventory due to wide berm width does not meet criteria for an erosion site. 2010 - Added back to the inventory after 10 ft of bank erosion in the winter 2009 storm. Steep vertical face. 2011 - Bank has retreated an additional 2.5 ft from last year. New tree popouts and erosion throughout the site. 2012 - Site continues to worsen with new tree popouts and many sections of new erosion. 2017 - Large sandbag on opposite bank, thalweg is moving closer to the levee.

USACE 2018 Erosion Photo #1

USACE 2018 Erosion Photo #2

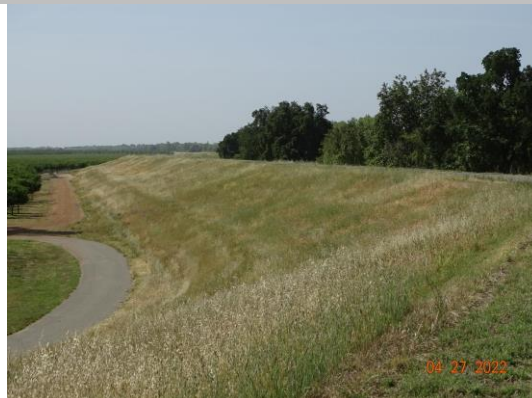
Photo 1 of 1 : SP\_2022\_RD0784\_532\_2\_20220503\_00004.jpg

View of annual vegetation on the landside slope, Spring 2022.

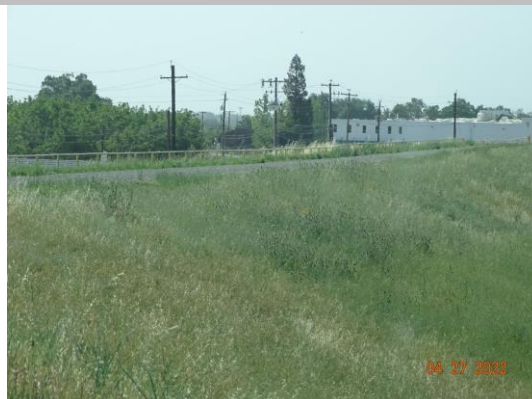
Photo 1 of 1 : SP\_2022\_RD0784\_532\_3\_20220503\_00005.jpg

LM Start	8.97	Rating **	M	Issue No.	3
LM End	12.79	Issue Type +	Ma	Location *	WS
Category	Earthen Levee			GPS Latitude/Longitude	
				Start	End
Item	Vegetation			39.009874 °	38.955620 °
				-121.579129 °	-121.574924 °
DWR ID	DWR_RD0784_02B_s_2022_3				
Comment Code					
V1 : Control annual grass and weeds on the levee slopes and easements.					
Inspector Comment					
Annual vegetation on the waterside slope needs to be maintained, Spring 2022.

View of annual vegetation on the waterside slope, Spring 2022.

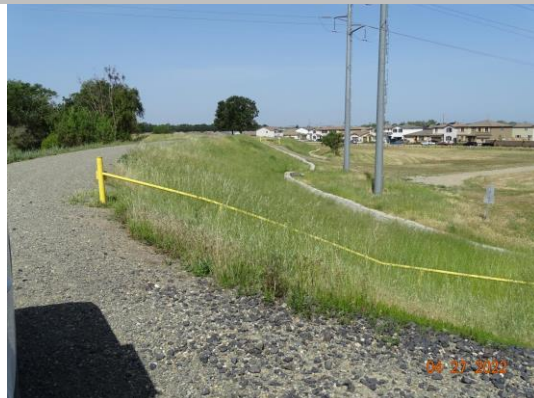
Photo 1 of 1 : SP\_2022\_RD0784\_533\_3\_20220503\_00010.jpg

View of annual vegetation on the landside slope, Spring 2022.

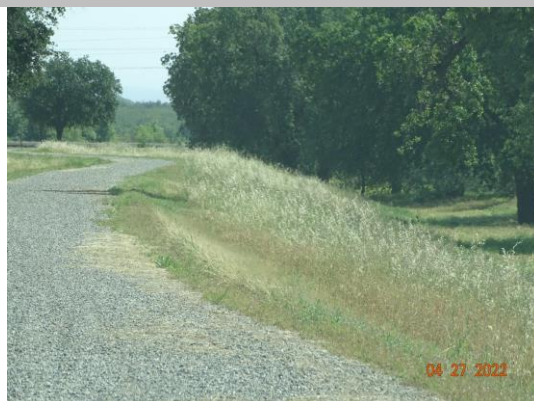
Photo 1 of 1 : SP\_2022\_RD0784\_533\_4\_20220503\_00009.jpg

LM Start	2.43	Rating **	M	Issue No.	4
LM End	3.21	Issue Type +	Ma	Location *	WS
Category	Earthen Levee			GPS Latitude/Longitude	
				Start	End
Item	Vegetation			38.970623 °	38.970560 °
				-121.547553 °	-121.547546 °
DWR ID	DWR_RD0784_03A_s_2022_4				
Comment Code					
V1 : Control annual grass and weeds on the levee slopes and easements.					
Inspector Comment					
Annual vegetation on the waterside slope needs to be maintained, Spring 2022.

View of annual vegetation on the waterside slope, Spring 2022.

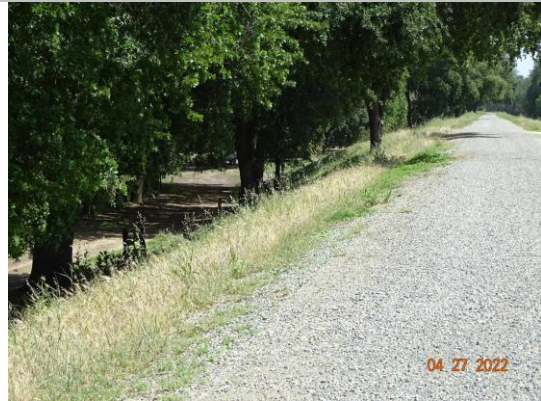
Photo 1 of 1 : SP\_2022\_RD0784\_534\_5\_20220503\_00010.jpg

View of annual vegetation on the landside slope, Spring 2022.

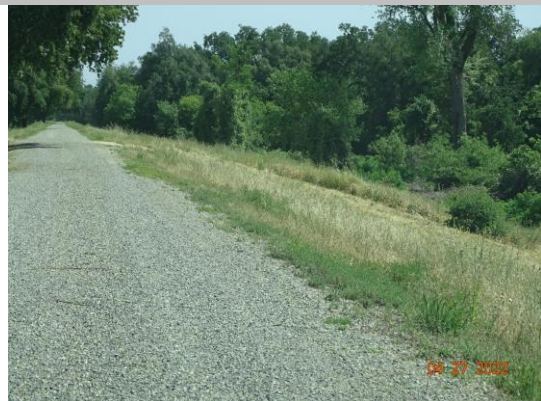
Photo 1 of 1 : SP\_2022\_RD0784\_534\_6\_20220503\_00011.jpg

LM Start	3.27	Rating **	M	Issue No.	6
LM End	4.69	Issue Type +	Ma	Location *	WS
Category	Earthen Levee			GPS Latitude/Longitude	
				Start	End
Item	Vegetation			38.974246 °	38.985554 °
				-121.531408 °	-121.510470 °
DWR ID	DWR_RD0784_03B_s_2022_6				
Comment Code					
V1 : Control annual grass and weeds on the levee slopes and easements.					
Inspector Comment					
Annual vegetation on the waterside slope needs to be maintained, Spring 2022.

View of annual vegetation on the waterside slope, Spring 2022.

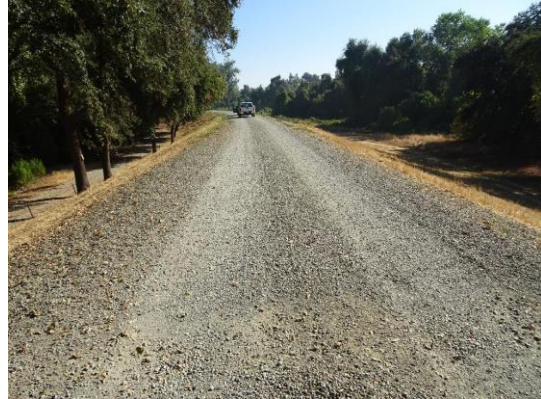
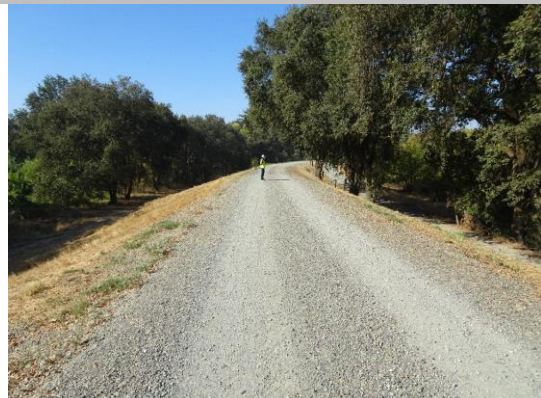
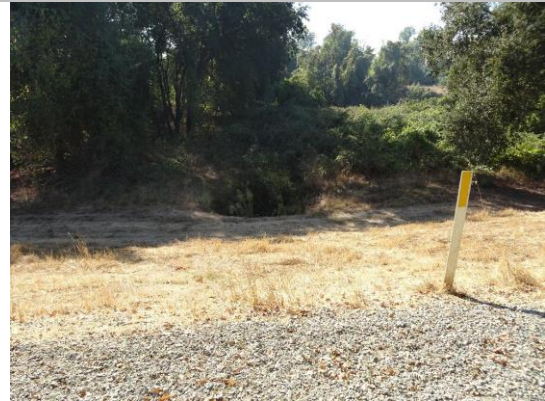
Comment Code						
Inspector Comment						
FS_ID:69907 DS_ID:18580 EP_NO: N/A Repair Type: Urgent Crossing Status: Found UCIP Comments: 10/05/2020 - Record has been updated from No Action Needed to Urgent. DWR DMP has found integrity issues, LOF between 5 and 6. Recommend monitoring crossing until funding becomes available to address. No permit was found authorizing this encroachment. CVFPB will need to review crossing to determine owner. (O. Magana - DWR UCIP)12/16/2019 - Pipe crossing was hydroflushed and video inspected in October 2019. Pending final review by RD784 District Engineer and DWR. (P. Meagher - RD784)02/01/2019 - Pipe crossing was video inspected on 8-14-2018. (P. Meagher - RD784) FIELD_STRUCT_DESC: 30-inch corrugated metal (CM) drainage pipe through the levee, 19.0 feet below the crown. Flap gate on the waterside (WS) end. Concrete headwall at the WS toe. (No permit found for this crossing. Owner unknown). [Additional Reference(s): DWR Levee Log, 2005, (HLM 3.56). USACE Sacramento O&M Manual, Unit No. 145, August 1955, Revised 6 August 2019, (Station 92+88)]. FS Date: 10/5/2020

Overview of Levee: Looking upstream from crown.

Overview of Levee: Looking downstream from crown.

Water-Side: View of waterside looking from crown.

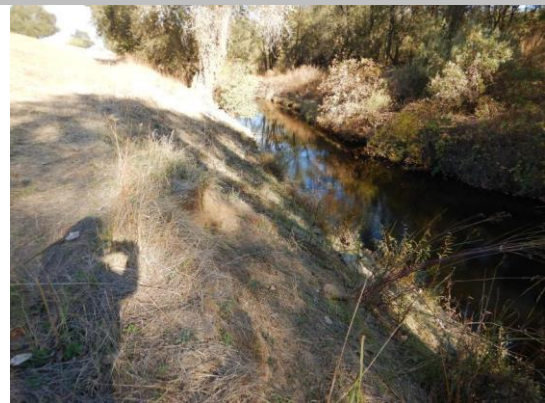
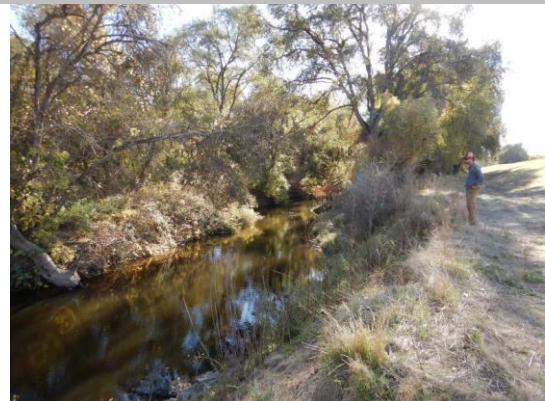
LM Start	4.28	Rating **	A/W	Issue No.	3
LM End	4.29	Issue Type +	Ma	Location *	WS
Category	Supplemental			GPS Latitude/Longitude	
				Start	End
Item	2018 USACE Erosion Survey			38.981271 °	38.981400 °
				-121.515999 °	-121.515848 °
DWR ID	DWR_RD0784_03B_s_2022_3				
Comment Code					
Inspector Comment					
2018 Site ID: BER 4.9 R					
Status: Eroding					
2018 Field Notes: No observed change.					
Site History: 2009 - Small site which could be repaired with maintenance. Erosion into the levee toe, rock has started to fail.

USACE 2018 Erosion Photo #1

USACE 2018 Erosion Photo #2

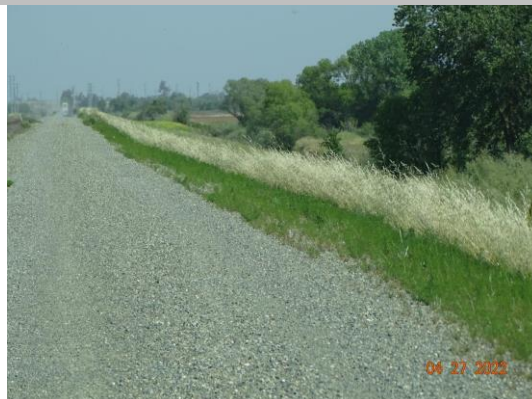
Photo 1 of 1 : SP\_2022\_RD0784\_181\_6\_20220503\_00014.jpg

LM Start	0.08	Rating **	M	Issue No.	6
LM End	6.31	Issue Type +	Ma	Location *	WS
Category	Earthen Levee			GPS Latitude/Longitude	
				Start	End
Item	Vegetation			38.975863 °	39.059291 °
				-121.535284 °	-121.550962 °
DWR ID	DWR_RD0784_04_s_2022_6				
Comment Code					
V1 : Control annual grass and weeds on the levee slopes and easements.					
Inspector Comment					
Annual vegetation on the waterside slope needs to be maintained, Spring 2022.

View of annual vegetation on the waterside slope, Spring 2022.

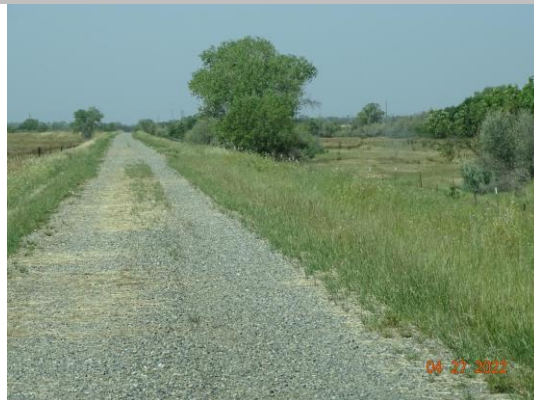
Photo 1 of 1 : SP\_2022\_RD0784\_182\_13\_20220503\_00025.jpg

View of annual vegetation on the waterside slope, Spring 2022.

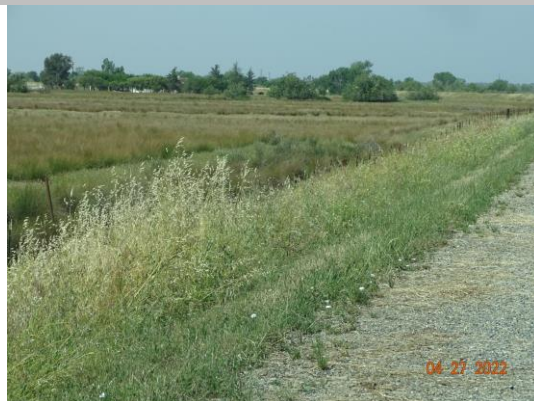
Photo 1 of 1 : SP\_2022\_RD0784\_182\_12\_20220503\_00026.jpg

LM Start	0.04	Rating **	M	Issue No.	12
LM End	3.86	Issue Type +	Ma	Location *	LS
Category	Earthen Levee			GPS Latitude/Longitude	
				Start	End
Item	Vegetation			38.974887 °	39.019464 °
				-121.532758 °	-121.515105 °
DWR ID	DWR_RD0784_05_s_2022_12				
Comment Code					
V1 : Control annual grass and weeds on the levee slopes and easements.					
Inspector Comment					
Annual vegetation on the landside slope needs to be maintained, Spring 2022.

View of annual vegetation on the landside slope, Spring 2022.

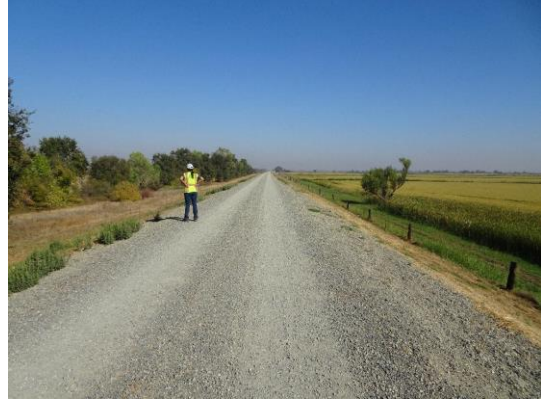
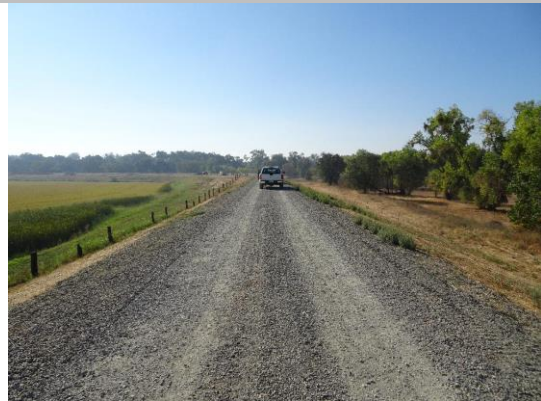
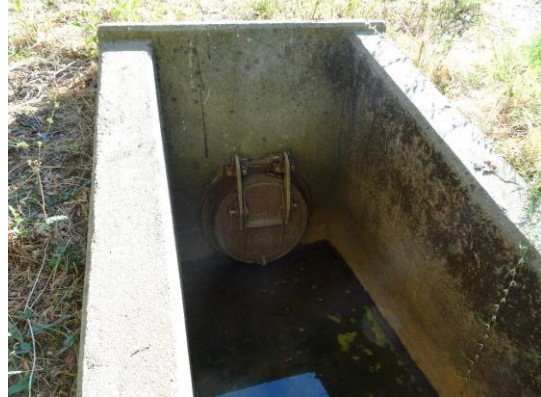
Comment Code						
Inspector Comment						
FS_ID:70298 DS_ID:18592 EP_NO: N/A Repair Type: Urgent Crossing Status: Found UCIP Comments: 10/05/2020 - Record has been updated from No Action Needed to Urgent. DWR DMP has found integrity issues, LOF between 5 and 6. Recommend monitoring crossing until funding becomes available to address. No permit was found authorizing this encroachment. CVFPB will need to review crossing to determine owner. (O. Magana - DWR UCIP)12/16/2019 - Pipe crossing was hydroflushed and video inspected (again) in October 2019. Pending final review by RD784 Engineer and DWR. (P. Meagher - RD784)02/01/2019 - Pipe crossing was video inspected on 8/13/2018. (P. Meagher - RD784)02/26/2013 Good candidate for video inspection. (W. Wylie - DWR UCIP) FIELD_STRUCT_DESC: 18-inch corrugated metal (CM) drainage pipe through the levee, 18.0 feet below the crown. Flap gate on the waterside (WS) end. Concrete U-shaped headwall on the WS end. Polyvinyl chloride (PVC) weir inlet on the landside (LS) toe. (No permit found authorizing this pipe. Owner unknown). [Additional Reference(s): DWR Levee Log, 2005, (HLM 0.10). USACE Sacramento O&M Manual, Unit No. 145, August 1955, Revised 6 August 2019, (Station 25+28). USACE As-Built Drawing No. 2-4-106, Sheet No. 106/5, July 1944, (Station 25+28)]. FS Date: 10/5/2020

Water-Side: Outlet structure with flap gate at waterside toe.

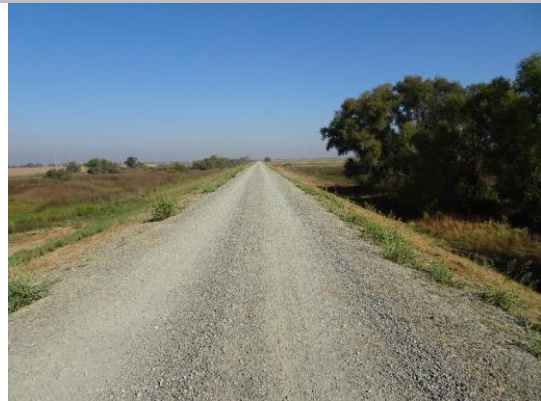
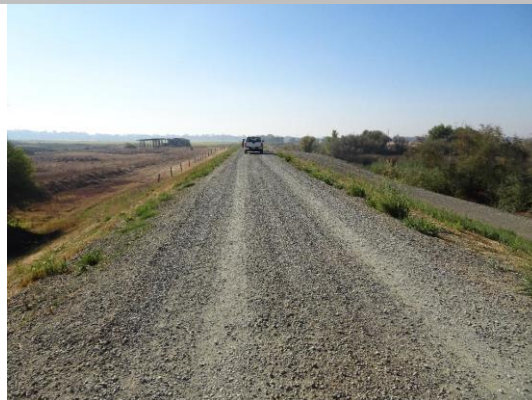
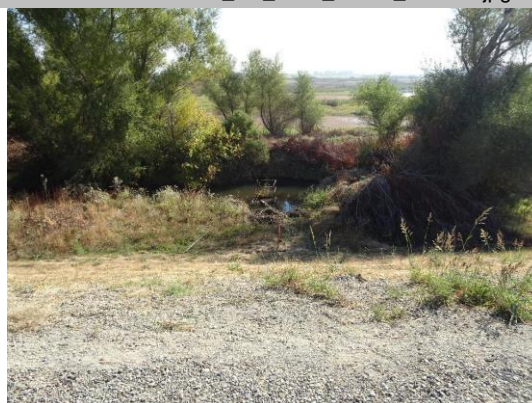
LM Start	<b>0.84</b>	Rating **	U	Issue No.	<b>2</b>
LM End	<b>0.84</b>	Issue Type +	Ma	Location *	
Category	Supplemental			GPS Latitude/Longitude	
				Start	End
Item	DWR UCIP LMA Responsibility			38.986432 °	38.986432 °
				-121.534983 °	-121.534983 °
DWR ID	18591

FS\_ID:70299  
DS\_ID:18591  
EP\_NO: N/A  
Repair Type: Urgent  
Crossing Status: Found  
UCIP Comments: 10/05/2020 - Record has been updated from Non-Urgent to Urgent. DWR DMP has found integrity issues, LOF between 5 and 6. Recommend monitoring crossing until funding becomes available to address. Pipe was underwater during site inspection. No permit was found authorizing this encroachment. CVFPB will need to review crossing to determine owner. (O. Magana - DWR UCIP)12/16/2019 - Pipe crossing was hydroflushed and video inspected (again) in October 2019. Pending final review by RD784 Engineer and DWR. (P. Meagher - RD784)02/01/2019 - Pipe crossing was video inspected on 8/14/2018. (P. Meagher)02/26/2013 - No handle or access to slide gate on LS toe. (W. Wylie - DWR UCIP) FIELD\_STRUCT\_DESC: 30-inch corrugated metal (CM) drainage pipe through the levee, 23.7 feet below the crown. Flap gate on the waterside (WS) end. Slide gate inside a concrete drop inlet on the landside (LS). (No permit found authorizing this pipe. Owner unknown). [Additional Reference(s): DWR Levee Log, 2005, (HLM 0.82). USACE Sacramento O&M Manual, Unit No. 145, August 1955, Revised 6 August 2019, (Station 63+00). USACE As-Built Drawing No. 2-4-106, Sheet No. 106/5, July 1944, (Station 63+00)].

Land-Side: Drop inlet at landside toe.

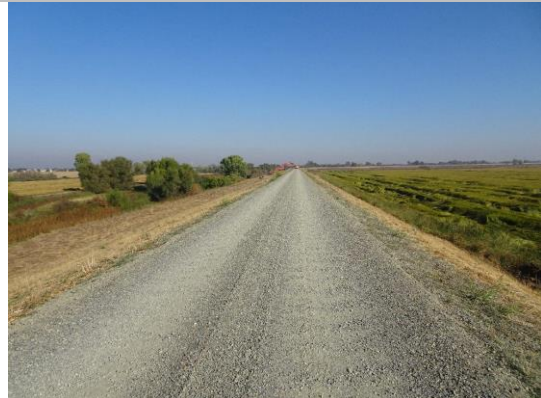
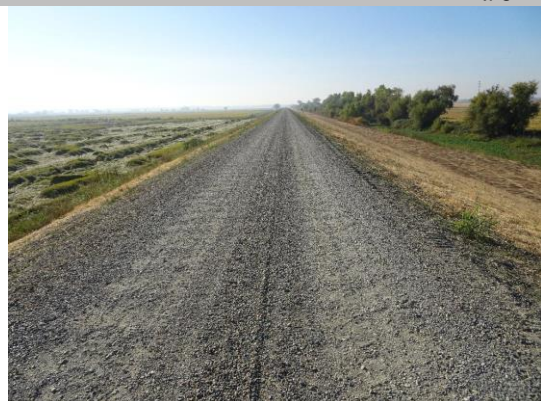
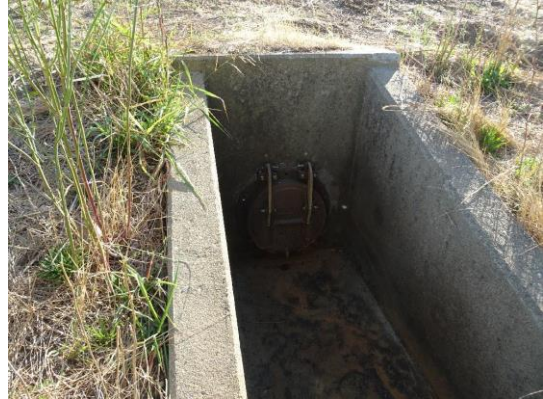
Comment Code						
Inspector Comment						
FS_ID:70301 DS_ID:18588 EP_NO: N/A Repair Type: Urgent Crossing Status: Found UCIP Comments: 10/05/2020 - Record has been updated from Non-Urgent to Urgent. DWR DMP has found integrity issues, LOF between 5 and 6. Recommend monitoring crossing until funding becomes available to address. No permit was found authorizing this encroachment. CVFPB will need to review crossing to determine owner. (O. Magana - DWR UCIP)12/16/2019 - Pipe crossing was hydroflushed and video inspected in October 2019. Pending final review by RD784 District Engineer and DWR. (P. Meagher - RD784)02/01/2019 - Pipe crossing was video inspected on 8-14-2018. (P. Meagher - RD784)09/11/2015 - Inlet buried. Good candidate for video inspection as pipe is corroded. (W. Wylie - DWR UCIP) FIELD_STRUCT_DESC: 18-inch corrugated metal (CM) drainage pipe through the levee, 14.5 feet below the crown. Flap gate on the waterside (WS) end. Concrete U-shaped headwall on the WS. [Additional Reference(s): DWR Levee Log, 2005, (HLM 1.86). USACE Sacramento O&M Manual, Unit No. 145, August 1955, Revised 6 August 2019, (Station 116+78). USACE As-Built Drawing No. 2-4-106, Sheet No. 106/5, July 1944, (Station 116+78)]. FS Date: 10/5/2020

Water-Side: Outlet structure with flap gate at waterside toe.

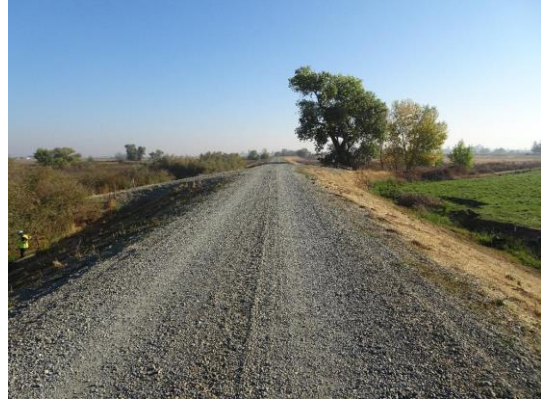
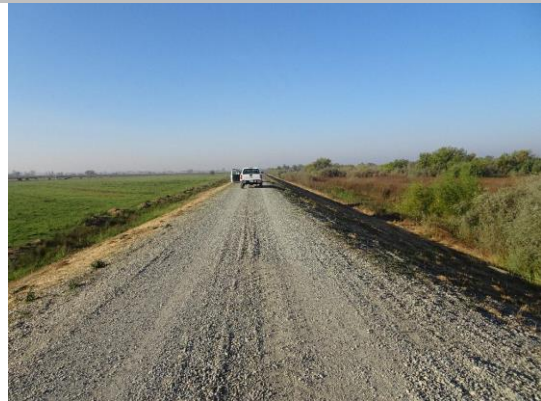
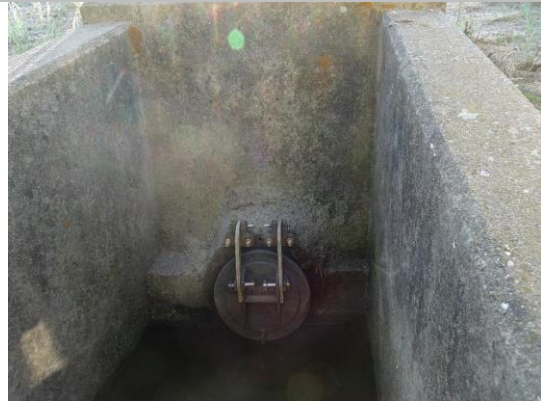
Comment Code						
Inspector Comment						
FS_ID:70306 DS_ID:18596 EP_NO: N/A Repair Type: Urgent Crossing Status: Found UCIP Comments: 10/05/2020 - Record has been updated from Non-Urgent to Urgent. DWR DMP has found integrity issues, LOF between 5 and 6. Recommend monitoring crossing until funding becomes available to address. No permit was found authorizing this encroachment. CVFPB will need to review crossing to determine owner. (O. Magana - DWR UCIP)12/16/2019 - Pipe crossing was hydroflushed and video inspected in October 2019. Pending final review by RD784 Engineer and DWR. (P. Meagher - RD784)02/01/2019 - Pipe crossing was video inspected on 8-15-2018. (P. Meagher - RD784)02/27/2013 - Pipe has been sliplined with PVC, but the liner appears to be eroding at outlet and may be disjointed internal to the levee. See pic. Good candidate for video inspection. (W. Wylie - DWR UCIP) FIELD_STRUCT_DESC: 12-inch corrugated metal (CM) drainage pipe through the levee, 12.0 feet below the crown. Flap gate and concrete U-shaped headwall on the waterside (WS). Polyvinyl chloride (PVC) weir on inlet at the landside (LS) toe. [Additional Reference(s): DWR Levee Log, 2005, (HLM 3.08). USACE Sacramento O&M Manual, Unit No. 145, August 1955, Revised 6 August 2019, (Station 44+96). USACE As-Built Drawing No. 2-4-106, Sheet No. 106/6, July 1944, (Station 44+96)]. FS Date: 10/5/2020

Water-Side: Outlet structure with flap gate at waterside toe.

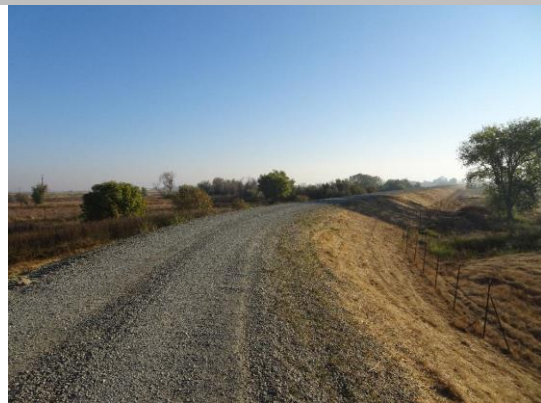
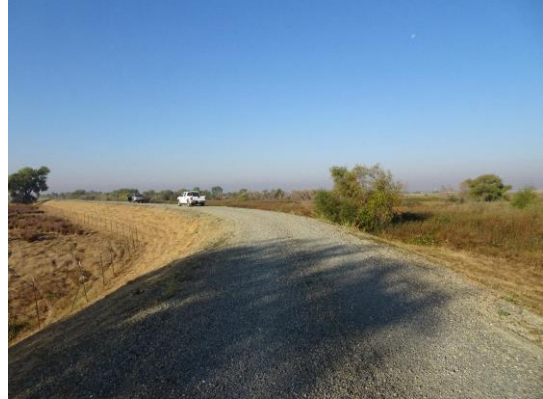
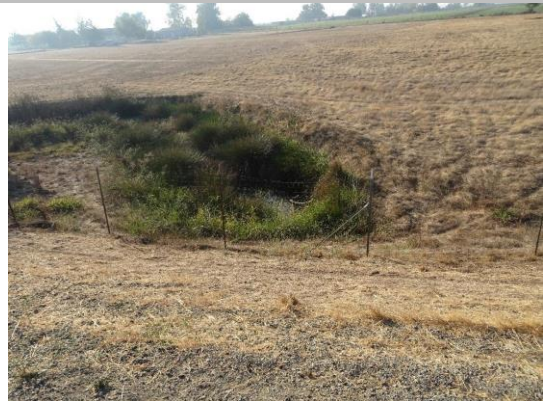
FS\_ID:70307  
 DS\_ID:18595  
 EP\_NO: N/A  
 Repair Type: Urgent  
 Crossing Status: Found  
 UCIP Comments: 10/05/2020 Record has been updated from No Action Needed to Urgent. DWR DMP has found integrity issues, LOF between 5 and 6. Recommend monitoring crossing until funding becomes available to address. No permit was found authorizing this encroachment. CVFPB will need to review crossing to determine owner. (O. Magana - DWR UCIP)12/16/2019 - Pipe crossing was hydroflushed and video inspected in October 2019. Pending final review by RD784 District Engineer and DWR. (P. Meagher - RD784)02/01/2019 - Pipe crossing was video inspected on 8-15-2018 (P. Meagher - RD784)02/27/2013 - Good candidate for video inspection. (W. Wylie - DWR UCIP)  
 FIELD\_STRUCT\_DESC: 18-inch corrugated metal (CM) drainage pipe through the levee, 15.8 feet below the crown. Flap gate on the waterside (WS) end. Polyvinyl chloride (PVC) weir on inlet at the landside (LS) toe. [Additional Reference(s): DWR Levee Log, 2005, (HLM 3.24). USACE Sacramento O&M Manual, Unit No. 145, August 1955, Revised 6 August 2019, (Station 53+86). USACE As-Built Drawing No. 2-4-106, Sheet No. 106/6, July 1944, (Station 53+86)].

Land-Side: Inlet structure at landside toe.

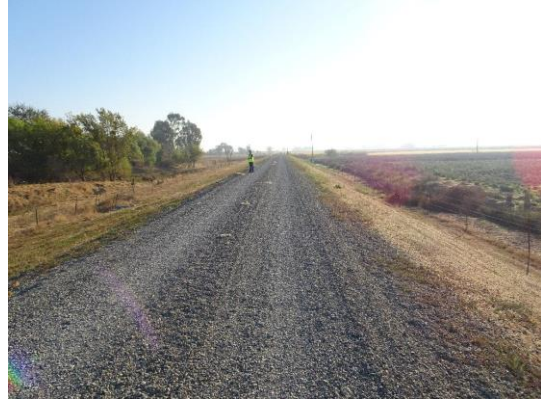
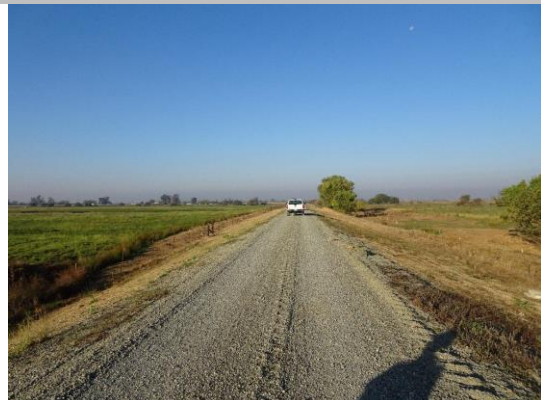
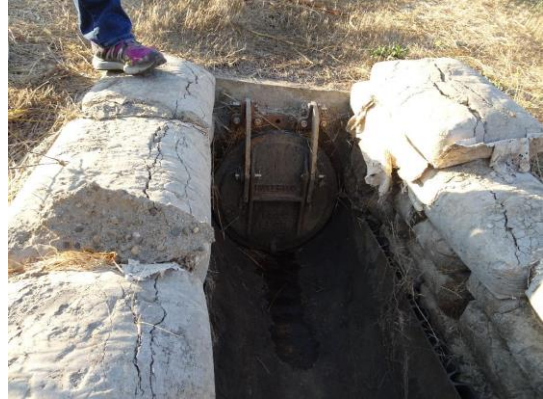
Comment Code						
Inspector Comment						
FS_ID:70308 DS_ID:18594 EP_NO: N/A Repair Type: Non-Urgent Crossing Status: Found UCIP Comments: 10/05/2020 - Record has been updated from No Action Needed to Non-Urgent. No permit was found authorizing this encroachment. CVFPB will need to review crossing to determine owner. DWR DMP has not found internal issues, LOF between 1 and 2. Recommend inspection in 5 years. (O. Magana - DWR UCIP)12/16/2019 - Pipe crossing was video inspected in October 2019. Pending final review by RD784 Engineer and DWR. (P. Meagher - RD784)02/01/2019 - Pipe crossing was video inspected on 8-15-2018. (P. Meagher - RD784) FIELD_STRUCT_DESC: 18-inch corrugated metal (CM) drainage pipe through the levee, 8.8 feet below the crown. Flap gate and headwall on the waterside (WS) end. [Additional Reference(s): DWR Levee Log, 2005, (HLM 3.81). USACE Sacramento O&M Manual, Unit No. 145, August 1955, Revised 6 August 2019, (Station 83+39). USACE As-Built Drawing No. 2-4-106, Sheet No. 106/6, July 1944, (Station 83+39)]. FS Date: 10/5/2020

Water-Side: Outlet structure with flap gate at waterside toe.

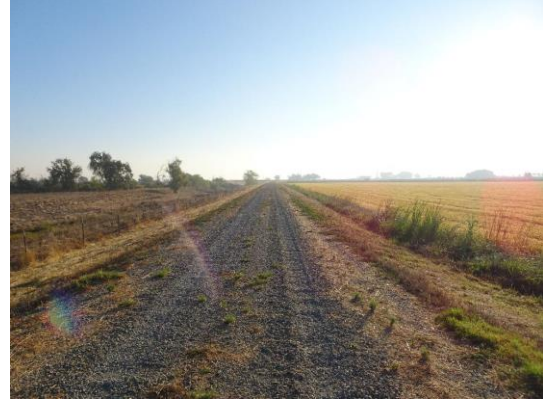
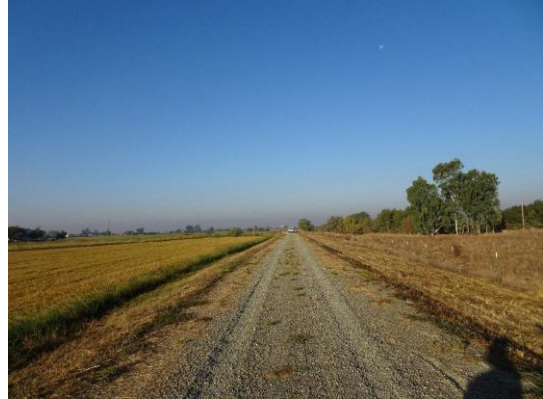
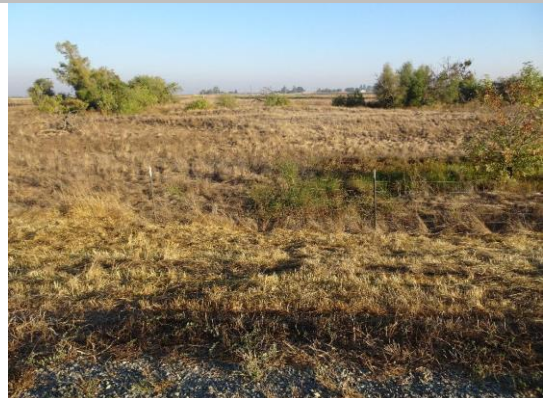
Comment Code						
Inspector Comment						
FS_ID:70309 DS_ID:18593 EP_NO: N/A Repair Type: Non-Urgent Crossing Status: Found UCIP Comments: 10/05/2020 - Record remains Non-Urgent. No permit was found authorizing this encroachment. CVFPB will need to review crossing to determine owner. No DWR DMP internal inspection has been completed yet. This crossing appears to be abandoned: buried inlet at landside toe. No access for internal video inspection. DWR DMP will complete assessment to determine final recommendation. (O. Magana - DWR UCIP) 02/01/2019 - An attempt was made to video inspect this pipe crossing on 8-15-2018 but conditions were too muddy inside the pipe. (P. Meagher - RD784)11/14/2016 - Photos added of exposed flap gate on WS and possible inlet location on LS. Condition remains as Non-Urgent because of inlet not being fully operable. Unknown if pipe will operate as designed during high water or if it is full of sediment. (P. Meagher - RD784)11/01/2015 - Waterside Flap Gate Uncovered. Photo sent to DWR Matt Hoffman on 3-3-2014. Fresh photo sent to DWR Pavel Kazi on 9-9-2015. Landside toe has never been able to be located. Requesting DWR inspector to change the status of this issue to "No Action Needed". (P. Meagher - RD784).02/26/2013 - Pipe buried on LS toe and flap gate is blocked by soil on WS toe. (W. Wylie - DWR UCIP). FIELD_STRUCT_DESC: 18-inch corrugated metal (CM) drainage pipe through the levee, 10.0 feet below the crown. Flap gate on the waterside (WS) end. [Additional Reference(s): DWR Levee Log, 2005, (HLM 3.98). USACE Sacramento O&M Manual, Unit No. 145, August 1955, Revised 6 August 2019, (Station 91+50). USACE As-Built Drawing No. 2-4-106, Sheet No. 106/6, July 1944, (Station 91+50)]. FS Date: 10/5/2020

Water-Side: View from crown. Outlet not visible.

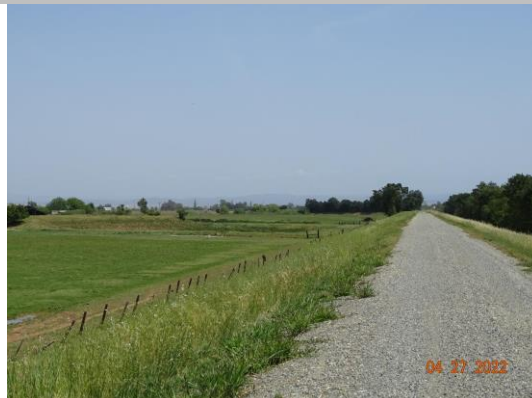
Photo 1 of 1 : SP\_2022\_RD0784\_183\_2\_20220503\_00004.jpg

View of annual vegetation on the landside slope, Spring 2022.

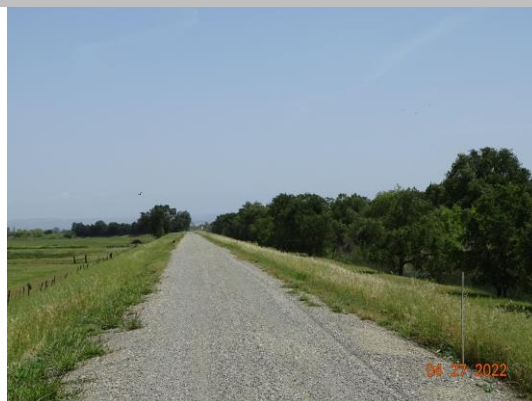
Photo 1 of 1 : SP\_2022\_RD0784\_183\_3\_20220503\_00005.jpg

View of annual vegetation on the waterside slope, Spring 2022.

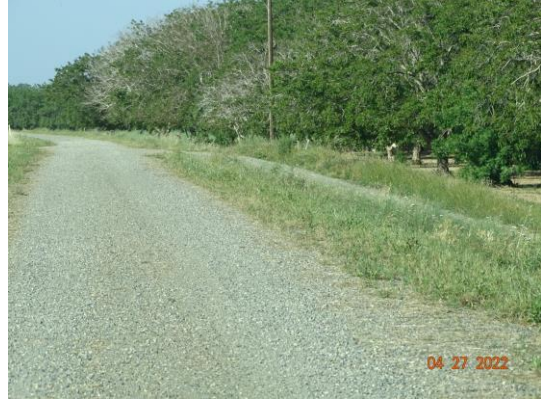
Photo 1 of 1 : SP\_2022\_RD0784\_184\_10\_20220503\_00023.jpg

View of annual vegetation on the waterside slope, Spring 2022.

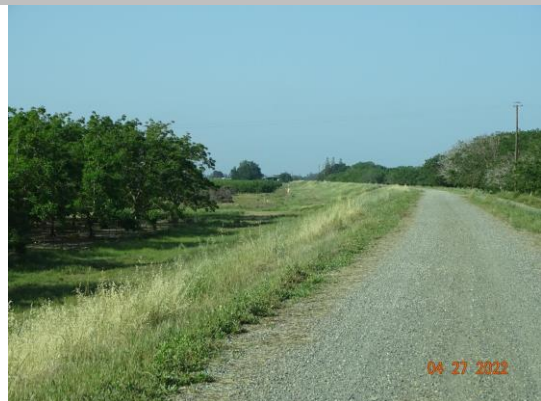
Photo 1 of 1 : SP\_2022\_RD0784\_184\_9\_20220503\_00024.jpg

View of annual vegetation on the landside slope, Spring 2022.

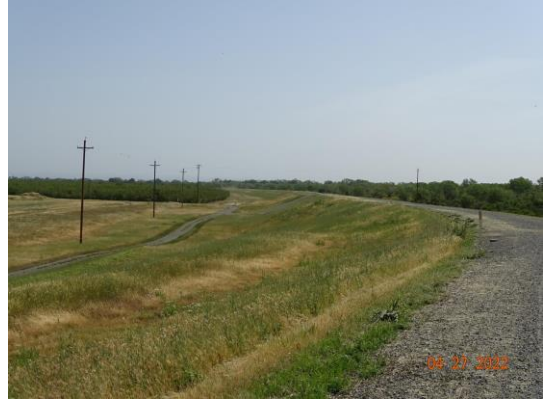
Photo 1 of 1 : SP\_2022\_RD0784\_437\_1\_20220503\_00001.jpg

View of annual vegetation on the landside slope, Spring 2022.

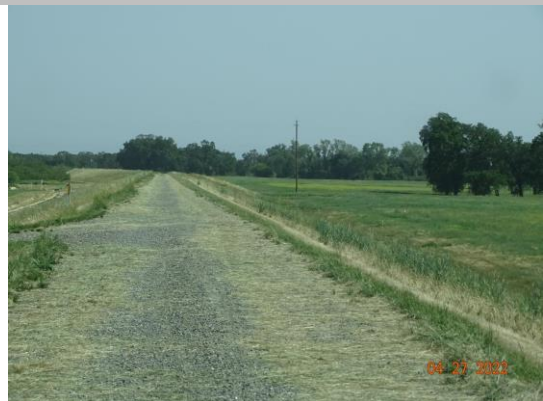
Photo 1 of 1 : SP\_2022\_RD0784\_437\_2\_20220503\_00002.jpg

View of annual vegetation on the waterside slope, Spring 2022.

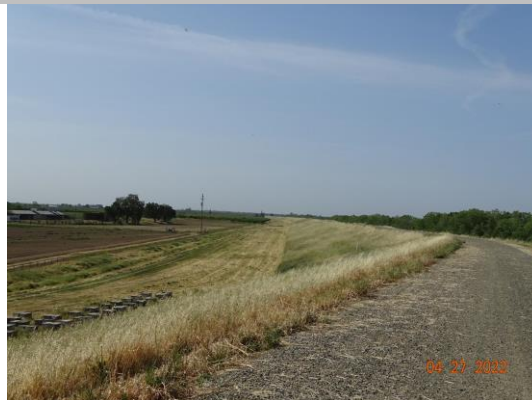
Photo 1 of 1 : SP\_2022\_RD0784\_530\_1\_20220503\_00001.jpg

View of annual vegetation on the landside slope, Spring 2022.

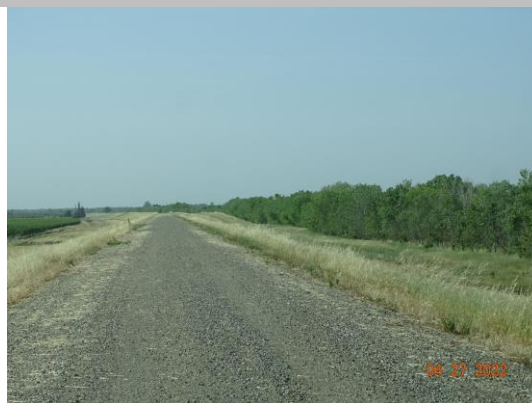
Photo 1 of 1 : SP\_2022\_RD0784\_530\_2\_20220503\_00002.jpg

View of annual vegetation on the waterside slope, Spring 2022.
