**Flood Control Project Maintenance  
Levee Inspections**

## Maintenance Issue Types Only, Levee Inspection Report By Mile - Spring 2023

### Reclamation District No. 0784 Plumas Lake

Waterway	Bank	Unit Miles	Inspection Start/End	Inspector
Unit No. 01 Yuba River	Left	2.21	04/10/2023 04/10/2023	Brooks Weisser

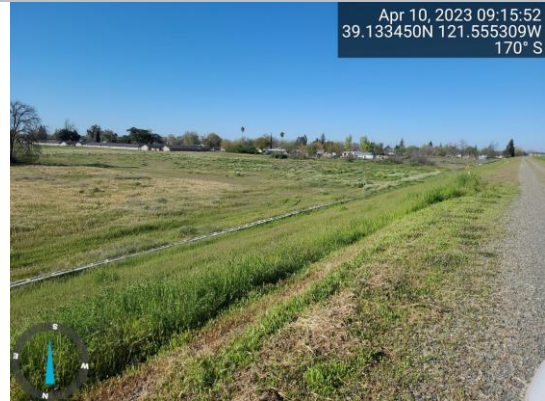
Photo 1 of 1 : SP\_2023\_RD0784\_178\_1\_20230420\_00002.jpg

LM Start	0.16	Rating **	M	Issue No.	1
LM End	2.21	Issue Type +	Ma	Location *	LS
Category	Earthen Levee			GPS Latitude/Longitude	
				Start	End
Item	Vegetation			39.133614°	39.125832°
				-121.554746°	-121.588669°
DWR ID	DWR_RD0784_01_s_2023_1				
Comment Code					
V1 : Control annual grass and weeds on the levee slopes and easements.					
Inspector Comment					
Annual vegetation on the landside slope needs to be maintained, Spring 2023.

View of annual vegetation on the landside slope, Spring 2023.

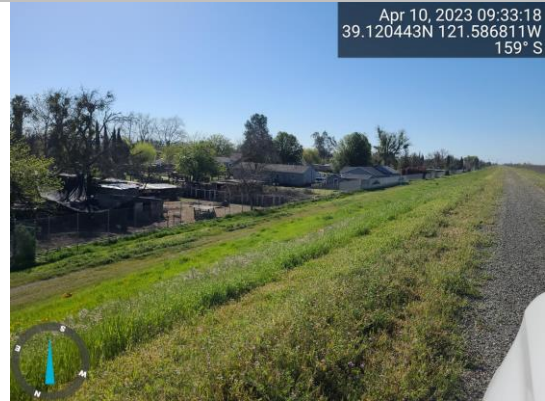
Photo 1 of 1 : SP\_2023\_RD0784\_531\_1\_20230420\_00001.jpg

View of annual vegetation on the landside slope, Spring 2023.

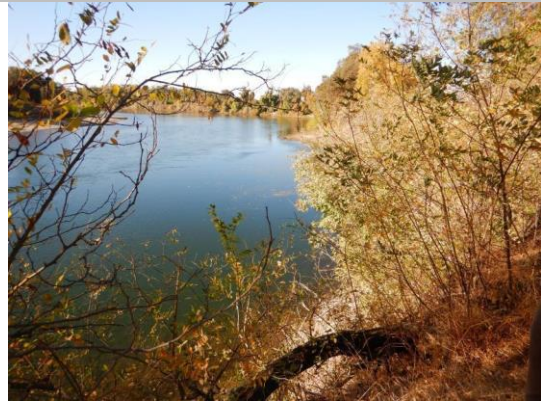
Photo 1 of 2 : SP\_2023\_RD0784\_532\_1\_20230403\_00001.jpg

Comment Code					
Inspector Comment					
2018 Site ID: FHR 17.8 L Status: Eroding 2018 Field Notes: Site continues to erode. Site History: 2003 - Bank is near vertical. Identified as a Potentially Critical site. 2004 - Eddy flow off downstream end of Modesto formation eroding the fluvial sediments. 2005 - Some new slumping. Actively eroding but berm width is greater than 50 ft. 2006 - Downgraded to regular erosion site. Still actively eroding. Large old rotational failures in high bank on the downstream end. 2008 - Removed from inventory due to wide berm width does not meet criteria for an erosion site. 2010 - Added back to the inventory after 10 ft of bank erosion in the winter 2009 storm. Steep vertical face. 2011 - Bank has retreated an additional 2.5 ft from last year. New tree popouts and erosion throughout the site. 2012 - Site continues to worsen with new tree popouts and many sections of new erosion. 2017 - Large sandbag on opposite bank, thalweg is moving closer to the levee.

USACE 2018 Erosion Photo #1

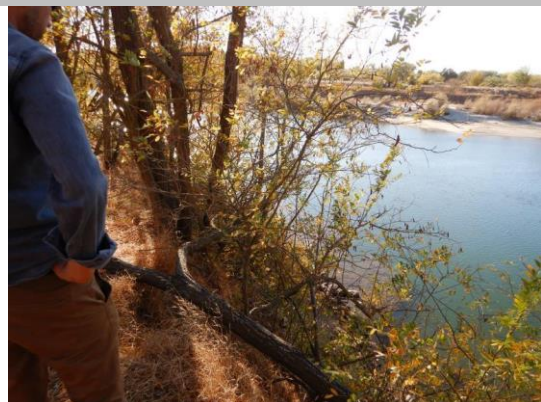
Photo 2 of 2 : SP\_2023\_RD0784\_532\_1\_20230403\_00002.jpg

USACE 2018 Erosion Photo #2

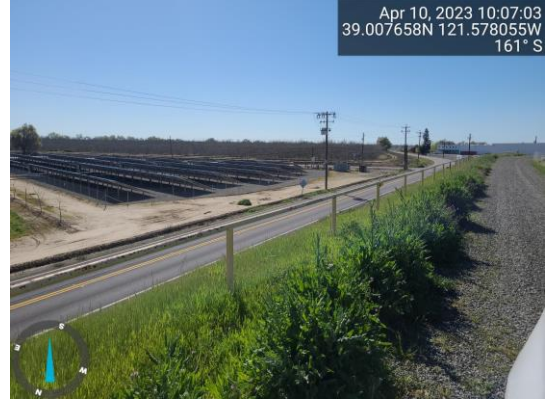
Photo 1 of 1 : SP\_2023\_RD0784\_532\_2\_20230420\_00004.jpg

View of annual vegetation on the landside slope, Spring 2023.

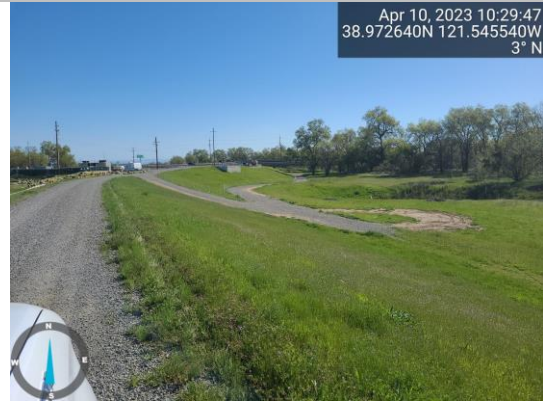
Photo 1 of 1 : SP\_2023\_RD0784\_533\_4\_20230420\_00008.jpg

View of annual vegetation on the waterside slope, Spring 2023.

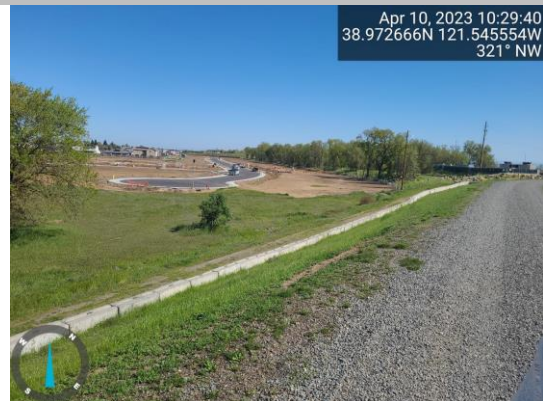
Photo 1 of 1 : SP\_2023\_RD0784\_533\_3\_20230420\_00007.jpg

LM Start	2.61	Rating **	A	Issue No.	3
LM End	3.19	Issue Type +	Ma	Location *	LS
Category	Earthen Levee			GPS Latitude/Longitude	
				Start	End
Item	Vegetation			38.972619°	38.974693°
				-121.545570°	-121.535477°
DWR ID	DWR_RD0784_03A_s_2023_3				
Comment Code					
V1 : Control annual grass and weeds on the levee slopes and easements.					
Inspector Comment					
Annual vegetation is well maintained.

View of annual vegetation on the landside slope, Spring 2023.

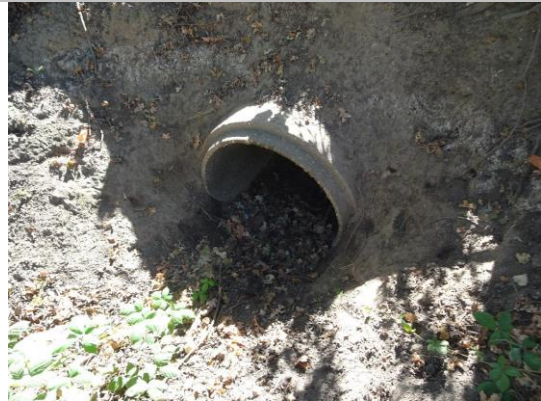
Photo 3 of 3 : UCIP\_SP\_2023\_69907\_101270.jpg

Comment Code						
Inspector Comment						
DS_ID:18580 FS_ID:69907 EP_NO: N/A Repair Type: Urgent EVAL Issue: 1, Pipe Integrity Crossing Status: Found UCIP Comments: 10/05/2020 - Record has been updated from No Action Needed to Urgent. DWR DMP has found integrity issues, LOF between 5 and 6. Recommend monitoring crossing until funding becomes available to address. No permit was found authorizing this encroachment. CVFPB will need to review crossing to determine owner. (O. Magana - DWR UCIP)12/16/2019 - Pipe crossing was hydroflushed and video inspected in October 2019. Pending final review by RD784 District Engineer and DWR. (P. Meagher - RD784)02/01/2019 - Pipe crossing was video inspected on 8-14-2018. (P. Meagher - RD784) FIELD_STRUCT_DESC: 30-inch corrugated metal (CM) drainage pipe through the levee, 19.0 feet below the crown. Flap gate on the waterside (WS) end. Concrete headwall at the WS toe. (No permit found for this crossing. Owner unknown). [Additional Reference(s): DWR Levee Log, 2005, (HLM 3.56). USACE Sacramento O&M Manual, Unit No. 145, August 1955, Revised 6 August 2019, (Station 92+88)]. FS Date: 10/5/2020

Land-Side: Pipe inlet beyond landside toe.

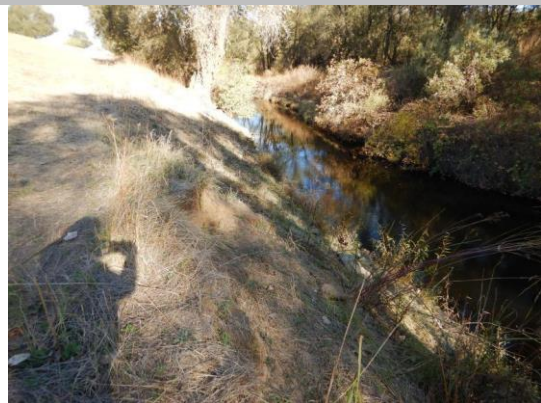
Photo 1 of 2 : SP\_2023\_RD0784\_534\_3\_20230403\_00001.jpg

2018 Site ID: BER 4.9 R  
Status: Eroding  
2018 Field Notes: No observed change.  
Site History: 2009 - Small site which could be repaired with maintenance. Erosion into the levee toe, rock has started to fail.

USACE 2018 Erosion Photo #1

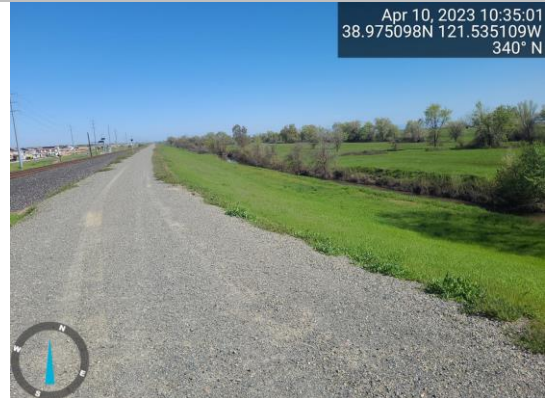
Photo 1 of 1 : SP\_2023\_RD0784\_181\_4\_20230420\_00008.jpg

View of annual vegetation on the waterside slope, Spring 2023.

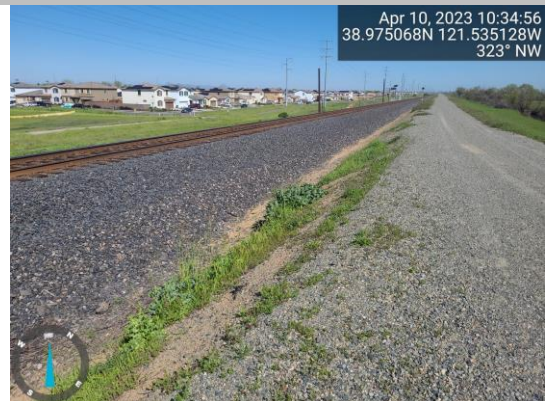
Photo 1 of 1 : SP\_2023\_RD0784\_181\_3\_20230420\_00007.jpg

LM Start	0.02	Rating **	A	Issue No.	3
LM End	5.84	Issue Type +	Ma	Location *	LS
Category	Earthen Levee			GPS Latitude/Longitude	
				Start	End
Item	Vegetation			38.974999°	39.058594°
				-121.535097°	-121.543072°
DWR ID	DWR_RD0784_04_s_2023_3				
Comment Code					
V1 : Control annual grass and weeds on the levee slopes and easements.					
Inspector Comment					
Annual vegetation is well maintained.

View of annual vegetation on the landside slope, Spring 2023.

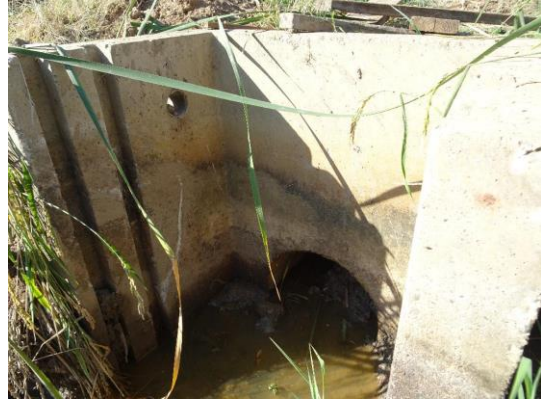
Photo 3 of 3 : UCIP\_SP\_2023\_70298\_100867.jpg

Comment Code						
Inspector Comment						
DS_ID:18592 FS_ID:70298 EP_NO: N/A Repair Type: Urgent EVAL Issue: 1, Pipe Integrity Crossing Status: Found UCIP Comments: 10/05/2020 - Record has been updated from No Action Needed to Urgent. DWR DMP has found integrity issues, LOF between 5 and 6. Recommend monitoring crossing until funding becomes available to address. No permit was found authorizing this encroachment. CVFPB will need to review crossing to determine owner. (O. Magana - DWR UCIP)12/16/2019 - Pipe crossing was hydroflushed and video inspected (again) in October 2019. Pending final review by RD784 Engineer and DWR. (P. Meagher - RD784)02/01/2019 - Pipe crossing was video inspected on 8/13/2018. (P. Meagher - RD784)02/26/2013 Good candidate for video inspection. (W. Wylie - DWR UCIP) FIELD_STRUCT_DESC: 18-inch corrugated metal (CM) drainage pipe through the levee, 18.0 feet below the crown. Flap gate on the waterside (WS) end. Concrete U-shaped headwall on the WS end. Polyvinyl chloride (PVC) weir inlet on the landside (LS) toe. (No permit found authorizing this pipe. Owner unknown). [Additional Reference(s): DWR Levee Log, 2005, (HLM 0.10). USACE Sacramento O&M Manual, Unit No. 145, August 1955, Revised 6 August 2019, (Station 25+28). USACE As-Built Drawing No. 2-4-106, Sheet No. 106/5, July 1944, (Station 25+28)]. FS Date: 10/5/2020

Land-Side: Inlet structure with open pipe at landside toe.

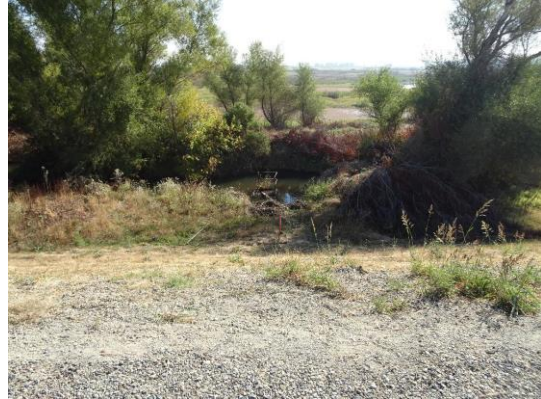
Photo 2 of 3 : UCIP\_SP\_2023\_70299\_100892.jpg

Comment Code					
Inspector Comment					
DS_ID:18591 FS_ID:70299 EP_NO: N/A Repair Type: Urgent EVAL Issue: 1, Pipe Integrity Crossing Status: Found UCIP Comments: 10/05/2020 - Record has been updated from Non-Urgent to Urgent. DWR DMP has found integrity issues, LOF between 5 and 6. Recommend monitoring crossing until funding becomes available to address. Pipe was underwater during site inspection. No permit was found authorizing this encroachment. CVFPB will need to review crossing to determine owner. (O. Magana - DWR UCIP)12/16/2019 - Pipe crossing was hydroflushed and video inspected (again) in October 2019. Pending final review by RD784 Engineer and DWR. (P. Meagher - RD784)02/01/2019 - Pipe crossing was video inspected on 8/14/2018. (P. Meagher)02/26/2013 - No handle or access to slide gate on LS toe. (W. Wylie - DWR UCIP) FIELD_STRUCT_DESC: 30-inch corrugated metal (CM) drainage pipe through the levee, 23.7 feet below the crown. Flap gate on the waterside (WS) end. Slide gate inside a concrete drop inlet on the landside (LS). (No permit found authorizing this pipe. Owner unknown). [Additional Reference(s): DWR Levee Log, 2005, (HLM 0.82). USACE Sacramento O&M Manual, Unit No. 145, August 1955, Revised 6 August 2019, (Station 63+00). USACE As-Built Drawing No. 2-4-106, Sheet No. 106/5, July 1944, (Station 63+00)]. FS Date: 10/5/2020

Land-Side: Drop inlet at landside toe.

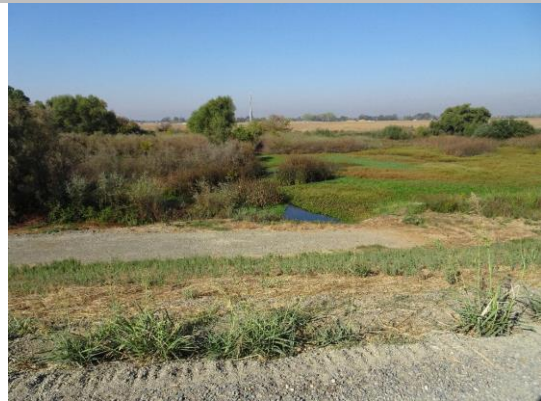
Photo 3 of 3 : UCIP\_SP\_2023\_70299\_100893.jpg

Water-Side: Outlet underwater at waterside toe.

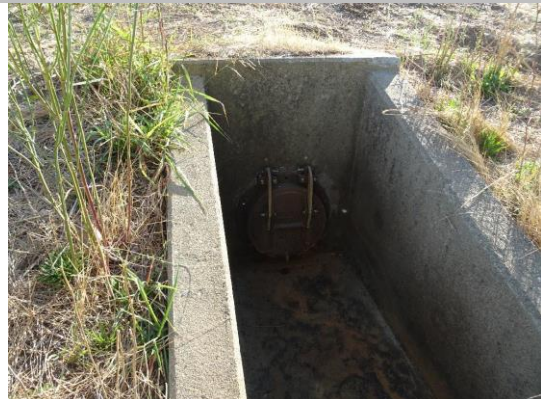
Photo 2 of 3 : UCIP\_SP\_2023\_70301\_100932.jpg

Comment Code						
Inspector Comment						
DS_ID:18588 FS_ID:70301 EP_NO: N/A Repair Type: Urgent EVAL Issue: 1, Pipe Integrity Crossing Status: Found UCIP Comments: 10/05/2020 - Record has been updated from Non-Urgent to Urgent. DWR DMP has found integrity issues, LOF between 5 and 6. Recommend monitoring crossing until funding becomes available to address. No permit was found authorizing this encroachment. CVFPB will need to review crossing to determine owner. (O. Magana - DWR UCIP)12/16/2019 - Pipe crossing was hydroflushed and video inspected in October 2019. Pending final review by RD784 District Engineer and DWR. (P. Meagher - RD784)02/01/2019 - Pipe crossing was video inspected on 8-14-2018. (P. Meagher - RD784)09/11/2015 - Inlet burried. Good candidate for video inspection as pipe is corroded. (W. Wylie - DWR UCIP) FIELD_STRUCT_DESC: 18-inch corrugated metal (CM) drainage pipe through the levee, 14.5 feet below the crown. Flap gate on the waterside (WS) end. Concrete U-shaped headwall on the WS. [Additional Reference(s): DWR Levee Log, 2005, (HLM 1.86). USACE Sacramento O&M Manual, Unit No. 145, August 1955, Revised 6 August 2019, (Station 116+78). USACE As-Built Drawing No. 2-4-106, Sheet No. 106/5, July 1944, (Station 116+78)]. FS Date: 10/5/2020

Water-Side: Outlet structure with flap gate at waterside toe.

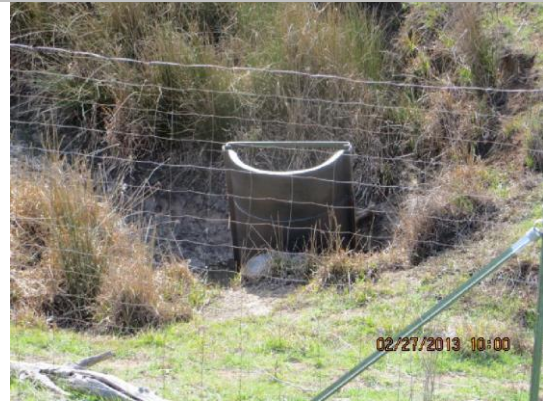
Photo 2 of 3 : UCIP\_SP\_2023\_70307\_16594.jpg

DS\_ID:18595  
 FS\_ID:70307  
 EP\_NO: N/A  
 Repair Type: Urgent  
 EVAL Issue: 1, Pipe Integrity  
 Crossing Status: Found  
 UCIP Comments: 10/05/2020 Record has been updated from No Action Needed to Urgent. DWR DMP has found integrity issues, LOF between 5 and 6. Recommend monitoring crossing until funding becomes available to address. No permit was found authorizing this encroachment. CVFPB will need to review crossing to determine owner. (O. Magana - DWR UCIP)12/16/2019 - Pipe crossing was hydroflushed and video inspected in October 2019. Pending final review by RD784 District Engineer and DWR. (P. Meagher - RD784)02/01/2019 - Pipe crossing was video inspected on 8-15-2018 (P. Meagher - RD784)02/27/2013 - Good candidate for video inspection. (W. Wylie - DWR UCIP)  
 FIELD\_STRUCT\_DESC: 18-inch corrugated metal (CM) drainage pipe through the levee, 15.8 feet below the crown. Flap gate on the waterside (WS) end. Polyvinyl chloride (PVC) weir on inlet at the landside (LS) toe. [Additional Reference(s): DWR Levee Log, 2005, (HLM 3.24). USACE Sacramento O&M Manual, Unit No. 145, August 1955, Revised 6 August 2019, (Station 53+86). USACE As-Built Drawing No. 2-4-106, Sheet No. 106/6, July 1944, (Station 53+86)].

PVC weir inlet on LS toe.

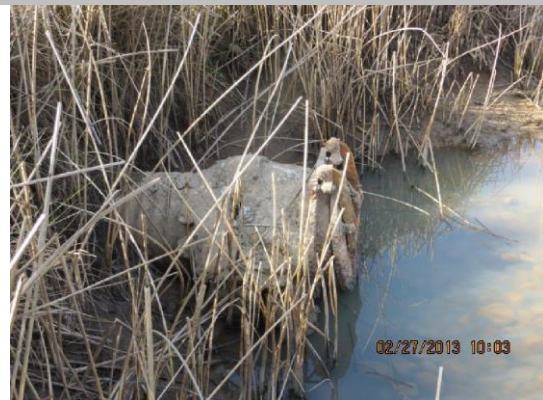
Photo 3 of 3 : UCIP\_SP\_2023\_70307\_16593.jpg

Flap gate at WS toe.

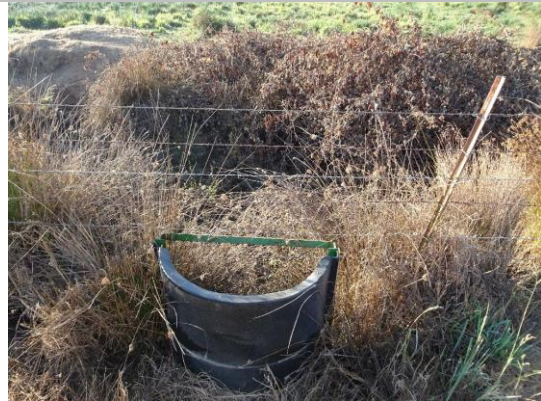
Photo 3 of 3 : UCIP\_SP\_2023\_70308\_100950.jpg

Comment Code					
Inspector Comment					
DS_ID:18594 FS_ID:70308 EP_NO: N/A Repair Type: Non-Urgent EVAL Issue: Crossing Status: Found UCIP Comments: 10/05/2020 - Record has been updated from No Action Needed to Non-Urgent. No permit was found authorizing this encroachment. CVFPB will need to review crossing to determine owner. DWR DMP has not found internal issues, LOF between 1 and 2. Recommend inspection in 5 years. (O. Magana - DWR UCIP)12/16/2019 - Pipe crossing was video inspected in October 2019. Pending final review by RD784 Engineer and DWR. (P. Meagher - RD784)02/01/2019 - Pipe crossing was video inspected on 8-15-2018. (P. Meagher - RD784) FIELD_STRUCT_DESC: 18-inch corrugated metal (CM) drainage pipe through the levee, 8.8 feet below the crown. Flap gate and headwall on the waterside (WS) end. [Additional Reference(s): DWR Levee Log, 2005, (HLM 3.81). USACE Sacramento O&M Manual, Unit No. 145, August 1955, Revised 6 August 2019, (Station 83+39). USACE As-Built Drawing No. 2-4-106, Sheet No. 106/6, July 1944, (Station 83+39)]. FS Date: 10/5/2020

Land-Side: Inlet structure at landside toe.

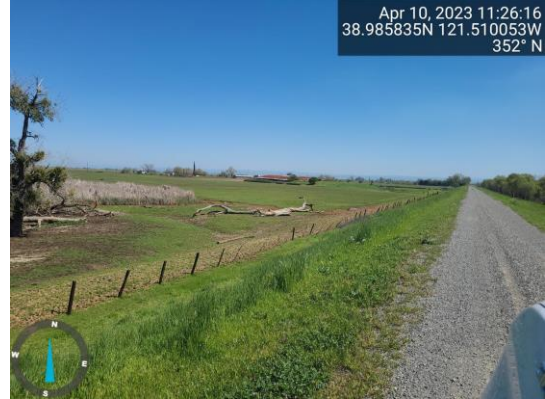
Photo 1 of 1 : SP\_2023\_RD0784\_183\_2\_20230420\_00004.jpg

View of annual vegetation on the landside slope, Spring 2023.

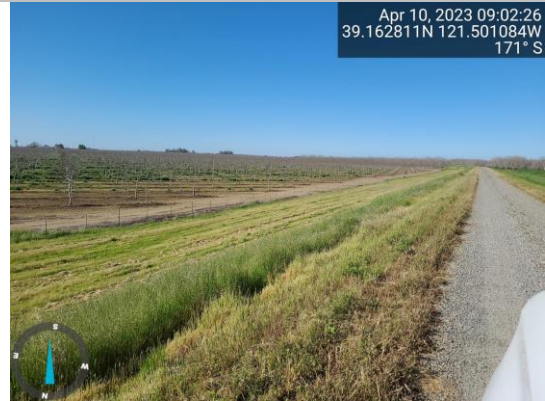
Photo 1 of 1 : SP\_2023\_RD0784\_184\_1\_20230420\_00001.jpg

View of annual vegetation on the landside slope, Spring 2023.

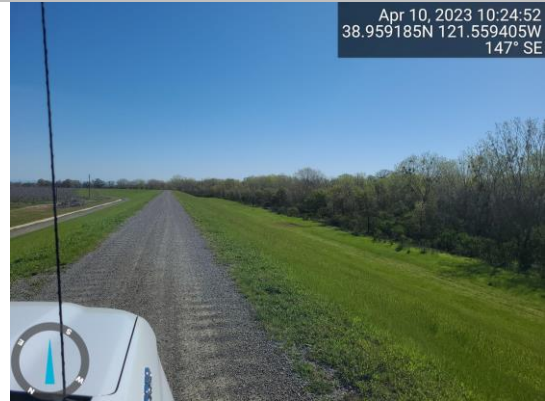
Photo 1 of 1 : SP\_2023\_RD0784\_437\_2\_20230420\_00002.jpg

View of annual vegetation on the waterside slope, Spring 2023.

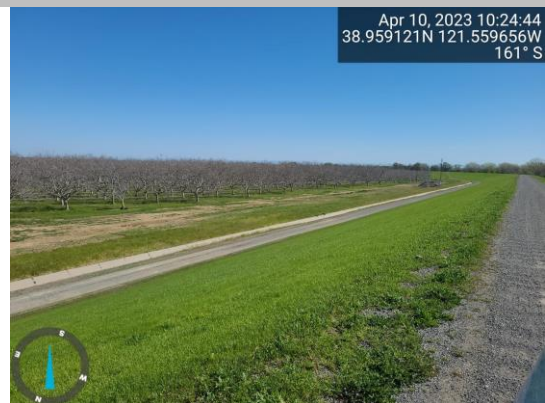
Photo 1 of 1 : SP\_2023\_RD0784\_437\_1\_20230420\_00001.jpg

View of annual vegetation on the landside slope, Spring 2023.

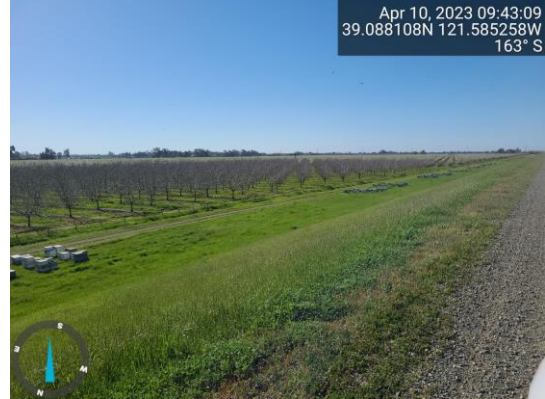
Photo 1 of 1 : SP\_2023\_RD0784\_530\_1\_20230420\_00001.jpg

View of annual vegetation on the landside slope, Spring 2023.
