**Flood Control Project Maintenance  
Levee Inspections**

## Maintenance Issue Types Only, Levee Inspection Report By Mile - Spring 2024

### Reclamation District No. 0784 Plumas Lake

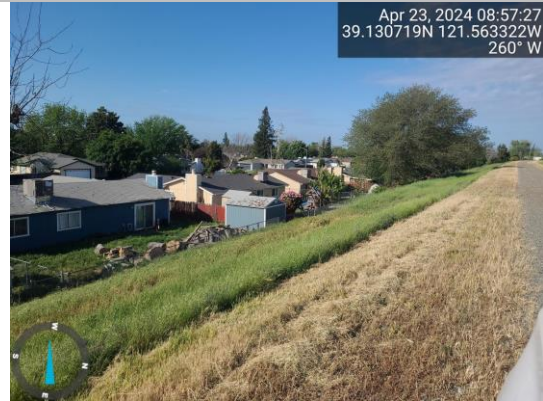
Photo 1 of 1 : SP\_2024\_RD0784\_178\_1\_20240423\_00002.jpg

LM Start	0.03	Rating **	M	Issue No.	1
LM End	2.18	Issue Type +	Ma	Location *	LS
Category	Earthen Levee			GPS Latitude/Longitude	
				Start	End
Item	Vegetation			39.134509°	39.126204°
				-121.552640°	-121.588517°
DWR ID	DWR_RD0784_01_s_2024_1				
Comment Code					
V1 : Control annual grass and weeds on the levee slopes and easements.					
Inspector Comment					
Annual vegetation on the landside slope needs to be maintained, Spring 2024.

View of vegetation on the landside slope, Spring 2024.

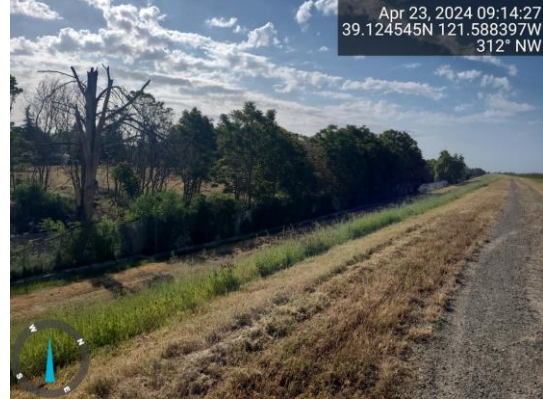
Photo 1 of 1 : SP\_2024\_RD0784\_531\_1\_20240423\_00001.jpg

View of vegetation on the landside slope, Spring 2024.

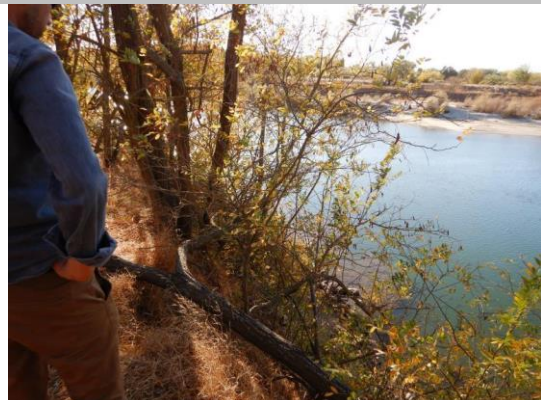
Photo 2 of 2 : SP\_2024\_RD0784\_532\_1\_20240326\_00002.jpg

Comment Code					
Inspector Comment					
2018 Site ID: FHR 17.8 L Status: Eroding 2018 Field Notes: Site continues to erode. Site History: 2003 - Bank is near vertical. Identified as a Potentially Critical site. 2004 - Eddy flow off downstream end of Modesto formation eroding the fluvial sediments. 2005 - Some new slumping. Actively eroding but berm width is greater than 50 ft. 2006 - Downgraded to regular erosion site. Still actively eroding. Large old rotational failures in high bank on the downstream end. 2008 - Removed from inventory due to wide berm width does not meet criteria for an erosion site. 2010 - Added back to the inventory after 10 ft of bank erosion in the winter 2009 storm. Steep vertical face. 2011 - Bank has retreated an additional 2.5 ft from last year. New tree popouts and erosion throughout the site. 2012 - Site continues to worsen with new tree popouts and many sections of new erosion. 2017 - Large sandbag on opposite bank, thalweg is moving closer to the levee.

USACE 2018 Erosion Photo #2

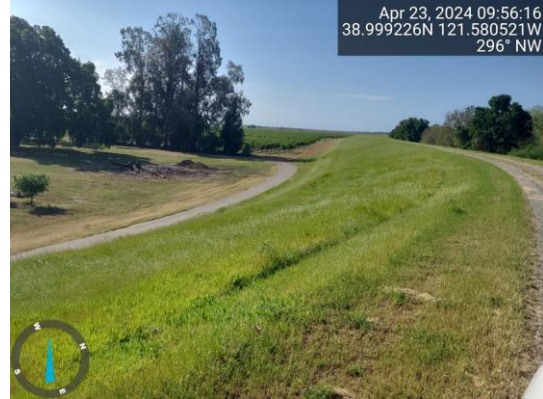
Photo 1 of 1 : SP\_2024\_RD0784\_532\_8\_20240423\_00019.jpg

View of vegetation on the landside slope, Spring 2024.

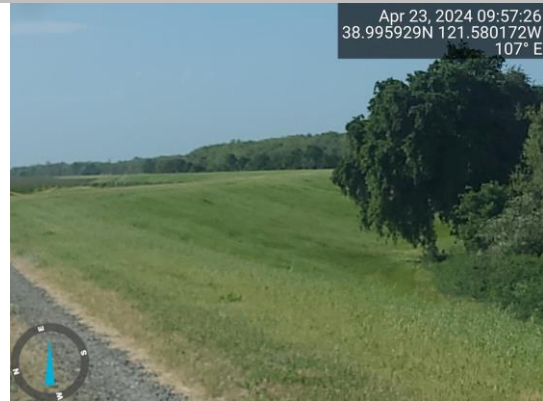
Photo 1 of 1 : SP\_2024\_RD0784\_532\_9\_20240423\_00020.jpg

LM Start	9.01	Rating **	M	Issue No.	9
LM End	12.18	Issue Type +	Ma	Location *	WS
Category	Earthen Levee			GPS Latitude/Longitude	
				Start	End
Item	Vegetation			39.009343°	38.964282°
				-121.578743°	-121.576996°
DWR ID	DWR_RD0784_02B_s_2024_9				
Comment Code					
V1 : Control annual grass and weeds on the levee slopes and easements.					
Inspector Comment					
Annual vegetation on the waterside slope needs to be maintained, Spring 2024.

View of vegetation on the waterside slope, Spring 2024.

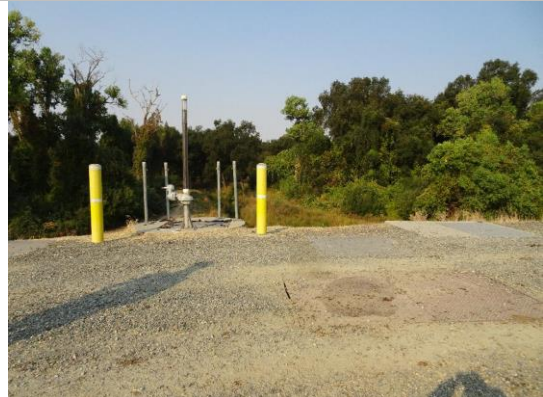
Photo 2 of 3 : UCIP\_SP\_2024\_69858\_101116.jpg

Water-Side: Vaults and screw gate at waterside shoulder.

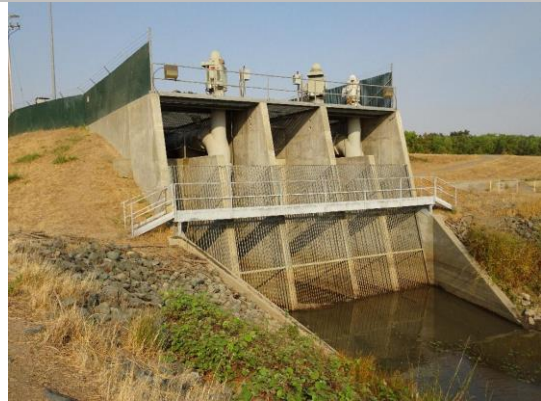
Photo 3 of 3 : UCIP\_SP\_2024\_69858\_101118.jpg

Land-Side: Inlet structure with pumps beyond landside toe.

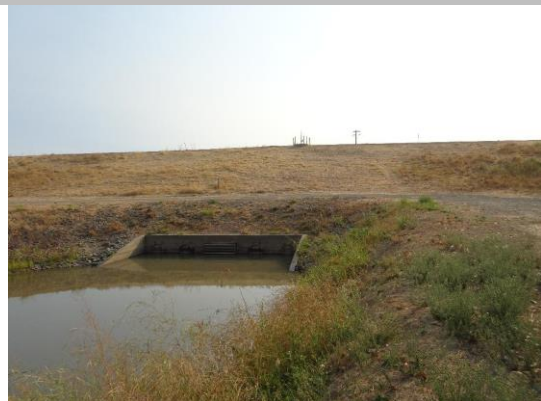
Photo 1 of 3 : UCIP\_SP\_2024\_69859\_101132.jpg

Water-Side: Outlet structure with five openings beyond waterside toe.

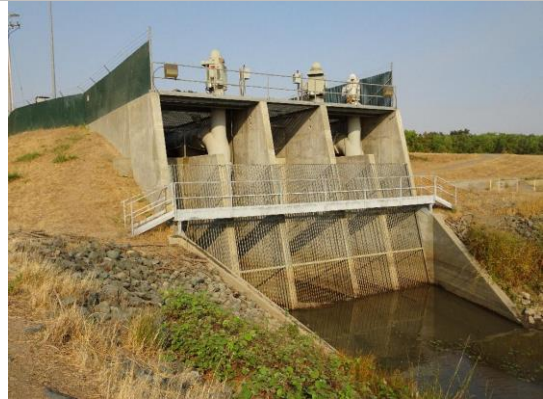
Photo 3 of 3 : UCIP\_SP\_2024\_69859\_101135.jpg

Land-Side: Inlet structure with pumps beyond landside toe.

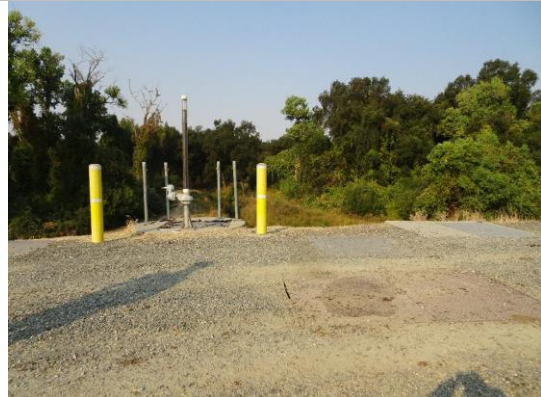
Photo 2 of 3 : UCIP\_SP\_2024\_69854\_101143.jpg

Water-Side: Vaults and screw gate at waterside shoulder.

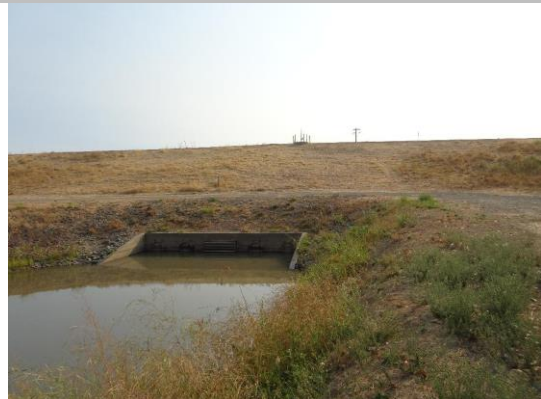
Photo 1 of 3 : UCIP\_SP\_2024\_69855\_101165.jpg

Water-Side: Outlet structure with five openings beyond waterside toe.

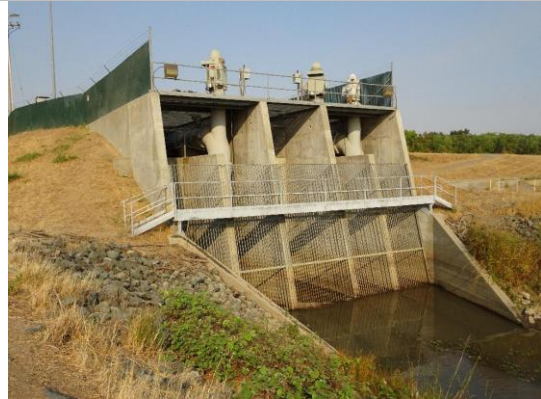
Photo 3 of 3 : UCIP\_SP\_2024\_69855\_101158.jpg

Land-Side: Inlet structure with pumps beyond landside toe.

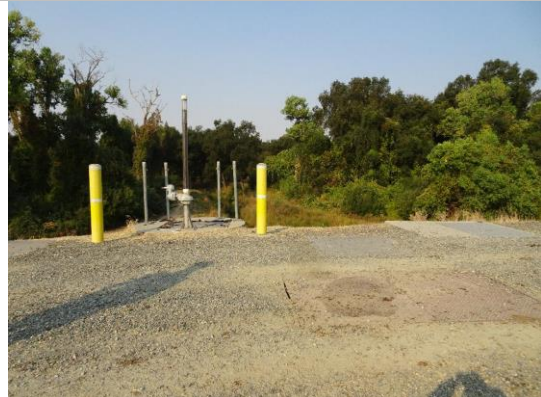
Photo 2 of 3 : UCIP\_SP\_2024\_69856\_101174.jpg

Water-Side: Vaults and screw gate at waterside shoulder.

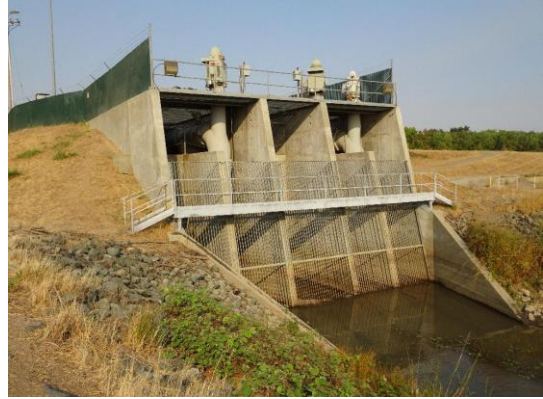
Photo 3 of 3 : UCIP\_SP\_2024\_69856\_101176.jpg

Land-Side: Inlet structure with pumps beyond landside toe.

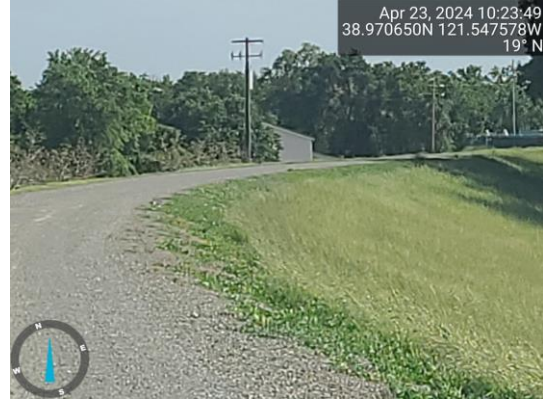
Photo 1 of 1 : SP\_2024\_RD0784\_533\_9\_20240423\_00022.jpg

View of vegetation on the waterside slope, Spring 2024.

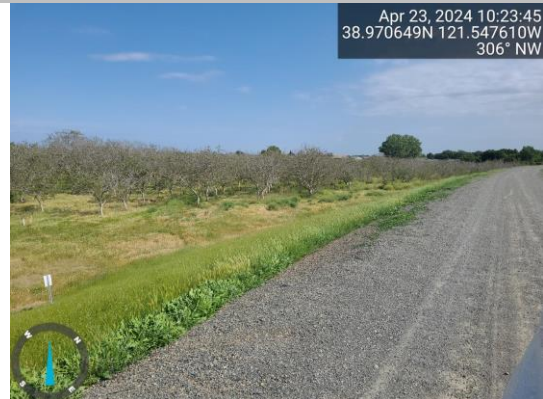
Photo 1 of 1 : SP\_2024\_RD0784\_533\_8\_20240423\_00023.jpg

View of vegetation on the landside slope, Spring 2024.

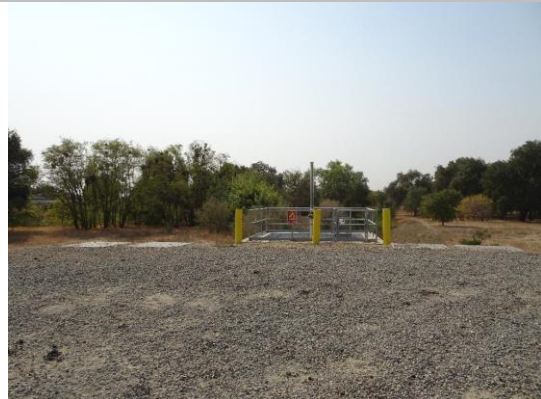
Photo 2 of 3 : UCIP\_SP\_2024\_69899\_101217.jpg

Water-Side: Five vaults and a screw gate at waterside shoulder.

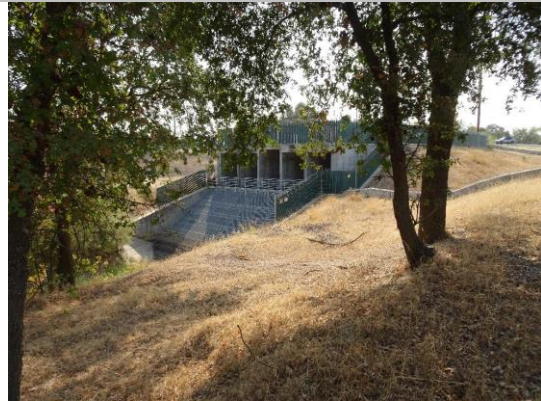
Photo 3 of 3 : UCIP\_SP\_2024\_69899\_101219.jpg

Land-Side: Inlet structure with pumps beyond landside toe.

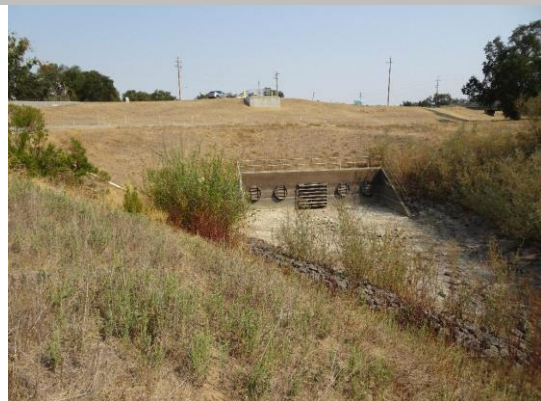
Photo 1 of 3 : UCIP\_SP\_2024\_69900\_101226.jpg

Water-Side: Outlet structure with five openings beyond waterside toe.

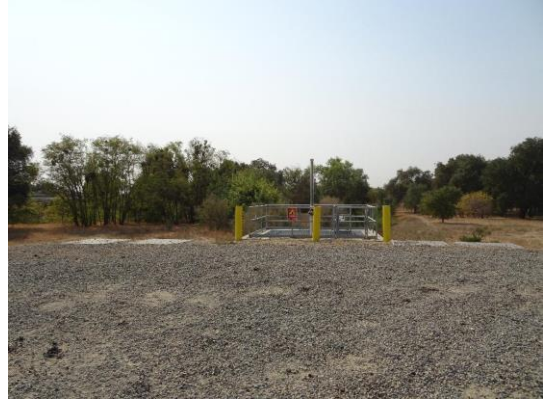
Photo 2 of 3 : UCIP\_SP\_2024\_69900\_101227.jpg

Water-Side: Five vaults and a screw gate at waterside shoulder.

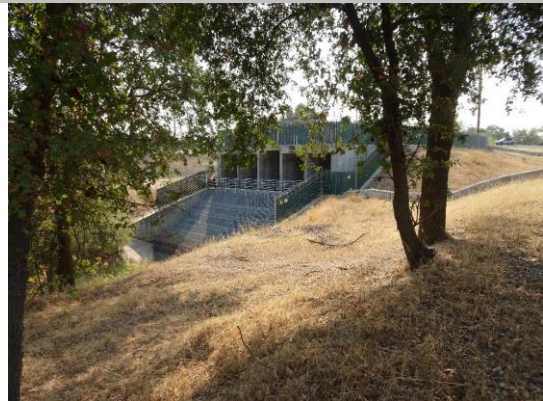
Photo 3 of 3 : UCIP\_SP\_2024\_69900\_101229.jpg

Land-Side: Inlet structure with pumps beyond landside toe.

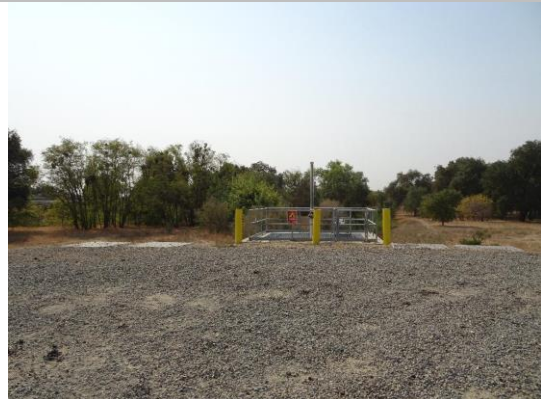
Photo 2 of 3 : UCIP\_SP\_2024\_69891\_101232.jpg

Water-Side: Five vaults and a screw gate at waterside shoulder.

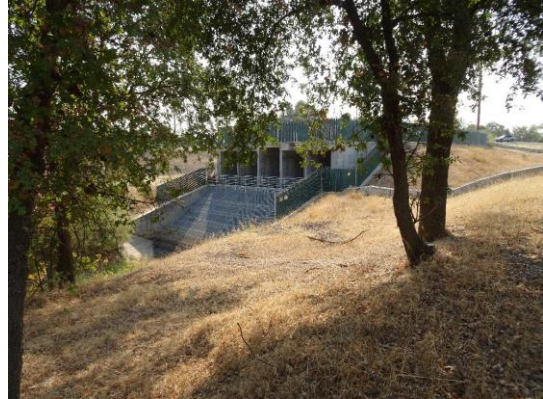
Photo 3 of 3 : UCIP\_SP\_2024\_69891\_101234.jpg

Land-Side: Inlet structure with pumps beyond landside toe.

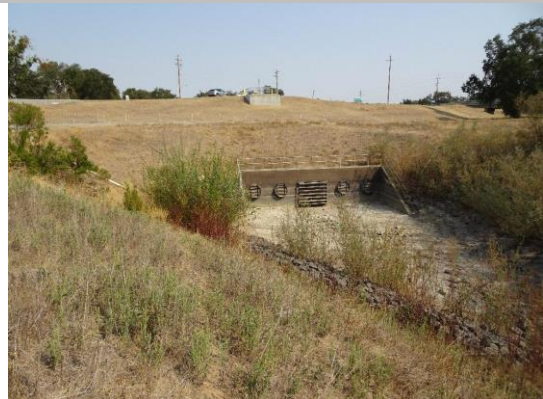
Photo 1 of 3 : UCIP\_SP\_2024\_69895\_101239.jpg

Water-Side: Outlet structure with five openings beyond waterside toe.

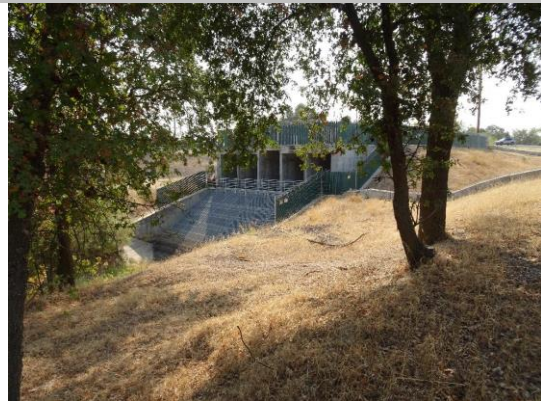
Photo 3 of 3 : UCIP\_SP\_2024\_69895\_101242.jpg

Land-Side: Inlet structure with pumps beyond landside toe.

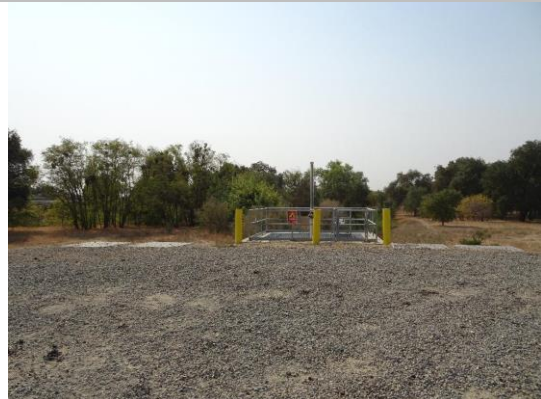
Photo 2 of 3 : UCIP\_SP\_2024\_69901\_101250.jpg

Water-Side: Five vaults and a screw gate at waterside shoulder.

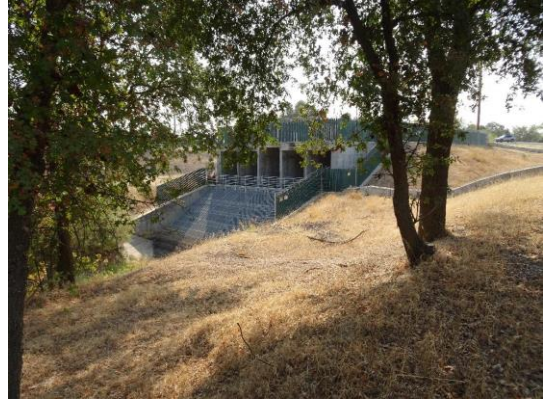
Photo 3 of 3 : UCIP\_SP\_2024\_69901\_101251.jpg

Land-Side: Inlet structure with pumps beyond landside toe.

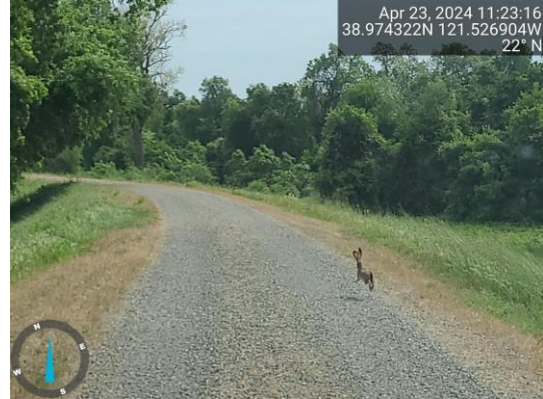
Photo 1 of 1 : SP\_2024\_RD0784\_534\_6\_20240423\_00011.jpg

View of vegetation on the waterside slope, Spring 2024.

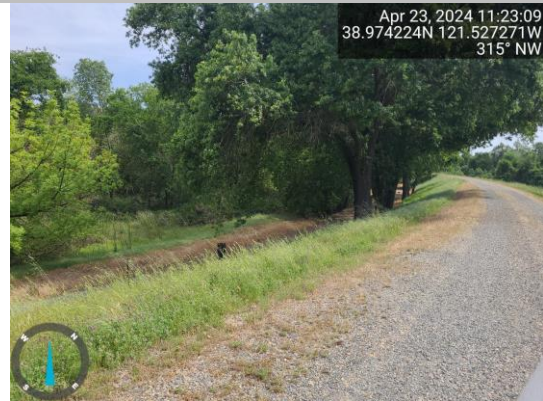
Photo 1 of 1 : SP\_2024\_RD0784\_534\_5\_20240423\_00010.jpg

View of vegetation on the landside slope, Spring 2024.

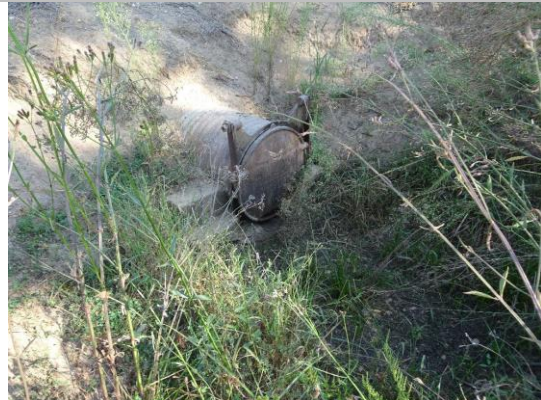
Photo 2 of 3 : UCIP\_SP\_2024\_69907\_101269.jpg

Comment Code					
Inspector Comment					
DS_ID:18580 FS_ID:69907 EP_NO: N/A Repair Type: Urgent EVAL Issue: 1, Pipe Integrity Crossing Status: Found UCIP Comments: 10/05/2020 - Record has been updated from No Action Needed to Urgent. DWR DMP has found integrity issues, LOF between 5 and 6. Recommend monitoring crossing until funding becomes available to address. No permit was found authorizing this encroachment. CVFPB will need to review crossing to determine owner. (O. Magana - DWR UCIP)12/16/2019 - Pipe crossing was hydroflushed and video inspected in October 2019. Pending final review by RD784 District Engineer and DWR. (P. Meagher - RD784)02/01/2019 - Pipe crossing was video inspected on 8-14-2018. (P. Meagher - RD784) FIELD_STRUCT_DESC: 30-inch corrugated metal (CM) drainage pipe through the levee, 19.0 feet below the crown. Flap gate on the waterside (WS) end. Concrete headwall at the WS toe. (No permit found for this crossing. Owner unknown). [Additional Reference(s): DWR Levee Log, 2005, (HLM 3.56). USACE Sacramento O&M Manual, Unit No. 145, August 1955, Revised 6 August 2019, (Station 92+88)]. FS Date: 10/5/2020

Water-Side: Pipe outlet and flap gate at waterside toe.

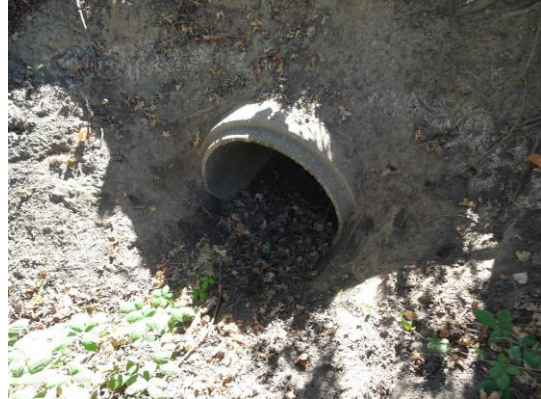
Photo 3 of 3 : UCIP\_SP\_2024\_69907\_101270.jpg

Land-Side: Pipe inlet beyond landside toe.

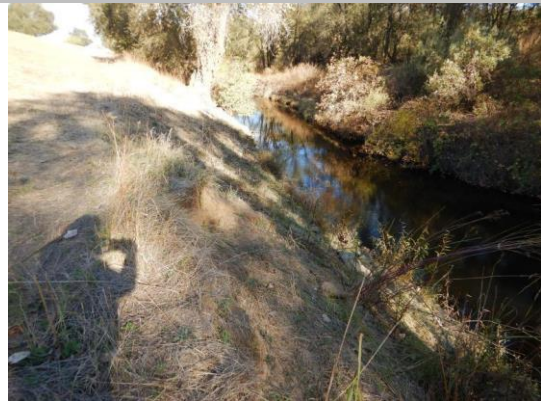
Photo 1 of 2 : SP\_2024\_RD0784\_534\_3\_20240326\_00001.jpg

LM Start	4.28	Rating **	A/W	Issue No.	3
LM End	4.29	Issue Type +	Ma	Location *	WS
Category	Supplemental			GPS Latitude/Longitude	
				Start	End
Item	2018 USACE Erosion Survey			38.981271°	38.981400°
				-121.515999°	-121.515848°
DWR ID	DWR_RD0784_03B_s_2022_3				
Comment Code					
Inspector Comment					
2018 Site ID: BER 4.9 R					
Status: Eroding					
2018 Field Notes: No observed change.					
Site History: 2009 - Small site which could be repaired with maintenance. Erosion into the levee toe, rock has started to fail.

USACE 2018 Erosion Photo #1

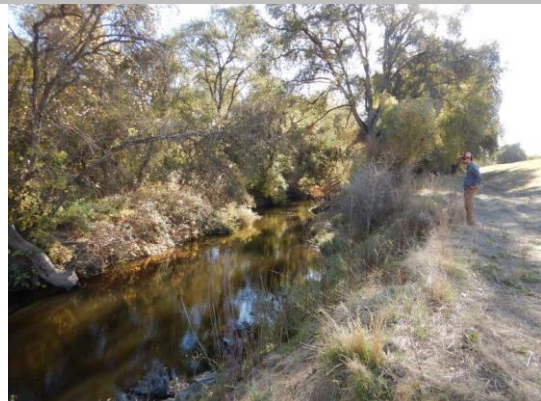
Photo 2 of 2 : SP\_2024\_RD0784\_534\_3\_20240326\_00002.jpg

USACE 2018 Erosion Photo #2

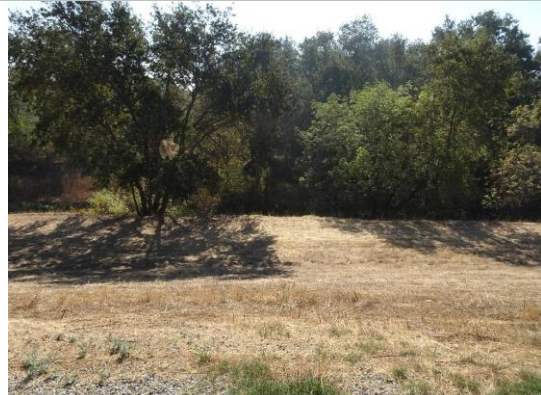
Photo 2 of 3 : UCIP\_SP\_2024\_69908\_101280.jpg

Comment Code						
Inspector Comment						
DS_ID:18579 FS_ID:69908 EP_NO: N/A Repair Type: Non-Urgent EVAL Issue: Crossing Status: Not Found UCIP Comments: 10/05/2020 Record has been updated from No Action Needed to Non-Urgent. DWR DMP geophysical study found no positive signal of pipe at latitude, longitude 38.983363, -121.513775. No signs or evidence of pipe were found during site inspection. No permit was found authorizing this encroachment. CVFPB will need to review crossing to determine owner. Record will remain in UCIP's database and will remain active until a levee improvement project can confirm that this crossing has been removed from the levee. (O. Magana - DWR UCIP) FIELD_STRUCT_DESC: 18-inch corrugated metal (CM) drainage pipe through the levee, 17.5 feet below the crown. Flap gate on the waterside (WS) end. (No permit found for this crossing. Owner unknown). [Additional Reference(s): DWR Levee Log, 2005, (HLM 4.52). USACE Sacramento O&M Manual, Unit No. 145, August 1955, Revised 6 August 2019, (Station 143+15)]. FS Date: 10/5/2020

Water-Side: View of waterside looking from crown.

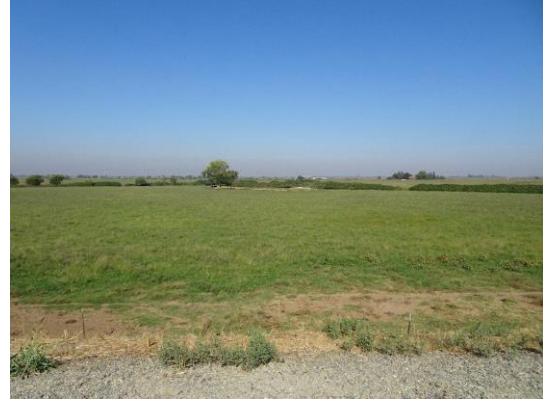
Photo 3 of 3 : UCIP\_SP\_2024\_69908\_101281.jpg

Land-Side: View of landside looking from crown.

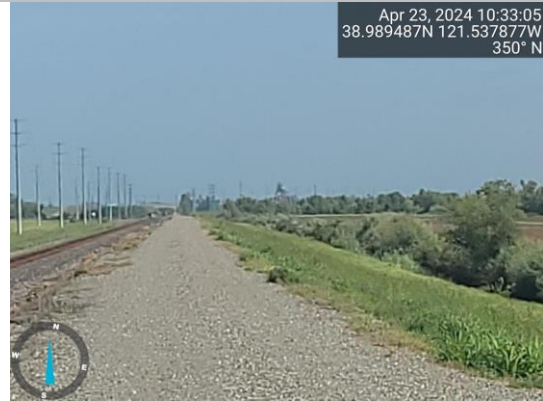
Photo 1 of 1 : SP\_2024\_RD0784\_181\_4\_20240423\_00008.jpg

View of vegetation on the waterside slope, Spring 2024.

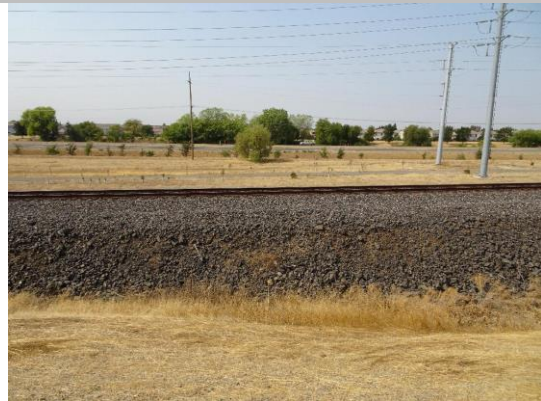
Photo 3 of 3 : UCIP\_SP\_2024\_70203\_100695.jpg

View of landside from crown, no indicator of pipe.

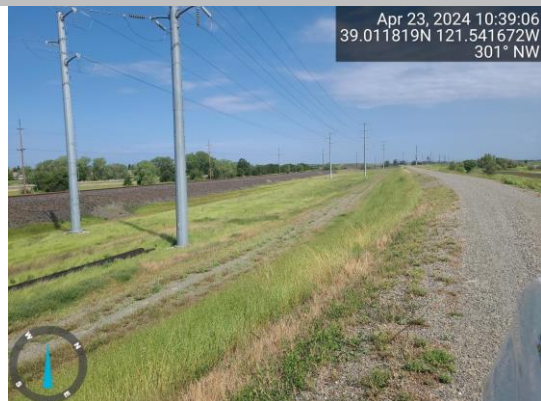
Photo 1 of 1 : SP\_2024\_RD0784\_181\_3\_20240423\_00007.jpg

View of vegetation on the landside slope, Spring 2024.

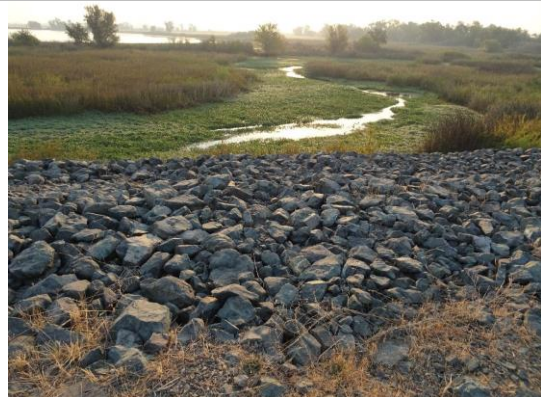
Photo 2 of 3 : UCIP\_SP\_2024\_70205\_100725.jpg

Waterside view from crown. Riprap on slope.

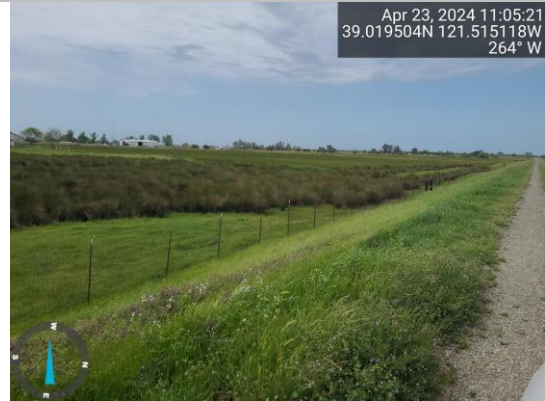
Photo 1 of 1 : SP\_2024\_RD0784\_182\_14\_20240423\_00025.jpg

View of vegetation on the landside slope, Spring 2024.

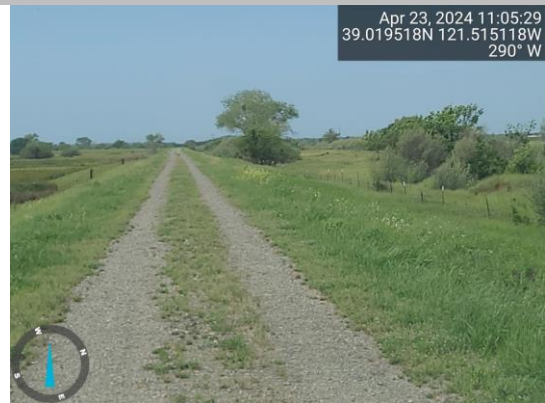
Photo 1 of 1 : SP\_2024\_RD0784\_182\_15\_20240423\_00027.jpg

View of vegetation on the waterside slope, Spring 2024.

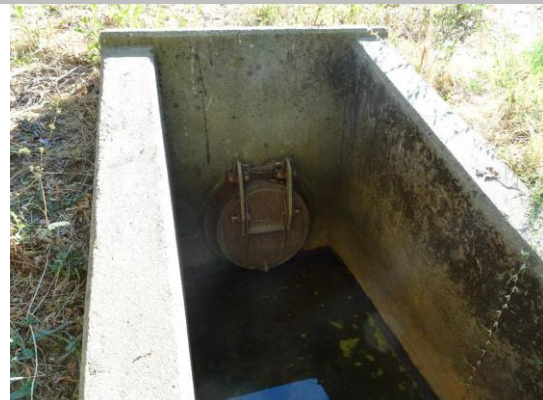
Photo 2 of 3 : UCIP\_SP\_2024\_70298\_100866.jpg

Water-Side: Outlet structure with flap gate at waterside toe.

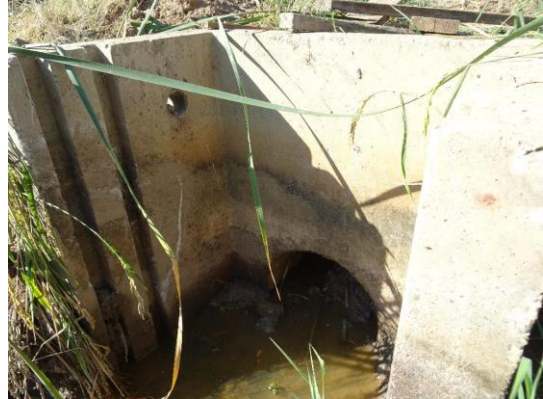
Photo 3 of 3 : UCIP\_SP\_2024\_70298\_100867.jpg

Land-Side: Inlet structure with open pipe at landside toe.

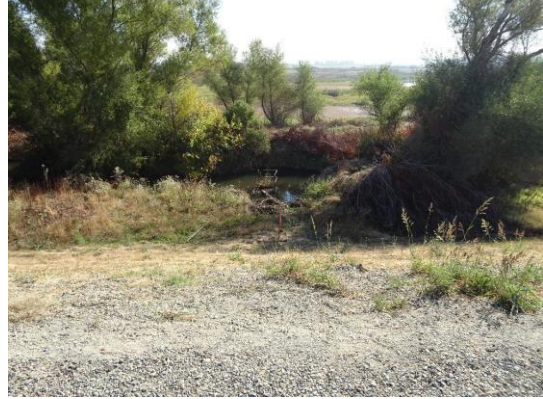
Photo 2 of 3 : UCIP\_SP\_2024\_70299\_100892.jpg

Land-Side: Drop inlet at landside toe.

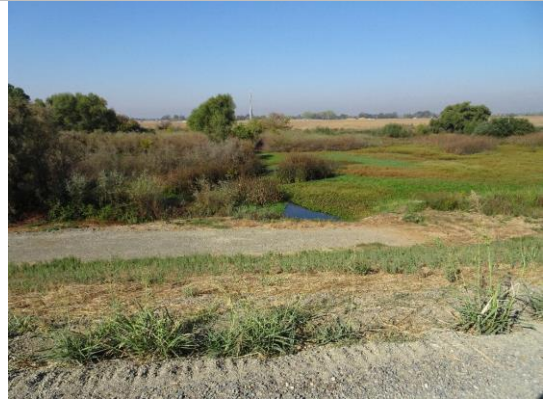
Photo 3 of 3 : UCIP\_SP\_2024\_70299\_100893.jpg

Water-Side: Outlet underwater at waterside toe.

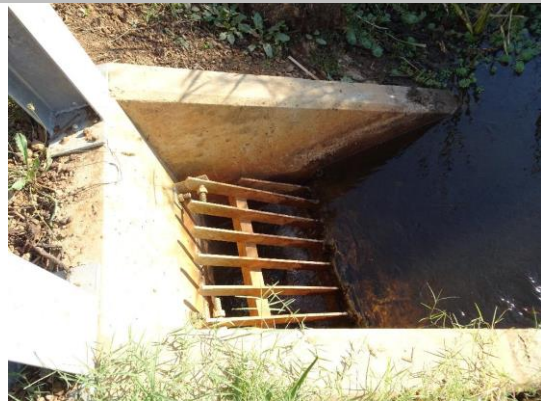
Photo 3 of 3 : UCIP\_SP\_2024\_82831\_100938.jpg

Land-Side: Inlet structure with grate at landside toe.

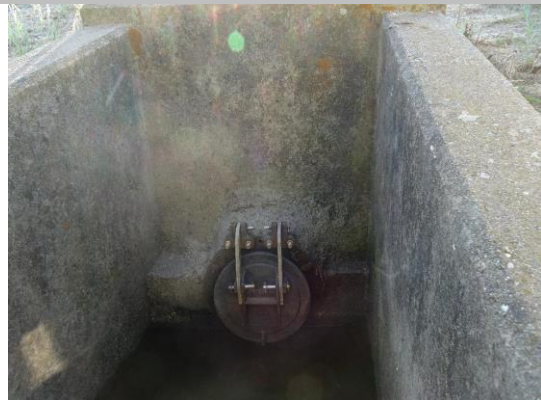
Photo 2 of 3 : UCIP\_SP\_2024\_70306\_100941.jpg

Water-Side: Outlet structure with flap gate at waterside toe.

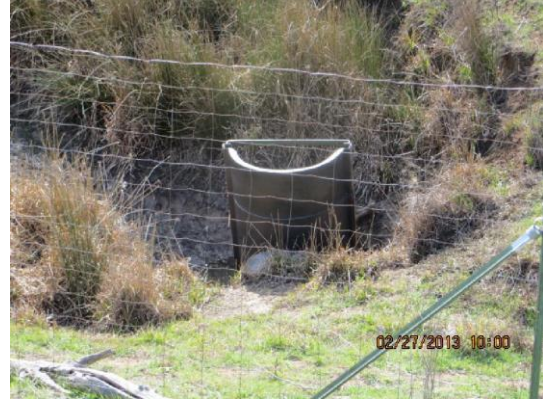
Photo 2 of 3 : UCIP\_SP\_2024\_70307\_16594.jpg

PVC weir inlet on LS toe.

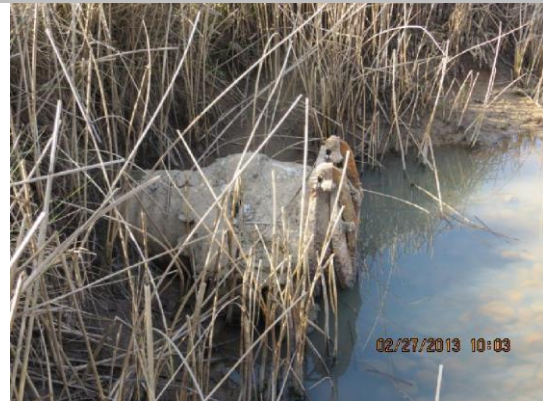
Photo 3 of 3 : UCIP\_SP\_2024\_70307\_16593.jpg

Flap gate at WS toe.

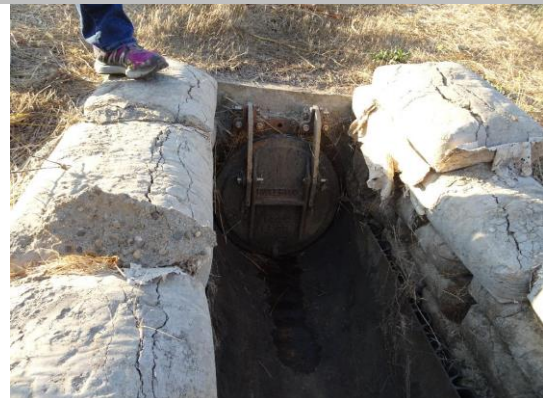
Photo 2 of 3 : UCIP\_SP\_2024\_70308\_100948.jpg

Water-Side: Outlet structure with flap gate at waterside toe.

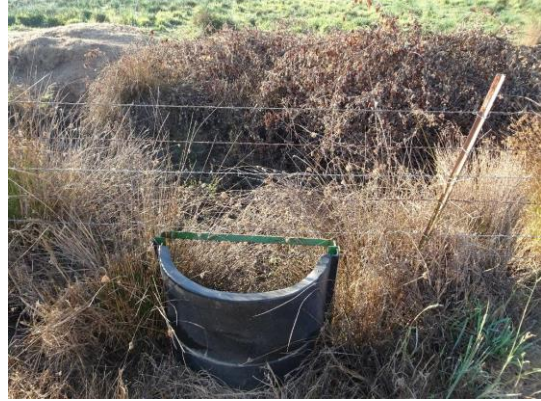
Photo 3 of 3 : UCIP\_SP\_2024\_70308\_100950.jpg

Land-Side: Inlet structure at landside toe.

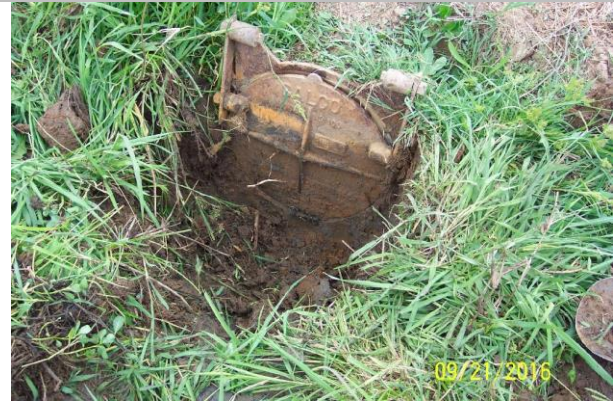
Photo 2 of 3 : UCIP\_SP\_2024\_70309\_76147.jpg

Flap gate on the WS toe is exposed

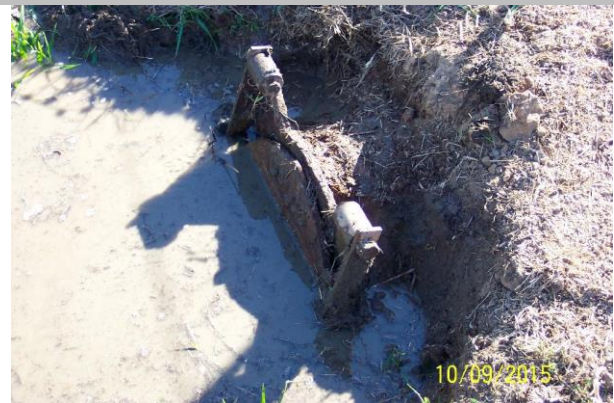
Photo 3 of 3 : UCIP\_SP\_2024\_70309\_74710.jpg

Flap gate at waterside toe partially under water

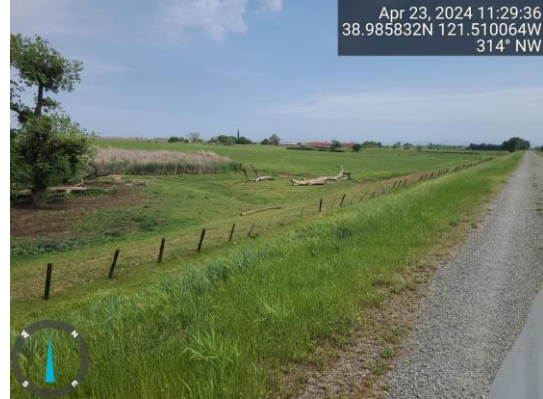
Photo 1 of 1 : SP\_2024\_RD0784\_183\_2\_20240423\_00004.jpg

View of vegetation on the landside slope, Spring 2024.

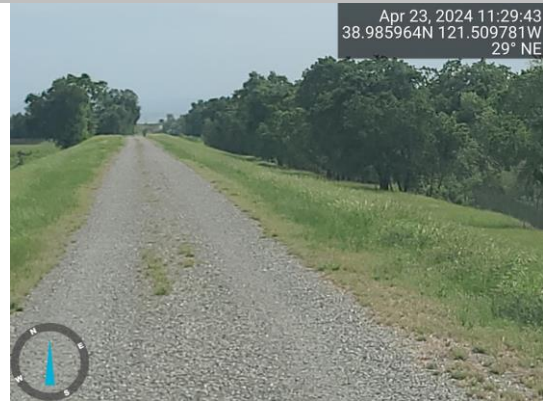
Photo 1 of 1 : SP\_2024\_RD0784\_183\_3\_20240423\_00005.jpg

View of vegetation on the waterside slope, Spring 2024.

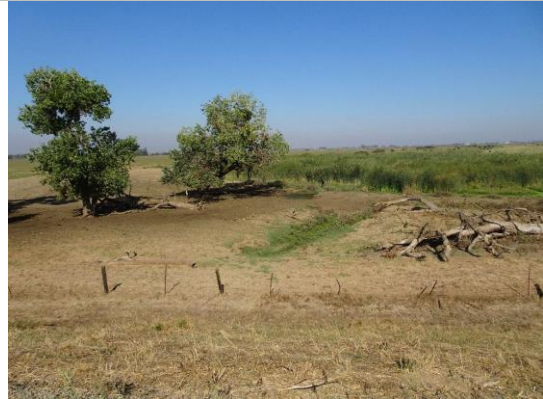
Photo 3 of 3 : UCIP\_SP\_2024\_70311\_100958.jpg

Land-Side: Inlet channel and pipe debris on landside.

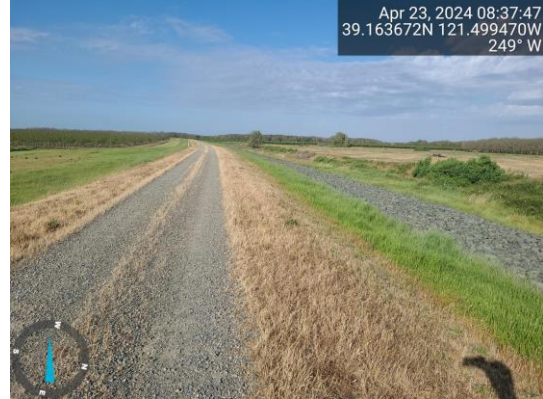
Photo 1 of 1 : SP\_2024\_RD0784\_184\_2\_20240423\_00002.jpg

View of vegetation on the waterside slope, Spring 2024.

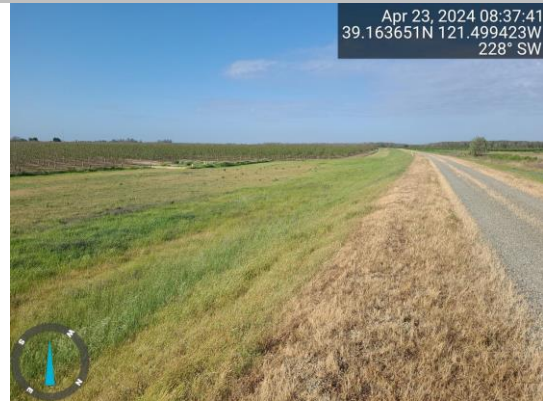
Photo 1 of 1 : SP\_2024\_RD0784\_184\_1\_20240423\_00001.jpg

View of vegetation on the landside slope, Spring 2024.

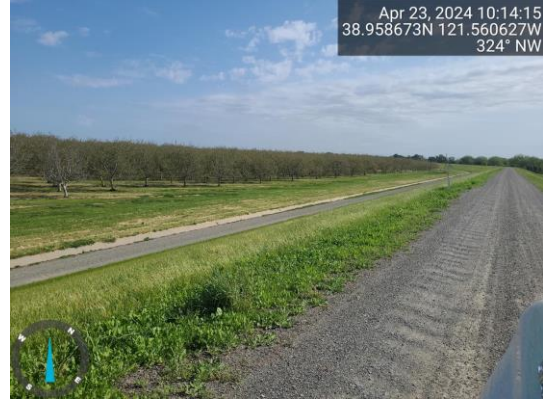
Photo 1 of 1 : SP\_2024\_RD0784\_437\_1\_20240423\_00003.jpg

View of vegetation on the landside slope, Spring 2024.

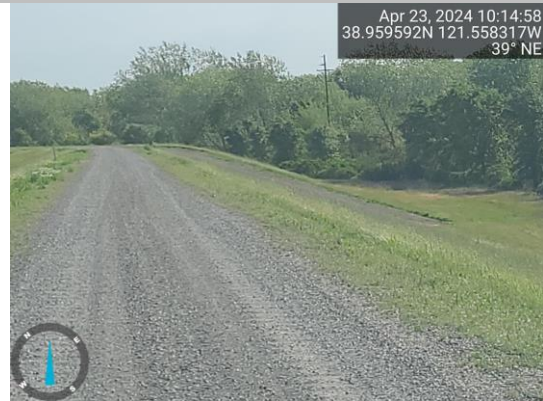
Photo 1 of 1 : SP\_2024\_RD0784\_437\_2\_20240423\_00004.jpg

View of vegetation on the waterside slope, Spring 2024.
