**Flood Control Project Maintenance
Levee Inspections**

Fall 2014 Levee Maintenance Deficiency Summary Report

Reclamation District No. 0785 Driver

Levee Inspection Report By Mile - Fall 2014

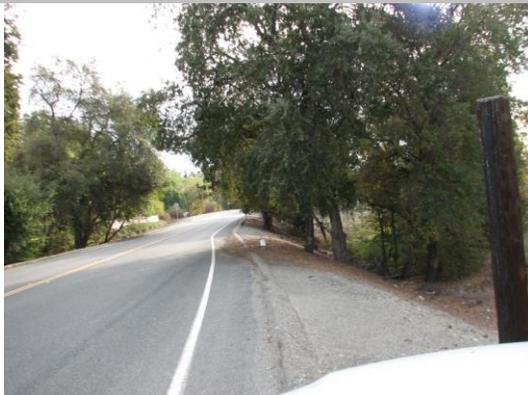
Photo 1 of 1 : FA_2014_RD0785_185_14_20141120_00020.jpg

LM Start	0.00	Rating **	A/W	Issue No.	14
LM End	2.31	Issue Type +	Ma	Location *	LS
Category	Earthen Levee		GPS Latitude/Longitude		
			Start	End	
Item	Vegetation			°	°
				°	°
DWR ID	DWR_RD0785_01_f_2014_14				
Action/Comments					
Control annual grass and weeds on the levee slopes and easements.

Levee mile 0.00, vegetation on the land side slope. Fall 2014.

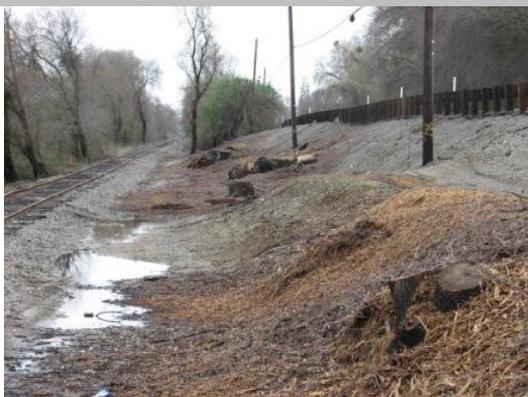
Photo 1 of 1 : FA_2014_RD0785_185_4_20141014_00003.jpg

LM Start	0.13	Rating **	N	Issue No.	4
LM End	1.36	Issue Type +	Ma	Location *	LS
Category	Earthen Levee		GPS Latitude/Longitude		
			Start	End	
Item	Trim / Thin Trees		38.660160	°	38.646214
			-121.611619	°	-121.598596
DWR ID	DWR_RD0785_01_s_2012_4				
Action/Comments					
Tree stumps.

The trees were cut by PG&E'S tree contractor. The district will take care of the stumps in the future.

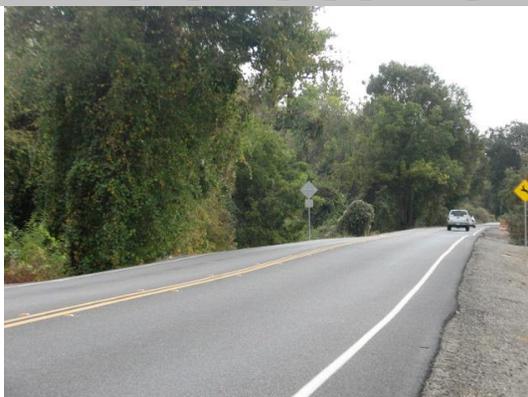
Photo 1 of 2 : FA_2014_RD0785_185_16_20141014_00011.jpg

LM Start	0.21	Rating **	M	Issue No.	16
LM End	1.37	Issue Type +	Ma	Location *	WS
Category	Earthen Levee		GPS Latitude/Longitude		
			Start	End	
Item	Vegetation		38.659340	°	38.646093
			-121.610405	°	-121.598518
DWR ID	DWR_RD0785_01_f_2013_16				
Action/Comments					
Remove the wild growth other than native grasses from the levee slopes.

Brush and other vegetation partially blocks visibility or access to the levee slope. Fall 2013

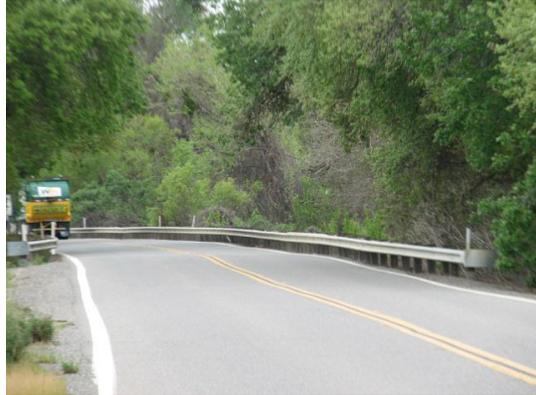
Photo 2 of 2 : FA_2014_RD0785_185_16_20141014_00012.jpg

LM Start	0.21	Rating **	M	Issue No.	16 (cont)
LM End	1.37	Issue Type +	Ma	Location *	WS
Category	Earthen Levee		GPS Latitude/Longitude		
			Start	End	
Item	Vegetation		38.659340 °	38.646093 °	
			-121.610405 °	-121.598518 °	
DWR ID	DWR_RD0785_01_f_2013_16				
Action/Comments					
Remove the wild growth other than native grasses from the levee slopes.

Brush and other vegetation partially blocks visibility. Spring 2014

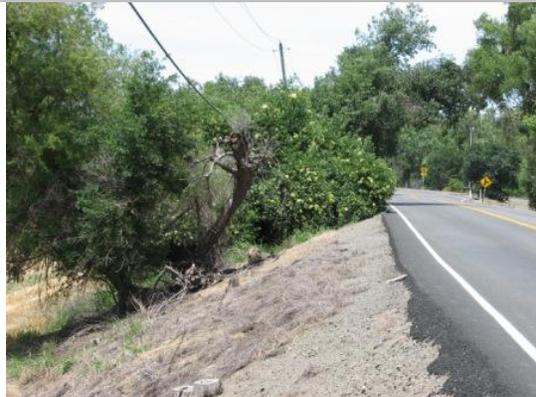
Photo 1 of 1 : FA_2014_RD0785_185_1_20141014_00001.jpg

LM Start	0.29	Rating **	A/W	Issue No.	1
LM End	0.29	Issue Type +	Ma	Location *	LS
Category	Earthen Levee		GPS Latitude/Longitude		
			Start	End	
Item	Vegetation		38.658467 °	38.658467 °	
			-121.609573 °	-121.609573 °	
DWR ID	DWR_RD0785_01_s_2012_1				
Action/Comments					
Elderberries are blocking visibility and flood fight capability.

Elderberry

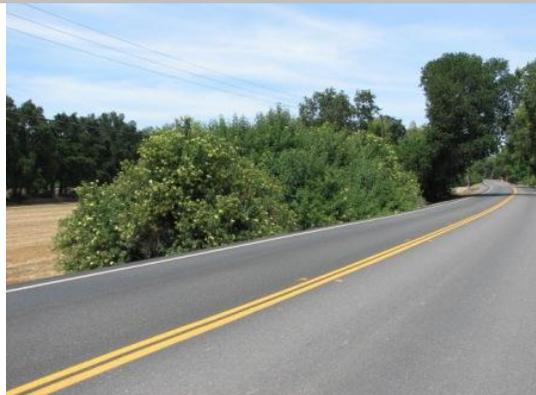
Photo 1 of 1 : FA_2014_RD0785_185_2_20141014_00002.jpg

LM Start	0.41	Rating **	A/W	Issue No.	2
LM End	0.45	Issue Type +	Ma	Location *	LS
Category	Earthen Levee		GPS Latitude/Longitude		
			Start	End	
Item	Vegetation		38.657168 °	38.656697 °	
			-121.608270 °	-121.607845 °	
DWR ID	DWR_RD0785_01_s_2012_2				
Action/Comments					
Elderberries are blocking visibility and flood fight capability.

Elderberry

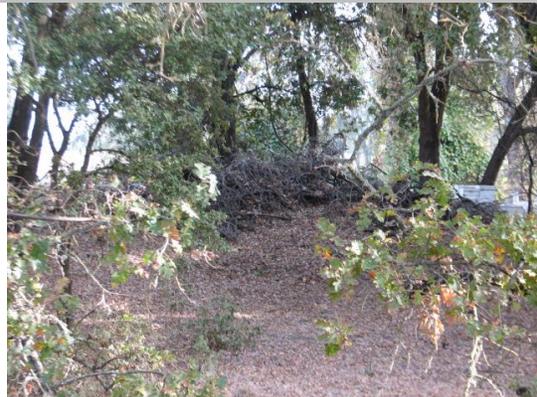
Photo 1 of 1 : FA_2014_RD0785_185_46_20141014_00013.jpg

LM Start	0.68	Rating **	M	Issue No.	46
LM End	0.68	Issue Type +	En	Location *	LS
Category	Earthen Levee			GPS Latitude/Longitude	
				Start	End
Item	Encroachments			38.653955 °	38.653955 °
				-121.605712 °	-121.605712 °
DWR ID	DWR_RD0785_01_s_2012_46				
Action/Comments					
Prunings

Pruning pile on the landside shoulder. Fall 2013

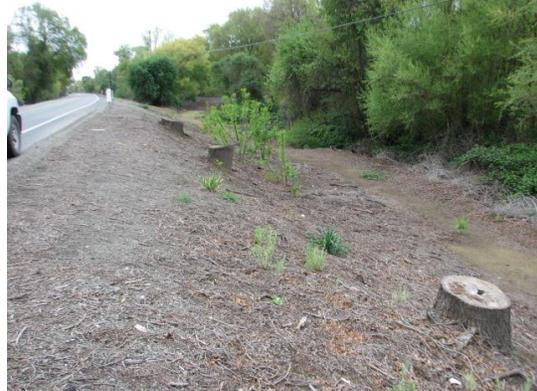
Photo 1 of 1 : FA_2014_RD0785_185_181_20141014_00018.jpg

LM Start	0.76	Rating **	N	Issue No.	181
LM End	0.76	Issue Type +	Ma	Location *	LS
Category	Earthen Levee		GPS Latitude/Longitude		
			Start	End	
Item	Trim / Thin Trees		38.653003 °	38.653003 °	
			-121.605061 °	-121.605061 °	
DWR ID	DWR_RD0785_01_s_2014_181				
Action/Comments					
Tree stumps.

Tree stumps along the landside shoulder of the levee. Spring 2014

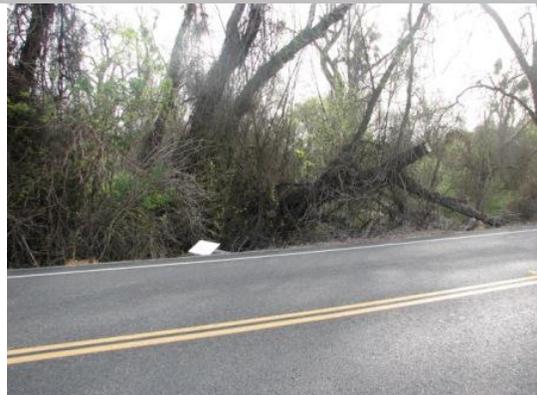
Photo 1 of 1 : FA_2014_RD0785_185_47_20141014_00014.jpg

LM Start	0.93	Rating **	M	Issue No.	47
LM End	0.93	Issue Type +	Ma	Location *	WS
Category	Earthen Levee		GPS Latitude/Longitude		
			Start	End	
Item	Trim / Thin Trees		38.650992 °	38.650992 °	
			-121.603392 °	-121.603392 °	
DWR ID	DWR_RD0785_01_s_2012_47				
Action/Comments					
Trim and thin trees to allow visibility of the ground and room to flood fight.

The fallen tree and brush on the waterside of the roadway needs to be removed. Photo taken spring 2012.

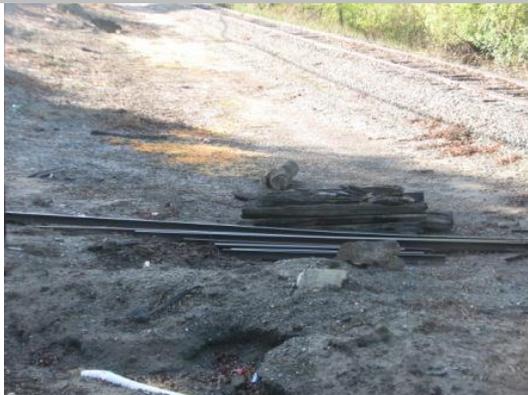
Photo 1 of 1 : FA_2014_RD0785_185_12_20141014_00008.jpg

LM Start	1.08	Rating **	M	Issue No.	12
LM End	1.08	Issue Type +	En	Location *	LS
Category	Earthen Levee		GPS Latitude/Longitude		
			Start	End	
Item	Encroachments		38.649355 °	38.649355 °	
			-121.601760 °	-121.601760 °	
DWR ID	DWR_RD0785_01_s_2013_12				
Action/Comments					
Debris

Railroad ties and rails lay along the toe of the levee. Spring 2013

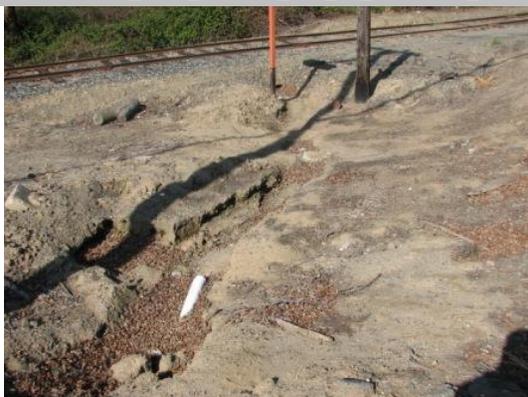
Photo 1 of 3 : FA_2014_RD0785_185_48_20141014_00015.jpg

LM Start	1.08	Rating **	M	Issue No.	48
LM End	1.08	Issue Type +	Ma	Location *	LS
Category	Earthen Levee		GPS Latitude/Longitude		
			Start	End	
Item	Erosion / Bank Caving		38.649292 °	38.649292 °	
			-121.601647 °	-121.601647 °	
DWR ID	DWR_RD0785_01_s_2012_48				
Action/Comments					
Schedule repair of erosion site prior to the next inspection.

The drain pipe across from the firehouse has caused erosion, photo taken spring 2012.

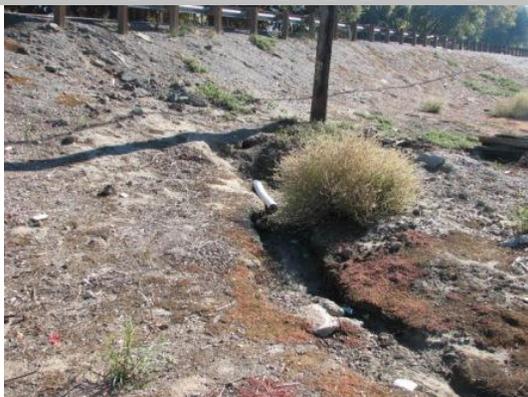
Photo 2 of 3 : FA_2014_RD0785_185_48_20141014_00016.jpg

LM Start	1.08	Rating **	M	Issue No.	48 (cont)
LM End	1.08	Issue Type +	Ma	Location *	LS

Erosion on the levee slope and toe. Fall 2012

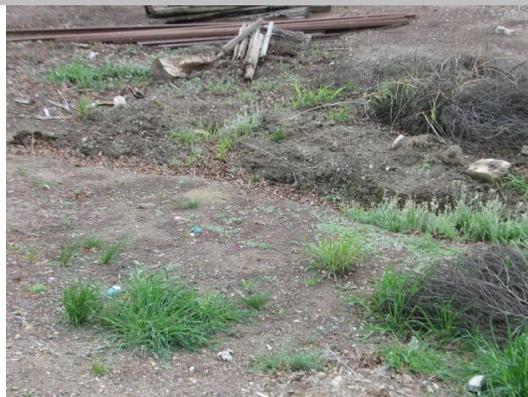
Photo 3 of 3 : FA_2014_RD0785_185_48_20141014_00017.jpg

LM Start	1.08	Rating **	M	Issue No.	48 (cont)
LM End	1.08	Issue Type +	Ma	Location *	LS
Category	Earthen Levee			GPS Latitude/Longitude	
				Start	End
Item	Erosion / Bank Caving			38.649292 °	38.649292 °
				-121.601647 °	-121.601647 °
DWR ID	DWR_RD0785_01_s_2012_48				
Action/Comments					
Schedule repair of erosion site prior to the next inspection.

Drain pipe is causing erosion on the landside of the levee between the slope and railroad tracks. Spring 2014

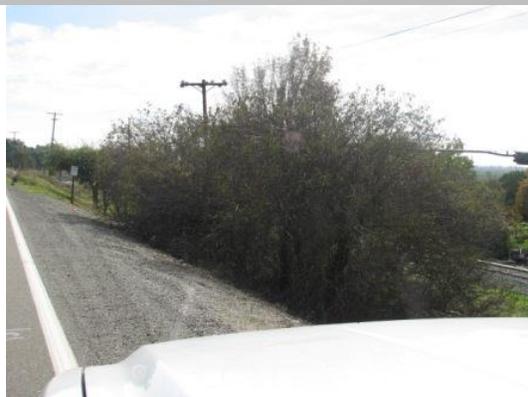
Photo 1 of 1 : FA_2014_RD0785_185_6_20141014_00004.jpg

LM Start	1.32	Rating **	A/W	Issue No.	6
LM End	1.32	Issue Type +	Ma	Location *	LS
Category	Earthen Levee			GPS Latitude/Longitude	
				Start	End
Item	Vegetation			38.646712 °	38.646712 °
				-121.599095 °	-121.599095 °
DWR ID	DWR_RD0785_01_s_2012_6				
Action/Comments					
Elderberries are blocking visibility and flood fight capability.

This is a very large Elderberry bush.

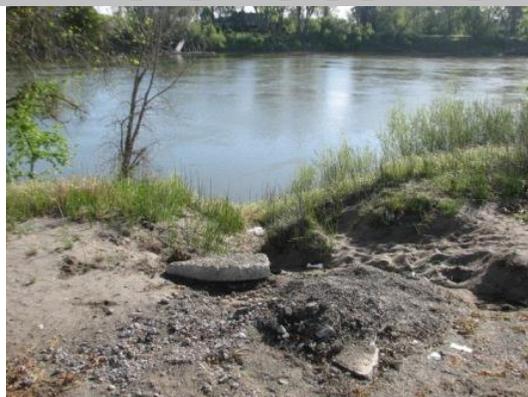
Photo 1 of 2 : FA_2014_RD0785_185_13_20141014_00009.jpg

LM Start	1.32	Rating **	M	Issue No.	13
LM End	1.32	Issue Type +	Ma	Location *	WS
Category	Earthen Levee			GPS Latitude/Longitude	
				Start	End
Item	Erosion / Bank Caving			38.646671 °	38.646671 °
				-121.598915 °	-121.598915 °
DWR ID	DWR_RD0785_01_s_2013_13				
Action/Comments					
Schedule repair of erosion site prior to the next inspection.

The erosion has become a trail for fishermen and contributes to it. Spring 2013

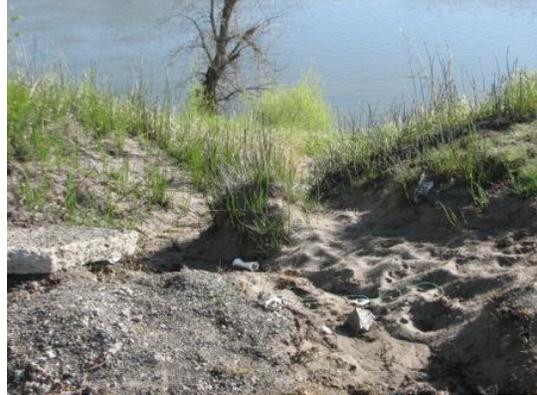
Photo 2 of 2 : FA_2014_RD0785_185_13_20141014_00010.jpg

LM Start	1.32	Rating **	M	Issue No.	13 (cont)
LM End	1.32	Issue Type +	Ma	Location *	WS
Category	Earthen Levee		GPS Latitude/Longitude		
			Start	End	
Item	Erosion / Bank Caving		38.646671 °	38.646671 °	
			-121.598915 °	-121.598915 °	
DWR ID	DWR_RD0785_01_s_2013_13				
Action/Comments					
Schedule repair of erosion site prior to the next inspection.

The waterside levee slope has erosion from surface run off. Spring 2013

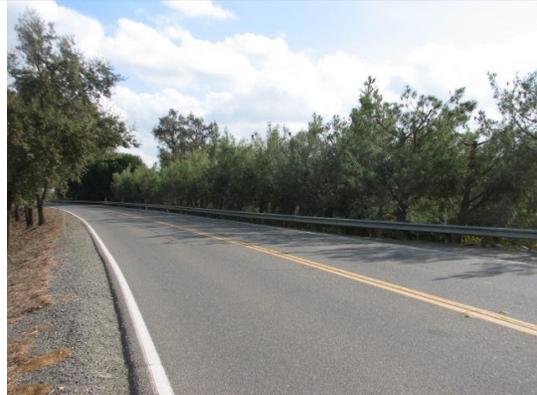
Photo 1 of 2 : FA_2014_RD0785_185_8_20141014_00005.jpg

LM Start	2.04	Rating **	M	Issue No.	8
LM End	2.14	Issue Type +	En	Location *	LS
Category	Earthen Levee		GPS Latitude/Longitude		
			Start	End	
Item	Vegetation		38.641623 °	38.642005 °	
			-121.588558 °	-121.586993 °	
DWR ID	DWR_RD0785_01_s_2012_8				
Action/Comments					
Landscaping Inspector Comments: Trees have been raised for visibility. Pine trees and oleander planted on shoulder.

The pine trees along the shoulder have been topped and thin out. Oleanders still on the shoulder. Fall 2013

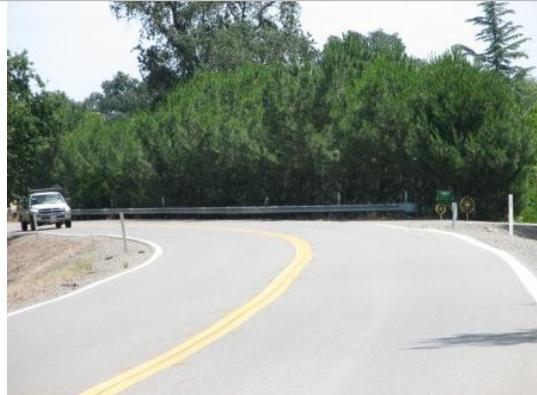
Photo 2 of 2 : FA_2014_RD0785_185_8_20141014_00006.jpg

LM Start	2.04	Rating **	M	Issue No.	8 (cont)
LM End	2.14	Issue Type +	En	Location *	LS

Pines and oleanders along shoulder.

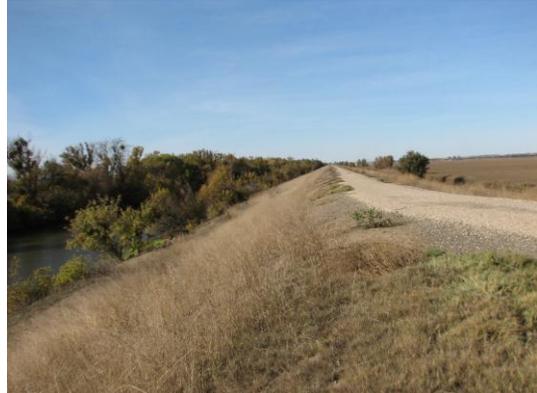
Photo 1 of 1 : FA_2014_RD0785_186_3_20141120_00017.jpg

LM Start	0.00	Rating **	A/W	Issue No.	3
LM End	3.30	Issue Type +	Ma	Location *	WS
Category	Earthen Levee		GPS Latitude/Longitude		
			Start	End	
Item	Vegetation			°	°
DWR ID	DWR_RD0785_02_f_2014_3				
Action/Comments					
Control annual grass and weeds on the levee slopes and easements.

Levee mile 3.29, vegetation on the water side slope. Fall 2014.

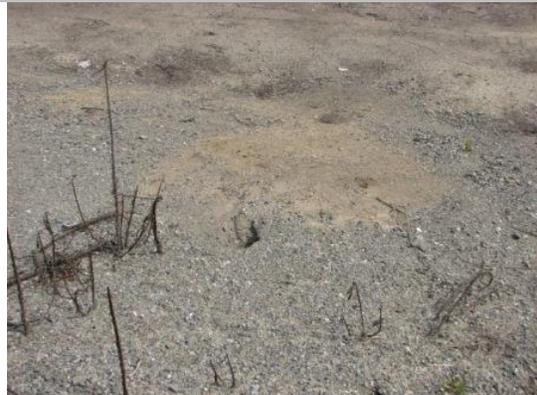
Photo 1 of 1 : FA_2014_RD0785_186_25_20141014_00001.jpg

LM Start	0.11	Rating **	M	Issue No.	25
LM End	0.11	Issue Type +	Ma	Location *	LS
Category	Earthen Levee		GPS Latitude/Longitude		
			Start	End	
Item	Animal Control		38.639670	°	38.639670
			-121.619460	°	-121.619460
DWR ID	DWR_RD0785_02_s_2012_25				
Action/Comments					
No rodents visible, but rodent burrows visible; need to backfill and compact or grout burrows. Inspector Comments: Unable to see slope.

Rodent holes on the landside levee slope, photo taken spring 2012.

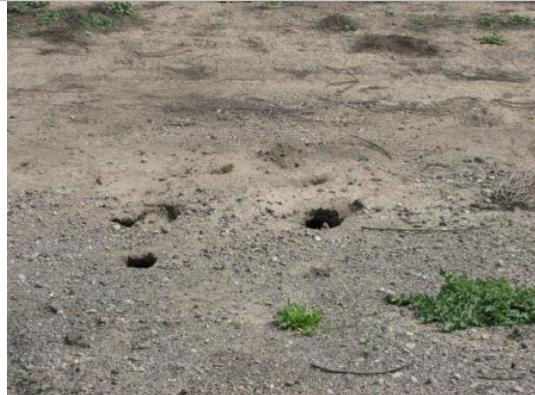
Photo 1 of 1 : FA_2014_RD0785_186_27_20141014_00002.jpg

Rodent holes on the landside levee slope, photo taken spring 2012.

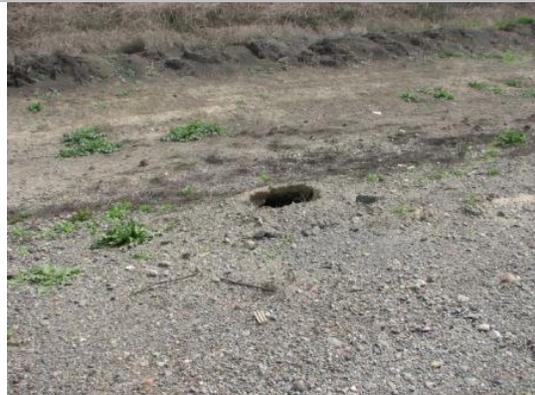
Photo 1 of 2 : FA_2014_RD0785_186_28_20141014_00003.jpg

LM Start	0.46	Rating **	A/W	Issue No.	28
LM End	0.46	Issue Type +	Ma	Location *	LS
Category	Earthen Levee		GPS Latitude/Longitude		
			Start	End	
Item	Animal Control		38.634978 °	38.634978 °	
			-121.616612 °	-121.616612 °	
DWR ID	DWR_RD0785_02_s_2012_28				
Action/Comments					
No rodents visible, but rodent burrows visible; need to backfill and compact or grout burrows. Inspector Comments: Unable to see slope. Vegetation to tall to see.

Many rodent holes with in 25' of each other, photo taken spring 2012.

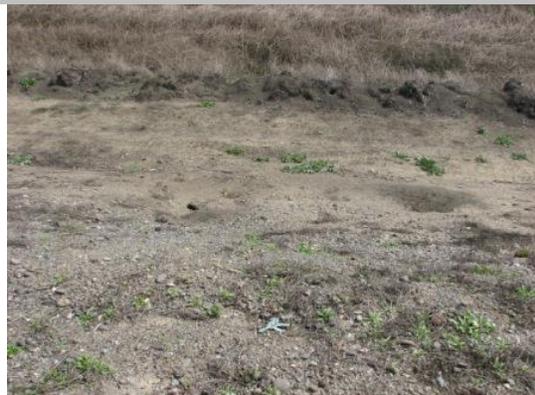
Photo 2 of 2 : FA_2014_RD0785_186_28_20141014_00004.jpg

LM Start	0.46	Rating **	A/W	Issue No.	28 (cont)
LM End	0.46	Issue Type +	Ma	Location *	LS

Rodent holes on the landside levee slope, photo taken spring 2012.

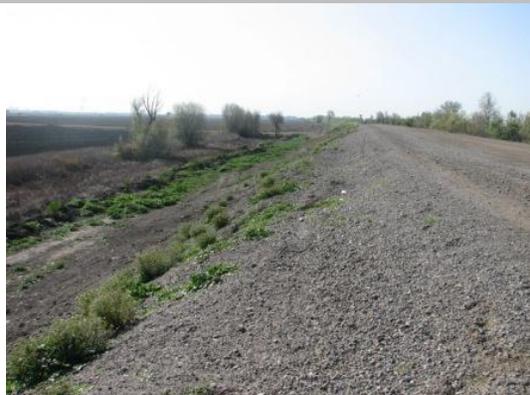
Photo 1 of 2 : FA_2014_RD0785_186_29_20141014_00005.jpg

LM Start	0.52	Rating **	M	Issue No.	29
LM End	0.52	Issue Type +	Ma	Location *	LS
Category	Earthen Levee		GPS Latitude/Longitude		
			Start	End	
Item	Slope Stability		38.634180 °	38.634180 °	
			-121.616142 °	-121.616142 °	
DWR ID	DWR_RD0785_02_s_2012_29				
Action/Comments					
Repair slope instability.

Slope instability at shoulder of landside levee buldge at toe.

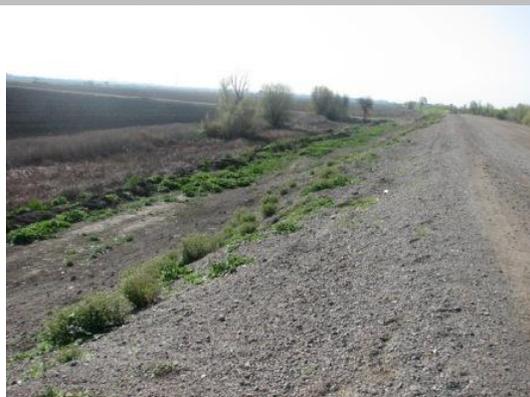
Photo 2 of 2 : FA_2014_RD0785_186_29_20141014_00006.jpg

LM Start	0.52	Rating **	M	Issue No.	29 (cont)
LM End	0.52	Issue Type +	Ma	Location *	LS

Buldge at the landside toe of the levee, photos taken spring 2012.

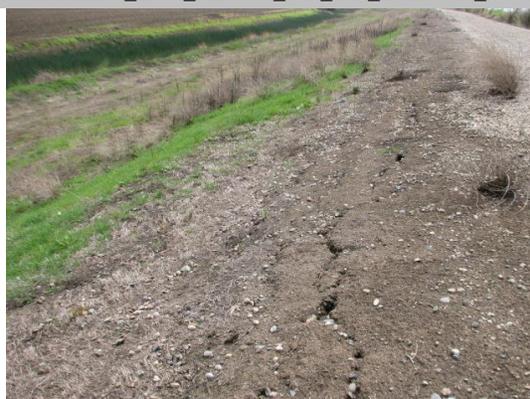
Photo 1 of 1 : FA_2014_RD0785_186_143_20141014_00013.jpg

LM Start	0.87	Rating **	M	Issue No.	143
LM End	0.87	Issue Type +	Ma	Location *	LS
Category	Earthen Levee		GPS Latitude/Longitude		
			Start	End	
Item	Slope Stability		38.629693 °	38.629693 °	
			-121.613436 °	-121.613436 °	
DWR ID	DWR_RD0785_02_s_2014_143				
Action/Comments					
Repair slope instability.

Cracking along the shoulder causing slope instability. Spring 2014

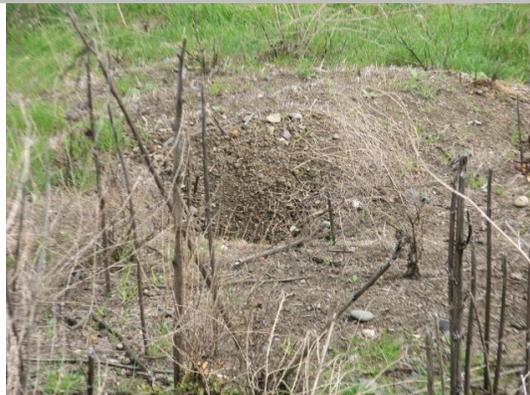
Photo 1 of 1 : FA_2014_RD0785_186_42_20141014_00011.jpg

Large rodent hole close to the toe of the levee. Spring 2014

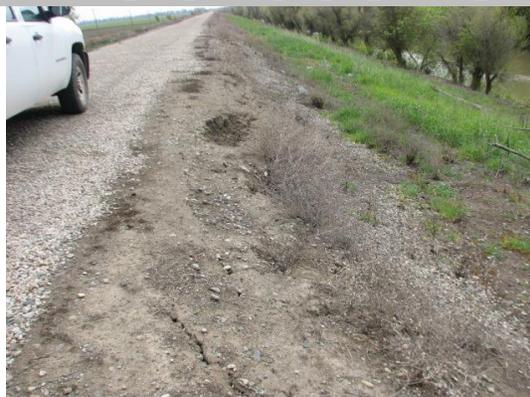
Photo 1 of 1 : FA_2014_RD0785_186_144_20141014_00014.jpg

LM Start	1.10	Rating **	M	Issue No.	144
LM End	1.10	Issue Type +	Ma	Location *	WS
Category	Earthen Levee		GPS Latitude/Longitude		
			Start	End	
Item	Slope Stability		38.626676 °	38.626676 °	
			-121.611325 °	-121.611325 °	
DWR ID	DWR_RD0785_02_s_2014_144				
Action/Comments					
Repair slope instability.

Slope instability along the waterside shoulder. Spring 2014

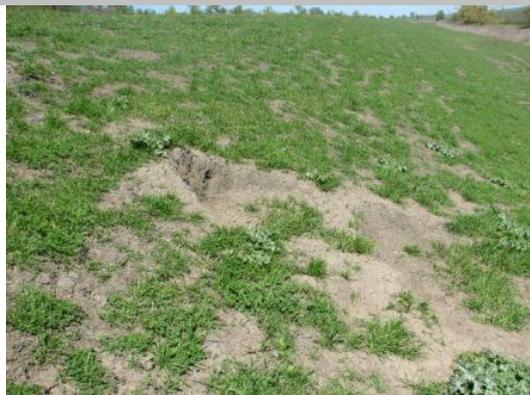
Photo 1 of 4 : FA_2014_RD0785_186_30_20141014_00007.jpg

LM Start	2.18	Rating **	M	Issue No.	30
LM End	2.18	Issue Type +	Ma	Location *	LS
Category	Earthen Levee		GPS Latitude/Longitude		
			Start	End	
Item	Slope Stability		38.613104 °	38.613104 °	
			-121.600915 °	-121.600915 °	
DWR ID	DWR_RD0785_02_s_2012_30				
Action/Comments					
Repair slope instability.

There is slope instability with three step like spots. The cuts are 1' to 1.5' deep. Photo taken spring 2012.

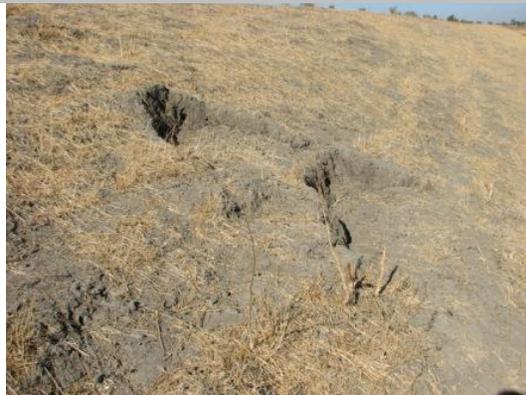
Photo 2 of 4 : FA_2014_RD0785_186_30_20141014_00008.jpg

LM Start	2.18	Rating **	M	Issue No.	30 (cont)
LM End	2.18	Issue Type +	Ma	Location *	LS
Category	Earthen Levee		GPS Latitude/Longitude		
			Start	End	
Item	Slope Stability		38.613104 °	38.613104 °	
			-121.600915 °	-121.600915 °	
DWR ID	DWR_RD0785_02_s_2012_30				
Action/Comments					
Repair slope instability.

Slope instability. Photo fall 2012.

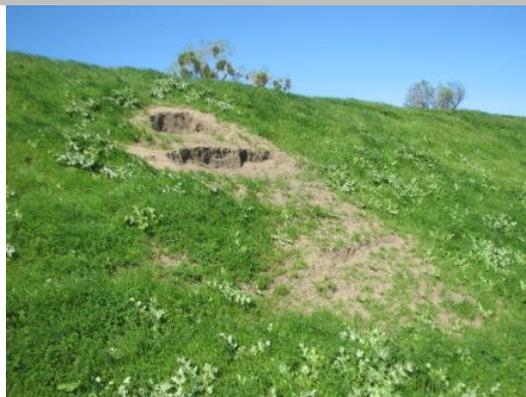
Photo 3 of 4 : FA_2014_RD0785_186_30_20141014_00009.jpg

LM Start	2.18	Rating **	M	Issue No.	30 (cont)
LM End	2.18	Issue Type +	Ma	Location *	LS

Slope instability is still there. Spring 2013

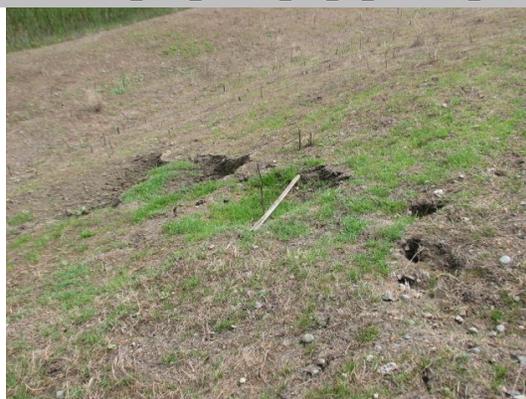
Photo 4 of 4 : FA_2014_RD0785_186_30_20141014_00010.jpg

LM Start	2.18	Rating **	M	Issue No.	30 (cont)
LM End	2.18	Issue Type +	Ma	Location *	LS

Current view of the slope instability. Spring 2014
