**Flood Control Project Maintenance
Levee Inspections**
LMA District Cover Sheet
Spring 2015 Levee Inspection Results

Reclamation District No. 0785 Driver

Spring 2015 Levee Inspection Results

Levee Inspection Report By Mile - Spring 2015

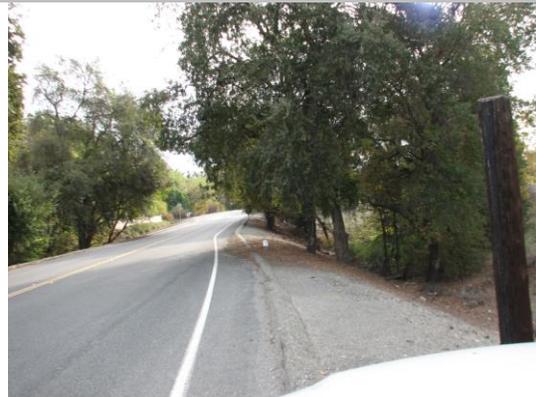
Photo 1 of 1 : SP_2015_RD0785_185_14_20150401_00011.jpg

LM Start	0.00	Rating **	A/W	Issue No.	14
LM End	2.31	Issue Type +	Ma	Location *	LS
Category	Earthen Levee			GPS Latitude/Longitude	
				Start	End
Item	Vegetation			°	°
				°	°
DWR ID	DWR_RD0785_01_f_2014_14				
Action/Comments					
Control annual grass and weeds on the levee slopes and easements.

Levee mile 0.00, vegetation on the land side slope. Fall 2014.

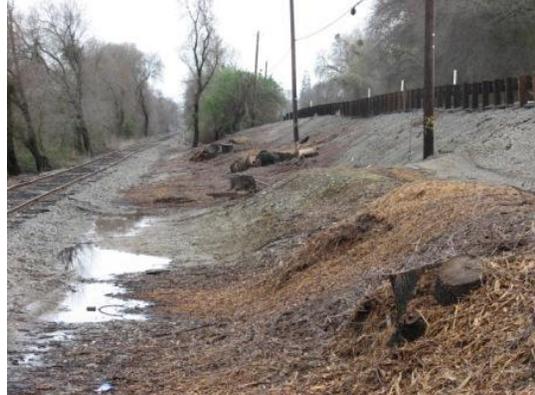
Photo 1 of 1 : SP_2015_RD0785_185_4_20150401_00003.jpg

LM Start	0.12	Rating **	N	Issue No.	4
LM End	1.34	Issue Type +	Ma	Location *	LS
Category	Earthen Levee		GPS Latitude/Longitude		
			Start	End	
Item	Trim / Thin Trees		38.660160 °	38.646214 °	
			-121.611619 °	-121.598596 °	
DWR ID	DWR_RD0785_01_s_2012_4				
Action/Comments					
Tree stumps.

The trees were cut by PG&E'S tree contractor. The district will take care of the stumps in the future.

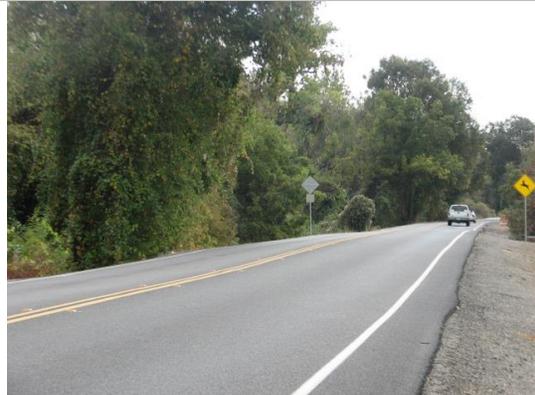
Photo 1 of 2 : SP_2015_RD0785_185_16_20150401_00012.jpg

LM Start	0.21	Rating **	M	Issue No.	16
LM End	1.35	Issue Type +	Ma	Location *	WS
Category	Earthen Levee		GPS Latitude/Longitude		
			Start	End	
Item	Vegetation		38.659340 °	38.646093 °	
			-121.610405 °	-121.598518 °	
DWR ID	DWR_RD0785_01_f_2013_16				
Action/Comments					
Remove the wild growth other than native grasses from the levee slopes.

Brush and other vegetation partially blocks visibility or access to the levee slope. Fall 2013

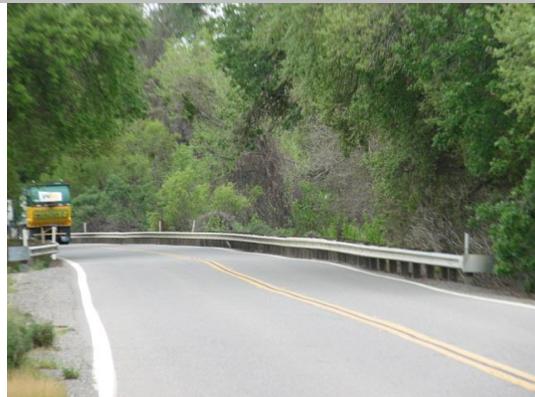
Photo 2 of 2 : SP_2015_RD0785_185_16_20150401_00013.jpg

Brush and other vegetation partially blocks visibility. Spring 2014

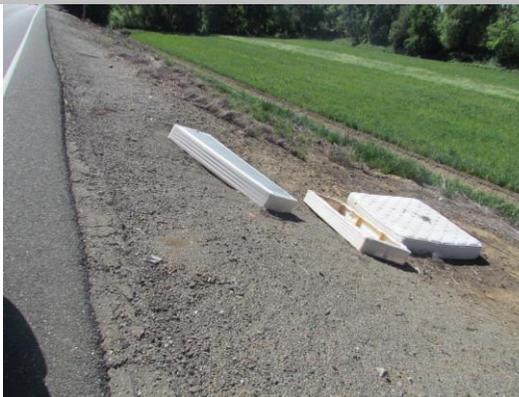
Photo 1 of 1 : SP_2015_RD0785_185_346_20150417_00021.jpg

View of the debris on the landward side of the levee looking downward. Spring 2015.

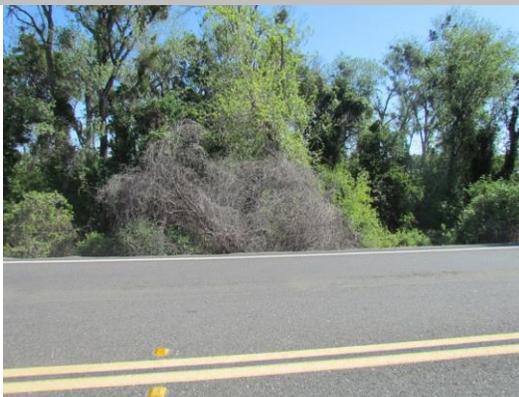
Photo 1 of 1 : SP_2015_RD0785_185_347_20150417_00022.jpg

LM Start	0.24	Rating **	M	Issue No.	347
LM End	0.24	Issue Type +	En	Location *	WS
Category	Earthen Levee			GPS Latitude/Longitude	
				Start	End
Item	Encroachments			38.658927 °	38.658927 °
				-121.610057 °	-121.610057 °
DWR ID	DWR_RD0785_01_s_2015_347				
Action/Comments					
Tree or limb

View of the tree on the waterward side of the levee taken from the landward side of the levee. Spring 2015.

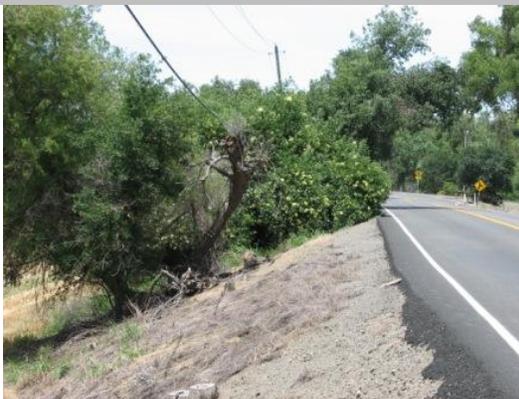
Photo 1 of 1 : SP_2015_RD0785_185_1_20150401_00001.jpg

LM Start	0.28	Rating **	A/W	Issue No.	1
LM End	0.28	Issue Type +	Ma	Location *	LS
Category	Earthen Levee			GPS Latitude/Longitude	
				Start	End
Item	Vegetation			38.658467 °	38.658467 °
				-121.609573 °	-121.609573 °
DWR ID	DWR_RD0785_01_s_2012_1				
Action/Comments					
Elderberries are blocking visibility and flood fight capability.

Elderberry

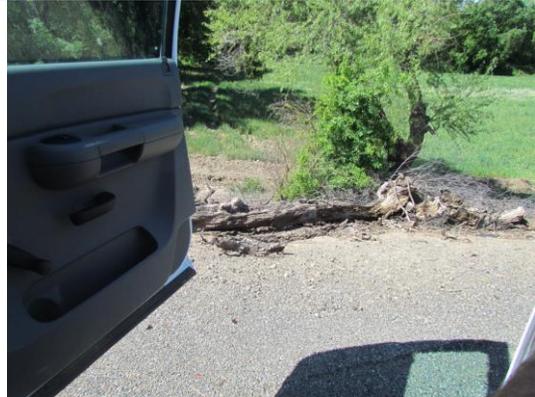
Photo 1 of 1 : SP_2015_RD0785_185_348_20150417_00023.jpg

View of the tree limb on the landward side of the levee. Spring 2015.

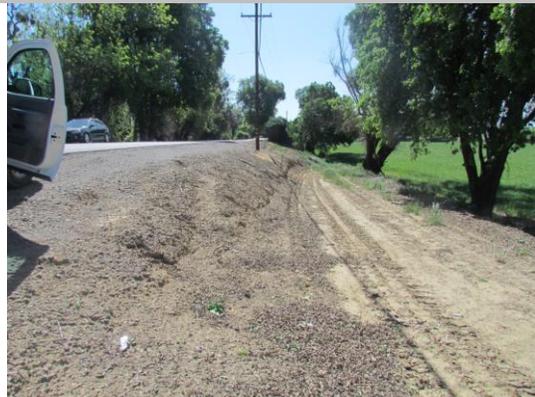
Photo 1 of 1 : SP_2015_RD0785_185_349_20150417_00024.jpg

LM Start	0.34	Rating **	M	Issue No.	349
LM End	0.34	Issue Type +	Ma	Location *	LS
Category	Earthen Levee		GPS Latitude/Longitude		
			Start	End	
Item	Slope Stability		38.657798 °	38.657798 °	
			-121.608898 °	-121.608898 °	
DWR ID	DWR_RD0785_01_s_2015_349				
Action/Comments					
Repair slope instability.

View of the slope stability on the landward side of the levee looking downstream. Spring 2015.

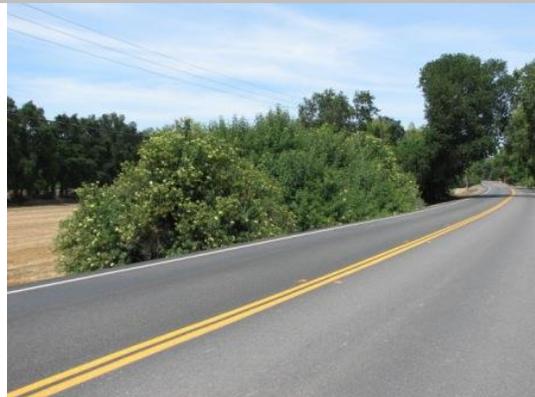
Photo 1 of 1 : SP_2015_RD0785_185_2_20150401_00002.jpg

LM Start	0.40	Rating **	A/W	Issue No.	2
LM End	0.44	Issue Type +	Ma	Location *	LS
Category	Earthen Levee		GPS Latitude/Longitude		
			Start	End	
Item	Vegetation		38.657168 °	38.656697 °	
			-121.608270 °	-121.607845 °	
DWR ID	DWR_RD0785_01_s_2012_2				
Action/Comments					
Elderberries are blocking visibility and flood fight capability.

Elderberry

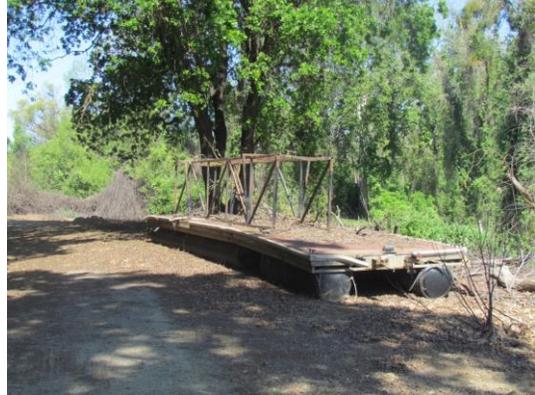
Photo 1 of 1 : SP_2015_RD0785_185_351_20150417_00026.jpg

View of a old dock on the waterward side of the levee looking upstream. Spring 2015.

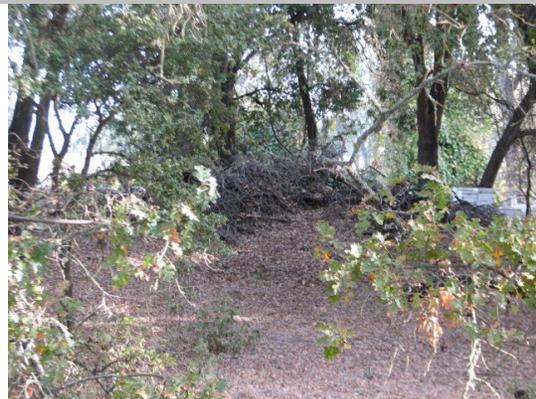
Photo 1 of 1 : SP_2015_RD0785_185_46_20150401_00014.jpg

Pruning pile on the landside shoulder. Fall 2013

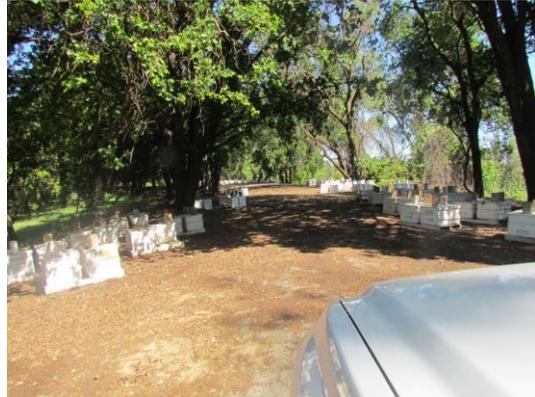
Photo 1 of 1 : SP_2015_RD0785_185_350_20150417_00025.jpg

View of the beehives on the crown of the levee looking upstream. Spring 2015.

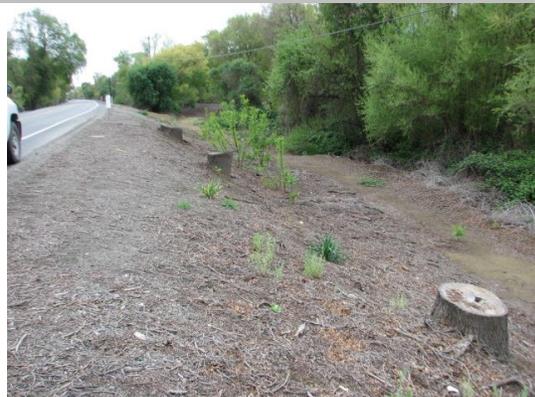
Photo 1 of 1 : SP_2015_RD0785_185_181_20150401_00019.jpg

LM Start	0.76	Rating **	N	Issue No.	181
LM End	0.76	Issue Type +	Ma	Location *	LS
Category	Earthen Levee			GPS Latitude/Longitude	
				Start	End
Item	Trim / Thin Trees			38.653003 °	38.653003 °
				-121.605061 °	-121.605061 °
DWR ID	DWR_RD0785_01_s_2014_181				
Action/Comments					
Tree stumps.

Tree stumps along the landside shoulder of the levee. Spring 2014

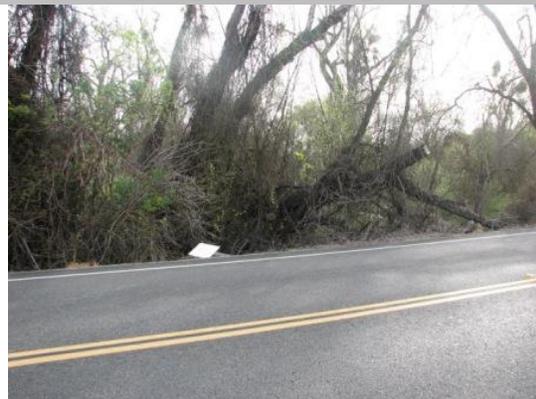
Photo 1 of 1 : SP_2015_RD0785_185_47_20150401_00015.jpg

The fallen tree and brush on the waterside of the roadway needs to be removed. Photo taken spring 2012.

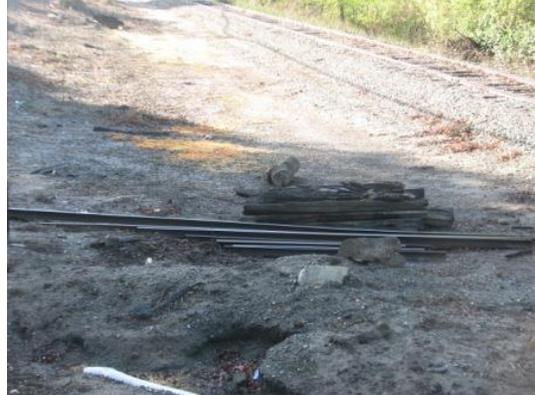
Photo 1 of 1 : SP_2015_RD0785_185_12_20150401_00008.jpg

Railroad ties and rails lay along the toe of the levee. Spring 2013

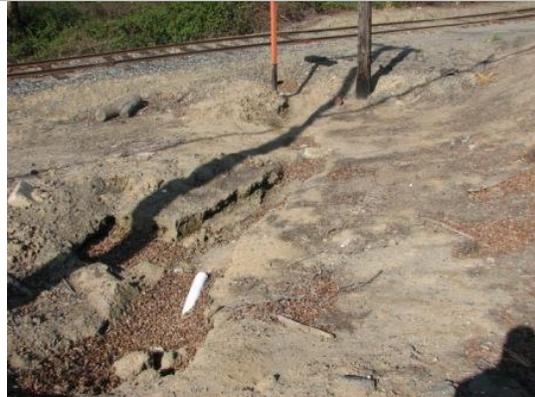
Photo 1 of 3 : SP_2015_RD0785_185_48_20150401_00016.jpg

LM Start	1.07	Rating **	M	Issue No.	48
LM End	1.07	Issue Type +	Ma	Location *	LS
Category	Earthen Levee		GPS Latitude/Longitude		
			Start	End	
Item	Erosion / Bank Caving		38.649292 °	38.649292 °	
			-121.601647 °	-121.601647 °	
DWR ID	DWR_RD0785_01_s_2012_48				
Action/Comments					
Schedule repair of erosion site prior to the next inspection.

The drain pipe across from the firehouse has caused erosion, photo taken spring 2012.

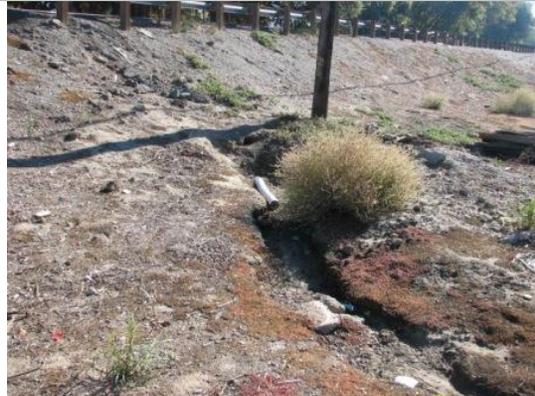
Photo 2 of 3 : SP_2015_RD0785_185_48_20150401_00017.jpg

Erosion on the levee slope and toe. Fall 2012

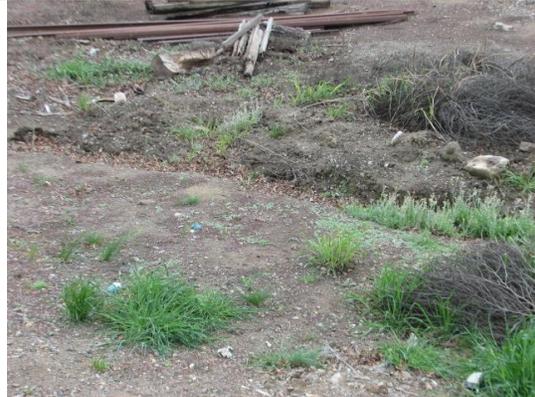
Photo 3 of 3 : SP_2015_RD0785_185_48_20150401_00018.jpg

LM Start	1.07	Rating **	M	Issue No.	48 (cont)
LM End	1.07	Issue Type +	Ma	Location *	LS
Category	Earthen Levee			GPS Latitude/Longitude	
				Start	End
Item	Erosion / Bank Caving			38.649292 °	38.649292 °
				-121.601647 °	-121.601647 °
DWR ID	DWR_RD0785_01_s_2012_48				
Action/Comments					
Schedule repair of erosion site prior to the next inspection.

Drain pipe is causing erosion on the landside of the levee between the slope and railroad tracks. Spring 2014

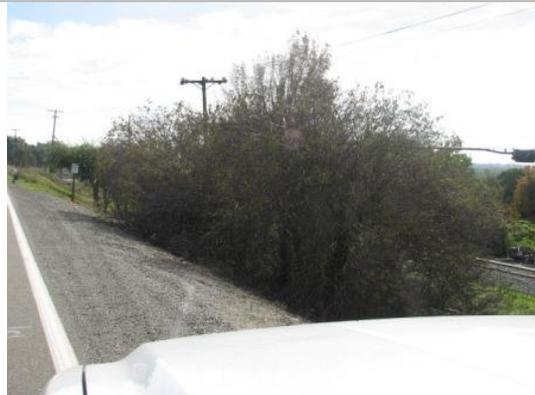
Photo 1 of 1 : SP_2015_RD0785_185_6_20150401_00004.jpg

This is a very large Elderberry bush.

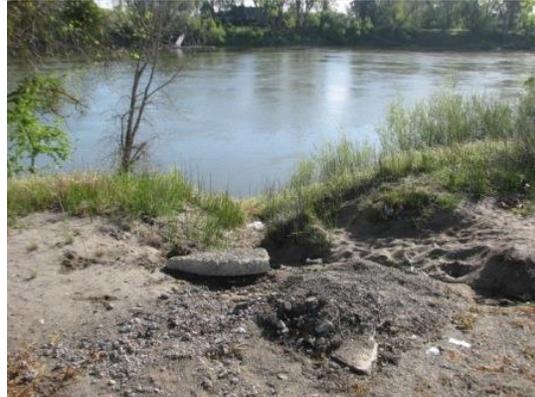
Photo 1 of 2 : SP_2015_RD0785_185_13_20150401_00009.jpg

LM Start	1.31	Rating **	M	Issue No.	13
LM End	1.31	Issue Type +	Ma	Location *	WS
Category	Earthen Levee		GPS Latitude/Longitude		
			Start	End	
Item	Erosion / Bank Caving		38.646671 °	38.646671 °	
			-121.598915 °	-121.598915 °	
DWR ID	DWR_RD0785_01_s_2013_13				
Action/Comments					
Schedule repair of erosion site prior to the next inspection.

The erosion has become a trail for fishermen and contributes to it. Spring 2013

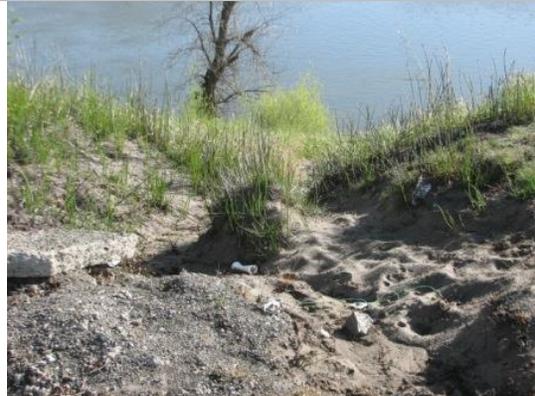
Photo 2 of 2 : SP_2015_RD0785_185_13_20150401_00010.jpg

The waterside levee slope has erosion from surface run off. Spring 2013

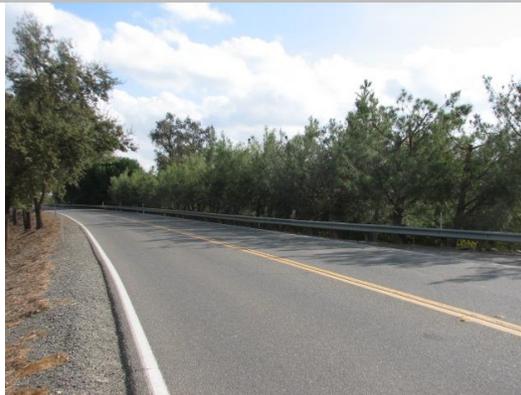
Photo 1 of 2 : SP_2015_RD0785_185_8_20150401_00005.jpg

The pine trees along the shoulder have been topped and thin out. Oleanders still on the shoulder. Fall 2013

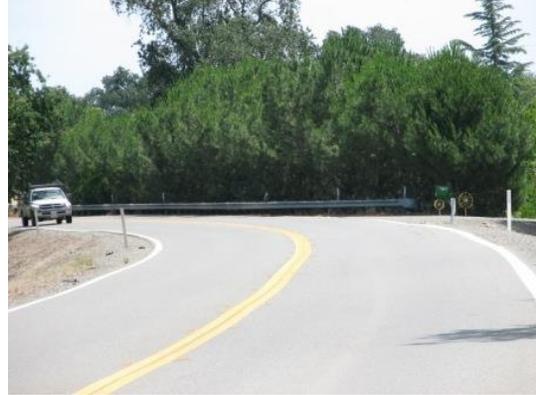
Photo 2 of 2 : SP_2015_RD0785_185_8_20150401_00006.jpg

Pines and oleanders along shoulder.

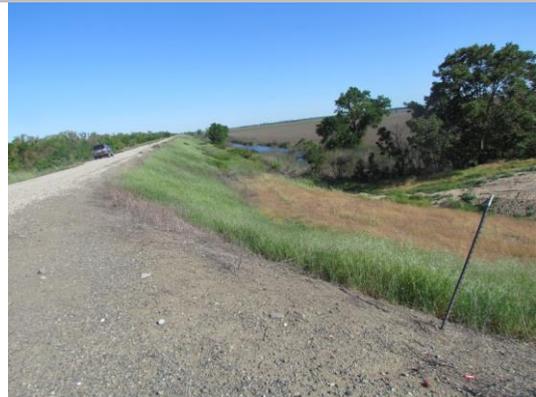
Photo 1 of 1 : SP_2015_RD0785_186_2_20150417_00018.jpg

View of the vegetation on the landward side of the levee looking upstream. Spring 2015.

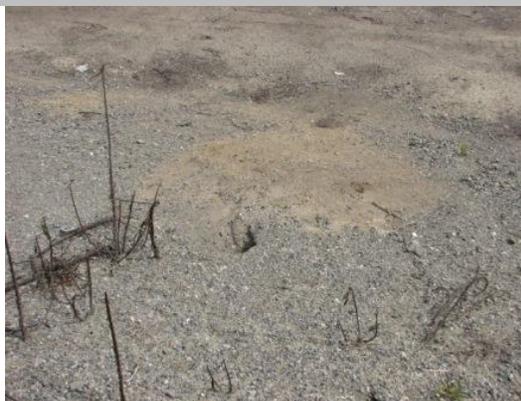
Photo 1 of 1 : SP_2015_RD0785_186_25_20150401_00003.jpg

Rodent holes on the landside levee slope, photo taken spring 2012.

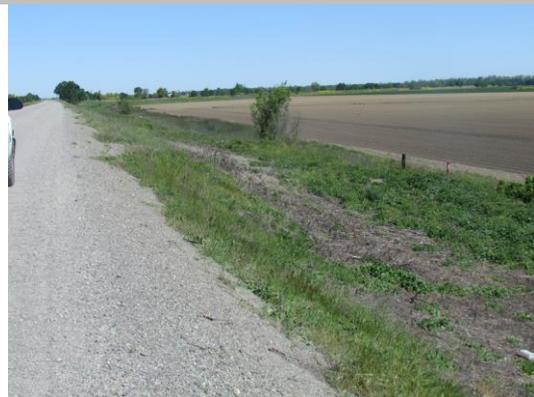
Photo 1 of 1 : SP_2015_RD0785_186_280_20150417_00019.jpg

LM Start	0.38	Rating **	M	Issue No.	280
LM End	0.38	Issue Type +	Ma	Location *	LS
Category	Earthen Levee			GPS Latitude/Longitude	
				Start	End
Item	Slope Stability			38.636265 °	38.636265 °
				-121.617422 °	-121.617422 °
DWR ID	DWR_RD0785_02_s_2015_280				
Action/Comments					
Repair slope instability.

View of the slope stability on the landward side of the levee looking upstream. Spring 2015.

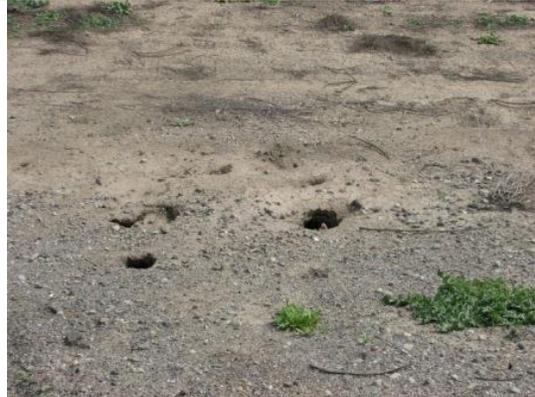
Photo 1 of 1 : SP_2015_RD0785_186_27_20150401_00004.jpg

Rodent holes on the landside levee slope, photo taken spring 2012.

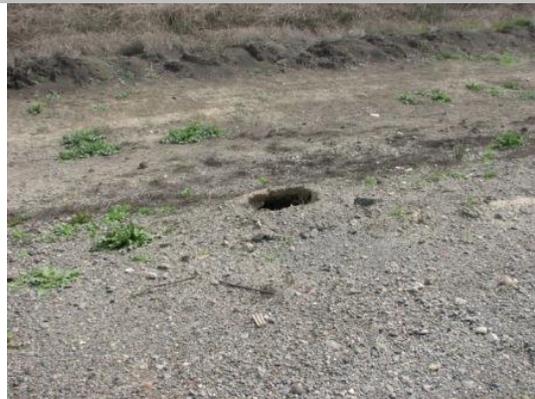
Photo 1 of 2 : SP_2015_RD0785_186_28_20150401_00005.jpg

Many rodent holes with in 25' of each other, photo taken spring 2012.

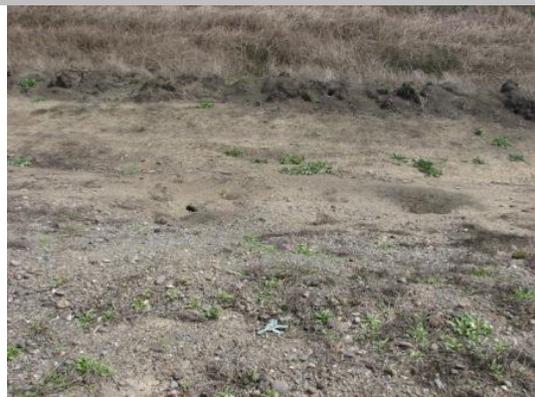
Photo 2 of 2 : SP_2015_RD0785_186_28_20150401_00006.jpg

Rodent holes on the landside levee slope, photo taken spring 2012.

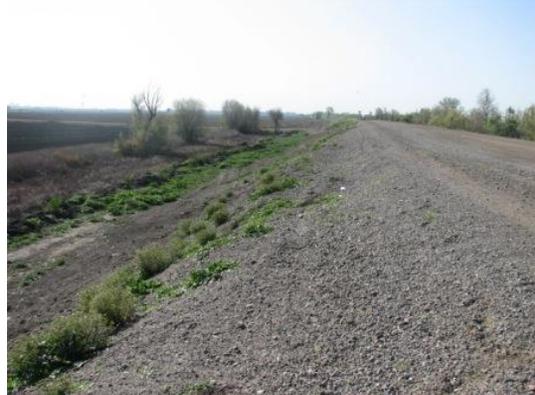
Photo 1 of 2 : SP_2015_RD0785_186_29_20150401_00007.jpg

LM Start	0.54	Rating **	M	Issue No.	29
LM End	0.54	Issue Type +	Ma	Location *	LS
Category	Earthen Levee		GPS Latitude/Longitude		
			Start	End	
Item	Slope Stability		38.634180 °	38.634180 °	
			-121.616142 °	-121.616142 °	
DWR ID	DWR_RD0785_02_s_2012_29				
Action/Comments					
Repair slope instability.

Slope instability at shoulder of landside levee buldge at toe.

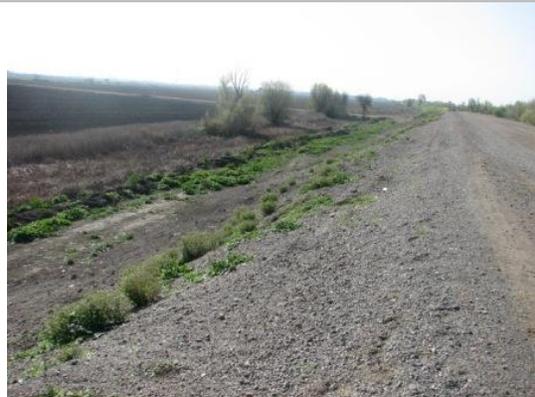
Photo 2 of 2 : SP_2015_RD0785_186_29_20150401_00008.jpg

Buldge at the landside toe of the levee, photos taken spring 2012.

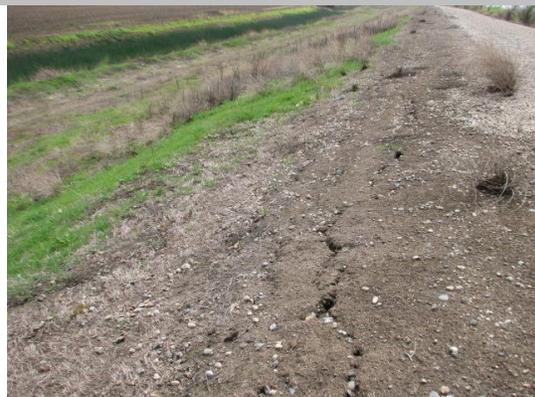
Photo 1 of 1 : SP_2015_RD0785_186_143_20150401_00015.jpg

LM Start	0.88	Rating **	M	Issue No.	143
LM End	0.88	Issue Type +	Ma	Location *	LS
Category	Earthen Levee		GPS Latitude/Longitude		
			Start	End	
Item	Slope Stability		38.629693 °	38.629693 °	
			-121.613436 °	-121.613436 °	
DWR ID	DWR_RD0785_02_s_2014_143				
Action/Comments					
Repair slope instability.

Cracking along the shoulder causing slope instability. Spring 2014

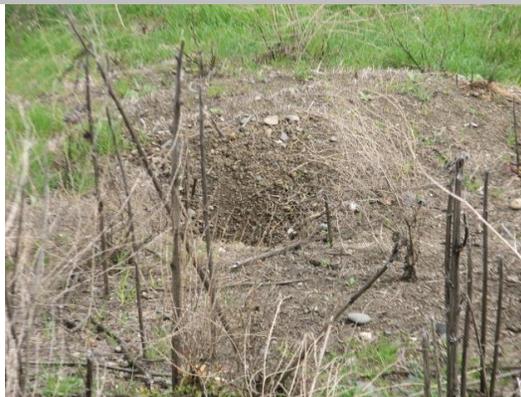
Photo 1 of 1 : SP_2015_RD0785_186_42_20150401_00013.jpg

Large rodent hole close to the toe of the levee. Spring 2014

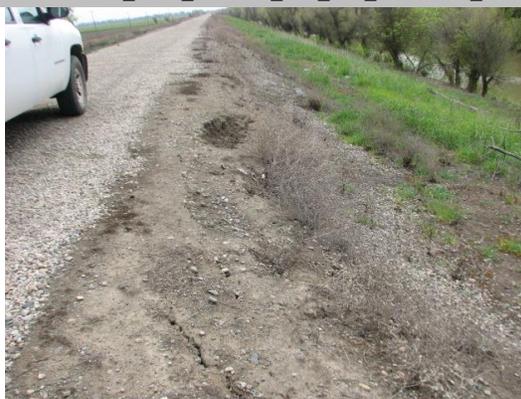
Photo 1 of 1 : SP_2015_RD0785_186_144_20150401_00016.jpg

LM Start	1.12	Rating **	M	Issue No.	144
LM End	1.12	Issue Type +	Ma	Location *	WS
Category	Earthen Levee		GPS Latitude/Longitude		
			Start	End	
Item	Slope Stability		38.626676 °	38.626676 °	
			-121.611325 °	-121.611325 °	
DWR ID	DWR_RD0785_02_s_2014_144				
Action/Comments					
Repair slope instability.

Slope instability along the waterside shoulder. Spring 2014

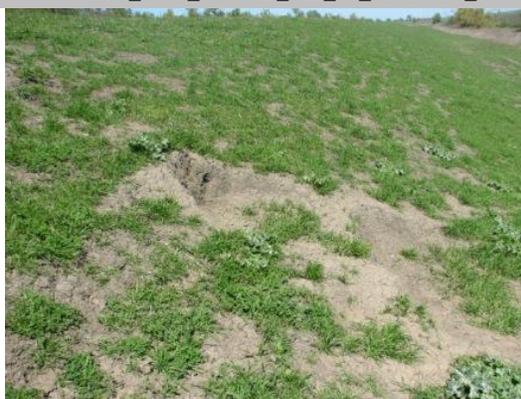
Photo 1 of 4 : SP_2015_RD0785_186_30_20150401_00009.jpg

LM Start	2.21	Rating **	M	Issue No.	30
LM End	2.21	Issue Type +	Ma	Location *	LS
Category	Earthen Levee		GPS Latitude/Longitude		
			Start	End	
Item	Slope Stability		38.613104 °	38.613104 °	
			-121.600915 °	-121.600915 °	
DWR ID	DWR_RD0785_02_s_2012_30				
Action/Comments					
Repair slope instability.

There is slope instability with three step like spots. The cuts are 1' to 1.5' deep. Photo taken spring 2012.

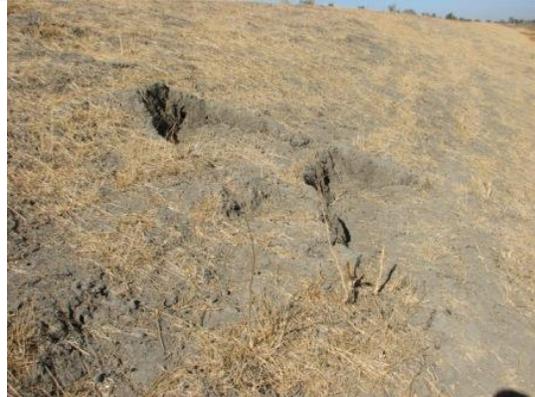
Photo 2 of 4 : SP_2015_RD0785_186_30_20150401_00010.jpg

LM Start	2.21	Rating **	M	Issue No.	30 (cont)
LM End	2.21	Issue Type +	Ma	Location *	LS
Category	Earthen Levee			GPS Latitude/Longitude	
				Start	End
Item	Slope Stability			38.613104 °	38.613104 °
				-121.600915 °	-121.600915 °
DWR ID	DWR_RD0785_02_s_2012_30				
Action/Comments					
Repair slope instability.

Slope instability. Photo fall 2012.

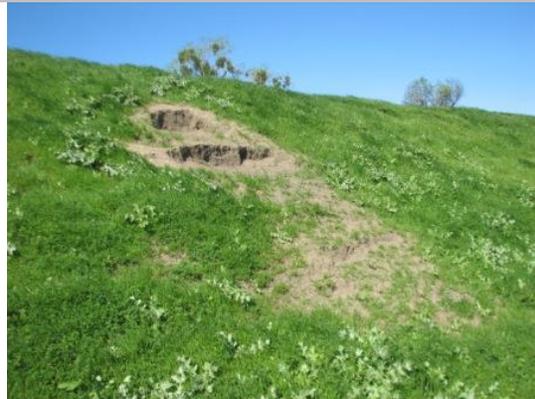
Photo 3 of 4 : SP_2015_RD0785_186_30_20150401_00011.jpg

Slope instability is still there. Spring 2013

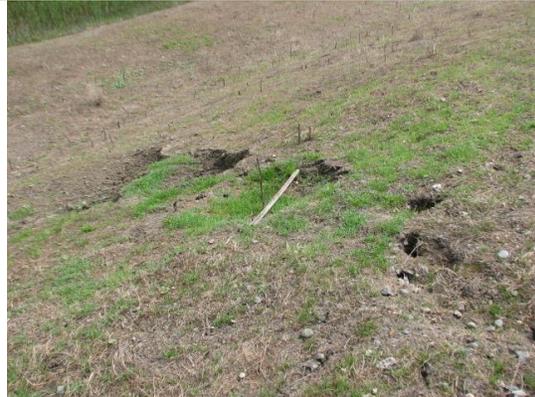
Photo 4 of 4 : SP_2015_RD0785_186_30_20150401_00012.jpg

Current view of the slope instability. Spring 2014

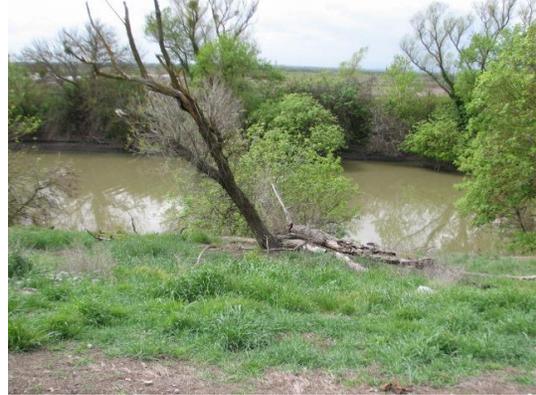
Photo 1 of 1 : SP_2015_RD0785_186_56_20150401_00014.jpg

Discarded branches lay at the toe of the levee. The trees is about to fall over and may cause damage to the levee. Spring 2014
