**Flood Control Project Maintenance  
Levee Inspections**  
**LMA District Cover Sheet**  
**Spring 2016 Levee Inspection Results**

**Reclamation District No. 0785 Driver**

**Levee Inspection Report By Mile - Spring 2016**

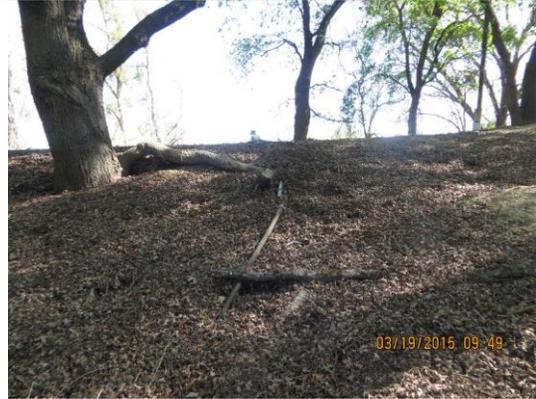
Photo 1 of 2 : UCIP\_SP\_2016\_43965\_73439.jpg

LM Start	<b>0.00</b>	Rating **	M	Issue No.	<b>360</b>
LM End	<b>0.00</b>	Issue Type +	En	Location *	LS
Category	Supplemental			GPS Latitude/Longitude	
				Start	End
Item	DWR UCIP Field Study			38.654407 °	38.654407 °
				-121.605937 °	-121.605937 °
DWR ID					
Comment Code					
Inspector Comment					
FS_ID:43965 DS_ID:22976 EP_NO: N/A Repair Type: Non-Urgent Crossing Status: Found UCIP Comments: Pipe appears abandoned and should be done so properly. FIELD_STRUCT_DESC: 1 of 2: 3/4-inch steel conduit through the levee 1-foot below the crown. FS Date: 3/19/2015

Pipe visible on LS slope.

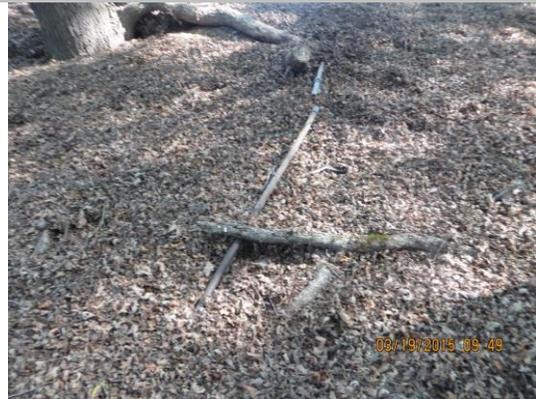
Photo 2 of 2 : UCIP\_SP\_2016\_43965\_73438.jpg

Pipe visible on LS slope.

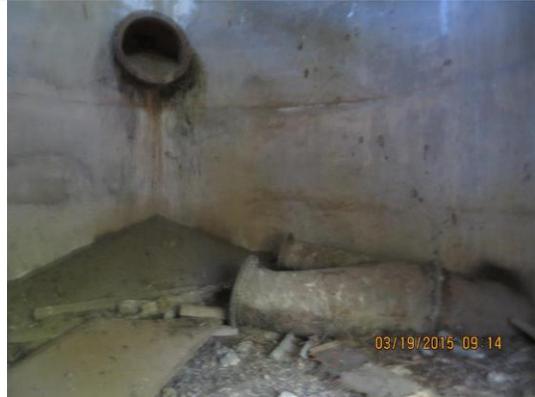
Photo 1 of 2 : UCIP\_SP\_2016\_43903\_73402.jpg

LM Start	<b>0.00</b>	Rating **	U	Issue No.	<b>358</b>
LM End	<b>0.00</b>	Issue Type +	En	Location *	LS
Category	Supplemental			GPS Latitude/Longitude	
				Start	End
Item	DWR UCIP Field Study			38.660986 °	38.660986 °
				-121.613532 °	-121.613532 °
DWR ID					
Comment Code					
Inspector Comment					
FS_ID:43903 DS_ID:22974 EP_NO: N/A Repair Type: Urgent Crossing Status: Found UCIP Comments: Pipe appears to be abandoned and should be done so properly as it is open on the LS inside the pumphouse. Dense vegetation on both sides of the levee. FIELD_STRUCT_DESC: 30-inch steel pipe through levee 10.0 feet below crown. Landward end open inside concrete pumphouse on LS shoulder, unable to find pipe on water side. Originally included in O&M Manual SAC 122-Part 1, RM: 69.50 Aug. 1955. FS Date: 3/19/2015

Pipe open at base of concrete building on LS shoulder. No pump found.

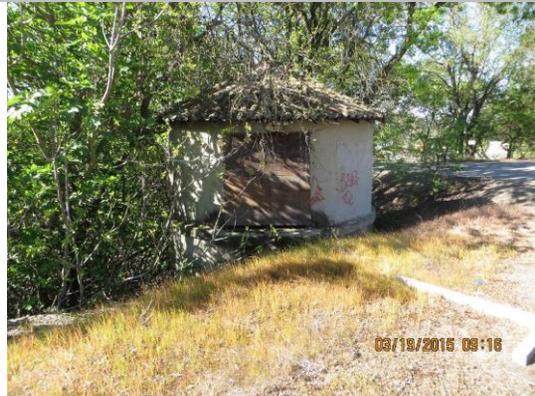
Photo 2 of 2 : UCIP\_SP\_2016\_43903\_73401.jpg

Pumphouse on LS shoulder.

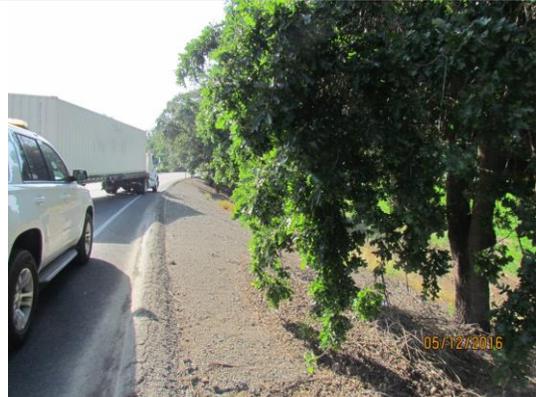
Photo 1 of 1 : SP\_2016\_RD0785\_185\_19\_20160516\_00030.jpg

View of the tree on the landward side of the levee looking downstream. Spring 2016.

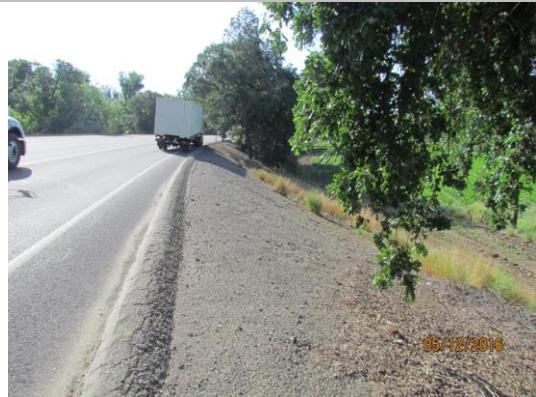
Photo 1 of 1 : SP\_2016\_RD0785\_185\_20\_20160516\_00031.jpg

LM Start	<b>0.10</b>	Rating **	A	Issue No.	<b>20</b>
LM End	<b>1.39</b>	Issue Type +	Ma	Location *	LS
Category	Earthen Levee		GPS Latitude/Longitude		
			Start	End	
Item	Vegetation		38.660319 °	38.645627 °	
			-121.611970 °	-121.597981 °	
DWR ID	DWR_RD0785_01_s_2016_20				
Comment Code					
V1 : Control annual grass and weeds on the levee slopes and easements.					
Inspector Comment					
Vegetation on slope has been maintained.

View of the vegetation on the landward side of the levee looking downstream. Spring 2016.

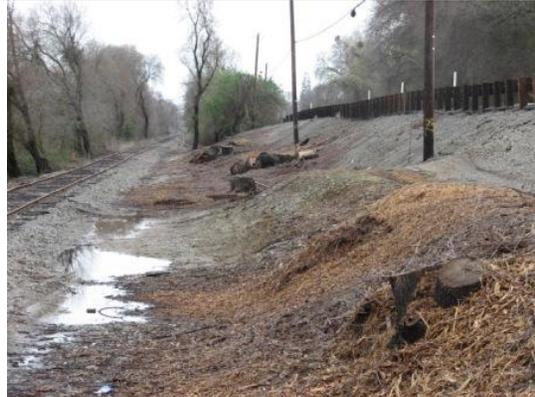
Photo 1 of 1 : SP\_2016\_RD0785\_185\_4\_20160304\_00001.jpg

The trees were cut by PG&E'S tree contractor. The district will take care of the stumps in the future.

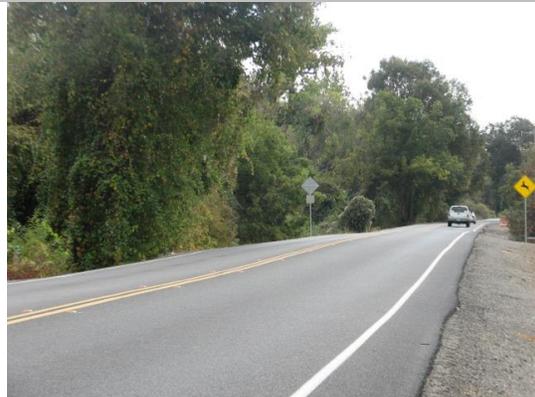
Photo 1 of 2 : SP\_2016\_RD0785\_185\_16\_20160304\_00007.jpg

LM Start	<b>0.21</b>	Rating **	M	Issue No.	<b>16</b>
LM End	<b>1.35</b>	Issue Type +	Ma	Location *	WS
Category	Earthen Levee		GPS Latitude/Longitude		
			Start	End	
Item	Vegetation		38.659340 °	38.646093 °	
			-121.610405 °	-121.598518 °	
DWR ID	DWR_RD0785_01_f_2013_16				
Comment Code					
V2 : Remove the wild growth other than native grasses from the levee slopes.					
Inspector Comment

Brush and other vegetation partially blocks visibility or access to the levee slope. Fall 2013

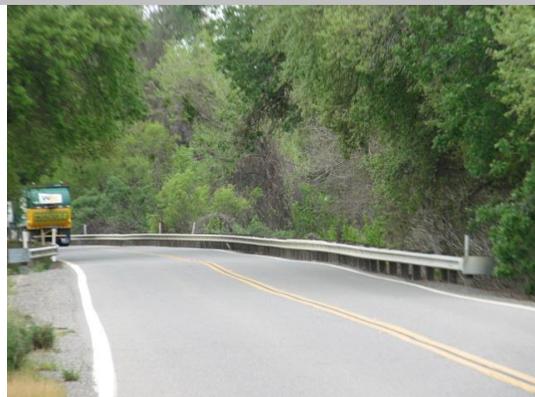
Photo 2 of 2 : SP\_2016\_RD0785\_185\_16\_20160304\_00008.jpg

Brush and other vegetation partially blocks visibility. Spring 2014

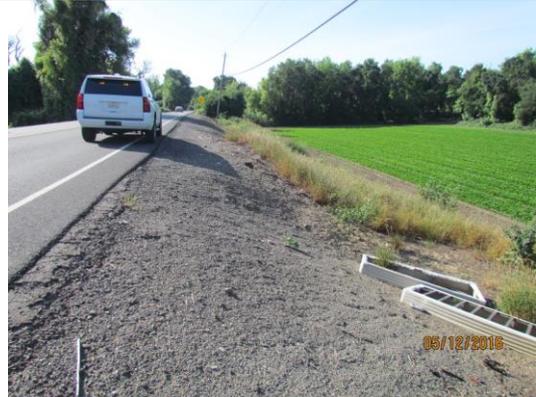
Photo 1 of 1 : SP\_2016\_RD0785\_185\_346\_20160516\_00032.jpg

View of the bed mattresses on the landward side of the levee looking downstream. Spring 2016.

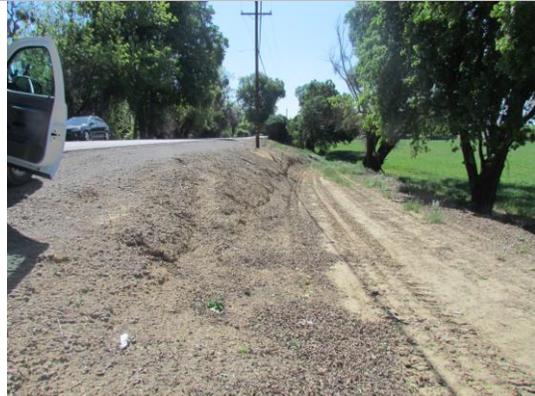
Photo 1 of 1 : SP\_2016\_RD0785\_185\_349\_20160304\_00016.jpg

LM Start	<b>0.34</b>	Rating **	M	Issue No.	<b>349</b>
LM End	<b>0.34</b>	Issue Type +	Ma	Location *	LS
Category	Earthen Levee			GPS Latitude/Longitude	
				Start	End
Item	Slope Stability			38.657798 °	38.657798 °
				-121.608898 °	-121.608898 °
DWR ID	DWR_RD0785_01_s_2015_349				
Comment Code					
S1 : Repair slope instability.					
Inspector Comment

View of the slope stability on the landward side of the levee looking downstream. Spring 2015.

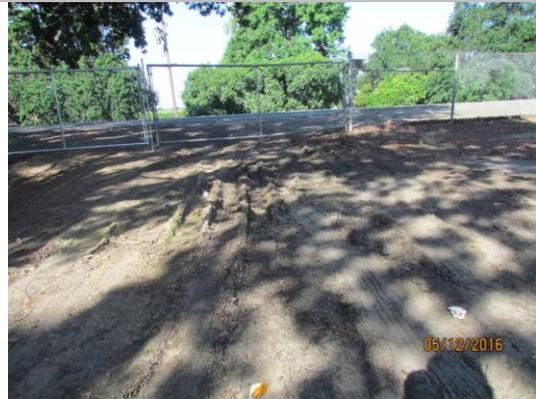
Photo 1 of 1 : SP\_2016\_RD0785\_185\_21\_20160516\_00035.jpg

LM Start	<b>0.58</b>	Rating **	M	Issue No.	<b>21</b>
LM End	<b>0.58</b>	Issue Type +	Ma	Location *	CR
Category	Earthen Levee		GPS Latitude/Longitude		
			Start	End	
Item	Crown Surface / Depressions / Rutting		38.655077 °	38.655077 °	
			-121.606237 °	-121.606237 °	
DWR ID	DWR_RD0785_01_s_2016_21				
Comment Code					
C2 : Repair depressions or ruts in the crown or slope.					
Inspector Comment

View of the ruts on the crown of the levee. The direction of the river is upstream which is to the left of the picture. Spring 2016.

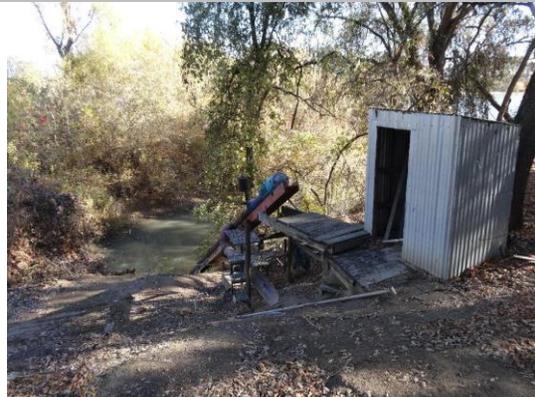
Photo 1 of 2 : UCIP\_SP\_2016\_43963\_45628.jpg

LM Start	<b>0.63</b>	Rating **	M	Issue No.	<b>359</b>
LM End	<b>0.63</b>	Issue Type +	En	Location *	WS
Category	Supplemental			GPS Latitude/Longitude	
				Start	End
Item	DWR UCIP Field Study			38.654641 °	38.654641 °
				-121.605538 °	-121.605538 °
DWR ID					
Comment Code					
Inspector Comment					
FS_ID:43963 DS_ID:22982 EP_NO: N/A Repair Type: Non-Urgent Crossing Status: Found UCIP Comments: Part of abandoned pipe also found on waterside that should be removed.No access to landside across the highway. FIELD_STRUCT_DESC: 2 of 2: 12-inch steel irrigation pipe through the levee, 11.0-feet below the crown, slant pump on the waterside slope. Pipe crosses under highway fill and discharge into irrigation ditch. FS Date: 11/21/2013

WS view: slant pump, walkway, and electric control box in shed on levee slope.

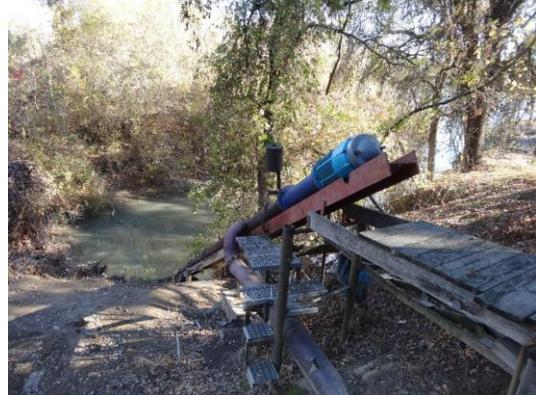
Photo 2 of 2 : UCIP\_SP\_2016\_43963\_45627.jpg

WS view: slant pump and walkway on levee slope.

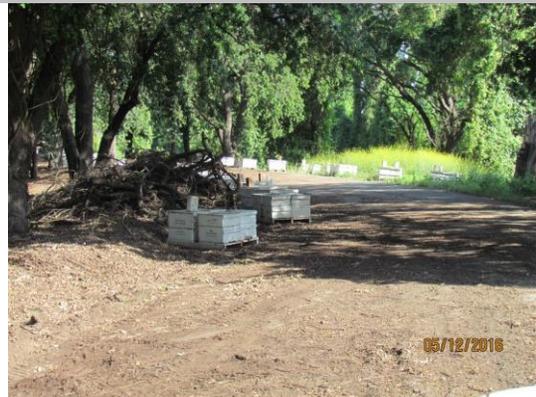
Photo 1 of 1 : SP\_2016\_RD0785\_185\_350\_20160516\_00034.jpg

LM Start	<b>0.66</b>	Rating **	A/W	Issue No.	<b>350</b>
LM End	<b>0.66</b>	Issue Type +	En	Location *	CR
Category	Earthen Levee			GPS Latitude/Longitude	
				Start	End
Item	Encroachments			38.654312 °	38.654312 °
				-121.605181 °	-121.605181 °
DWR ID	DWR_RD0785_01_s_2015_350				
Comment Code					
BU : Building					
Inspector Comment					
Beehives are on the crown of the levee.

View of the beehives on the crown of the levee looking upstream. Spring 2016.

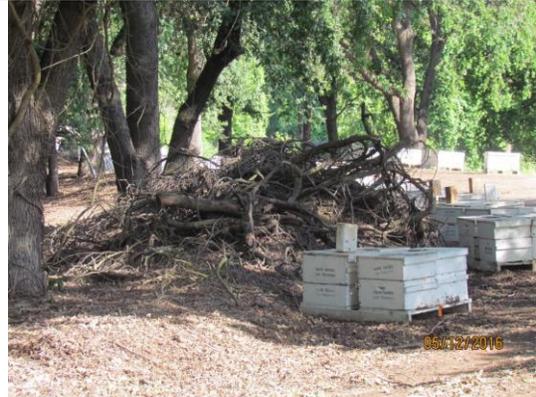
Photo 1 of 1 : SP\_2016\_RD0785\_185\_14\_20160516\_00033.jpg

View of the pruning pile on the landward side of the levee looking upstream. Spring 2016.

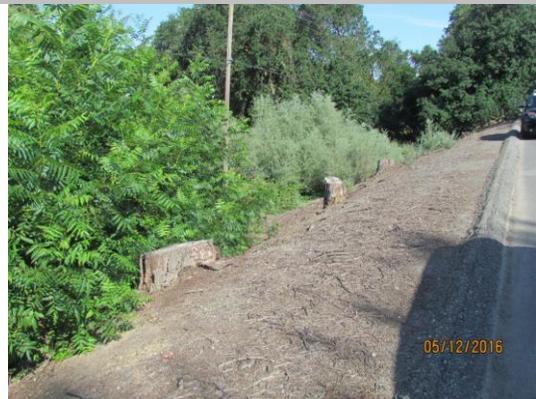
Photo 1 of 1 : SP\_2016\_RD0785\_185\_181\_20160516\_00036.jpg

LM Start	<b>0.76</b>	Rating **	N	Issue No.	<b>181</b>
LM End	<b>0.76</b>	Issue Type +	Ma	Location *	LS
Category	Earthen Levee		GPS Latitude/Longitude		
			Start	End	
Item	Trim / Thin Trees		38.653003 °	38.653003 °	
			-121.605061 °	-121.605061 °	
DWR ID	DWR_RD0785_01_s_2014_181				
Comment Code					
T5 : Tree stumps.					
Inspector Comment

View of the tree stumps on the landward side of the levee looking upstream. Spring 2016.

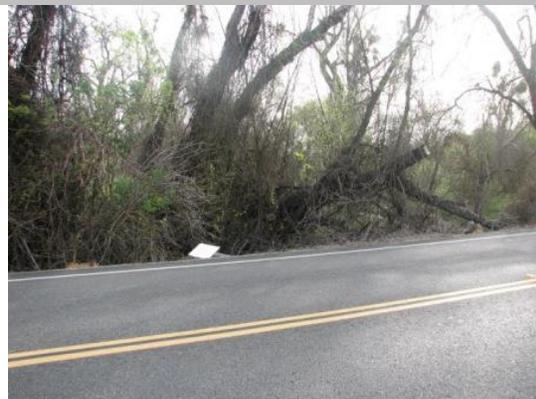
Photo 1 of 1 : SP\_2016\_RD0785\_185\_47\_20160304\_00009.jpg

The fallen tree and brush on the waterside of the roadway needs to be removed. Photo taken spring 2012.

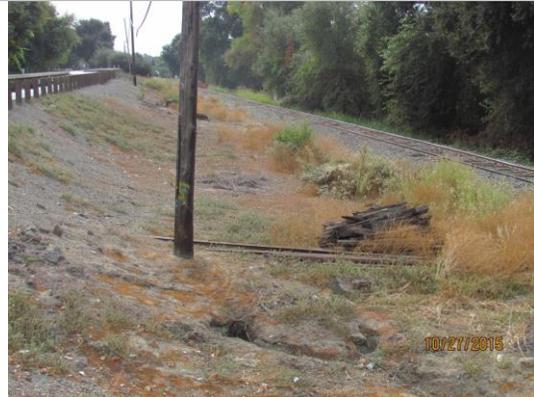
Photo 1 of 1 : SP\_2016\_RD0785\_185\_12\_20160304\_00004.jpg

View of the railroad ties and rails at the toe of the landward side of the levee looking downstream. Fall 2015.

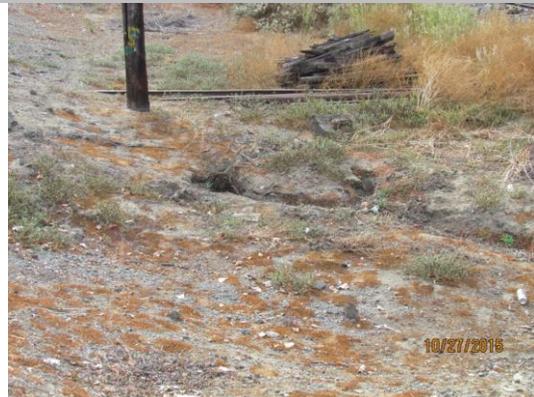
Photo 1 of 3 : SP\_2016\_RD0785\_185\_48\_20160304\_00011.jpg

LM Start	<b>1.07</b>	Rating **	M	Issue No.	<b>48</b>
LM End	<b>1.07</b>	Issue Type +	Ma	Location *	LS
Category	Earthen Levee		GPS Latitude/Longitude		
			Start	End	
Item	Erosion / Bank Caving		38.649392 °	38.649392 °	
			-121.601636 °	-121.601636 °	
DWR ID	DWR_RD0785_01_s_2012_48				
Comment Code					
E2 : Schedule repair of erosion site prior to the next inspection.					
Inspector Comment

View of the erosion at the toe of the levee on the landward side of the levee looking downstream. Fall 2015.

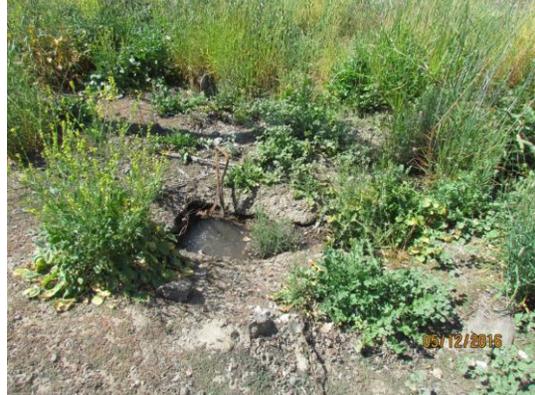
Photo 2 of 3 : SP\_2016\_RD0785\_185\_48\_20160516\_00040.jpg

Drain pipe is causing erosion on the landward side of the levee between the Isope and railroad tracks. Spring 2016.

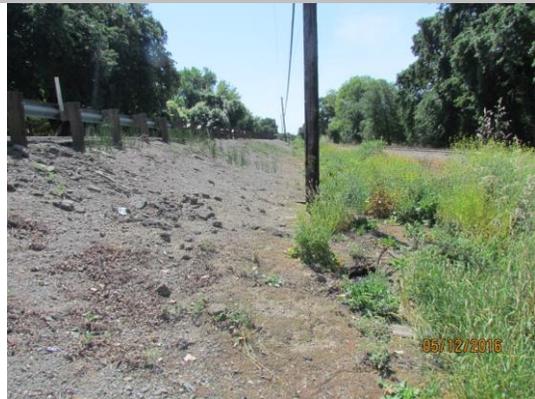
Photo 3 of 3 : SP\_2016\_RD0785\_185\_48\_20160516\_00041.jpg

Perspective view of the erosion on the landward side of the levee looking downstream. Spring 2016.

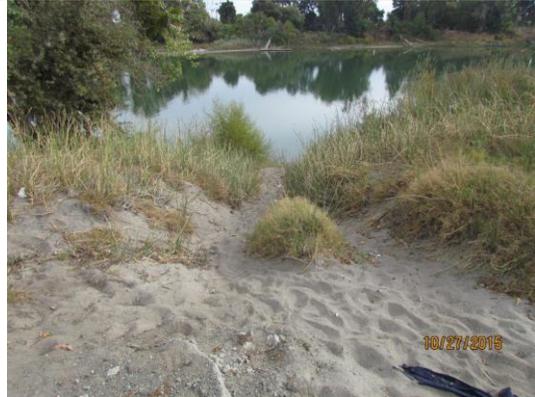
Photo 1 of 1 : SP\_2016\_RD0785\_185\_13\_20160304\_00005.jpg

LM Start	<b>1.31</b>	Rating **	M	Issue No.	<b>13</b>
LM End	<b>1.31</b>	Issue Type +	Ma	Location *	WS
Category	Earthen Levee			GPS Latitude/Longitude	
				Start	End
Item	Slope Stability			38.646671 °	38.646671 °
				-121.598915 °	-121.598915 °
DWR ID	DWR_RD0785_01_s_2013_13				
Comment Code					
S3 : Repair the levee slope damaged by vehicle traffic and prevent access where possible.					
Inspector Comment

View of the slope stability on the waterward side of the levee. Fall 2015.

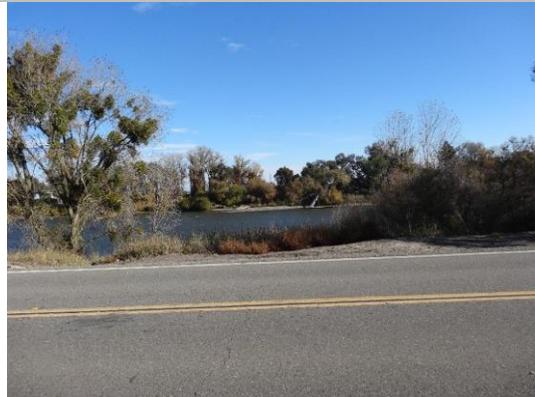
Photo 1 of 2 : UCIP\_SP\_2016\_41984\_44484.jpg

LM Start	<b>1.31</b>	Rating **	M	Issue No.	<b>357</b>
LM End	<b>1.31</b>	Issue Type +	En	Location *	WS
Category	Supplemental			GPS Latitude/Longitude	
				Start	End
Item	DWR UCIP Field Study			38.646547 °	38.646547 °
				-121.598924 °	-121.598924 °
DWR ID					
Comment Code					
Inspector Comment					
FS_ID:41984 DS_ID:22978 EP_NO: N/A Repair Type: Non-Urgent Crossing Status: Found UCIP Comments: Dense vegetation on waterside. No pipe found/visible on waterside. FIELD_STRUCT_DESC: 12-inch steel pipe through levee, 6.0 feet below crown. Plate bolted on both ends. FS Date: 11/21/2013

WS view: crown and waterside. No pipe found due to dense vegetation.

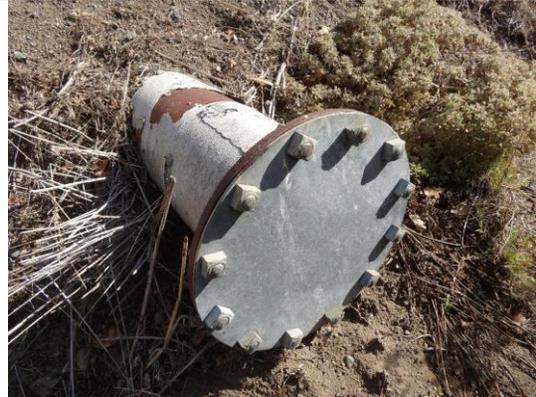
Photo 2 of 2 : UCIP\_SP\_2016\_41984\_44483.jpg

LS view: plate bolted pipe on levee slope.

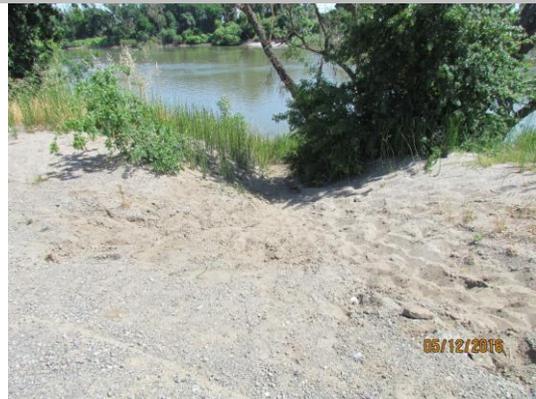
Photo 1 of 2 : SP\_2016\_RD0785\_185\_25\_20160516\_00038.jpg

LM Start	<b>1.34</b>	Rating **	M	Issue No.	<b>25</b>
LM End	<b>1.34</b>	Issue Type +	Ma	Location *	WS
Category	Earthen Levee			GPS Latitude/Longitude	
				Start	End
Item	Slope Stability			38.646240 °	38.646240 °
				-121.598505 °	-121.598505 °
DWR ID	DWR_RD0785_01_s_2016_25				
Comment Code					
S2 : Repair the levee slope damaged by foot traffic and prevent access where possible.					
Inspector Comment

View of the slope stability caused by foot traffic on the waterward side of the levee. Spring 2016.

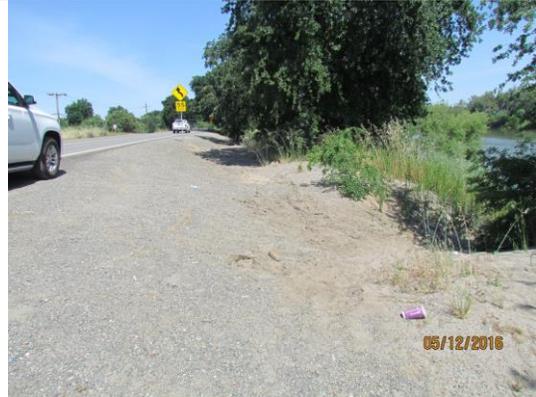
Photo 2 of 2 : SP\_2016\_RD0785\_185\_25\_20160516\_00039.jpg

Perspective view of the slope stability looking upstream. Spring 2016.

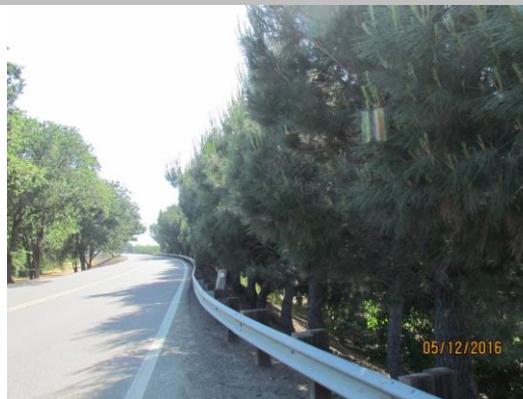
Photo 1 of 1 : SP\_2016\_RD0785\_185\_8\_20160516\_00037.jpg

View of the pines on the shoulder of the landward side of the levee looking downstream. Spring 2016.

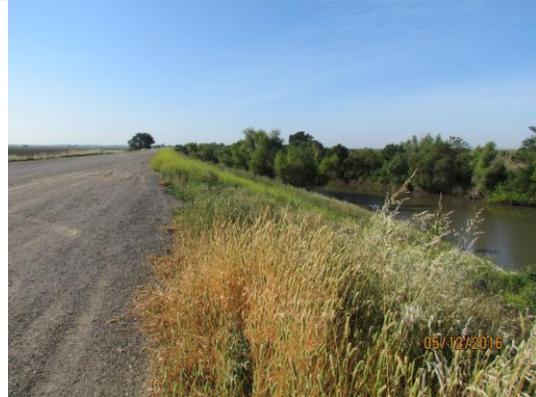
Photo 1 of 1 : SP\_2016\_RD0785\_186\_7\_20160516\_00021.jpg

View of the vegetation on the waterward side of the levee looking downstream. Spring 2016.

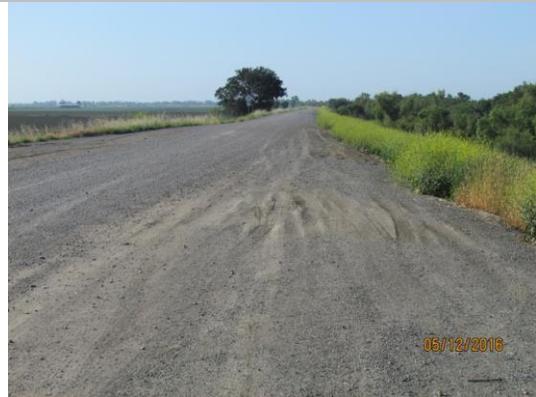
Photo 1 of 1 : SP\_2016\_RD0785\_186\_8\_20160516\_00022.jpg

LM Start	<b>0.01</b>	Rating **	M	Issue No.	<b>8</b>
LM End	<b>0.01</b>	Issue Type +	Ma	Location *	CR
Category	Earthen Levee		GPS Latitude/Longitude		
			Start	End	
Item	Crown Surface / Depressions / Rutting		38.641105 °	38.641105 °	
			-121.620402 °	-121.620402 °	
DWR ID	DWR_RD0785_02_s_2016_8				
Comment Code					
C2 : Repair depressions or ruts in the crown or slope.					
Inspector Comment

View of the ruts on the crown of the levee looking downstream. Spring 2016.

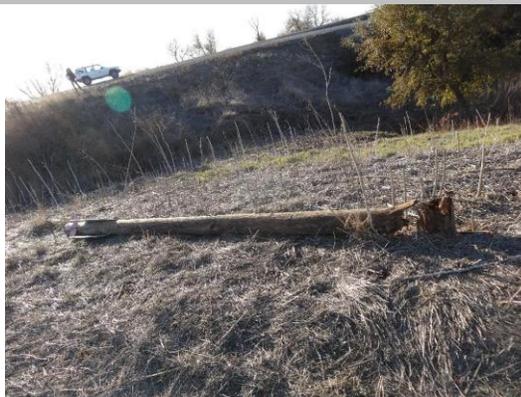
Photo 1 of 2 : UCIP\_SP\_2016\_24750\_44372.jpg

LM Start	<b>0.01</b>	Rating **	M	Issue No.	<b>281</b>
LM End	<b>0.01</b>	Issue Type +	En	Location *	CR
Category	Supplemental			GPS Latitude/Longitude	
				Start	End
Item	DWR UCIP Field Study			38.641086 °	38.641086 °
				-121.620350 °	-121.620350 °
DWR ID					
Comment Code					
Inspector Comment					
FS_ID:24750 DS_ID:22985 EP_NO: 16982 Repair Type: Non-Urgent Crossing Status: Indicator Found UCIP Comments: Only a damaged indicator post found on landside across the road. Damaged indicator needs to be fixed. FIELD_STRUCT_DESC: Three 2-inch-diameter and three 1.5-inch diameter HDPE conduits containing fiber optic cables across and under the east levee (County Road 124), 67 feet below the crown. HDPE pipes were pulled through an 8-inch bore hole and backfilled with bentonite. (App. No. 16982 - Pacific Fiber Link) FS Date: 12/2/2013

LS view: damaged indicator post across the levee road.

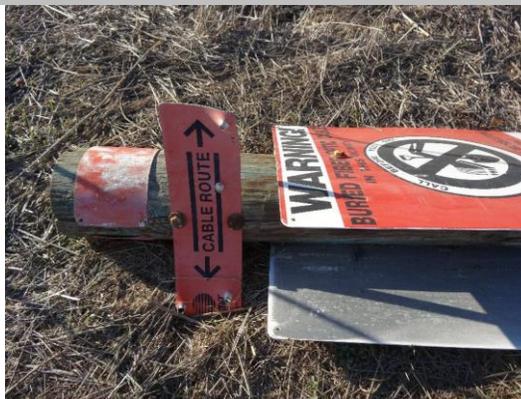
Photo 2 of 2 : UCIP\_SP\_2016\_24750\_44371.jpg

LS view: closer view of damaged indicator post.

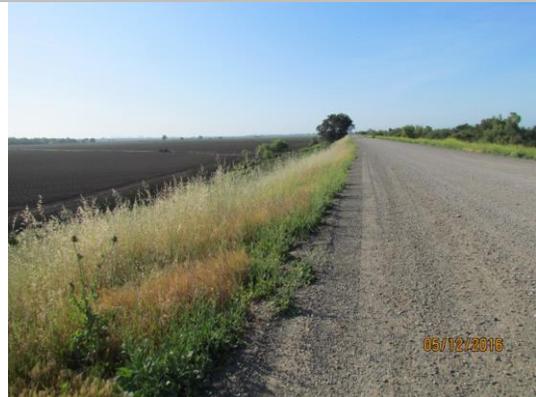
Photo 1 of 1 : SP\_2016\_RD0785\_186\_4\_20160516\_00023.jpg

View of the vegetation on the landward side of the levee looking downstream. Spring 2016.

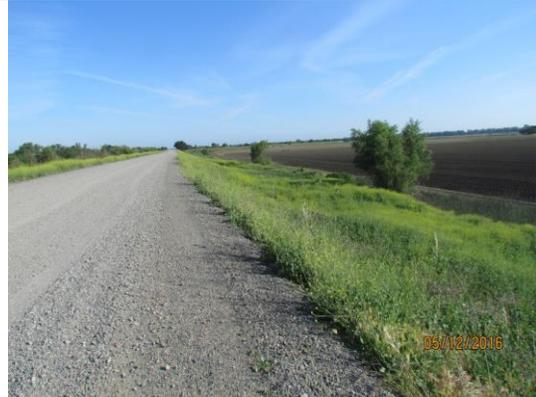
Photo 1 of 1 : SP\_2016\_RD0785\_186\_280\_20160516\_00024.jpg

View of the slope stability on the landward side of the levee looking upstream. Spring 2016.

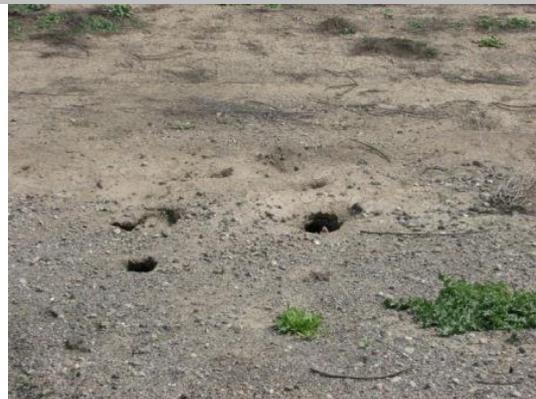
Photo 1 of 1 : SP\_2016\_RD0785\_186\_27\_20160304\_00005.jpg

Rodent holes on the landside levee slope, photo taken spring 2012.

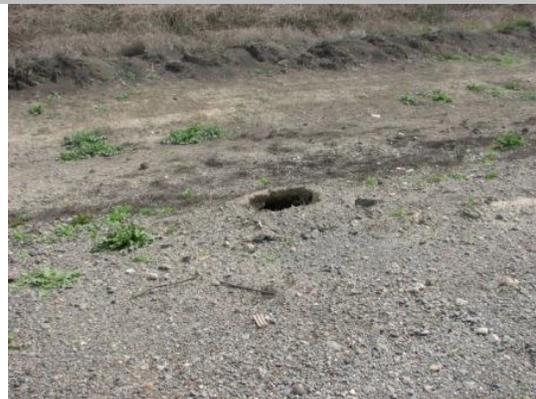
Photo 1 of 2 : SP\_2016\_RD0785\_186\_28\_20160304\_00006.jpg

Many rodent holes with in 25' of each other, photo taken spring 2012.

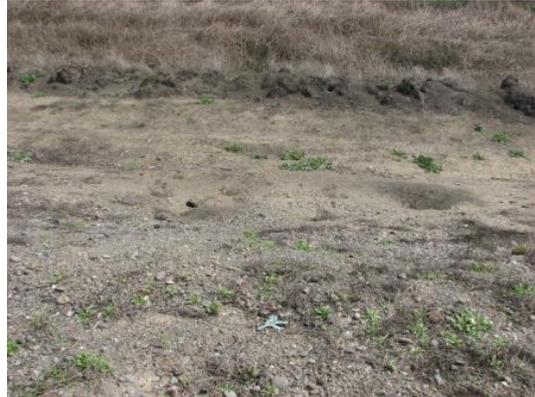
Photo 2 of 2 : SP\_2016\_RD0785\_186\_28\_20160304\_00007.jpg

Rodent holes on the landside levee slope, photo taken spring 2012.

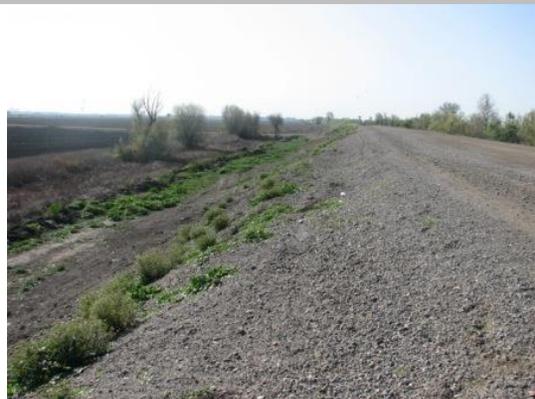
Photo 1 of 2 : SP\_2016\_RD0785\_186\_29\_20160304\_00008.jpg

Slope instability at shoulder of landside levee buldge at toe.

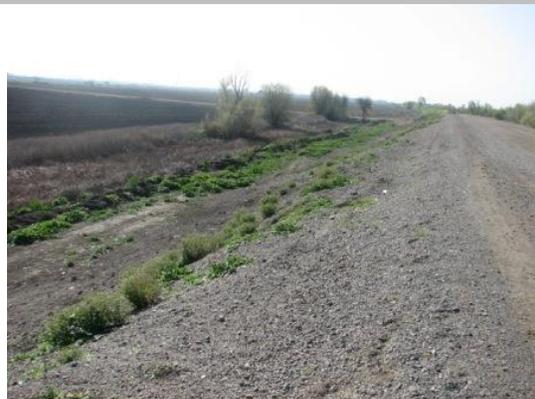
Photo 2 of 2 : SP\_2016\_RD0785\_186\_29\_20160304\_00009.jpg

Buldge at the landside toe of the levee, photos taken spring 2012.

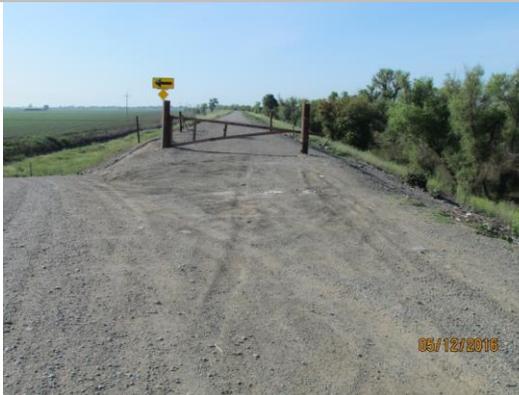
Photo 1 of 1 : SP\_2016\_RD0785\_186\_2\_20160516\_00025.jpg

View of the ruts on the crown of the levee looking downstream. Spring 2016.

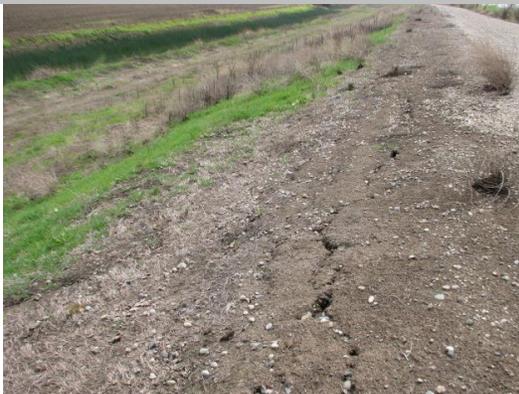
Photo 1 of 1 : SP\_2016\_RD0785\_186\_143\_20160304\_00017.jpg

Cracking along the shoulder causing slope instability. Spring 2014

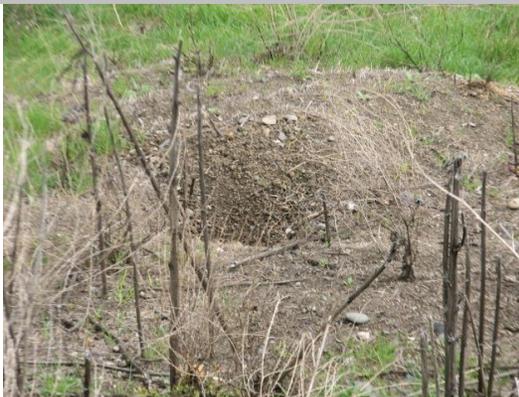
Photo 1 of 1 : SP\_2016\_RD0785\_186\_42\_20160304\_00014.jpg

Large rodent hole close to the toe of the levee. Spring 2014

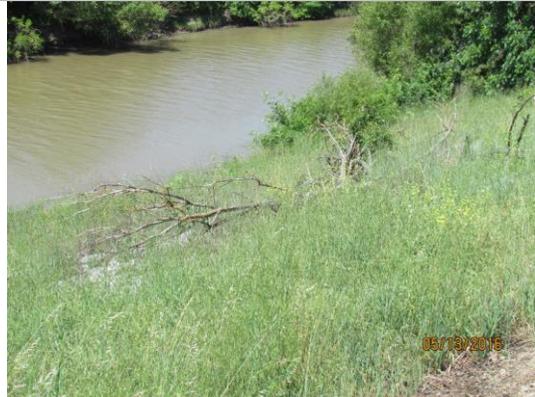
Photo 1 of 2 : SP\_2016\_RD0785\_186\_10\_20160517\_00031.jpg

Discarded tree is on the waterward slope of the levee. Spring 2016.

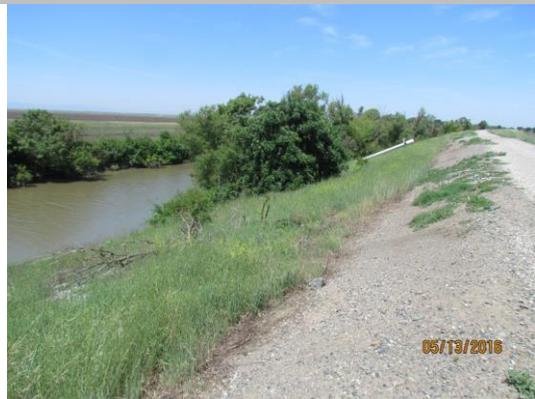
Photo 2 of 2 : SP\_2016\_RD0785\_186\_10\_20160517\_00030.jpg

Perspective view of the discarded tree looking upstream. Spring 2016.

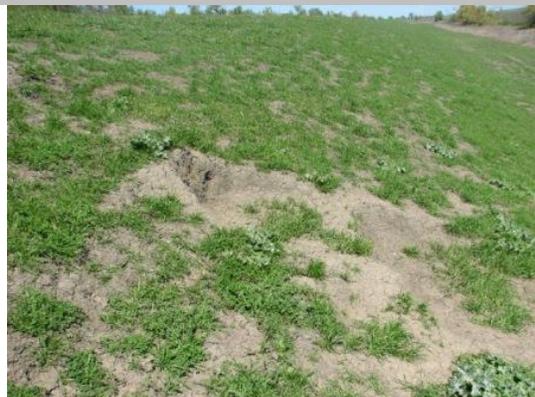
Photo 1 of 4 : SP\_2016\_RD0785\_186\_30\_20160304\_00010.jpg

There is slope instability with three step like spots. The cuts are 1' to 1.5' deep. Photo taken spring 2012.

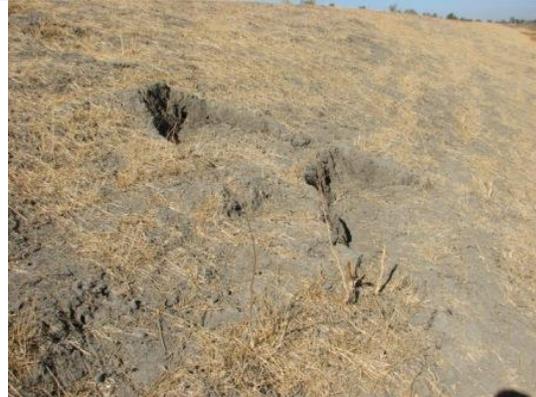
Photo 2 of 4 : SP\_2016\_RD0785\_186\_30\_20160304\_00011.jpg

Slope instability. Photo fall 2012.

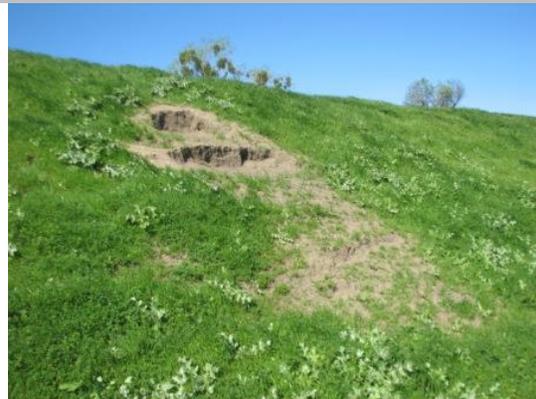
Photo 3 of 4 : SP\_2016\_RD0785\_186\_30\_20160304\_00012.jpg

Slope instability is still there. Spring 2013

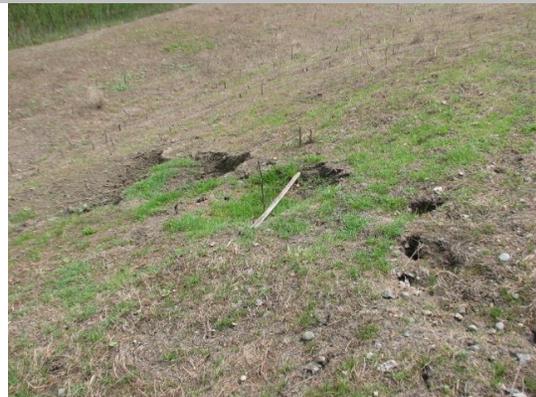
Photo 4 of 4 : SP\_2016\_RD0785\_186\_30\_20160304\_00013.jpg

Current view of the slope instability. Spring 2014

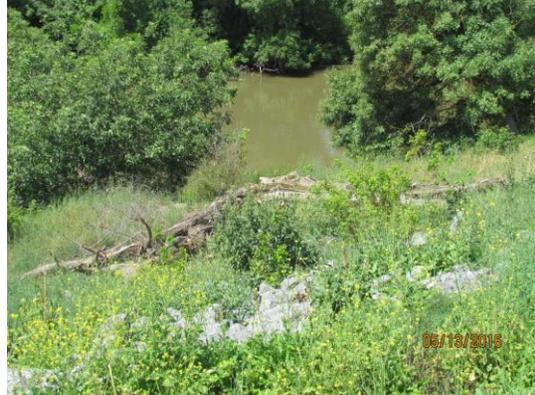
Photo 1 of 2 : SP\_2016\_RD0785\_186\_56\_20160517\_00028.jpg

Discarded tree is on the slope of the waterward side of the levee. Spring 2016.

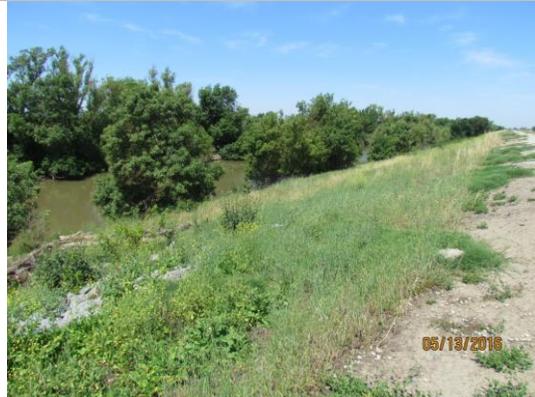
Photo 2 of 2 : SP\_2016\_RD0785\_186\_56\_20160517\_00029.jpg

Perspective view of the tree looking upstream. Spring 2016.

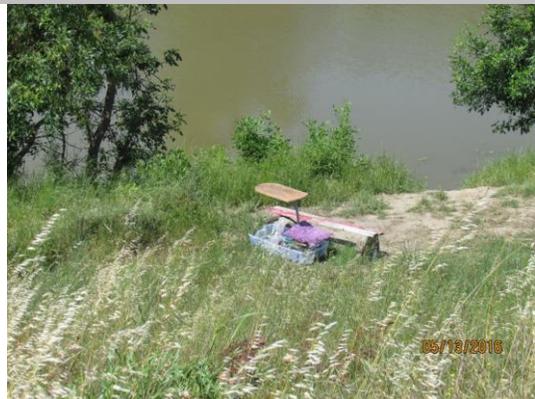
Photo 1 of 2 : SP\_2016\_RD0785\_186\_9\_20160517\_00026.jpg

Bench is on the berm of the waterward side of the levee. Spring 2016.

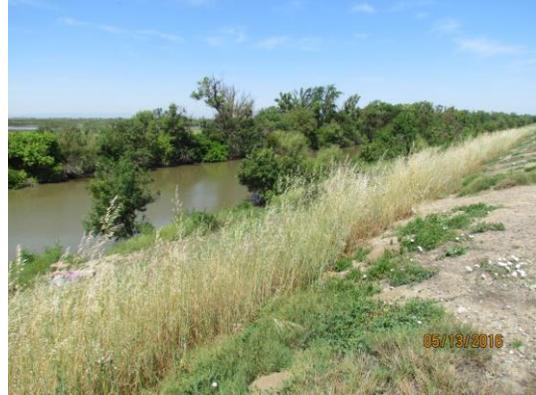
Photo 2 of 2 : SP\_2016\_RD0785\_186\_9\_20160517\_00027.jpg

Perspective view of the bench looking upstream. Spring 2016.
