**Flood Control Project Maintenance
Levee Inspections**

Maintenance Issue Types Only, Levee Inspection Report By Mile - Fall 2014

Reclamation District No. 0785 Driver

Waterway	Bank	Unit Miles	Inspection Start/End	Inspector
Unit No. 01 Sacramento River	Right	2.26	11/18/2014 11/18/2014	Clay Thomas

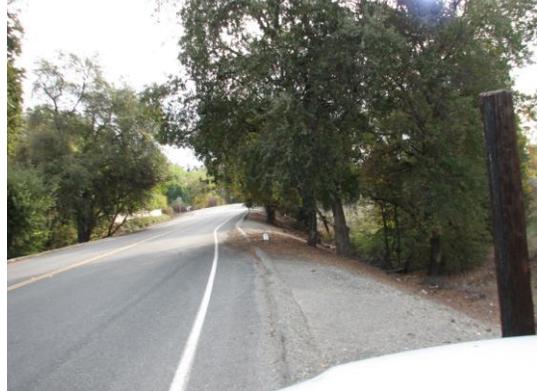
Photo 1 of 1 : FA_2014_RD0785_185_14_20141120_00020.jpg

LM Start	0.00	Rating **	A/W	Issue No.	14
LM End	2.31	Issue Type +	Ma	Location *	LS
Category	Earthen Levee		GPS Latitude/Longitude		
			Start	End	
Item	Vegetation			°	°
				°	°
DWR ID	DWR_RD0785_01_f_2014_14				
Action/Comments					
Control annual grass and weeds on the levee slopes and easements.

Levee mile 0.00, vegetation on the land side slope. Fall 2014.

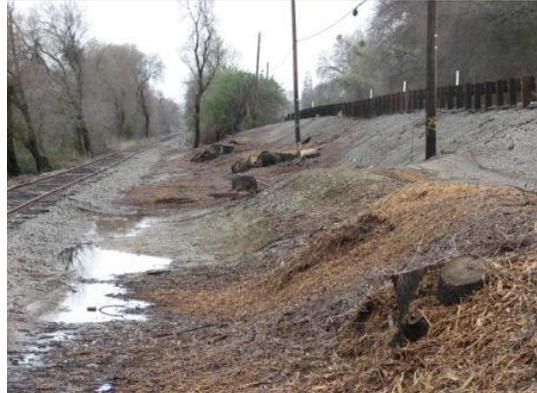
Photo 1 of 1 : FA_2014_RD0785_185_4_20141014_00003.jpg

LM Start	0.13	Rating **	N	Issue No.	4
LM End	1.36	Issue Type +	Ma	Location *	LS
Category	Earthen Levee		GPS Latitude/Longitude		
			Start	End	
Item	Trim / Thin Trees		38.660160	°	38.646214
			-121.611619	°	-121.598596
DWR ID	DWR_RD0785_01_s_2012_4				
Action/Comments					
Tree stumps.

The trees were cut by PG&E'S tree contractor. The district will take care of the stumps in the future.

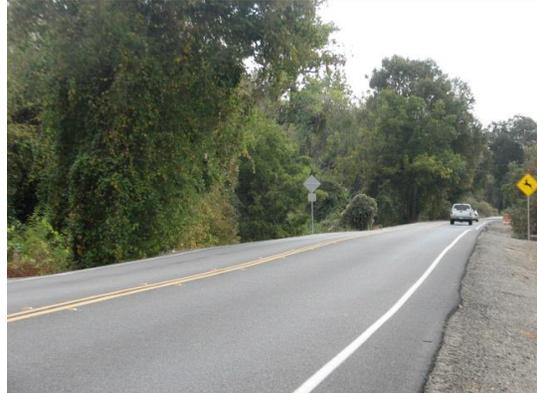
Photo 1 of 2 : FA_2014_RD0785_185_16_20141014_00011.jpg

Brush and other vegetation partially blocks visibility or access to the levee slope. Fall 2013

LM Start	0.21	Rating **	M	Issue No.	16
LM End	1.37	Issue Type +	Ma	Location *	WS
Category	Earthen Levee		GPS Latitude/Longitude		
			Start	End	
Item	Vegetation		38.659340	°	38.646093
			-121.610405	°	-121.598518
DWR ID	DWR_RD0785_01_f_2013_16				
Action/Comments					
Remove the wild growth other than native grasses from the levee slopes.

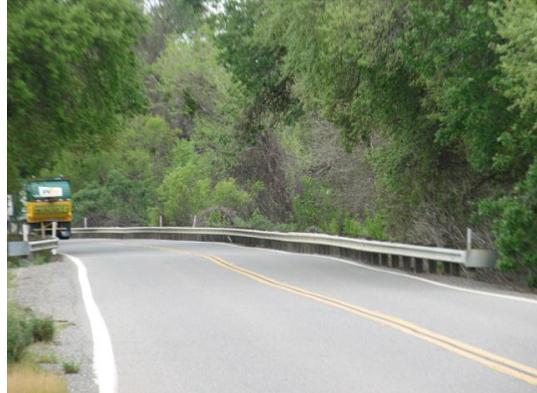
Photo 2 of 2 : FA_2014_RD0785_185_16_20141014_00012.jpg

Brush and other vegetation partially blocks visibility. Spring 2014

LM Start	0.21	Rating **	M	Issue No.	16 (cont)
LM End	1.37	Issue Type +	Ma	Location *	WS
Category	Earthen Levee		GPS Latitude/Longitude		
			Start	End	
Item	Vegetation		38.659340 °	38.646093 °	
			-121.610405 °	-121.598518 °	
DWR ID	DWR_RD0785_01_f_2013_16				
Action/Comments					
Remove the wild growth other than native grasses from the levee slopes.

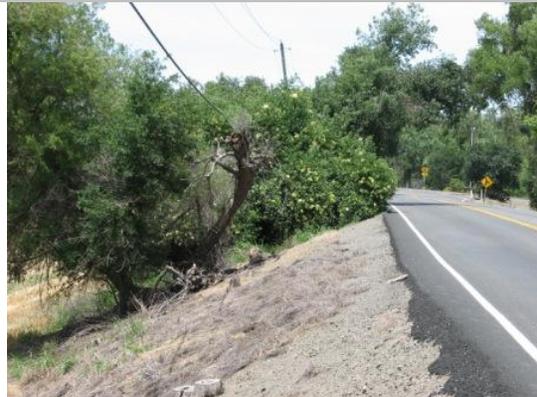
Photo 1 of 1 : FA_2014_RD0785_185_1_20141014_00001.jpg

LM Start	0.29	Rating **	A/W	Issue No.	1
LM End	0.29	Issue Type +	Ma	Location *	LS
Category	Earthen Levee		GPS Latitude/Longitude		
			Start	End	
Item	Vegetation		38.658467 °	38.658467 °	
			-121.609573 °	-121.609573 °	
DWR ID	DWR_RD0785_01_s_2012_1				
Action/Comments					
Elderberries are blocking visibility and flood fight capability.

Elderberry

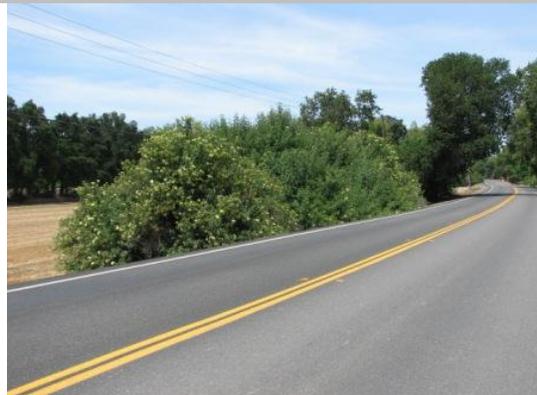
Photo 1 of 1 : FA_2014_RD0785_185_2_20141014_00002.jpg

LM Start	0.41	Rating **	A/W	Issue No.	2
LM End	0.45	Issue Type +	Ma	Location *	LS
Category	Earthen Levee		GPS Latitude/Longitude		
			Start	End	
Item	Vegetation		38.657168 °	38.656697 °	
			-121.608270 °	-121.607845 °	
DWR ID	DWR_RD0785_01_s_2012_2				
Action/Comments					
Elderberries are blocking visibility and flood fight capability.

Elderberry

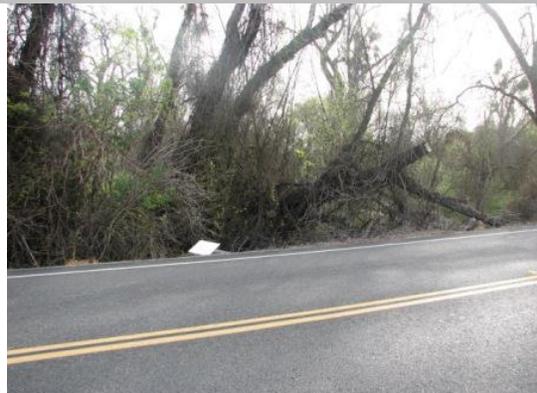
Photo 1 of 1 : FA_2014_RD0785_185_47_20141014_00014.jpg

The fallen tree and brush on the waterside of the roadway needs to be removed. Photo taken spring 2012.

LM Start	0.93	Rating **	M	Issue No.	47
LM End	0.93	Issue Type +	Ma	Location *	WS
Category	Earthen Levee		GPS Latitude/Longitude		
			Start	End	
Item	Trim / Thin Trees		38.650992 °	38.650992 °	
			-121.603392 °	-121.603392 °	
DWR ID	DWR_RD0785_01_s_2012_47				
Action/Comments					
Trim and thin trees to allow visibility of the ground and room to flood fight.

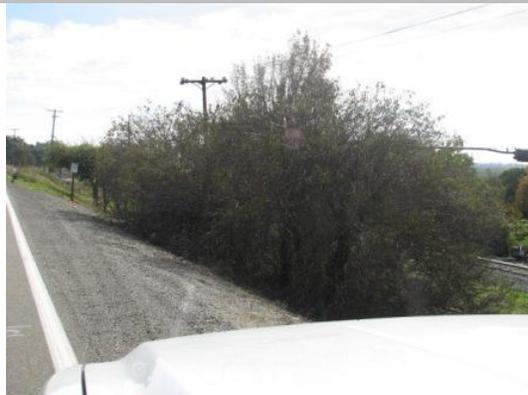
Photo 1 of 1 : FA_2014_RD0785_185_6_20141014_00004.jpg

LM Start	1.32	Rating **	A/W	Issue No.	6
LM End	1.32	Issue Type +	Ma	Location *	LS
Category	Earthen Levee		GPS Latitude/Longitude		
			Start	End	
Item	Vegetation		38.646712 °	38.646712 °	
			-121.599095 °	-121.599095 °	
DWR ID	DWR_RD0785_01_s_2012_6				
Action/Comments					
Elderberries are blocking visibility and flood fight capability.

This is a very large Elderberry bush.

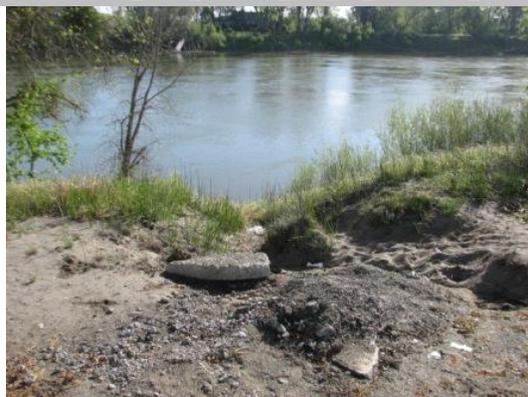
Photo 1 of 2 : FA_2014_RD0785_185_13_20141014_00009.jpg

The erosion has become a trail for fishermen and contributes to it. Spring 2013

LM Start	1.32	Rating **	M	Issue No.	13
LM End	1.32	Issue Type +	Ma	Location *	WS
Category	Earthen Levee		GPS Latitude/Longitude		
			Start	End	
Item	Erosion / Bank Caving		38.646671 °	38.646671 °	
			-121.598915 °	-121.598915 °	
DWR ID	DWR_RD0785_01_s_2013_13				
Action/Comments					
Schedule repair of erosion site prior to the next inspection.

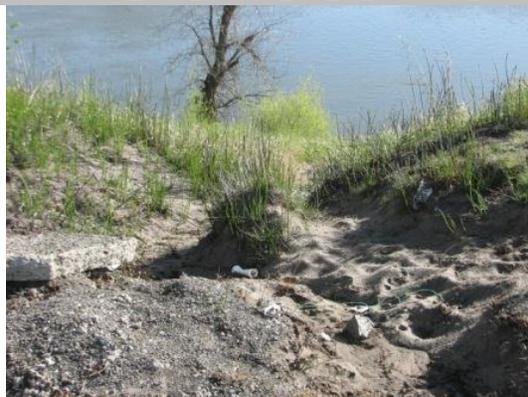
Photo 2 of 2 : FA_2014_RD0785_185_13_20141014_00010.jpg

The waterside levee slope has erosion from surface run off. Spring 2013

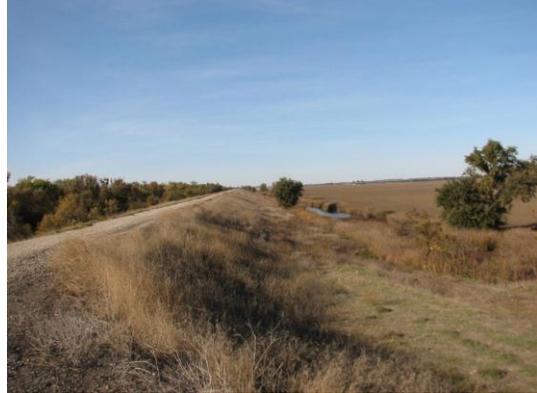
Photo 1 of 1 : FA_2014_RD0785_186_2_20141120_00016.jpg

Levee mile 3.29, vegetation on the land side slope. Fall 2014.

LM Start	0.00	Rating **	A/W	Issue No.	2
LM End	3.30	Issue Type +	Ma	Location *	LS
Category	Earthen Levee		GPS Latitude/Longitude		
			Start	End	
Item	Vegetation			°	°
				°	°
DWR ID	DWR_RD0785_02_f_2014_2				
Action/Comments					
Control annual grass and weeds on the levee slopes and easements.

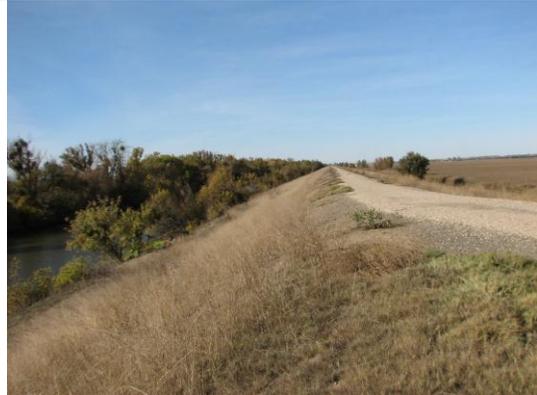
Photo 1 of 1 : FA_2014_RD0785_186_3_20141120_00017.jpg

Levee mile 3.29, vegetation on the water side slope. Fall 2014.

LM Start	0.00	Rating **	A/W	Issue No.	3
LM End	3.30	Issue Type +	Ma	Location *	WS
Category	Earthen Levee		GPS Latitude/Longitude		
			Start	End	
Item	Vegetation			°	°
				°	°
DWR ID	DWR_RD0785_02_f_2014_3				
Action/Comments					
Control annual grass and weeds on the levee slopes and easements.

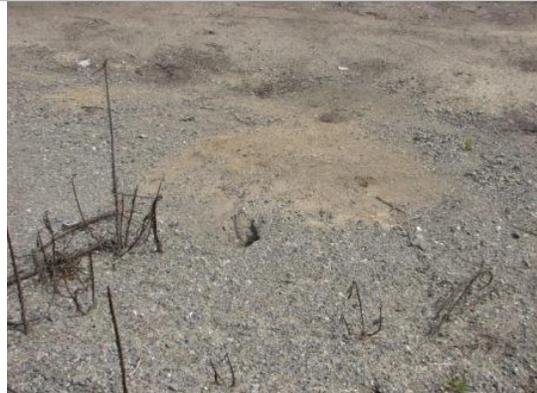
Photo 1 of 1 : FA_2014_RD0785_186_25_20141014_00001.jpg

Rodent holes on the landside levee slope, photo taken spring 2012.

LM Start	0.11	Rating **	M	Issue No.	25
LM End	0.11	Issue Type +	Ma	Location *	LS
Category	Earthen Levee		GPS Latitude/Longitude		
			Start	End	
Item	Animal Control		38.639670	°	38.639670
			-121.619460	°	-121.619460
DWR ID	DWR_RD0785_02_s_2012_25				
Action/Comments					
No rodents visible, but rodent burrows visible; need to backfill and compact or grout burrows. Inspector Comments: Unable to see slope.

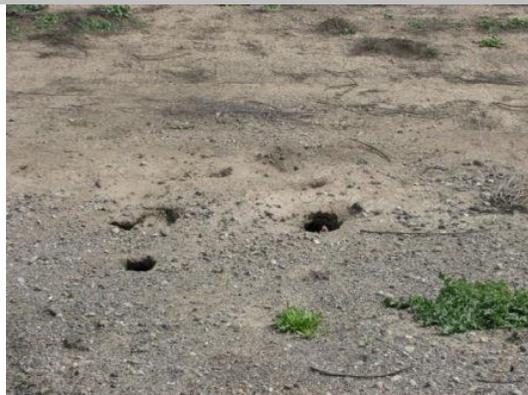
Photo 1 of 1 : FA_2014_RD0785_186_27_20141014_00002.jpg

Rodent holes on the landside levee slope, photo taken spring 2012.

LM Start	0.38	Rating **	A/W	Issue No.	27
LM End	0.38	Issue Type +	Ma	Location *	LS
Category	Earthen Levee		GPS Latitude/Longitude		
			Start	End	
Item	Animal Control		38.636065 °	38.636065 °	
			-121.617295 °	-121.617295 °	
DWR ID	DWR_RD0785_02_s_2012_27				
Action/Comments					
No rodents visible, but rodent burrows visible; need to backfill and compact or grout burrows. Inspector Comments: Unable to see slope. Vegetation too tall to see.

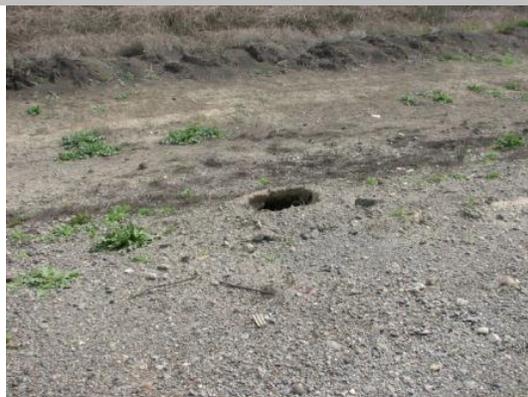
Photo 1 of 2 : FA_2014_RD0785_186_28_20141014_00003.jpg

Many rodent holes within 25' of each other, photo taken spring 2012.

LM Start	0.46	Rating **	A/W	Issue No.	28
LM End	0.46	Issue Type +	Ma	Location *	LS
Category	Earthen Levee		GPS Latitude/Longitude		
			Start	End	
Item	Animal Control		38.634978 °	38.634978 °	
			-121.616612 °	-121.616612 °	
DWR ID	DWR_RD0785_02_s_2012_28				
Action/Comments					
No rodents visible, but rodent burrows visible; need to backfill and compact or grout burrows. Inspector Comments: Unable to see slope. Vegetation too tall to see.

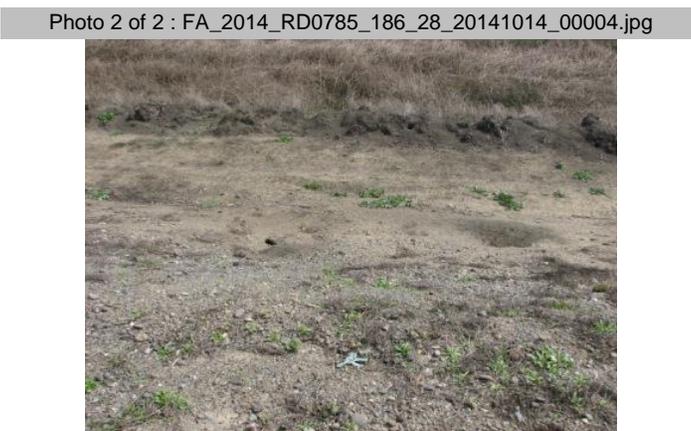
Rodent holes on the landside levee slope, photo taken spring 2012.

LM Start	0.46	Rating **	A/W	Issue No.	28 (cont)
LM End	0.46	Issue Type +	Ma	Location *	LS
Category	Earthen Levee		GPS Latitude/Longitude		
			Start	End	
Item	Animal Control		38.634978 °	38.634978 °	
			-121.616612 °	-121.616612 °	
DWR ID	DWR_RD0785_02_s_2012_28				
Action/Comments					
No rodents visible, but rodent burrows visible; need to backfill and compact or grout burrows. Inspector Comments: Unable to see slope. Vegetation too tall to see.

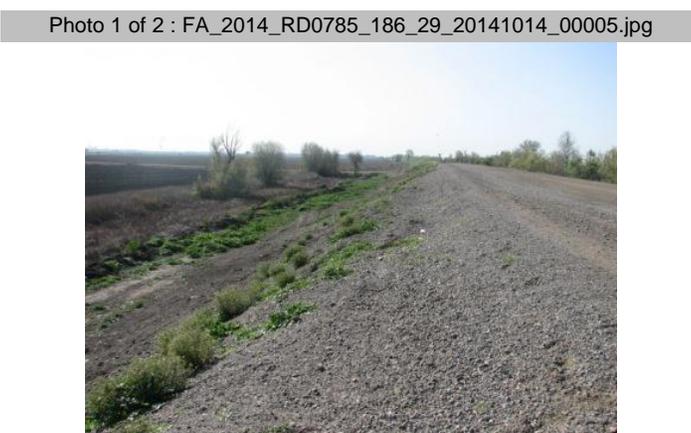
Slope instability at shoulder of landside levee buldge at toe.

LM Start	0.52	Rating **	M	Issue No.	29
LM End	0.52	Issue Type +	Ma	Location *	LS
Category	Earthen Levee		GPS Latitude/Longitude		
			Start	End	
Item	Slope Stability		38.634180 °	38.634180 °	
			-121.616142 °	-121.616142 °	
DWR ID	DWR_RD0785_02_s_2012_29				
Action/Comments					
Repair slope instability.

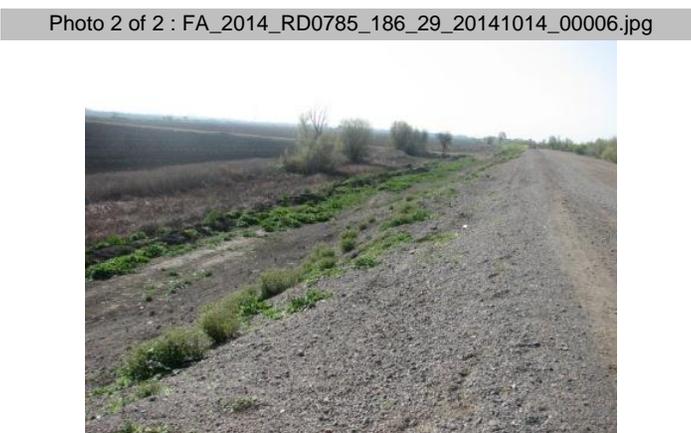
Buldge at the landside toe of the levee, photos taken spring 2012.

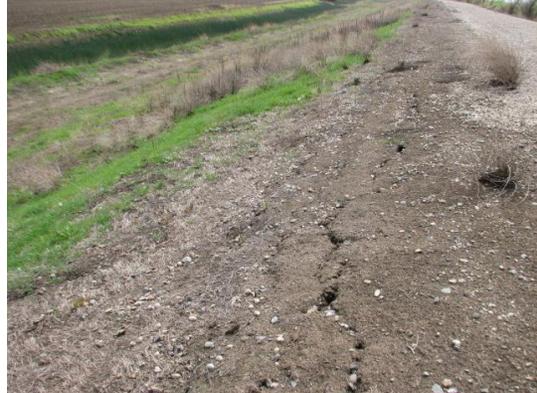
Photo 1 of 1 : FA_2014_RD0785_186_143_20141014_00013.jpg

Cracking along the shoulder causing slope instability. Spring 2014

LM Start	0.87	Rating **	M	Issue No.	143
LM End	0.87	Issue Type +	Ma	Location *	LS
Category	Earthen Levee		GPS Latitude/Longitude		
			Start	End	
Item	Slope Stability		38.629693 °	38.629693 °	
			-121.613436 °	-121.613436 °	
DWR ID	DWR_RD0785_02_s_2014_143				
Action/Comments					
Repair slope instability.

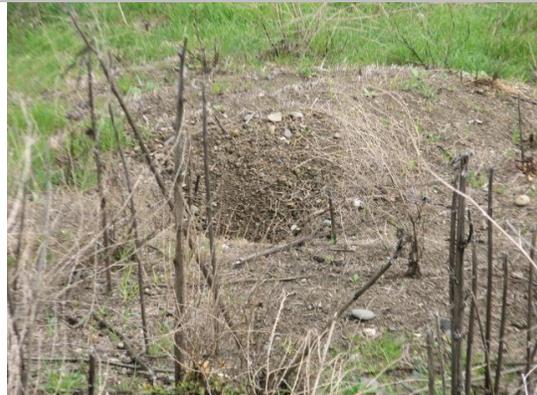
Photo 1 of 1 : FA_2014_RD0785_186_42_20141014_00011.jpg

Large rodent hole close to the toe of the levee. Spring 2014

LM Start	0.87	Rating **	M	Issue No.	42
LM End	0.90	Issue Type +	Ma	Location *	LS
Category	Earthen Levee		GPS Latitude/Longitude		
			Start	End	
Item	Animal Control		38.629589 °	38.629259 °	
			-121.613372 °	-121.613156 °	
DWR ID	DWR_RD0785_02_s_2014_42				
Action/Comments					
No rodents visible, but rodent burrows visible; need to backfill and compact or grout burrows.

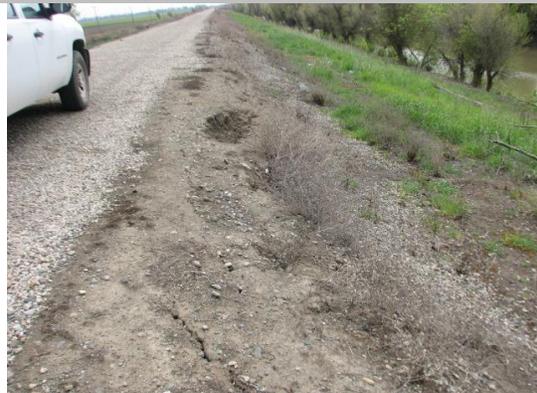
Photo 1 of 1 : FA_2014_RD0785_186_144_20141014_00014.jpg

Slope instability along the waterside shoulder. Spring 2014

LM Start	1.10	Rating **	M	Issue No.	144
LM End	1.10	Issue Type +	Ma	Location *	WS
Category	Earthen Levee		GPS Latitude/Longitude		
			Start	End	
Item	Slope Stability		38.626676 °	38.626676 °	
			-121.611325 °	-121.611325 °	
DWR ID	DWR_RD0785_02_s_2014_144				
Action/Comments					
Repair slope instability.

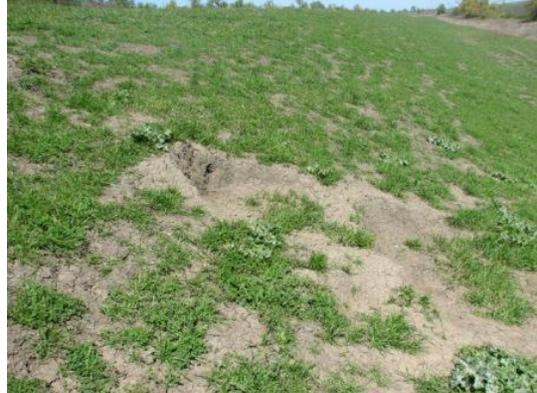
Photo 1 of 4 : FA_2014_RD0785_186_30_20141014_00007.jpg

There is slope instability with three step like spots. The cuts are 1' to 1.5' deep. Photo taken spring 2012.

LM Start	2.18	Rating **	M	Issue No.	30
LM End	2.18	Issue Type +	Ma	Location *	LS
Category	Earthen Levee		GPS Latitude/Longitude		
			Start	End	
Item	Slope Stability		38.613104 °	38.613104 °	
			-121.600915 °	-121.600915 °	
DWR ID	DWR_RD0785_02_s_2012_30				
Action/Comments					
Repair slope instability.

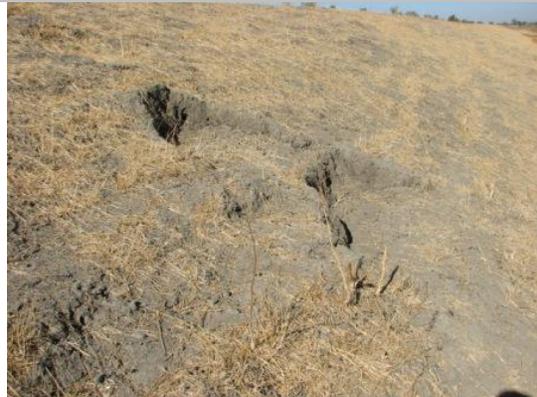
Photo 2 of 4 : FA_2014_RD0785_186_30_20141014_00008.jpg

Slope instability. Photo fall 2012.

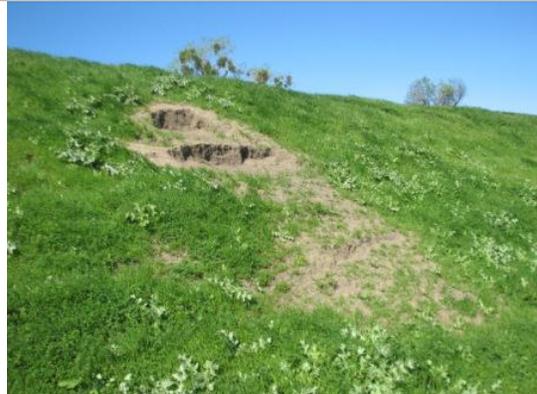
Photo 3 of 4 : FA_2014_RD0785_186_30_20141014_00009.jpg

Slope instability is still there. Spring 2013
