**Flood Control Project Maintenance
Levee Inspections**

Maintenance Issue Types Only, Levee Inspection Report By Mile - Fall 2015

Reclamation District No. 0785 Driver

Waterway	Bank	Unit Miles	Inspection Start/End	Inspector
Unit No. 01 Sacramento River	Right	2.26	10/27/2015 10/27/2015	Jai Lor

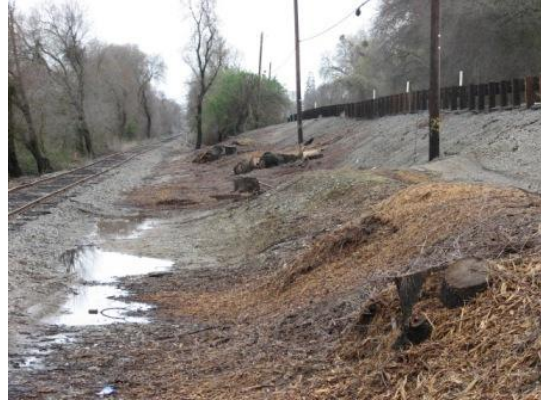
Photo 1 of 1 : FA_2015_RD0785_185_4_20150914_00003.jpg

LM Start	0.12	Rating **	N	Issue No.	4
LM End	1.34	Issue Type +	Ma	Location *	LS
Category	Earthen Levee			GPS Latitude/Longitude	
				Start	End
Item	Trim / Thin Trees			38.660160 °	38.646214 °
				-121.611619 °	-121.598596 °
DWR ID	DWR_RD0785_01_s_2012_4				
Action/Comments					
Tree stumps.

The trees were cut by PG&E'S tree contractor. The district will take care of the stumps in the future.

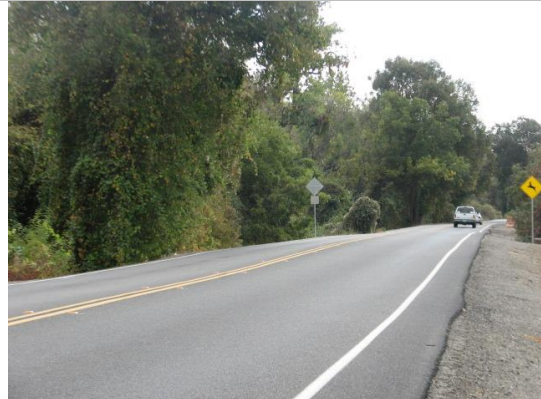
Photo 1 of 2 : FA_2015_RD0785_185_16_20150914_00011.jpg

Brush and other vegetation partially blocks visibility or access to the levee slope. Fall 2013

LM Start	0.21	Rating **	M	Issue No.	16
LM End	1.35	Issue Type +	Ma	Location *	WS
Category	Earthen Levee			GPS Latitude/Longitude	
				Start	End
Item	Vegetation			38.659340 °	38.646093 °
				-121.610405 °	-121.598518 °
DWR ID	DWR_RD0785_01_f_2013_16				
Action/Comments					
Remove the wild growth other than native grasses from the levee slopes.

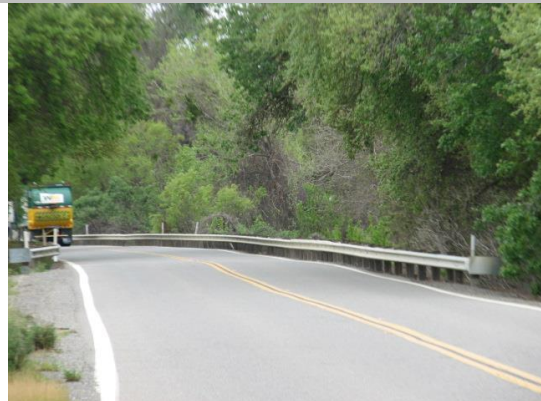
Photo 2 of 2 : FA_2015_RD0785_185_16_20150914_00012.jpg

Brush and other vegetation partially blocks visibility. Spring 2014

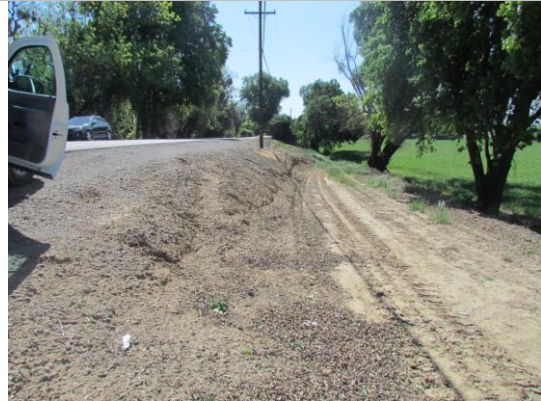
Photo 1 of 1 : FA_2015_RD0785_185_349_20150914_00022.jpg

View of the slope stability on the landward side of the levee looking downstream. Spring 2015.

LM Start	0.34	Rating **	M	Issue No.	349
LM End	0.34	Issue Type +	Ma	Location *	LS
Category	Earthen Levee			GPS Latitude/Longitude	
				Start	End
Item	Slope Stability			38.657798 °	38.657798
				-121.608898 °	-121.608898
DWR ID	DWR_RD0785_01_s_2015_349				
Action/Comments					
Repair slope instability.

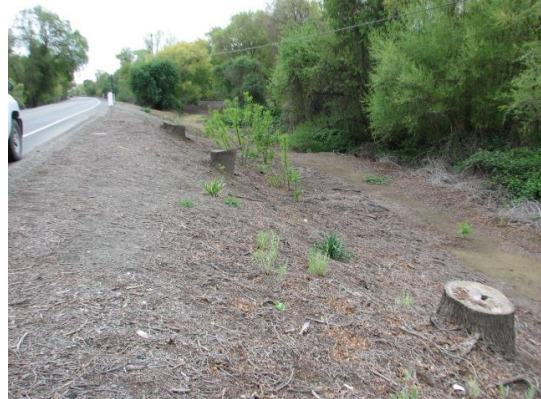
Photo 1 of 1 : FA_2015_RD0785_185_181_20150914_00018.jpg

Tree stumps along the landside shoulder of the levee. Spring 2014

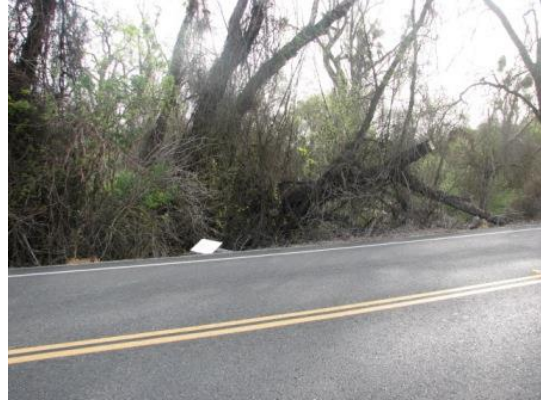
Photo 1 of 1 : FA_2015_RD0785_185_47_20150914_00014.jpg

The fallen tree and brush on the waterside of the roadway needs to be removed. Photo taken spring 2012.

LM Start	0.92	Rating **	M	Issue No.	47
LM End	0.92	Issue Type +	Ma	Location *	WS
Category	Earthen Levee			GPS Latitude/Longitude	
				Start	End
Item	Trim / Thin Trees			38.650992 °	38.650992 °
				-121.603392 °	-121.603392 °
DWR ID	DWR_RD0785_01_s_2012_47				
Action/Comments					
Trim and thin trees to allow visibility of the ground and room to flood fight.

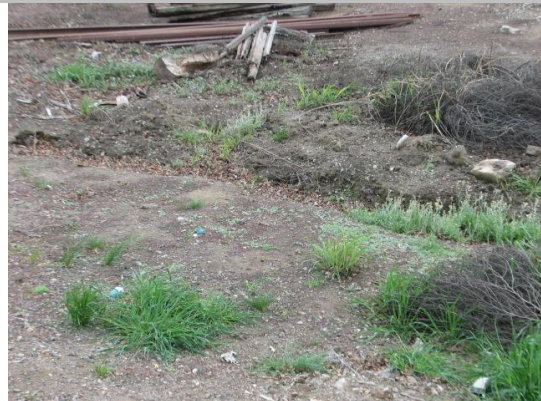
Photo 1 of 2 : FA_2015_RD0785_185_48_20150914_00017.jpg

Drain pipe is causing erosion on the landside of the levee between the slope and railroad tracks. Spring 2014

LM Start	1.07	Rating **	M	Issue No.	48
LM End	1.07	Issue Type +	Ma	Location *	LS
Category	Earthen Levee			GPS Latitude/Longitude	
				Start	End
Item	Erosion / Bank Caving			38.649292 °	38.649292 °
				-121.601647 °	-121.601647 °
DWR ID	DWR_RD0785_01_s_2012_48				
Action/Comments					
Schedule repair of erosion site prior to the next inspection.

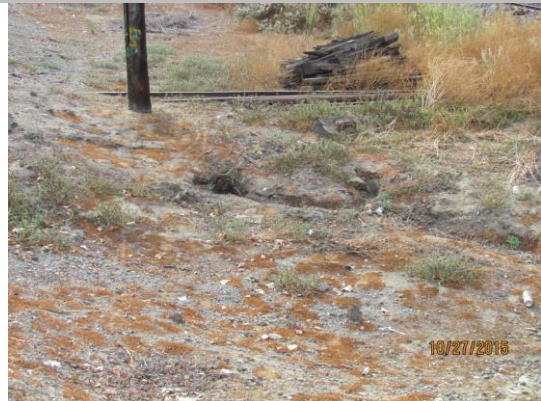
Photo 2 of 2 : FA_2015_RD0785_185_48_20151102_00029.jpg

View of the erosion at the toe of the levee on the landward side of the levee looking downstream. Fall 2015.

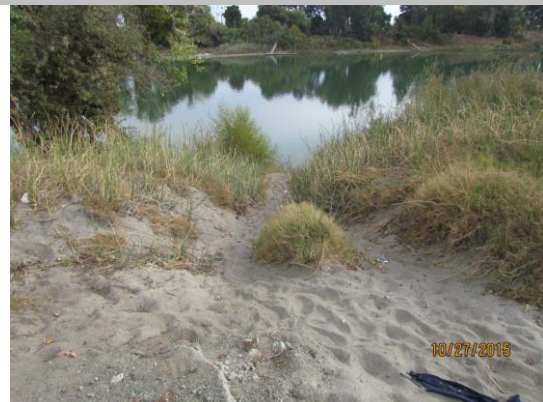
Photo 1 of 1 : FA_2015_RD0785_185_13_20151102_00030.jpg

View of the slope stability on the waterward side of the levee. Fall 2015.

LM Start	1.31	Rating **	M	Issue No.	13
LM End	1.31	Issue Type +	Ma	Location *	WS
Category	Earthen Levee			GPS Latitude/Longitude	
				Start	End
Item	Slope Stability			38.646671 °	38.646671 °
				-121.598915 °	-121.598915 °
DWR ID	DWR_RD0785_01_s _ 2013_13				
Action/Comments					
Repair the levee slope damaged by vehicle traffic and prevent access where possible.

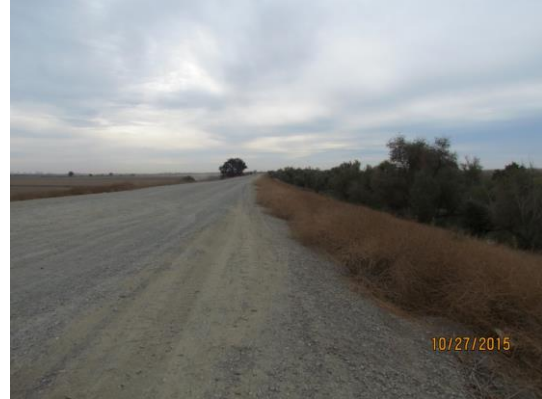
Photo 1 of 1 : FA_2015_RD0785_186_2_20151102_00017.jpg

View of the vegetation on the waterward side of the levee looking downstream. Fall 2015.

LM Start	0.02	Rating **	M	Issue No.	2
LM End	3.30	Issue Type +	Ma	Location *	WS
Category	Earthen Levee			GPS Latitude/Longitude	
				Start	End
Item	Vegetation			38.640996 °	38.599641 °
				-121.620333 °	-121.590437 °
DWR ID	DWR_RD0785_02_f_2015_2				
Action/Comments					
Control annual grass and weeds on the levee slopes and easements.

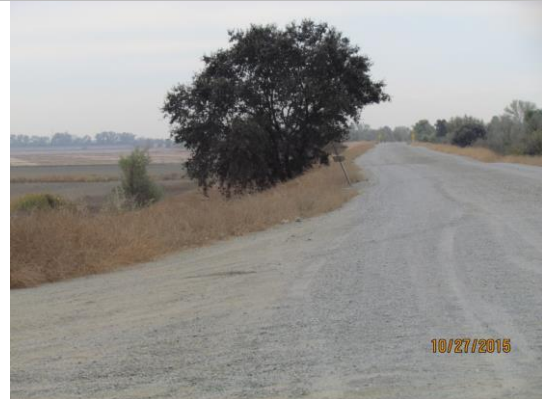
Photo 1 of 1 : FA_2015_RD0785_186_4_20151102_00018.jpg

View of the vegetation on the landward side of the levee looking downstream. Fall 2015.

LM Start	0.05	Rating **	M	Issue No.	4
LM End	3.30	Issue Type +	Ma	Location *	LS
Category	Earthen Levee			GPS Latitude/Longitude	
				Start	End
Item	Vegetation			38.640546 °	38.599641 °
				-121.620049 °	-121.590437 °
DWR ID	DWR_RD0785_02_f_2015_4				
Action/Comments					
Control annual grass and weeds on the levee slopes and easements.

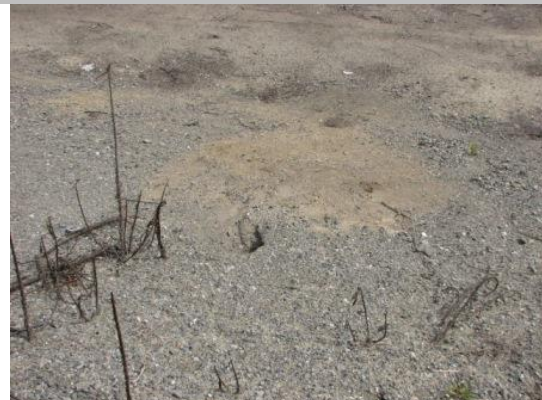
Photo 1 of 1 : FA_2015_RD0785_186_25_20150914_00001.jpg

Rodent holes on the landside levee slope, photo taken spring 2012.

LM Start	0.12	Rating **	M	Issue No.	25
LM End	0.12	Issue Type +	Ma	Location *	LS
Category	Earthen Levee			GPS Latitude/Longitude	
				Start	End
Item	Animal Control			38.639670 °	38.639670 °
				-121.619460 °	-121.619460 °
DWR ID	DWR_RD0785_02_s_2012_25				
Action/Comments					
No rodents visible, but rodent burrows visible; need to backfill and compact or grout burrows. Inspector Comments: Unable to see slope.

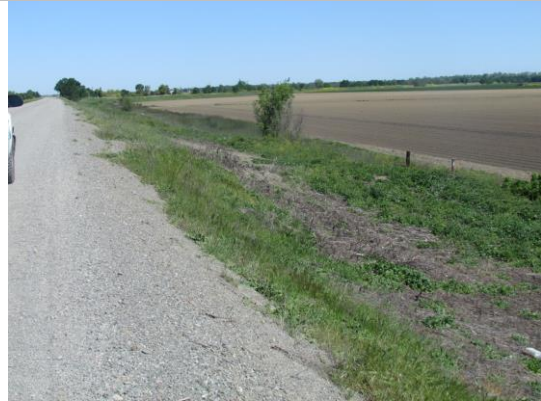
Photo 1 of 1 : FA_2015_RD0785_186_280_20150914_00015.jpg

View of the slope stability on the landward side of the levee looking upstream. Spring 2015.

LM Start	0.38	Rating **	M	Issue No.	280
LM End	0.38	Issue Type +	Ma	Location *	LS
Category	Earthen Levee			GPS Latitude/Longitude	
				Start	End
Item	Slope Stability			38.636265 °	38.636265 °
				-121.617422 °	-121.617422 °
DWR ID	DWR_RD0785_02_s_2015_280				
Action/Comments					
Repair slope instability.

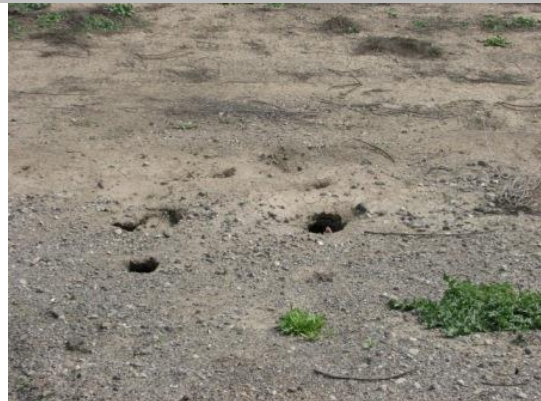
Photo 1 of 1 : FA_2015_RD0785_186_27_20150914_00002.jpg

Rodent holes on the landside levee slope, photo taken spring 2012.

LM Start	0.40	Rating **	A/W	Issue No.	27
LM End	0.40	Issue Type +	Ma	Location *	LS
Category	Earthen Levee			GPS Latitude/Longitude	
				Start	End
Item	Animal Control			38.636065 °	38.636065 °
				-121.617295 °	-121.617295 °
DWR ID	DWR_RD0785_02_s_2012_27				
Action/Comments					
No rodents visible, but rodent burrows visible; need to backfill and compact or grout burrows.					
Inspector Comments: Unable to see slope. Vegetation to tall to see.

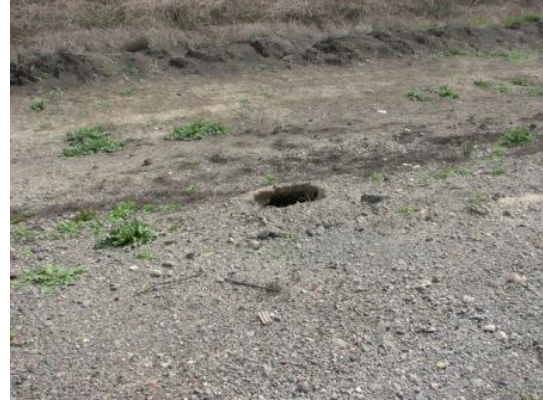
Photo 1 of 2 : FA_2015_RD0785_186_28_20150914_00003.jpg

Many rodent holes with in 25' of each other, photo taken spring 2012.

LM Start	0.48	Rating **	A/W	Issue No.	28
LM End	0.48	Issue Type +	Ma	Location *	LS
Category	Earthen Levee			GPS Latitude/Longitude	
				Start	End
Item	Animal Control			38.634978 °	38.634978 °
				-121.616612 °	-121.616612 °
DWR ID	DWR_RD0785_02_s _ 2012_28				
Action/Comments					
No rodents visible, but rodent burrows visible; need to backfill and compact or grout burrows.					
Inspector Comments: Unable to see slope. Vegetation too tall to see.

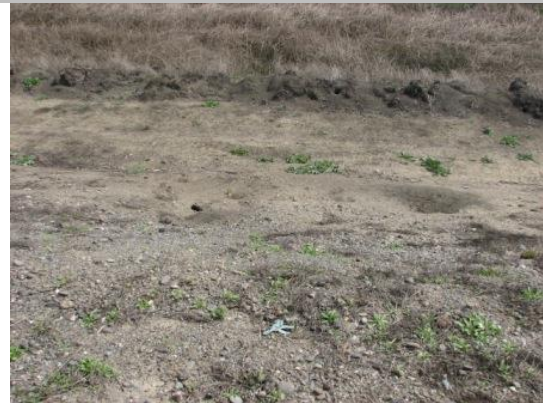
Photo 2 of 2 : FA_2015_RD0785_186_28_20150914_00004.jpg

Rodent holes on the landside levee slope, photo taken spring 2012.

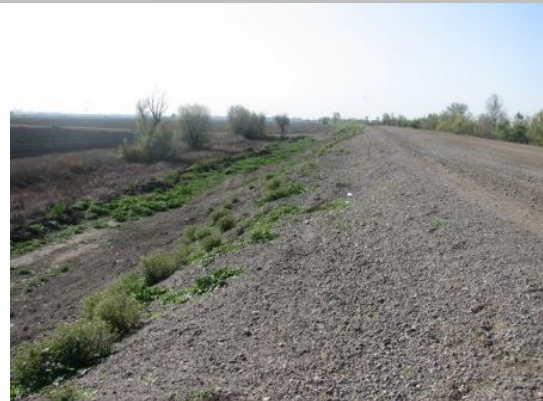
Photo 1 of 2 : FA_2015_RD0785_186_29_20150914_00005.jpg

Slope instability at shoulder of landside levee buldge at toe.

LM Start	0.54	Rating **	M	Issue No.	29
LM End	0.54	Issue Type +	Ma	Location *	LS
Category	Earthen Levee			GPS Latitude/Longitude	
				Start	End
Item	Slope Stability			38.634180 °	38.634180 °
				-121.616142 °	-121.616142 °
DWR ID	DWR_RD0785_02_s _ 2012_29				
Action/Comments					
Repair slope instability.

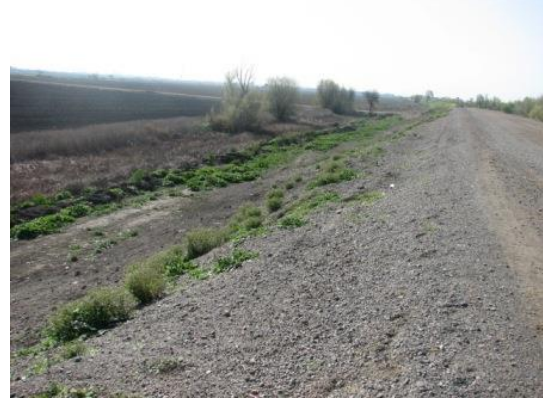
Photo 2 of 2 : FA_2015_RD0785_186_29_20150914_00006.jpg

Buldge at the landside toe of the levee, photos taken spring 2012.

LM Start	0.54	Rating **	M	Issue No.	29 (cont)	
LM End	0.54	Issue Type +	Ma	Location *	LS	
Category	Earthen Levee			GPS Latitude/Longitude		
				Start		End
Item	Slope Stability			38.634180 °		38.634180 °
				-121.616142 °		-121.616142 °
DWR ID	DWR_RD0785_02_s _ 2012_29					
Action/Comments						
Repair slope instability.

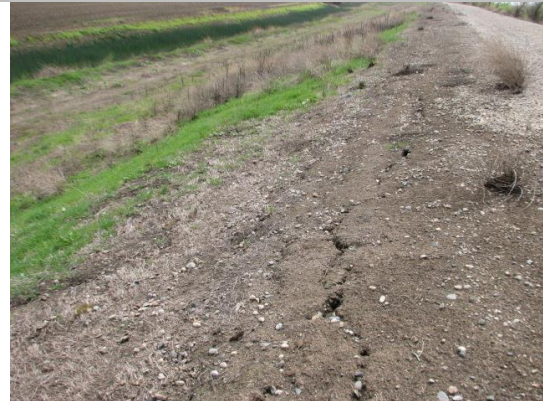
Photo 1 of 1 : FA_2015_RD0785_186_143_20150914_00013.jpg

Cracking along the shoulder causing slope instability. Spring 2014

LM Start	0.88	Rating **	M	Issue No.	143
LM End	0.88	Issue Type +	Ma	Location *	LS
Category	Earthen Levee			GPS Latitude/Longitude	
				Start	End
Item	Slope Stability			38.629693 °	38.629693 °
				-121.613436 °	-121.613436 °
DWR ID	DWR_RD0785_02_s _ 2014_143				
Action/Comments					
Repair slope instability.

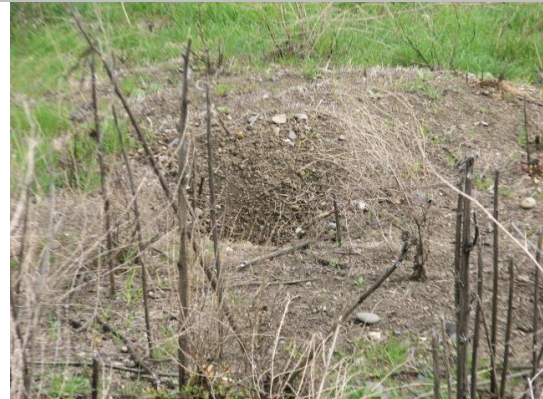
Photo 1 of 1 : FA_2015_RD0785_186_42_20150914_00011.jpg

Large rodent hole close to the toe of the levee. Spring 2014

LM Start	0.89	Rating **	M	Issue No.	42
LM End	0.92	Issue Type +	Ma	Location *	LS
Category	Earthen Levee			GPS Latitude/Longitude	
				Start	End
Item	Animal Control			38.629589 °	38.629259 °
				-121.613372 °	-121.613156 °
DWR ID	DWR_RD0785_02_s _ 2014_42				
Action/Comments					
No rodents visible, but rodent burrows visible; need to backfill and compact or grout burrows.

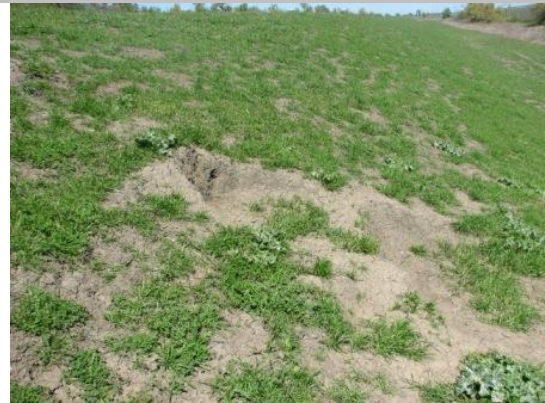
Photo 1 of 4 : FA_2015_RD0785_186_30_20150914_00007.jpg

There is slope instability with three step like spots. The cuts are 1' to 1.5' deep. Photo taken spring 2012.

LM Start	2.21	Rating **	M	Issue No.	30
LM End	2.21	Issue Type +	Ma	Location *	LS
Category	Earthen Levee			GPS Latitude/Longitude	
				Start	End
Item	Slope Stability			38.613104 °	38.613104 °
				-121.600915 °	-121.600915 °
DWR ID	DWR_RD0785_02_s _ 2012_30				
Action/Comments					
Repair slope instability.

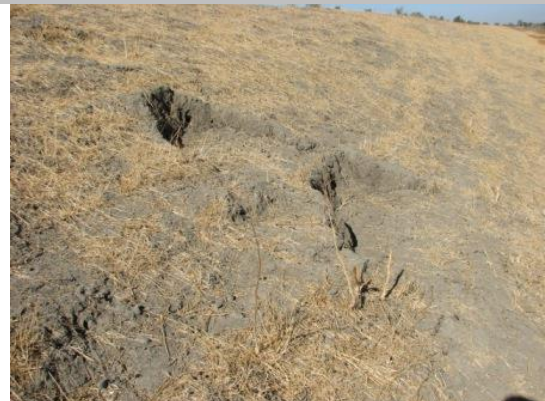
Photo 2 of 4 : FA_2015_RD0785_186_30_20150914_00008.jpg

Slope instability. Photo fall 2012.

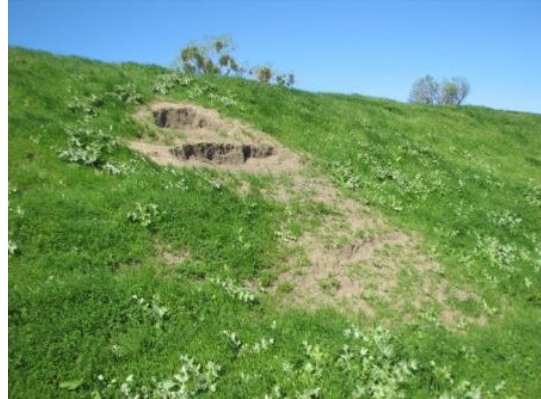
Photo 3 of 4 : FA_2015_RD0785_186_30_20150914_00009.jpg

Slope instability is still there. Spring 2013

LM Start	2.21	Rating **	M	Issue No.	30 (cont)	
LM End	2.21	Issue Type +	Ma	Location *	LS	
Category	Earthen Levee			GPS Latitude/Longitude		
				Start		End
Item	Slope Stability			38.613104 °		38.613104
				-121.600915 °		-121.600915
DWR ID	DWR_RD0785_02_s _ 2012_30					
Action/Comments						
Repair slope instability.

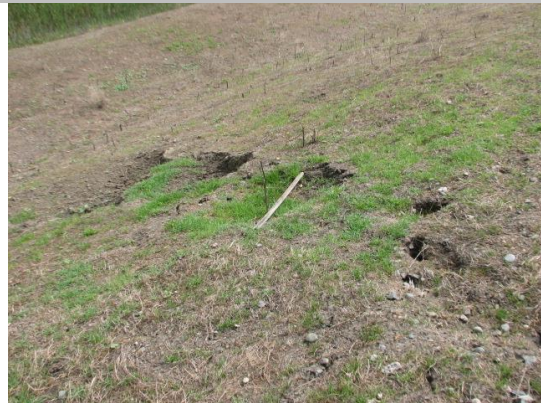
Photo 4 of 4 : FA_2015_RD0785_186_30_20150914_00010.jpg

Current view of the slope instability. Spring 2014
