**Flood Control Project Maintenance  
Levee Inspections**

## Maintenance Issue Types Only, Levee Inspection Report By Mile - Fall 2016

### Reclamation District No. 0785 Driver

Waterway	Bank	Unit Miles	Inspection Start/End	Inspector
Unit No. 01 Sacramento River	Right	2.26	10/24/2016 10/24/2016	Oleg Yakimov

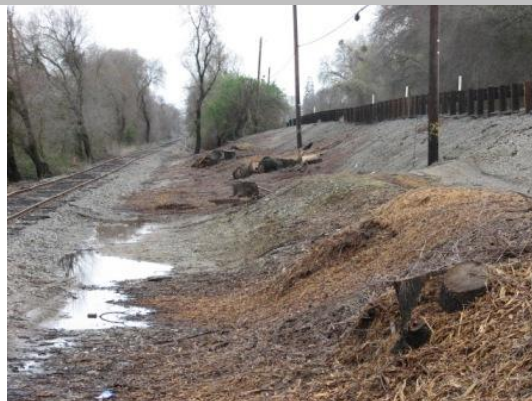
Photo 1 of 1 : FA\_2016\_RD0785\_185\_4\_20160913\_00001.jpg

The trees were cut by PG&E'S tree contractor. The district will take care of the stumps in the future.

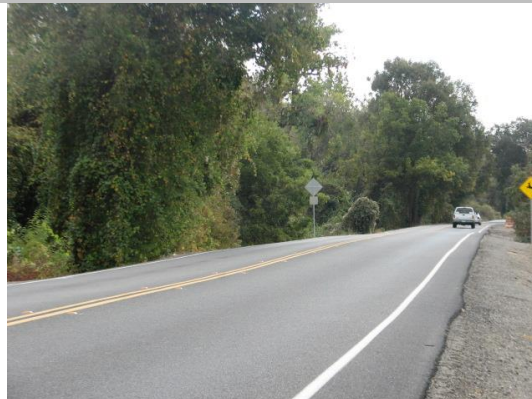
Photo 1 of 2 : FA\_2016\_RD0785\_185\_16\_20160913\_00007.jpg

Brush and other vegetation partially blocks visibility or access to the levee slope. Fall 2013

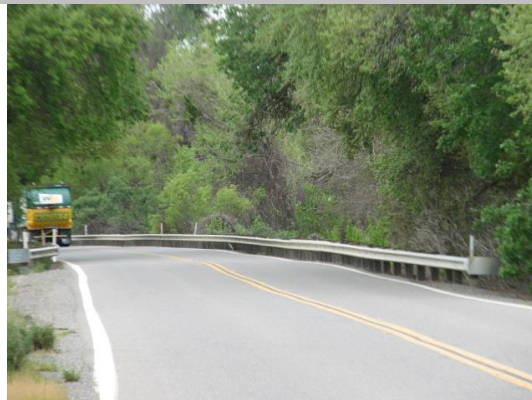
Photo 2 of 2 : FA\_2016\_RD0785\_185\_16\_20160913\_00008.jpg

Brush and other vegetation partially blocks visibility. Spring 2014

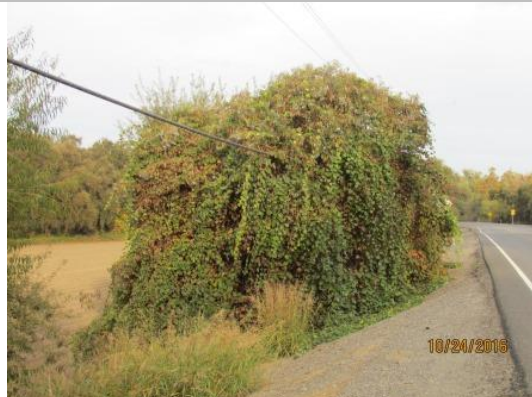
Photo 1 of 1 : FA\_2016\_RD0785\_185\_1\_20161024\_00034.jpg

LM Start	0.28	Rating **	A/W	Issue No.	1
LM End	0.28	Issue Type +	Ma	Location *	LS
Category	Earthen Levee			GPS Latitude/Longitude	
				Start	End
Item	Vegetation			38.658467°	38.658467°
				-121.609573°	-121.609573°
DWR ID	DWR_RD0785_01_s_2012_1				
Comment Code					
V4 : Elderberries are blocking visibility and flood fight capability.					
Inspector Comment

Elderberry tree on LS slope. Fall 2016.

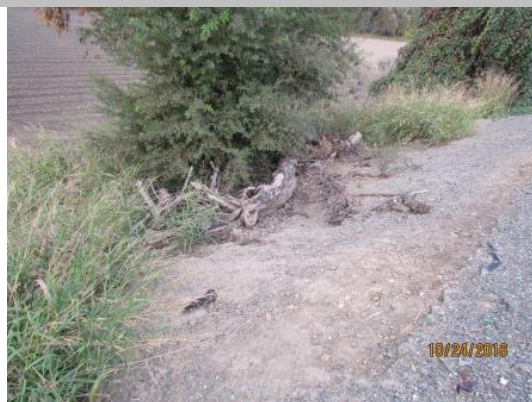
Photo 1 of 1 : FA\_2016\_RD0785\_185\_20\_20161024\_00032.jpg

View of a tree on LS slope. Fall 2016.

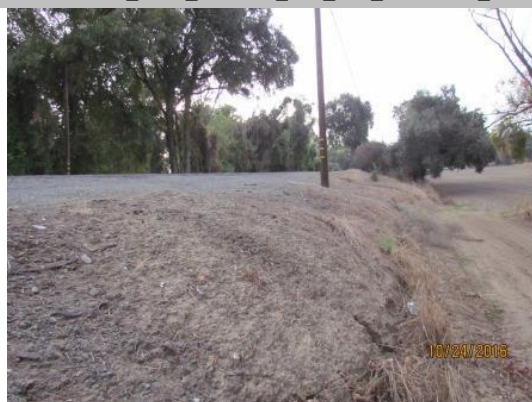
Photo 1 of 2 : FA\_2016\_RD0785\_185\_349\_20161024\_00033.jpg

An updated view of a slope stability issue on LS slope. Fall 2016.

LM Start	0.34	Rating **	M	Issue No.	349
LM End	0.34	Issue Type +	Ma	Location *	LS
Category	Earthen Levee			GPS Latitude/Longitude	
				Start	End
Item	Slope Stability			38.657798 °	38.657798 °
				-121.608898 °	-121.608898 °
DWR ID	DWR_RD0785_01_s_2015_349				
Comment Code					
S1 : Repair slope instability.					
Inspector Comment

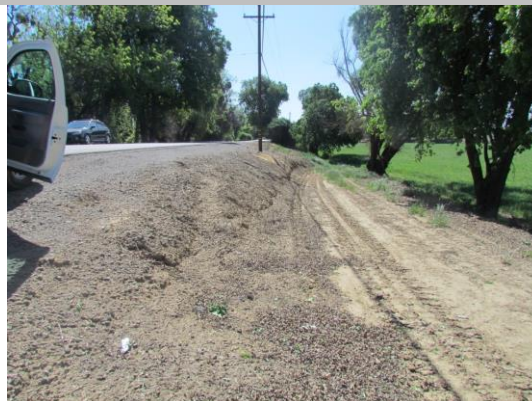
Photo 2 of 2 : FA\_2016\_RD0785\_185\_349\_20160913\_00019.jpg

View of the slope stability on the landward side of the levee looking downstream. Spring 2015.

LM Start	0.34	Rating **	M	Issue No.	349 (cont)	
LM End	0.34	Issue Type +	Ma	Location *	LS	
Category	Earthen Levee			GPS Latitude/Longitude		
				Start		End
Item	Slope Stability			38.657798°		38.657798°
				-121.608898°		-121.608898°
DWR ID	DWR_RD0785_01_s_2015_349					
Comment Code						
S1 : Repair slope instability.						
Inspector Comment

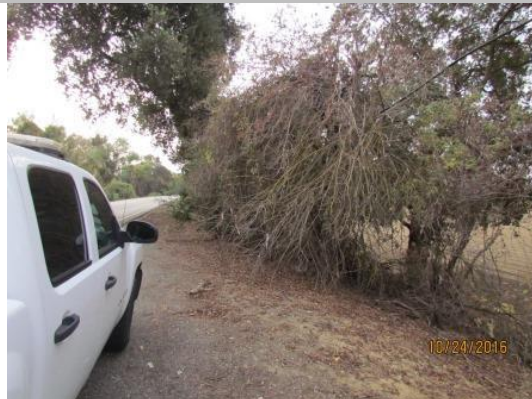
Photo 1 of 1 : FA\_2016\_RD0785\_185\_2\_20161024\_00035.jpg

LM Start	0.40	Rating **	A/W	Issue No.	2
LM End	0.44	Issue Type +	Ma	Location *	LS
Category	Earthen Levee			GPS Latitude/Longitude	
				Start	End
Item	Vegetation			38.657168°	38.656697°
				-121.608270°	-121.607845°
DWR ID	DWR_RD0785_01_s_2012_2				
Comment Code					
V4 : Elderberries are blocking visibility and flood fight capability.					
Inspector Comment

Elderberry tree on LS slope. Fall 2016.

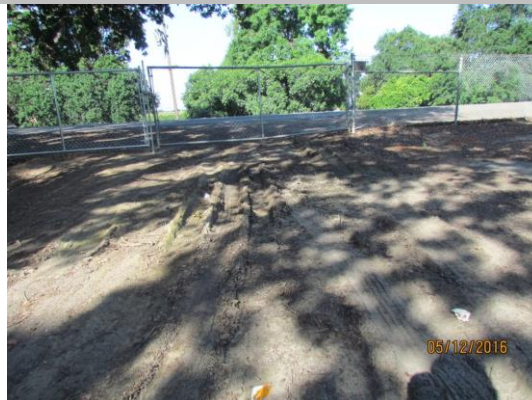
Photo 1 of 1 : FA\_2016\_RD0785\_185\_21\_20160913\_00010.jpg

View of the ruts on the crown of the levee. The direction of the river is upstream which is to the left of the picture. Spring 2016.

LM Start	0.58	Rating **	M	Issue No.	21
LM End	0.58	Issue Type +	Ma	Location *	CR
Category	Earthen Levee			GPS Latitude/Longitude	
				Start	End
Item	Crown Surface / Depressions / Rutting			38.655077 °	38.655077 °
				-121.606237 °	-121.606237 °
DWR ID	DWR_RD0785_01_s_2016_21				
Comment Code					
C2 : Repair depressions or ruts in the crown or slope.					
Inspector Comment

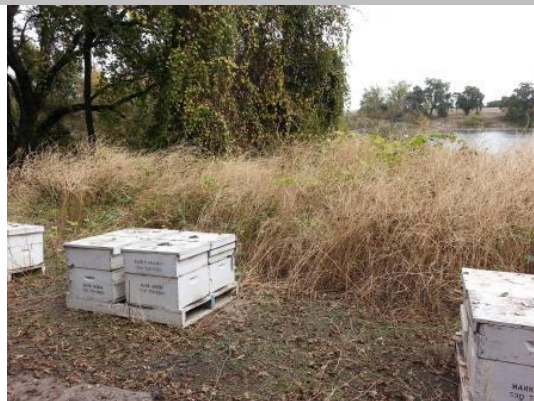
Photo 1 of 1 : FA\_2016\_RD0785\_185\_51\_20161024\_00046.jpg

View of vegetation site on WS slope. Fall 2016.

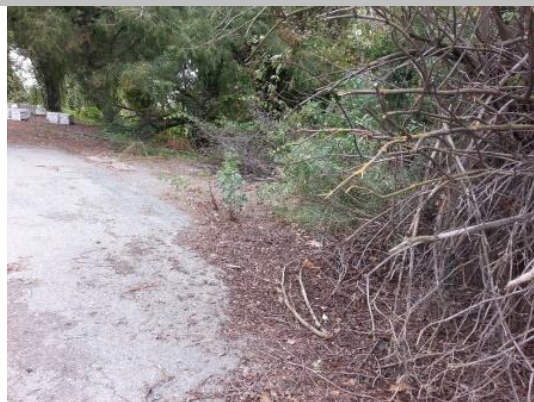
Photo 1 of 1 : FA\_2016\_RD0785\_185\_45\_20161024\_00049.jpg

LM Start	0.70	Rating **	M	Issue No.	45
LM End	0.73	Issue Type +	Ma	Location *	WS
Category	Earthen Levee			GPS Latitude/Longitude	
				Start	End
Item	Trim / Thin Trees			38.653882 °	38.653357 °
				-121.605007 °	-121.605043 °
DWR ID	DWR_RD0785_01_f_2016_45				
Comment Code					
T3 : Trim and thin trees to allow visibility of the ground and room to flood fight.					
Inspector Comment

View of a site where tree trimming is needed. Fall 2016.

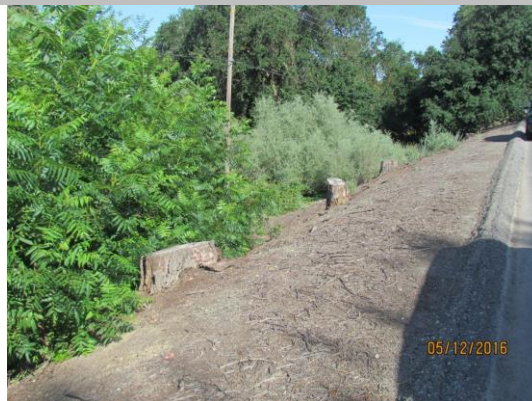
Photo 1 of 1 : FA\_2016\_RD0785\_185\_181\_20160913\_00017.jpg

View of the tree stumps on the landward side of the levee looking upstream. Spring 2016.

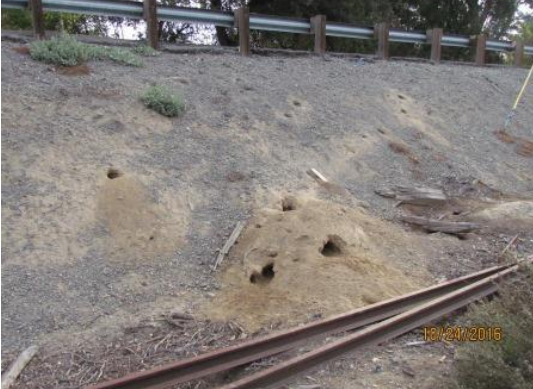
Photo 1 of 2 : FA\_2016\_RD0785\_185\_29\_20161024\_00037.jpg

View of rodent holes on LS slope. Fall 2016.

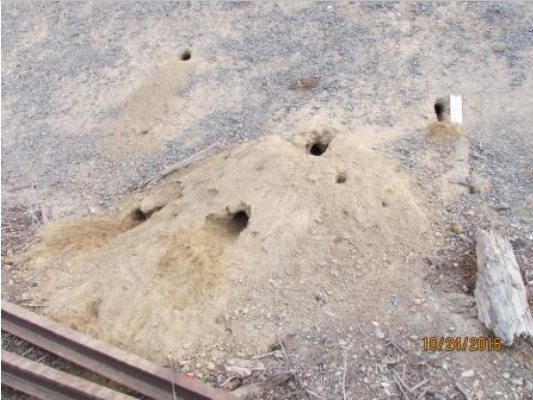
Photo 2 of 2 : FA\_2016\_RD0785\_185\_29\_20161024\_00038.jpg

Another view of rodent holes. Fall 2016.

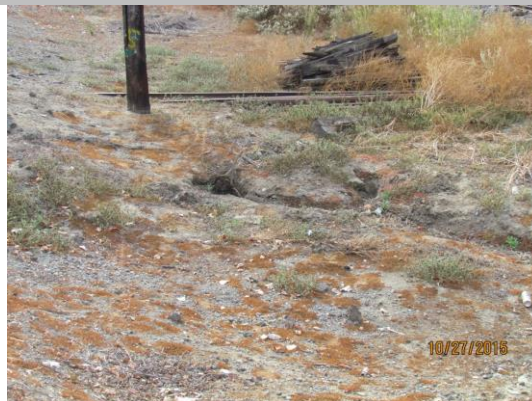
Photo 1 of 3 : FA\_2016\_RD0785\_185\_48\_20160913\_00014.jpg

View of the erosion at the toe of the levee on the landward side of the levee looking downstream. Fall 2015.

LM Start	1.07	Rating **	M	Issue No.	48
LM End	1.07	Issue Type +	Ma	Location *	LS
Category	Earthen Levee			GPS Latitude/Longitude	
				Start	End
Item	Erosion / Bank Caving			38.649392°	38.649392°
				-121.601636°	-121.601636°
DWR ID	DWR_RD0785_01_s_2012_48				
Comment Code					
E2 : Schedule repair of erosion site prior to the next inspection.					
Inspector Comment

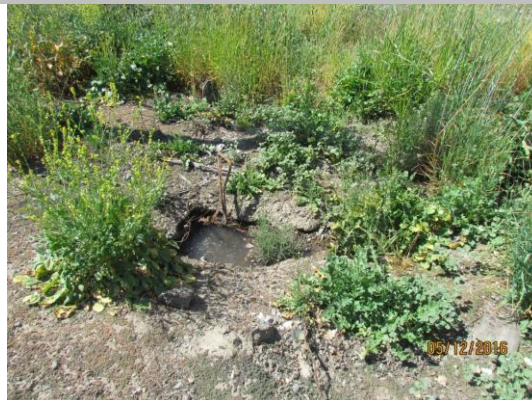
Photo 2 of 3 : FA\_2016\_RD0785\_185\_48\_20160913\_00015.jpg

Drain pipe is causing erosion on the landward side of the levee between the Isope and railroad tracks. Spring 2016.

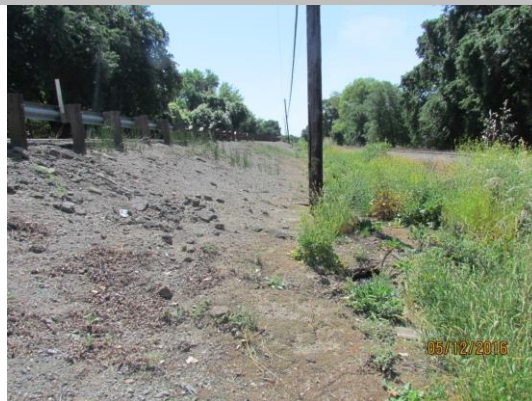
Photo 3 of 3 : FA\_2016\_RD0785\_185\_48\_20160913\_00016.jpg

Perspective view of the erosion on the landward side of the levee looking downstream. Spring 2016.

LM Start	1.07	Rating **	M	Issue No.	48 (cont)	
LM End	1.07	Issue Type +	Ma	Location *	LS	
Category	Earthen Levee			GPS Latitude/Longitude		
				Start		End
Item	Erosion / Bank Caving			38.649392°		38.649392°
				-121.601636°		-121.601636°
DWR ID	DWR_RD0785_01_s_2012_48					
Comment Code						
E2 : Schedule repair of erosion site prior to the next inspection.						
Inspector Comment

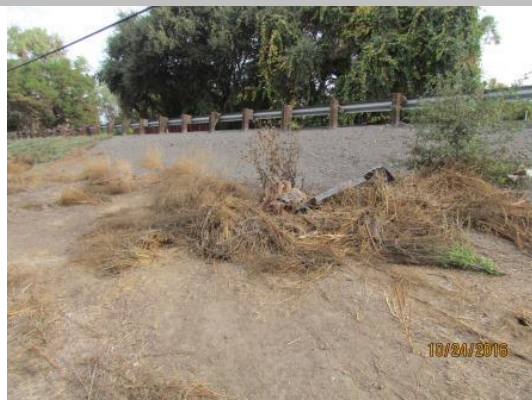
Photo 1 of 1 : FA\_2016\_RD0785\_185\_31\_20161024\_00050.jpg

LM Start	1.11	Rating **	U	Issue No.	31
LM End	1.11	Issue Type +	Ma	Location *	LS
Category	Earthen Levee			GPS Latitude/Longitude	
				Start	End
Item	Trim / Thin Trees			38.648813 °	38.648813 °
				-121.601380 °	-121.601380 °
DWR ID	DWR_RD0785_01_f_2016_31				
Comment Code					
T5 : Tree stumps.					
Inspector Comment					
Decomposing tree stump

Decomposing tree stump near levee toe on landside. Fall 2016.

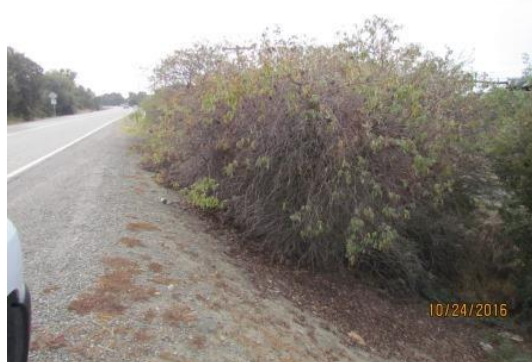
Photo 1 of 1 : FA\_2016\_RD0785\_185\_6\_20161024\_00040.jpg

View of elderberry trees on LS slope. Fall 2016.

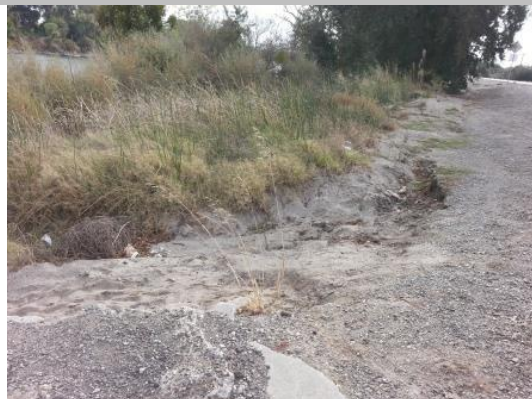
Photo 1 of 3 : FA\_2016\_RD0785\_185\_13\_20161024\_00061.jpg

Updated view of the slope stability site. Fall 2016.

LM Start	1.31	Rating **	M	Issue No.	13
LM End	1.31	Issue Type +	Ma	Location *	WS
Category	Earthen Levee			GPS Latitude/Longitude	
				Start	End
Item	Slope Stability			38.646671 °	38.646671 °
				-121.598915 °	-121.598915 °
DWR ID	DWR_RD0785_01_s_2013_13				
Comment Code					
S2 : Repair the levee slope damaged by foot traffic and prevent access where possible.					
Inspector Comment

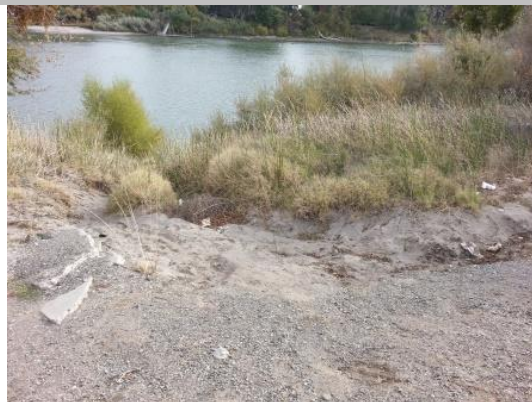
Photo 2 of 3 : FA\_2016\_RD0785\_185\_13\_20161024\_00060.jpg

Updated view of the slope stability site. Fall 2016.

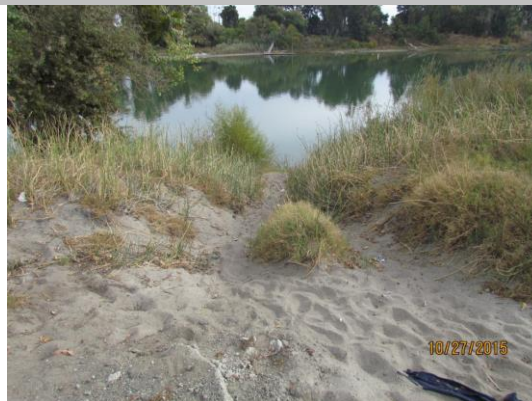
Photo 3 of 3 : FA\_2016\_RD0785\_185\_13\_20160913\_00005.jpg

View of the slope stability on the waterward side of the levee. Fall 2015.

LM Start	1.31	Rating **	M	Issue No.	13 (cont)
LM End	1.31	Issue Type +	Ma	Location *	WS
Category	Earthen Levee			GPS Latitude/Longitude	
				Start	End
Item	Slope Stability			38.646671 °	38.646671 °
				-121.598915 °	-121.598915 °
DWR ID	DWR_RD0785_01_s_2013_13				
Comment Code					
S2 : Repair the levee slope damaged by foot traffic and prevent access where possible.					
Inspector Comment

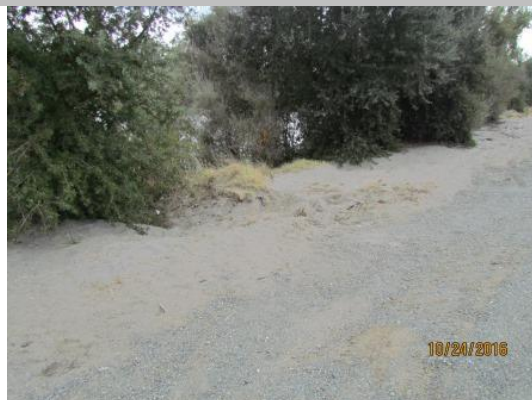
Photo 1 of 4 : FA\_2016\_RD0785\_185\_25\_20161024\_00041.jpg

An updated view of the slope stability caused by foot traffic on the waterward side of the levee. Fall 2016.

LM Start	1.34	Rating **	M	Issue No.	25
LM End	1.34	Issue Type +	Ma	Location *	WS
Category	Earthen Levee			GPS Latitude/Longitude	
				Start	End
Item	Slope Stability			38.646240 °	38.646240 °
				-121.598505 °	-121.598505 °
DWR ID	DWR_RD0785_01_s_2016_25				
Comment Code					
S2 : Repair the levee slope damaged by foot traffic and prevent access where possible.					
Inspector Comment

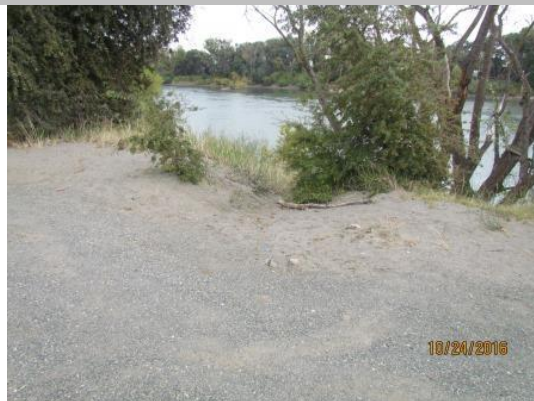
Photo 2 of 4 : FA\_2016\_RD0785\_185\_25\_20161024\_00043.jpg

An updated view of the slope stability caused by foot traffic on the waterward side of the levee. Fall 2016.

LM Start	1.34	Rating **	M	Issue No.	25 (cont)	
LM End	1.34	Issue Type +	Ma	Location *	WS	
Category	Earthen Levee			GPS Latitude/Longitude		
				Start		End
Item	Slope Stability			38.646240 °		38.646240 °
				-121.598505 °		-121.598505 °
DWR ID	DWR_RD0785_01_s_2016_25					
Comment Code						
S2 : Repair the levee slope damaged by foot traffic and prevent access where possible.						
Inspector Comment

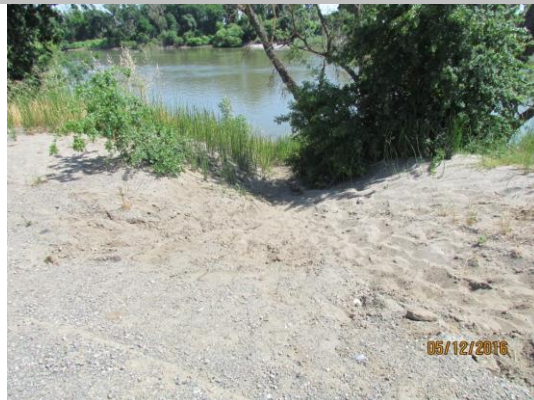
Photo 3 of 4 : FA\_2016\_RD0785\_185\_25\_20160913\_00011.jpg

View of the slope stability caused by foot traffic on the waterward side of the levee. Spring 2016.

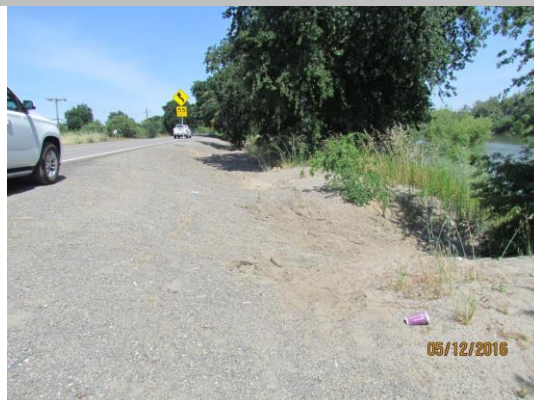
Photo 4 of 4 : FA\_2016\_RD0785\_185\_25\_20160913\_00012.jpg

Perspective view of the slope stability looking upstream. Spring 2016.

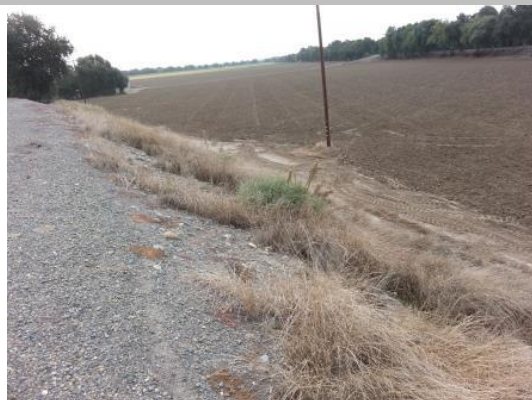
Photo 1 of 1 : FA\_2016\_RD0785\_185\_39\_20161024\_00062.jpg

View of vegetation of LS slope. Fall 2016.

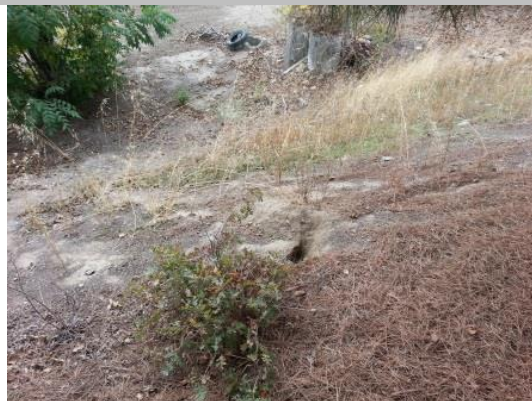
Photo 1 of 1 : FA\_2016\_RD0785\_185\_40\_20161024\_00064.jpg

Rodent burrows on LS slope of the levee. Fall 2016.

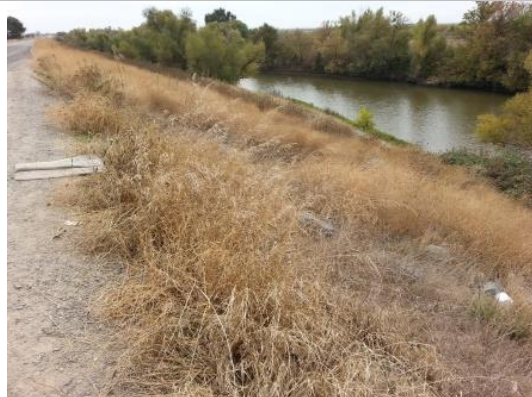
Photo 1 of 1 : FA\_2016\_RD0785\_186\_5\_20161024\_00024.jpg

View of vegetation on WS slope. Unable to see through vegetation. Fall 2016.

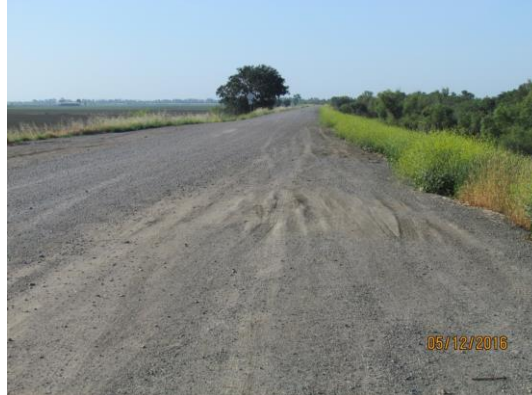
Photo 1 of 1 : FA\_2016\_RD0785\_186\_8\_20160913\_00002.jpg

View of the ruts on the crown of the levee looking downstream. Spring 2016.

LM Start	0.01	Rating **	M	Issue No.	8
LM End	0.01	Issue Type +	Ma	Location *	CR
Category	Earthen Levee			GPS Latitude/Longitude	
				Start	End
Item	Crown Surface / Depressions / Rutting			38.641105°	38.641105°
				-121.620402°	-121.620402°
DWR ID	DWR_RD0785_02_s_2016_8				
Comment Code					
C2 : Repair depressions or ruts in the crown or slope.					
Inspector Comment

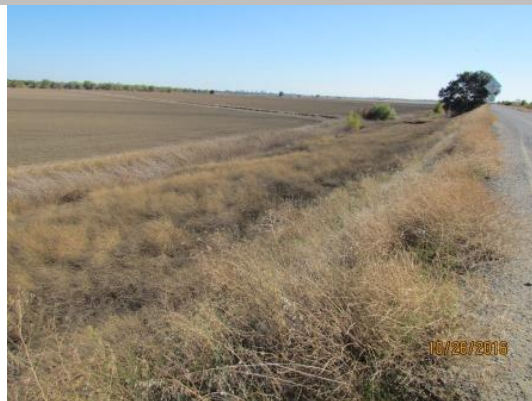
Photo 1 of 1 : FA\_2016\_RD0785\_186\_6\_20161027\_00038.jpg

View of dense vegetation on landside slope. Fall 2016.

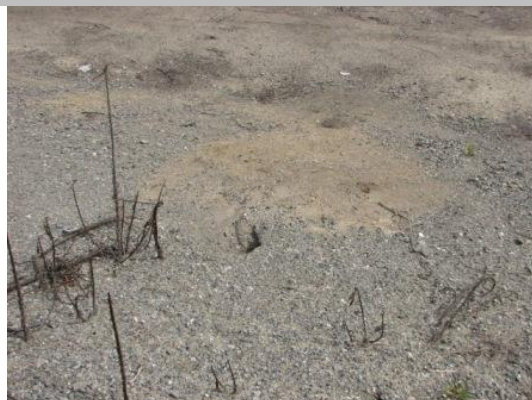
Photo 1 of 1 : FA\_2016\_RD0785\_186\_25\_20160913\_00007.jpg

Rodent holes on the landside levee slope, photo taken spring 2012.

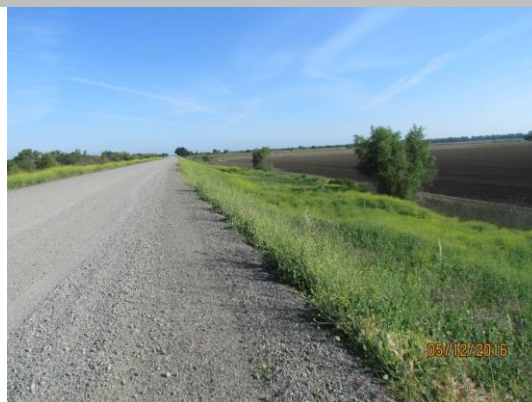
Photo 1 of 1 : FA\_2016\_RD0785\_186\_280\_20160913\_00021.jpg

LM Start	0.38	Rating **	M	Issue No.	280
LM End	0.38	Issue Type +	Ma	Location *	LS
Category	Earthen Levee			GPS Latitude/Longitude	
				Start	End
Item	Slope Stability			38.636265 °	38.636265 °
				-121.617422 °	-121.617422 °
DWR ID	DWR_RD0785_02_s_2015_280				
Comment Code					
S1 : Repair slope instability.					
Inspector Comment					
Seems to be a bulge at the toe of the levee. Dense vegetation.

View of the slope stability on the landward side of the levee looking upstream. Spring 2016.

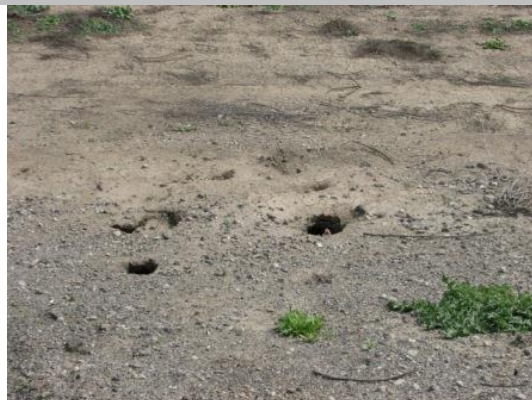
Photo 1 of 1 : FA\_2016\_RD0785\_186\_27\_20160913\_00008.jpg

Rodent holes on the landside levee slope, photo taken spring 2012.

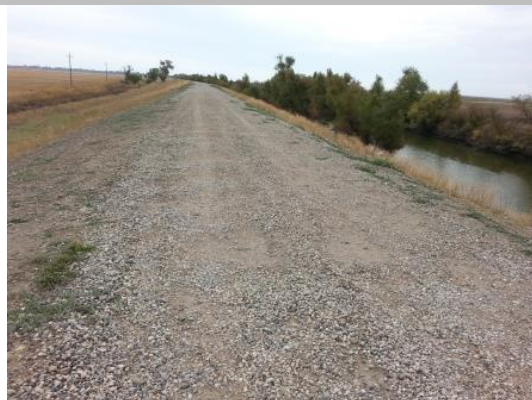
Photo 1 of 1 : FA\_2016\_RD0785\_186\_11\_20161024\_00026.jpg

Ruts on levee crown. Fall 2016.

LM Start	0.84	Rating **	M	Issue No.	11
LM End	0.90	Issue Type +	Ma	Location *	CR
Category	Earthen Levee			GPS Latitude/Longitude	
				Start	End
Item	Crown Surface / Depressions / Rutting			38.630203 °	38.629503 °
				-121.613761 °	-121.613317 °
DWR ID	DWR_RD0785_02_f_2016_11				
Comment Code					
C2 : Repair depressions or ruts in the crown or slope.					
Inspector Comment

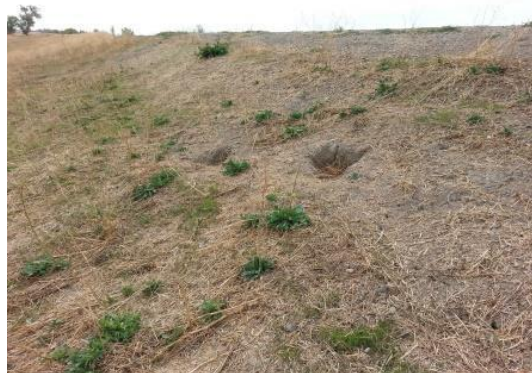
Photo 1 of 2 : FA\_2016\_RD0785\_186\_42\_20161024\_00027.jpg

View of rodent holes on LS slope. Holes are partially filled with soil and dry weeds/ grass. No evidence of rodent activity. Fall 2016.

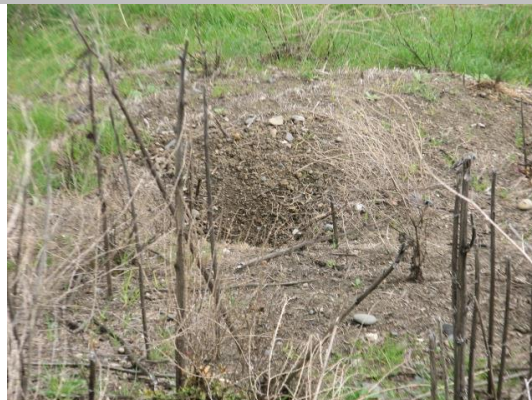
Photo 2 of 2 : FA\_2016\_RD0785\_186\_42\_20160913\_00017.jpg

Large rodent hole close to the toe of the levee. Spring 2014

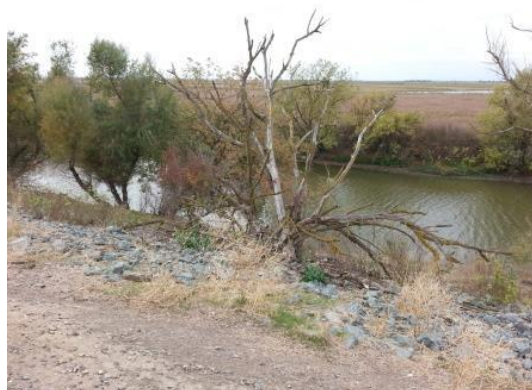
Photo 1 of 1 : FA\_2016\_RD0785\_186\_13\_20161024\_00028.jpg

View of dry tree on waterward slope. Fall 2016.

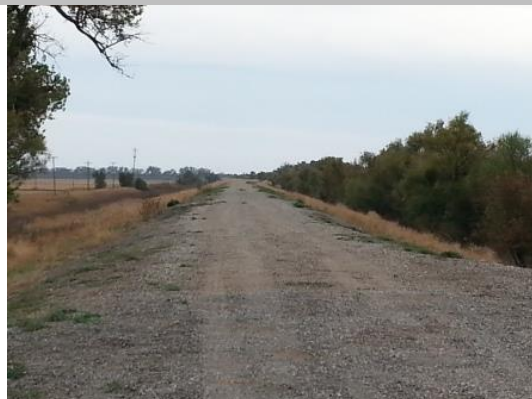
Photo 1 of 1 : FA\_2016\_RD0785\_186\_14\_20161025\_00029.jpg

Ruts on the crown. Fall 2016.

LM Start	1.08	Rating **	M	Issue No.	14
LM End	1.12	Issue Type +	Ma	Location *	CR
Category	Earthen Levee			GPS Latitude/Longitude	
				Start	End
Item	Crown Surface / Depressions / Rutting			38.627165 °	38.626711 °
				-121.611698 °	-121.611349 °
DWR ID	DWR_RD0785_02_f_2016_14				
Comment Code					
C2 : Repair depressions or ruts in the crown or slope.					
Inspector Comment

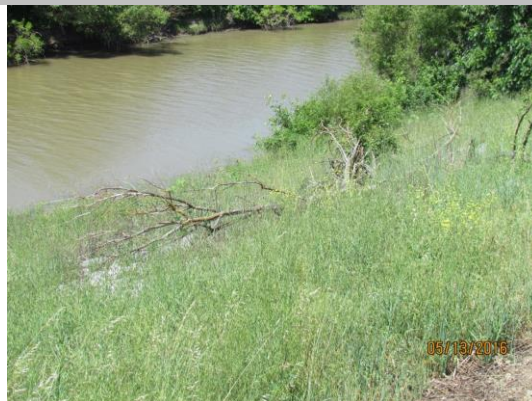
Photo 1 of 2 : FA\_2016\_RD0785\_186\_10\_20160913\_00005.jpg

Discarded tree is on the waterward slope of the levee. Spring 2016.

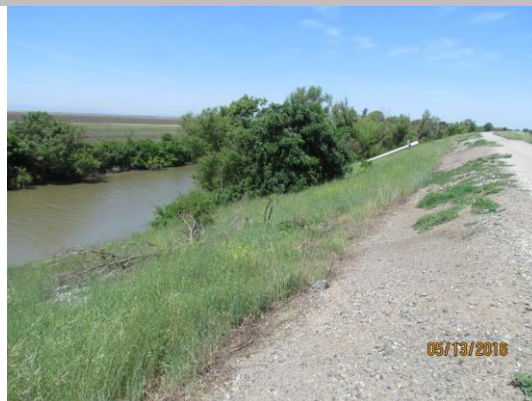
Photo 2 of 2 : FA\_2016\_RD0785\_186\_10\_20160913\_00006.jpg

Perspective view of the discarded tree looking upstream. Spring 2016.

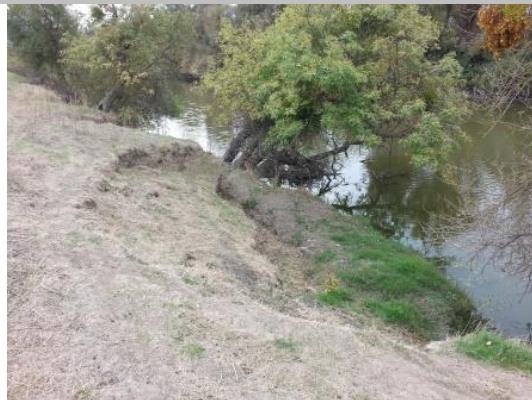
Photo 1 of 1 : FA\_2016\_RD0785\_186\_17\_20161025\_00030.jpg

View of erosion site on waterward side of the levee. Fall 2016.

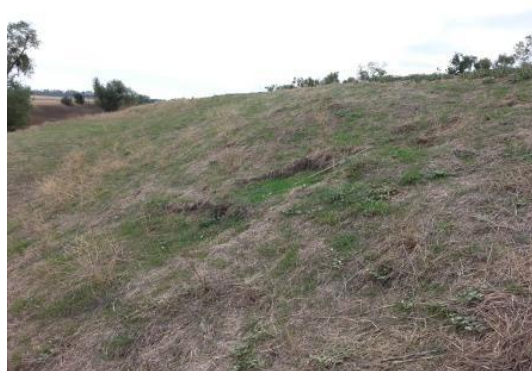
Photo 1 of 5 : FA\_2016\_RD0785\_186\_30\_20161025\_00031.jpg

LM Start	2.21	Rating **	M	Issue No.	30
LM End	2.21	Issue Type +	Ma	Location *	LS
Category	Earthen Levee			GPS Latitude/Longitude	
				Start	End
Item	Slope Stability			38.613104 °	38.613104 °
				-121.600915 °	-121.600915 °
DWR ID	DWR_RD0785_02_s_2012_30				
Comment Code					
S1 : Repair slope instability.					
Inspector Comment					
Spring 2016: cannot tell if issue has been fixed due to vegetations.

Updated view of the slope stability site Fall 2016.

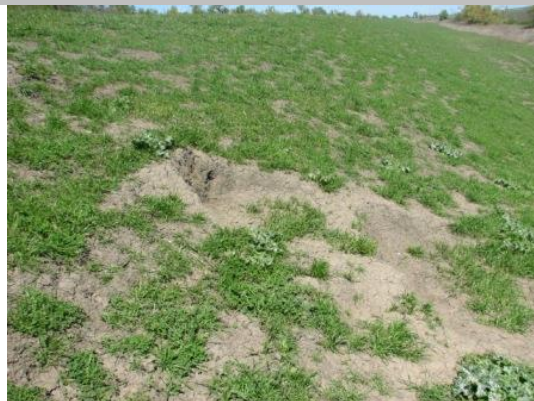
Photo 2 of 5 : FA\_2016\_RD0785\_186\_30\_20160913\_00013.jpg

There is slope instability with three step like spots. The cuts are 1' to 1.5' deep. Photo taken spring 2012.

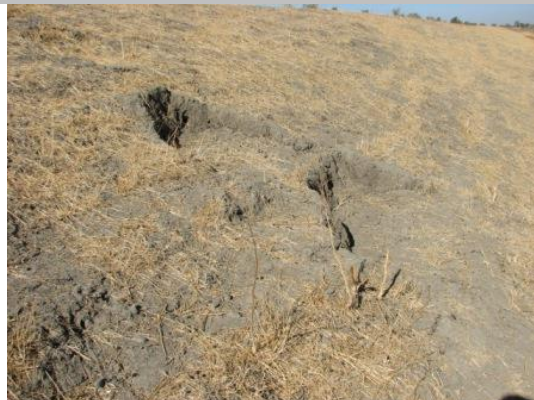
Photo 3 of 5 : FA\_2016\_RD0785\_186\_30\_20160913\_00014.jpg

Slope instability. Photo fall 2012.

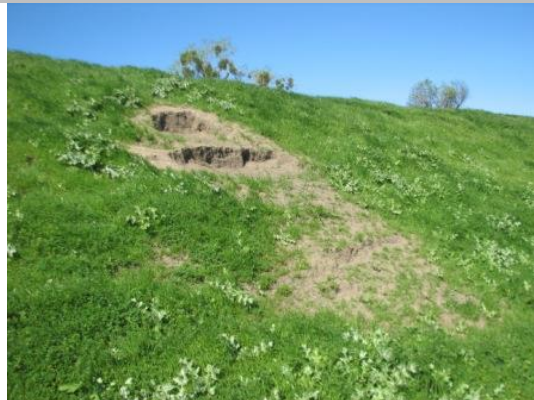
Photo 4 of 5 : FA\_2016\_RD0785\_186\_30\_20160913\_00015.jpg

Slope instability is still there. Spring 2013

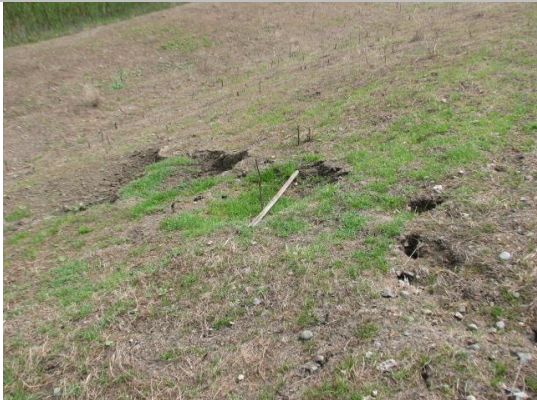
Photo 5 of 5 : FA\_2016\_RD0785\_186\_30\_20160913\_00016.jpg

Current view of the slope instability. Spring 2014

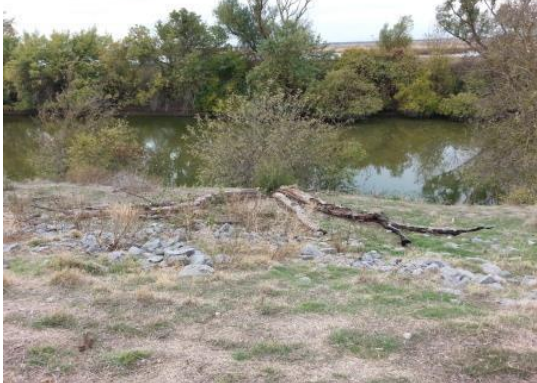
Photo 1 of 3 : FA\_2016\_RD0785\_186\_56\_20161025\_00034.jpg

Updated view of a tree on waterward side of the levee. Fall 2016.

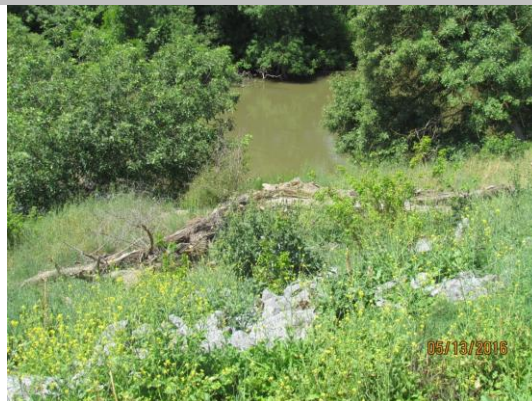
Photo 2 of 3 : FA\_2016\_RD0785\_186\_56\_20160913\_00018.jpg

Discarded tree is on the slope of the waterward side of the levee. Spring 2016.

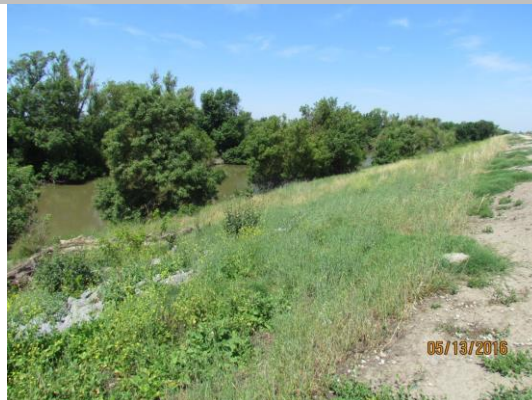
Photo 3 of 3 : FA\_2016\_RD0785\_186\_56\_20160913\_00019.jpg

Perspective view of the tree looking upstream. Spring 2016.
