**Flood Control Project Maintenance  
Levee Inspections**

## Maintenance Issue Types Only, Levee Inspection Report By Mile - Fall 2017

### Reclamation District No. 0785 Driver

Waterway	Bank	Unit Miles	Inspection Start/End	Inspector
Unit No. 01 Sacramento River	Right	2.26	11/08/2017 11/08/2017	Zach Jojola

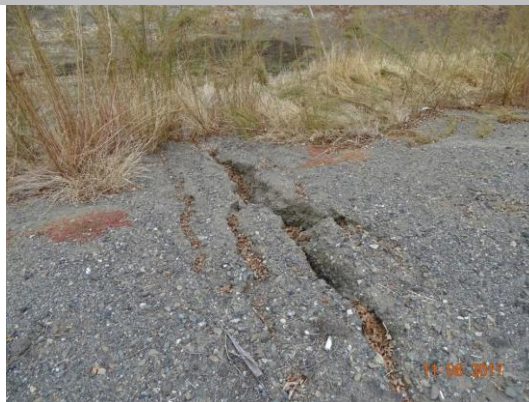
Photo 1 of 1 : FA\_2017\_RD0785\_185\_9\_20171108\_00064.jpg

LM Start	0.12	Rating **	M	Issue No.	9
LM End	0.12	Issue Type +	Ma	Location *	LS
Category	Earthen Levee			GPS Latitude/Longitude	
				Start	End
Item	Erosion / Bank Caving			38.660162 °	38.660162 °
				-121.611655 °	-121.611655 °
DWR ID	DWR_RD0785_01_f_2017_9				
Comment Code					
E2 : Schedule repair of erosion site prior to the next inspection.					
Inspector Comment					
Runoff erosion on landside slope.

View of runoff erosion on the landside slope. Fall 2017.

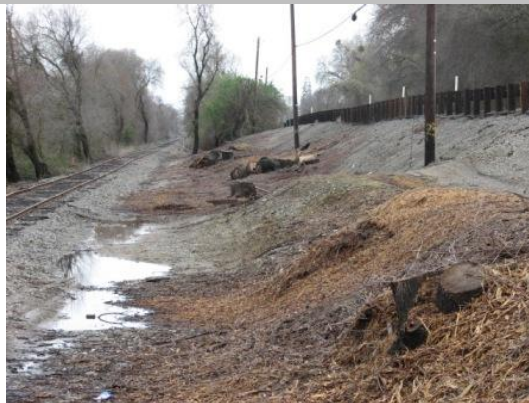
Photo 1 of 1 : FA\_2017\_RD0785\_185\_4\_20170911\_00003.jpg

LM Start	0.12	Rating **	N	Issue No.	4
LM End	1.34	Issue Type +	Ma	Location *	LS
Category	Earthen Levee			GPS Latitude/Longitude	
				Start	End
Item	Trim / Thin Trees			38.660160 °	38.646214 °
				-121.611619 °	-121.598596 °
DWR ID	DWR_RD0785_01_s_2012_4				
Comment Code					
T5 : Tree stumps.					
Inspector Comment

The trees were cut by PG&E'S tree contractor. The district will take care of the stumps in the future.

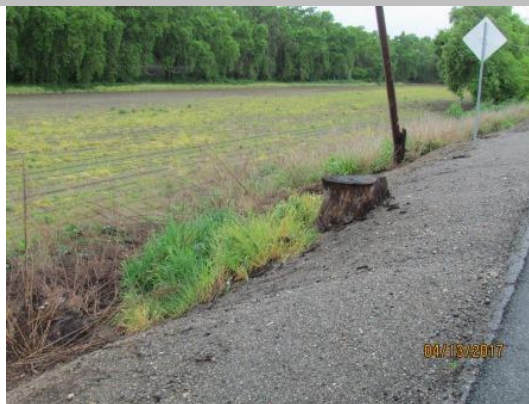
Photo 1 of 1 : FA\_2017\_RD0785\_185\_36\_20170911\_00029.jpg

View of stump on landside levee slope. Spring 2017.

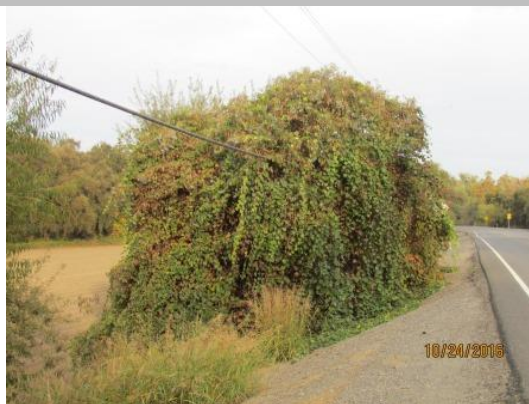
Photo 1 of 1 : FA\_2017\_RD0785\_185\_1\_20170911\_00001.jpg

LM Start	0.28	Rating **	A/W	Issue No.	1
LM End	0.28	Issue Type +	Ma	Location *	LS
Category	Earthen Levee			GPS Latitude/Longitude	
				Start	End
Item	Vegetation			38.658467 °	38.658467 °
				-121.609573 °	-121.609573 °
DWR ID	DWR_RD0785_01_s_2012_1				
Comment Code					
V4 : Elderberries are blocking visibility and flood fight capability.					
Inspector Comment

Elderberry tree on LS slope. Fall 2016.

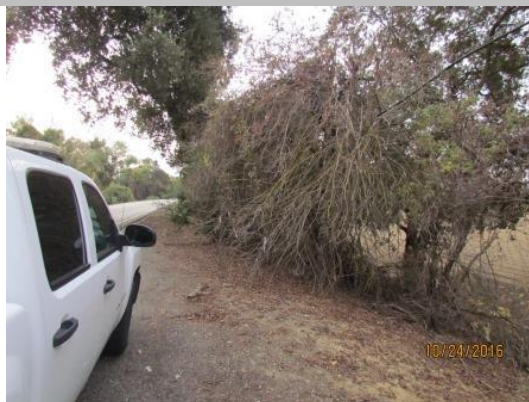
Photo 1 of 1 : FA\_2017\_RD0785\_185\_2\_20170911\_00002.jpg

Elderberry tree on LS slope. Fall 2016.

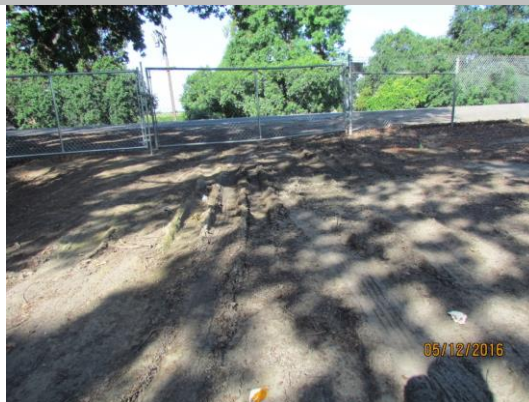
Photo 1 of 1 : FA\_2017\_RD0785\_185\_21\_20170911\_00016.jpg

LM Start	0.58	Rating **	M	Issue No.	21
LM End	0.58	Issue Type +	Ma	Location *	CR
Category	Earthen Levee			GPS Latitude/Longitude	
				Start	End
Item	Crown Surface / Depressions / Rutting			38.655077 °	38.655077 °
				-121.606237 °	-121.606237 °
DWR ID	DWR_RD0785_01_s_2016_21				
Comment Code					
C2 : Repair depressions or ruts in the crown or slope.					
Inspector Comment

View of the ruts on the crown of the levee. The direction of the river is upstream which is to the left of the picture. Spring 2016.

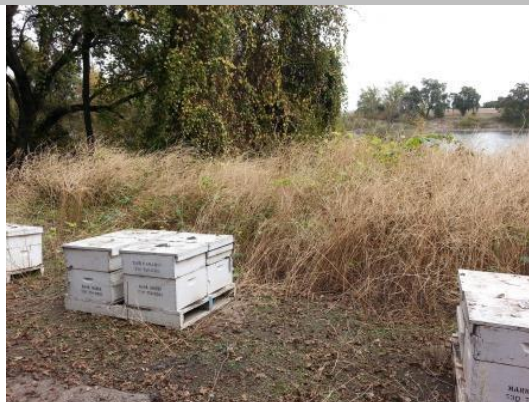
Photo 1 of 1 : FA\_2017\_RD0785\_185\_51\_20170911\_00044.jpg

View of vegetation site on WS slope. Fall 2016.

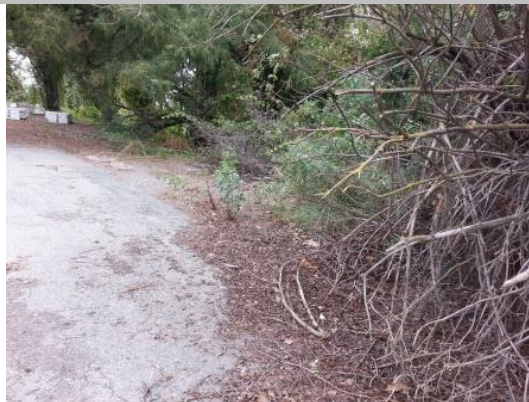
Photo 1 of 1 : FA\_2017\_RD0785\_185\_45\_20170911\_00038.jpg

LM Start	0.70	Rating **	M	Issue No.	45
LM End	0.73	Issue Type +	Ma	Location *	WS
Category	Earthen Levee			GPS Latitude/Longitude	
				Start	End
Item	Trim / Thin Trees			38.653882 °	38.653357 °
				-121.605007 °	-121.605043 °
DWR ID	DWR_RD0785_01_f_2016_45				
Comment Code					
T3 : Trim and thin trees to allow visibility of the ground and room to flood fight.					
Inspector Comment

View of a site where tree trimming is needed. Fall 2016.

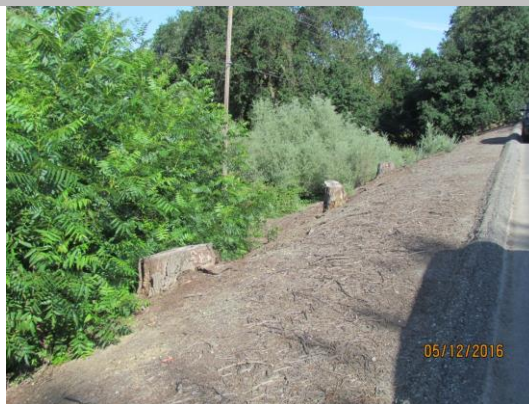
Photo 1 of 1 : FA\_2017\_RD0785\_185\_181\_20170911\_00045.jpg

View of the tree stumps on the landward side of the levee looking upstream. Spring 2016.

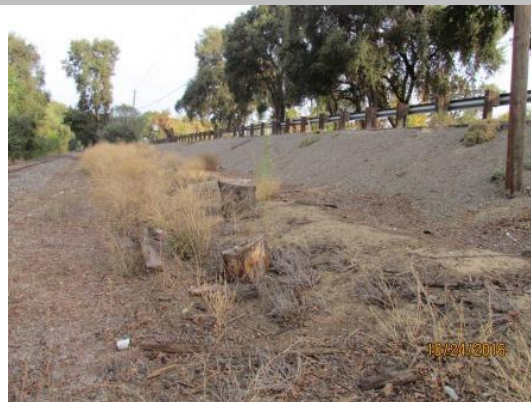
Photo 1 of 1 : FA\_2017\_RD0785\_185\_28\_20170911\_00019.jpg

Two decomposing tree stumps near levee toe on landside. Fall 2016.

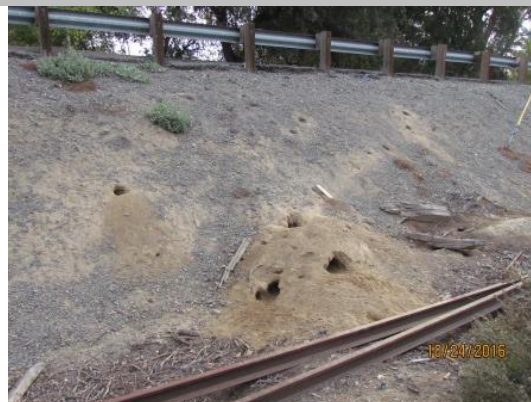
Photo 1 of 2 : FA\_2017\_RD0785\_185\_29\_20170911\_00020.jpg

LM Start	1.02	Rating **	U	Issue No.	29
LM End	1.02	Issue Type +	Ma	Location *	LS
Category	Earthen Levee			GPS Latitude/Longitude	
				Start	End
Item	Animal Control			38.649798 °	38.649798 °
				-121.602373 °	-121.602373 °
DWR ID	DWR_RD0785_01_f_2016_29				
Comment Code					
A3 : No rodents visible, but rodent burrows visible; need to backfill and compact or grout burrows.					
Inspector Comment					
Large rodent holes with more than 2 cu.ft of soil around

View of rodent holes on LS slope. Fall 2016.

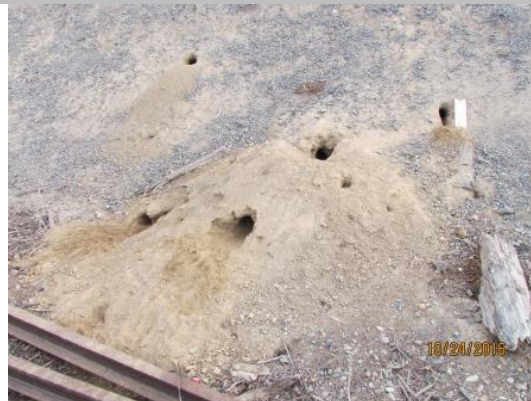
Photo 2 of 2 : FA\_2017\_RD0785\_185\_29\_20170911\_00021.jpg

Another view of rodent holes. Fall 2016.

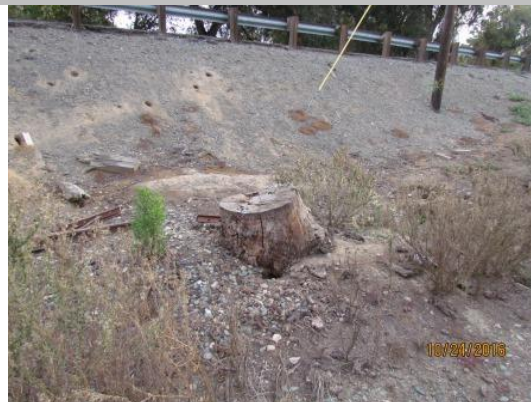
Photo 1 of 1 : FA\_2017\_RD0785\_185\_30\_20170911\_00022.jpg

LM Start	1.02	Rating **	N	Issue No.	30
LM End	1.02	Issue Type +	Ma	Location *	LS
Category	Earthen Levee			GPS Latitude/Longitude	
				Start	End
Item	Trim / Thin Trees			38.649775 °	38.649775 °
				-121.602363 °	-121.602363 °
DWR ID	DWR_RD0785_01_f_2016_30				
Comment Code					
T5 : Tree stumps.					
Inspector Comment					
Decomposing tree stump near levee toe

View of a decomposing stump near levee toe on landside. Fall 2016.

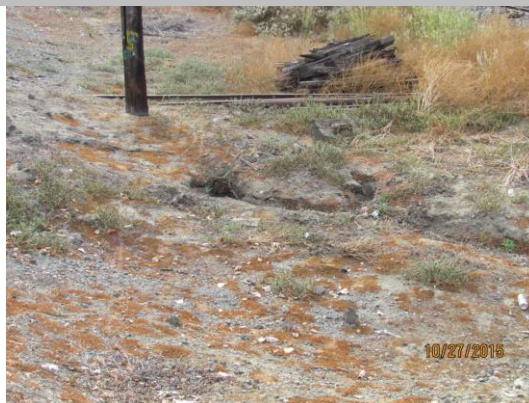
Photo 1 of 3 : FA\_2017\_RD0785\_185\_48\_20170911\_00040.jpg

LM Start	1.07	Rating **	M	Issue No.	48
LM End	1.07	Issue Type +	Ma	Location *	LS
Category	Earthen Levee			GPS Latitude/Longitude	
				Start	End
Item	Erosion / Bank Caving			38.649392 °	38.649392 °
				-121.601636 °	-121.601636 °
DWR ID	DWR_RD0785_01_s_2012_48				
Comment Code					
E2 : Schedule repair of erosion site prior to the next inspection.					
Inspector Comment

View of the erosion at the toe of the levee on the landward side of the levee looking downstream. Fall 2015.

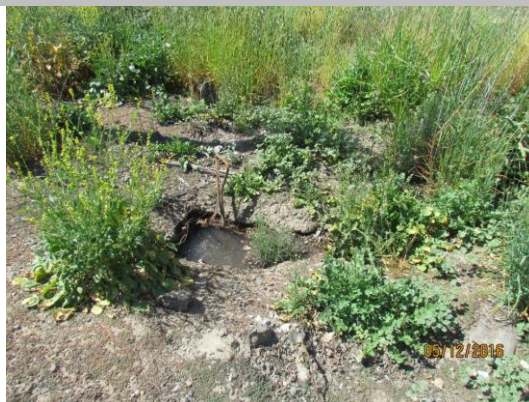
Photo 2 of 3 : FA\_2017\_RD0785\_185\_48\_20170911\_00041.jpg

Drain pipe is causing erosion on the landward side of the levee between the Isope and railroad tracks. Spring 2016.

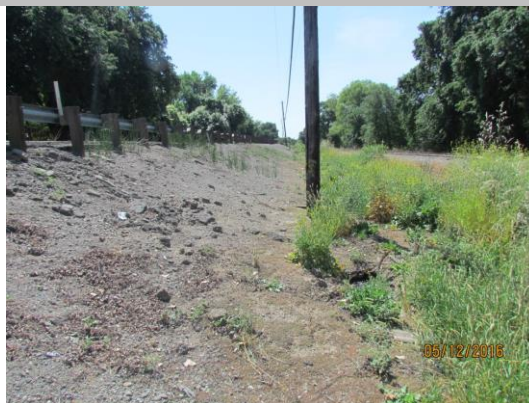
Photo 3 of 3 : FA\_2017\_RD0785\_185\_48\_20170911\_00042.jpg

LM Start	1.07	Rating **	M	Issue No.	48 (cont)	
LM End	1.07	Issue Type +	Ma	Location *	LS	
Category	Earthen Levee			GPS Latitude/Longitude		
				Start		End
Item	Erosion / Bank Caving			38.649392 °		38.649392 °
				-121.601636 °		-121.601636 °
DWR ID	DWR_RD0785_01_s_2012_48					
Comment Code						
E2 : Schedule repair of erosion site prior to the next inspection.						
Inspector Comment

Perspective view of the erosion on the landward side of the levee looking downstream. Spring 2016.

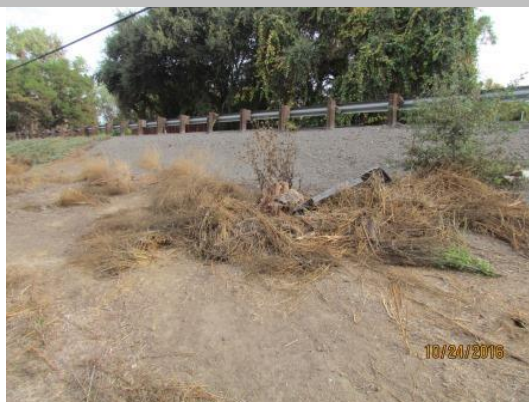
Photo 1 of 1 : FA\_2017\_RD0785\_185\_31\_20170911\_00023.jpg

LM Start	1.11	Rating **	U	Issue No.	31
LM End	1.11	Issue Type +	Ma	Location *	LS
Category	Earthen Levee			GPS Latitude/Longitude	
				Start	End
Item	Trim / Thin Trees			38.648813 °	38.648813 °
				-121.601380 °	-121.601380 °
DWR ID	DWR_RD0785_01_f_2016_31				
Comment Code					
T5 : Tree stumps.					
Inspector Comment					
Decomposing tree stump

Decomposing tree stump near levee toe on landside. Fall 2016.

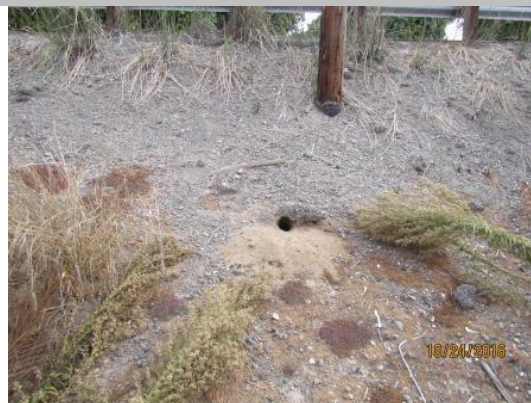
Photo 1 of 1 : FA\_2017\_RD0785\_185\_32\_20170911\_00024.jpg

View of rodent hole on LS slope. Fall 2016.

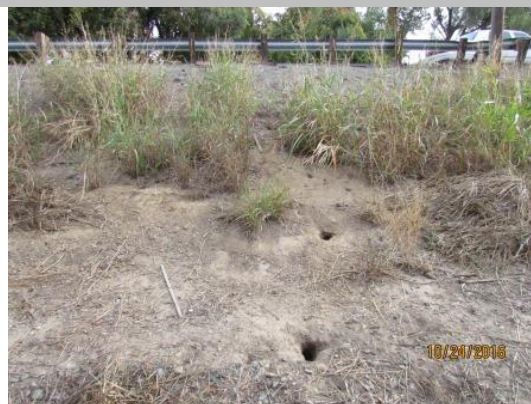
Photo 1 of 1 : FA\_2017\_RD0785\_185\_33\_20170911\_00025.jpg

LM Start	1.17	Rating **	M	Issue No.	33
LM End	1.17	Issue Type +	Ma	Location *	LS
Category	Earthen Levee			GPS Latitude/Longitude	
				Start	End
Item	Animal Control			38.648127 °	38.648127 °
				-121.600677 °	-121.600677 °
DWR ID	DWR_RD0785_01_f_2016_33				
Comment Code					
A3 : No rodents visible, but rodent burrows visible; need to backfill and compact or grout burrows.					
Inspector Comment

View of rodent holes on LS slope. Fall 2016.

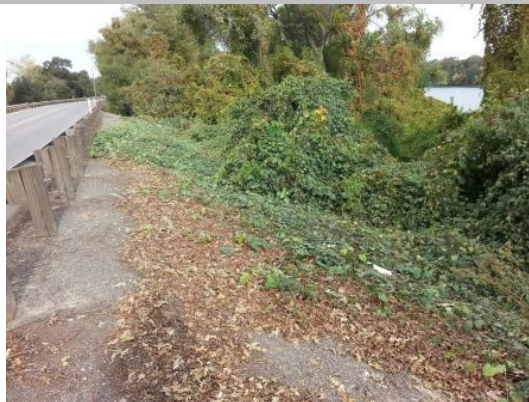
Photo 1 of 2 : FA\_2017\_RD0785\_185\_44\_20170911\_00036.jpg

Elderberry trees on WS slope Fall 2016.

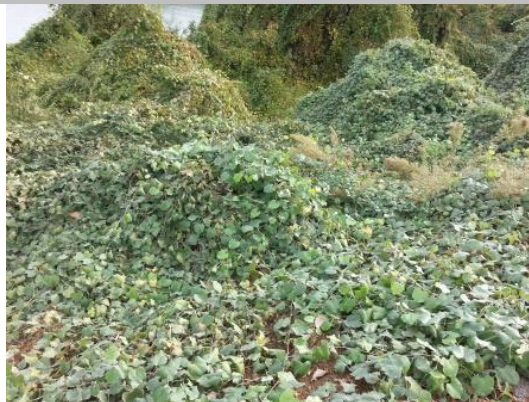
Photo 2 of 2 : FA\_2017\_RD0785\_185\_44\_20170911\_00037.jpg

Elderberry trees on WS slope. Fall 2016.

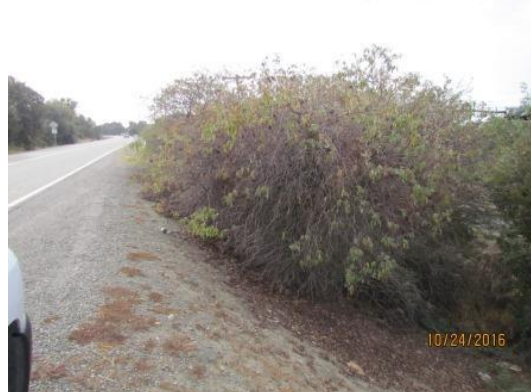
Photo 1 of 1 : FA\_2017\_RD0785\_185\_6\_20170911\_00004.jpg

View of elderberry trees on LS slope. Fall 2016.

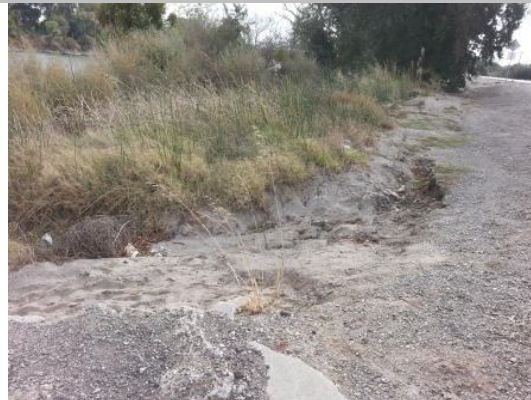
Photo 1 of 3 : FA\_2017\_RD0785\_185\_13\_20170911\_00008.jpg

LM Start	1.31	Rating **	M	Issue No.	13
LM End	1.31	Issue Type +	Ma	Location *	WS
Category	Earthen Levee			GPS Latitude/Longitude	
				Start	End
Item	Slope Stability			38.646652 °	38.646652 °
				-121.598907 °	-121.598907 °
DWR ID	DWR_RD0785_01_s_2013_13				
Comment Code					
S2 : Repair the levee slope damaged by foot traffic and prevent access where possible.					
Inspector Comment

Updated view of the slope stability site. Fall 2016.

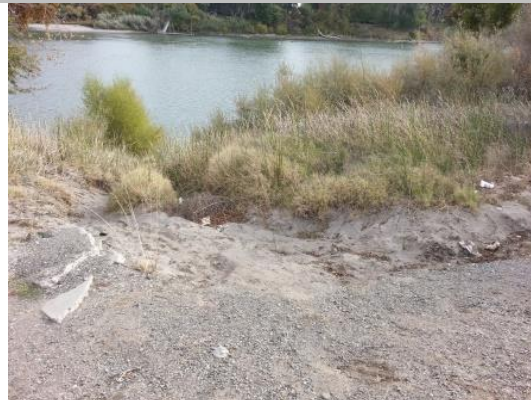
Photo 2 of 3 : FA\_2017\_RD0785\_185\_13\_20170911\_00009.jpg

Updated view of the slope stability site. Fall 2016.

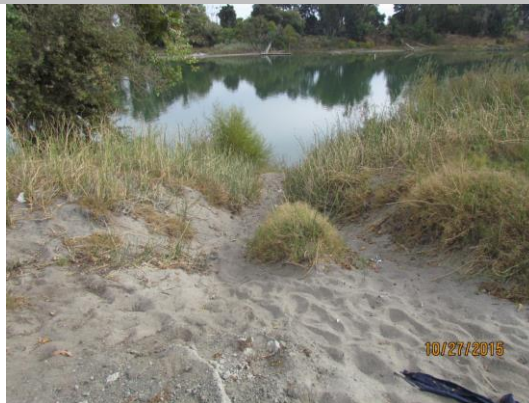
Photo 3 of 3 : FA\_2017\_RD0785\_185\_13\_20170911\_00010.jpg

LM Start	1.31	Rating **	M	Issue No.	13 (cont)	
LM End	1.31	Issue Type +	Ma	Location *	WS	
Category	Earthen Levee			GPS Latitude/Longitude		
				Start	End	
Item	Slope Stability			38.646652 °	38.646652 °	
				-121.598907 °	-121.598907 °	
DWR ID	DWR_RD0785_01_s_2013_13					
Comment Code						
S2 : Repair the levee slope damaged by foot traffic and prevent access where possible.						
Inspector Comment

View of the slope stability on the waterward side of the levee. Fall 2015.

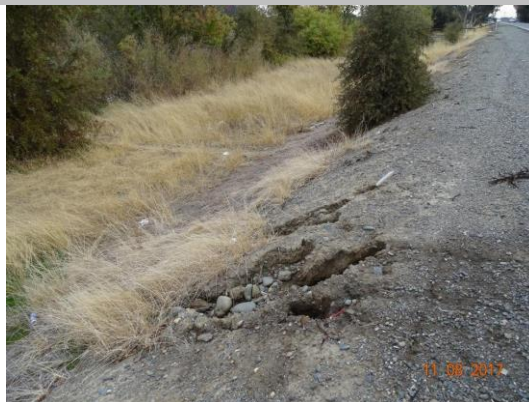
Photo 1 of 1 : FA\_2017\_RD0785\_185\_55\_20171108\_00063.jpg

LM Start	1.51	Rating **	M	Issue No.	55
LM End	1.51	Issue Type +	Ma	Location *	WS
Category	Earthen Levee			GPS Latitude/Longitude	
				Start	End
Item	Erosion / Bank Caving			38.644349 °	38.644349 °
				-121.596506 °	-121.596506 °
DWR ID	DWR_RD0785_01_f_2017_55				
Comment Code					
E2 : Schedule repair of erosion site prior to the next inspection.					
Inspector Comment					
Runoff on waterside slope.

View of the runoff erosion on the waterside slope. Fall 2017.

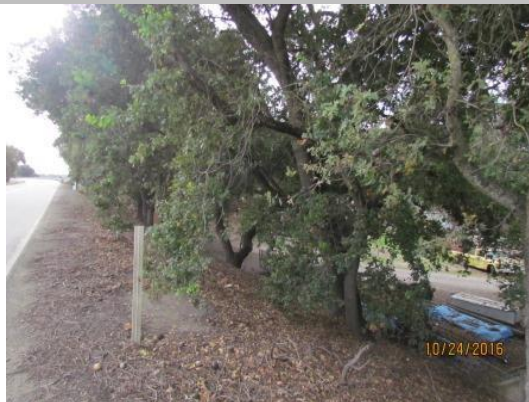
Photo 1 of 1 : FA\_2017\_RD0785\_185\_22\_20170911\_00017.jpg

LM Start	1.61	Rating **	M	Issue No.	22
LM End	1.62	Issue Type +	Ma	Location *	LS
Category	Earthen Levee			GPS Latitude/Longitude	
				Start	End
Item	Trim / Thin Trees			38.643359 °	38.643229 °
				-121.595237 °	-121.595011 °
DWR ID	DWR_RD0785_01_s_2016_22				
Comment Code					
T1 : Trim trees to at least five feet above ground level.					
Inspector Comment

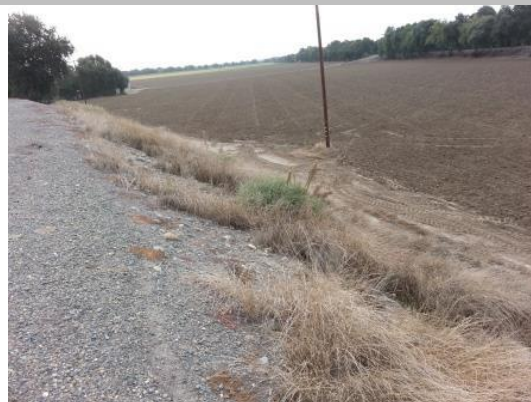
Photo 1 of 1 : FA\_2017\_RD0785\_185\_39\_20170911\_00032.jpg

View of vegetation of LS slope. Fall 2016.

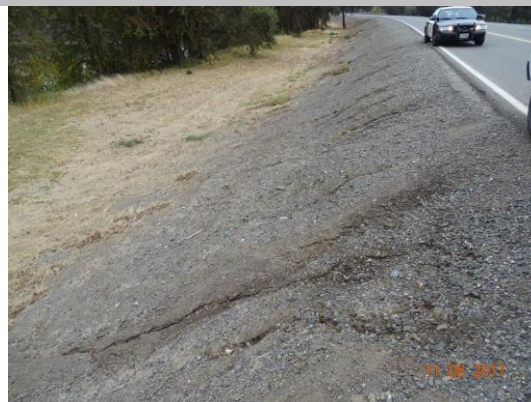
Photo 1 of 1 : FA\_2017\_RD0785\_185\_19\_20171108\_00062.jpg

LM Start	2.23	Rating **	A/W	Issue No.	19
LM End	2.23	Issue Type +	Ma	Location *	WS
Category	Earthen Levee			GPS Latitude/Longitude	
				Start	End
Item	Erosion / Bank Caving			38.642908 °	38.642908 °
				-121.584647 °	-121.584647 °
DWR ID	DWR_RD0785_01_f_2017_19				
Comment Code					
E1 : Note and monitor erosion site.					
Inspector Comment					
Runoff erosion on waterside slope. Recommend monitoring.

View of runoff erosion on the waterside slope. Fall 2017.

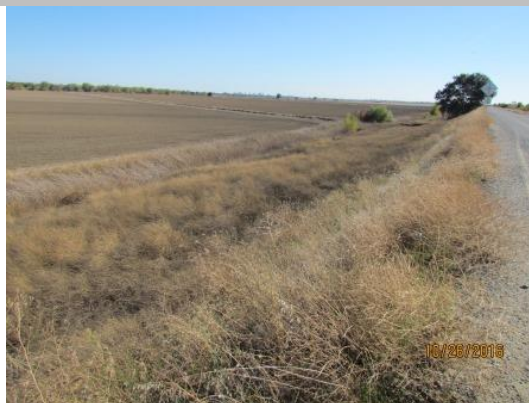
Photo 1 of 1 : FA\_2017\_RD0785\_186\_6\_20170911\_00002.jpg

View of dense vegetation on landside slope. Fall 2016.

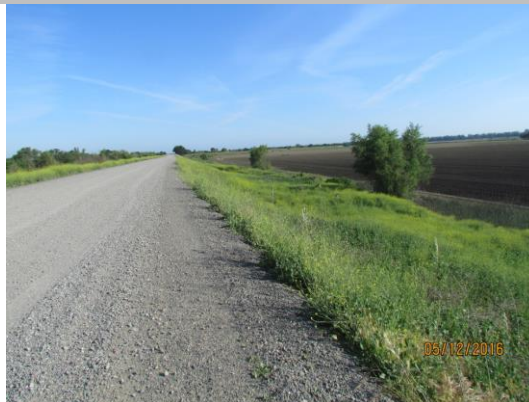
Photo 1 of 1 : FA\_2017\_RD0785\_186\_280\_20170911\_00022.jpg

LM Start	0.38	Rating **	A/W	Issue No.	280
LM End	0.38	Issue Type +	Ma	Location *	LS
Category	Earthen Levee			GPS Latitude/Longitude	
				Start	End
Item	Slope Stability			38.636265 °	38.636265 °
				-121.617422 °	-121.617422 °
DWR ID	DWR_RD0785_02_s_2015_280				
Comment Code					
S1 : Repair slope instability.					
Inspector Comment					
Seems to be a bulge at the toe of the levee.

View of the slope stability on the landward side of the levee looking upstream. Spring 2016.

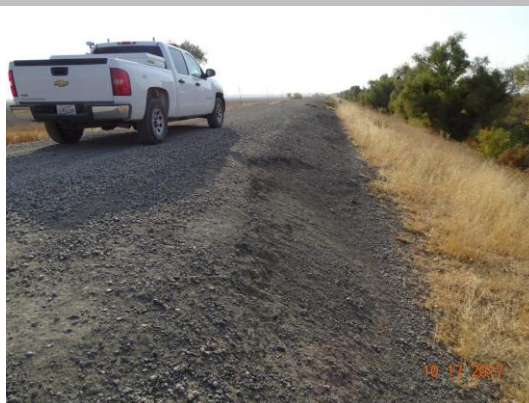
Photo 1 of 1 : FA\_2017\_RD0785\_186\_7\_20171017\_00025.jpg

LM Start	1.14	Rating **	A/W	Issue No.	7
LM End	1.14	Issue Type +	Ma	Location *	WS
Category	Earthen Levee			GPS Latitude/Longitude	
				Start	End
Item	Slope Stability			38.626440 °	38.626440 °
				-121.611164 °	-121.611164 °
DWR ID	DWR_RD0785_02_f_2017_7				
Comment Code					
S1 : Repair slope instability.					
Inspector Comment					
Minor sloughing on waterside hinge point. Recommend monitoring.

View of sloughing section on waterside hinge point. Fall 2017.

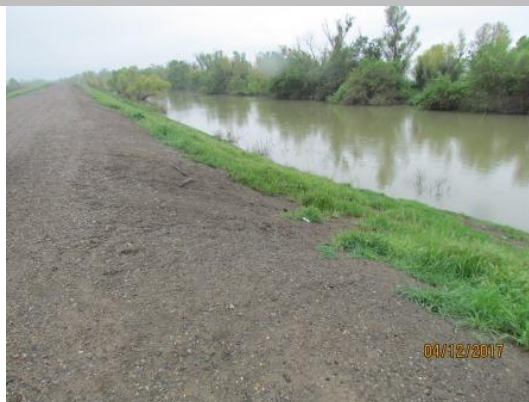
Photo 1 of 1 : FA\_2017\_RD0785\_186\_24\_20170911\_00010.jpg

LM Start	1.52	Rating **	M	Issue No.	24
LM End	1.52	Issue Type +	Ma	Location *	WS
Category	Earthen Levee			GPS Latitude/Longitude	
				Start	End
Item	Slope Stability			38.621694 °	38.621694 °
				-121.607610 °	-121.607610 °
DWR ID	DWR_RD0785_02_s_2017_24				
Comment Code					
S2 : Repair the levee slope damaged by foot traffic and prevent access where possible.					
Inspector Comment					
Footpath for environmental access site. There is a noticeable dip on the waterside slope.

View of slope stability on waterside levee slope. Spring 2017.

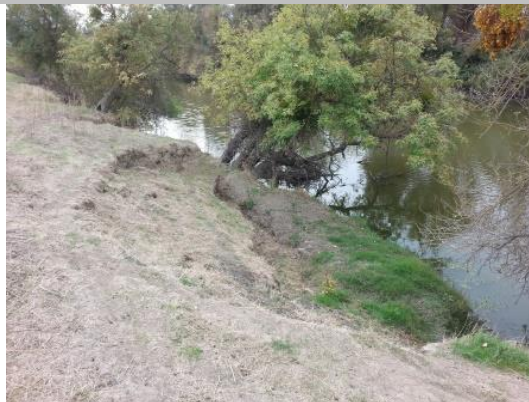
Photo 1 of 1 : FA\_2017\_RD0785\_186\_17\_20170911\_00008.jpg

LM Start	2.04	Rating **	A/W	Issue No.	17
LM End	2.04	Issue Type +	Ma	Location *	WS
Category	Earthen Levee			GPS Latitude/Longitude	
				Start	End
Item	Slope Stability			38.615215 °	38.615215 °
				-121.602596 °	-121.602596 °
DWR ID	DWR_RD0785_02_f_2016_17				
Comment Code					
S1 : Repair slope instability.					
Inspector Comment					
Historical sloughing site that was repaired and has considerable desiccation cracks. Recommend monitoring.

View of erosion site on waterward side of the levee. Fall 2016.
