**Flood Control Project Maintenance
Levee Inspections**

Maintenance Issue Types Only, Levee Inspection Report By Mile - Fall 2018

Reclamation District No. 0785 Driver

Waterway	Bank	Unit Miles	Inspection Start/End	Inspector
Unit No. 01 Sacramento River	Right	2.26	11/05/2018 11/05/2018	Zach Jojola

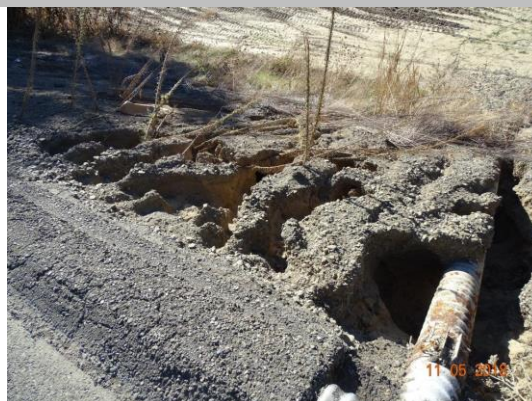
Photo 1 of 5 : FA_2018_RD0785_185_9_20181105_00047.jpg

LM Start	0.11	Rating **	U	Issue No.	9	
LM End	0.11	Issue Type +	Ma	Location *	LS	
Category	Earthen Levee			GPS Latitude/Longitude		
				Start		End
Item	Erosion / Bank Caving			38.660211 °		38.660211 °
				-121.611748 °		-121.611748 °
DWR ID	DWR_RD0785_01_f_2017_9					
Comment Code						
E2 : Schedule repair of erosion site prior to the next inspection.						
Inspector Comment						
Runoff erosion on landside slope that has gotten worse.

Updated view of erosion on the landside slope. Fall 2018.

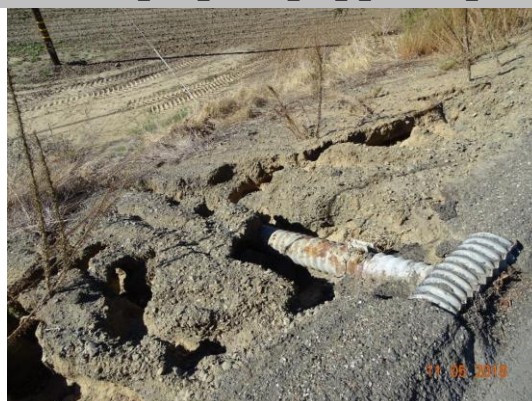
Photo 2 of 5 : FA_2018_RD0785_185_9_20181105_00048.jpg

Additional view of erosion on the landside slope. Fall 2018.

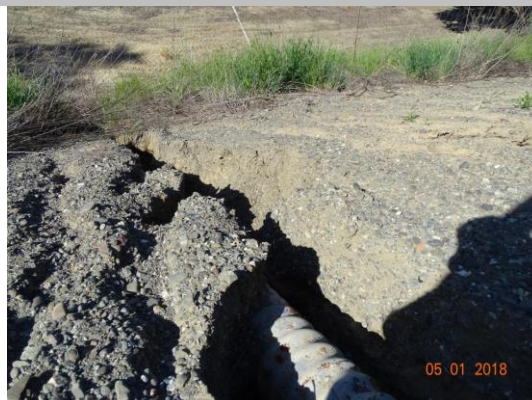
Photo 3 of 5 : FA_2018_RD0785_185_9_20180904_00006.jpg

View of runoff on the landside slope. Spring 2018.

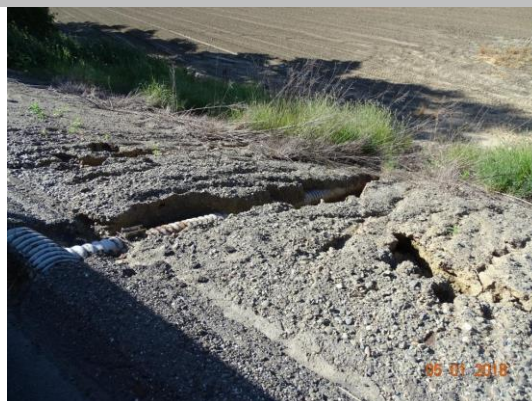
Photo 4 of 5 : FA_2018_RD0785_185_9_20180904_00007.jpg

LM Start	0.11	Rating **	U	Issue No.	9 (cont)	
LM End	0.11	Issue Type +	Ma	Location *	LS	
Category	Earthen Levee			GPS Latitude/Longitude		
				Start		End
Item	Erosion / Bank Caving			38.660211 °	38.660211 °	
				-121.611748 °	-121.611748 °	
DWR ID	DWR_RD0785_01_f_2017_9					
Comment Code						
E2 : Schedule repair of erosion site prior to the next inspection.						
Inspector Comment						
Runoff erosion on landside slope that has gotten worse.

Additional view of runoff on the landside slope. Spring 2018.

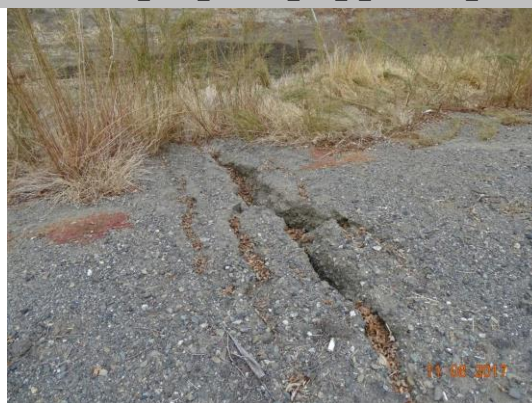
Photo 5 of 5 : FA_2018_RD0785_185_9_20180904_00008.jpg

View of runoff erosion on the landside slope. Fall 2017.

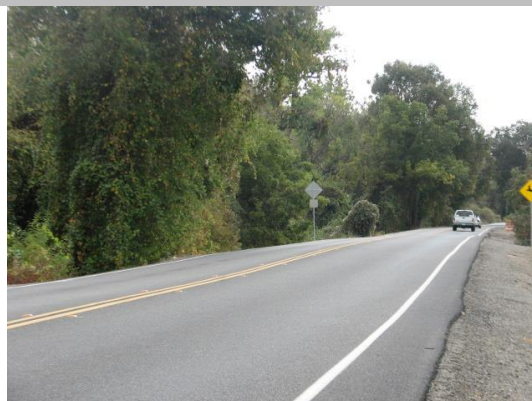
Photo 1 of 2 : FA_2018_RD0785_185_16_20180904_00013.jpg

LM Start	0.21	Rating **	M	Issue No.	16
LM End	1.35	Issue Type +	Ma	Location *	WS
Category	Earthen Levee			GPS Latitude/Longitude	
				Start	End
Item	Vegetation			38.659340 °	38.646093 °
				-121.610405 °	-121.598518 °
DWR ID	DWR_RD0785_01_f_2013_16				
Comment Code					
V2 : Remove the wild growth other than native grasses from the levee slopes.					
Inspector Comment

Brush and other vegetation partially blocks visibility or access to the levee slope. Fall 2013

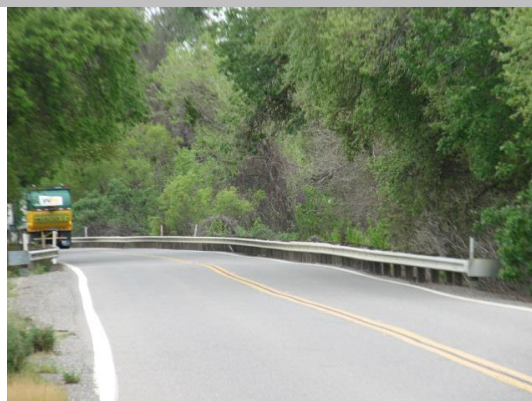
Photo 2 of 2 : FA_2018_RD0785_185_16_20180904_00014.jpg

LM Start	0.21	Rating **	M	Issue No.	16 (cont)	
LM End	1.35	Issue Type +	Ma	Location *	WS	
Category	Earthen Levee			GPS Latitude/Longitude		
				Start		End
Item	Vegetation			38.659340 °		38.646093 °
				-121.610405 °		-121.598518 °
DWR ID	DWR_RD0785_01_f_2013_16					
Comment Code						
V2 : Remove the wild growth other than native grasses from the levee slopes.						
Inspector Comment

Brush and other vegetation partially blocks visibility. Spring 2014

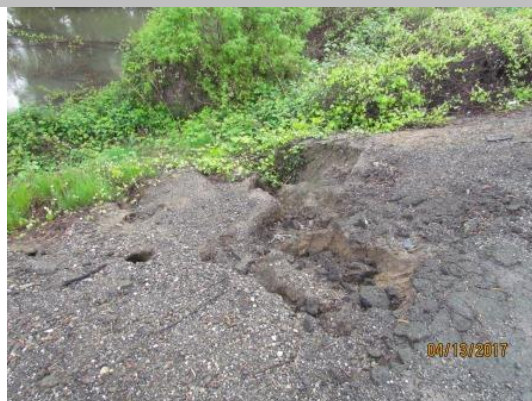
Photo 1 of 1 : FA_2018_RD0785_185_24_20180904_00017.jpg

LM Start	0.24	Rating **	M	Issue No.	24
LM End	0.24	Issue Type +	Ma	Location *	WS
Category	Earthen Levee			GPS Latitude/Longitude	
				Start	End
Item	Erosion / Bank Caving			38.658998 °	38.658998 °
				-121.610081 °	-121.610081 °
DWR ID	DWR_RD0785_01_s_2017_24				
Comment Code					
E2 : Schedule repair of erosion site prior to the next inspection.					
Inspector Comment					
Runoff erosion on waterside slope.

Runoff erosion on waterside levee slope. Spring 2017.

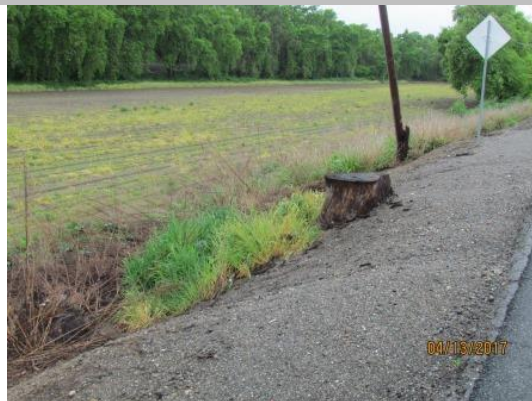
Photo 1 of 1 : FA_2018_RD0785_185_36_20180904_00023.jpg

LM Start	0.28	Rating **	N	Issue No.	36
LM End	0.28	Issue Type +	Ma	Location *	LS
Category	Earthen Levee			GPS Latitude/Longitude	
				Start	End
Item	Trim / Thin Trees			38.658537 °	38.658537 °
				-121.609675 °	-121.609675 °
DWR ID	DWR_RD0785_01_s_2017_36				
Comment Code					
T5 : Tree stumps.					
Inspector Comment

View of stump on landside levee slope. Spring 2017.

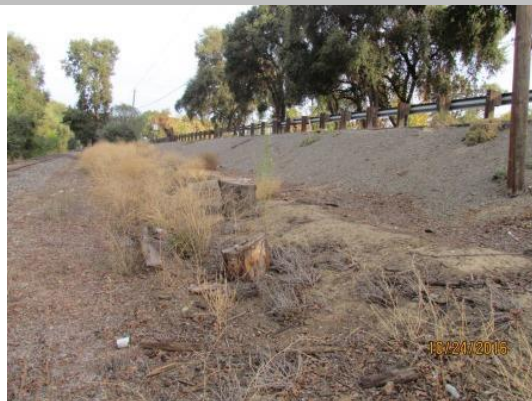
Photo 1 of 1 : FA_2018_RD0785_185_28_20180904_00019.jpg

LM Start	0.99	Rating **	N	Issue No.	28
LM End	0.99	Issue Type +	Ma	Location *	LS
Category	Earthen Levee			GPS Latitude/Longitude	
				Start	End
Item	Trim / Thin Trees			38.650055 °	38.650055 °
				-121.602752 °	-121.602752 °
DWR ID	DWR_RD0785_01_f_2016_28				
Comment Code					
T5 : Tree stumps.					
Inspector Comment

Two tree stumps near levee toe on landside. Fall 2016.

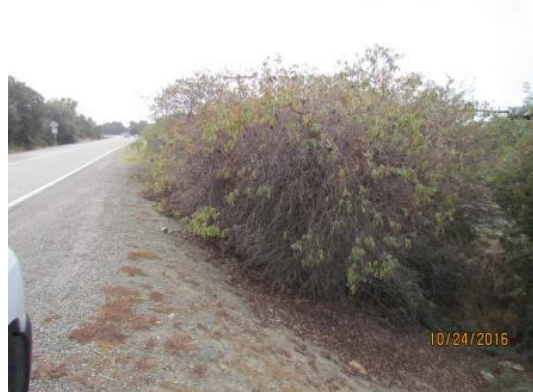
Photo 1 of 1 : FA_2018_RD0785_185_6_20180904_00004.jpg

LM Start	1.30	Rating **	A/W	Issue No.	6
LM End	1.30	Issue Type +	Ma	Location *	LS
Category	Earthen Levee			GPS Latitude/Longitude	
				Start	End
Item	Vegetation			38.646712 °	38.646712 °
				-121.599095 °	-121.599095 °
DWR ID	DWR_RD0785_01_s_2012_6				
Comment Code					
V4 : Elderberries are blocking visibility and flood fight capability.					
Inspector Comment

View of elderberry trees on LS slope. Fall 2016.

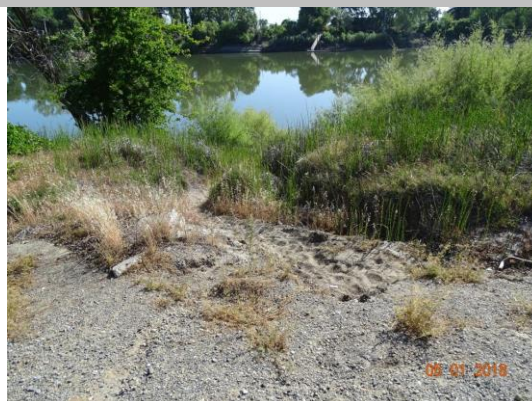
Photo 1 of 4 : FA_2018_RD0785_185_13_20180904_00009.jpg

LM Start	1.31	Rating **	M	Issue No.	13
LM End	1.31	Issue Type +	Ma	Location *	WS
Category	Earthen Levee			GPS Latitude/Longitude	
				Start	End
Item	Slope Stability			38.646652 °	38.646652 °
				-121.598907 °	-121.598907 °
DWR ID	DWR_RD0785_01_s_2013_13				
Comment Code					
S2 : Repair the levee slope damaged by foot traffic and prevent access where possible.					
Inspector Comment					
Footpath on the waterside slope.

Updated view of slope stability on the waterside slope. Spring 2018.

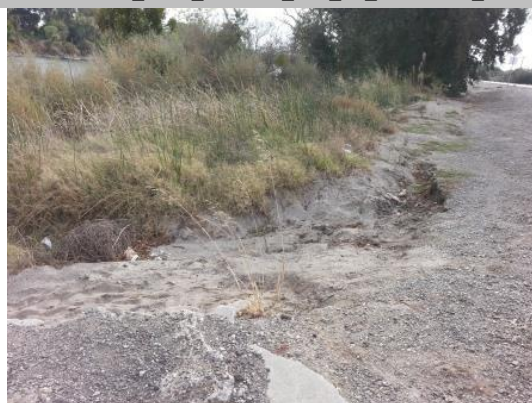
Photo 2 of 4 : FA_2018_RD0785_185_13_20180904_00010.jpg

Updated view of the slope stability site. Fall 2016.

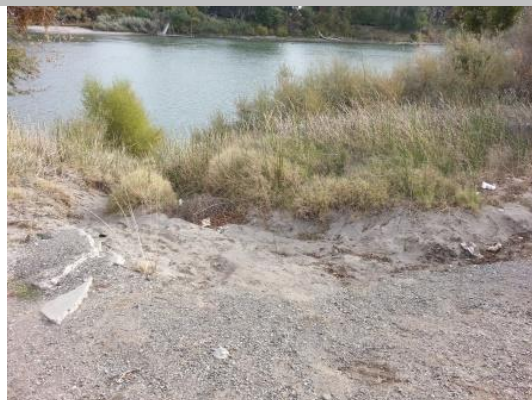
Photo 3 of 4 : FA_2018_RD0785_185_13_20180904_00011.jpg

Updated view of the slope stability site. Fall 2016.

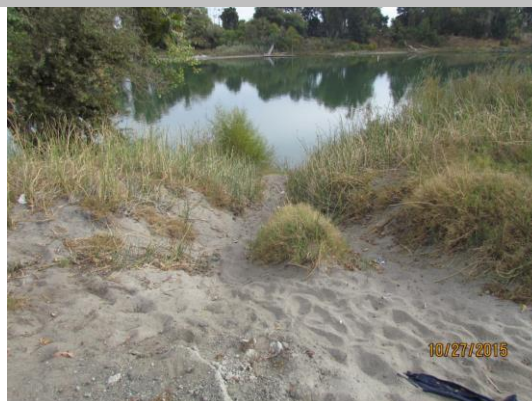
Photo 4 of 4 : FA_2018_RD0785_185_13_20180904_00012.jpg

LM Start	1.31	Rating **	M	Issue No.	13 (cont)
LM End	1.31	Issue Type +	Ma	Location *	WS
Category	Earthen Levee			GPS Latitude/Longitude	
				Start	End
Item	Slope Stability			38.646652 °	38.646652 °
				-121.598907 °	-121.598907 °
DWR ID	DWR_RD0785_01_s_2013_13				
Comment Code					
S2 : Repair the levee slope damaged by foot traffic and prevent access where possible.					
Inspector Comment					
Footpath on the waterside slope.

View of the slope stability on the waterward side of the levee. Fall 2015.

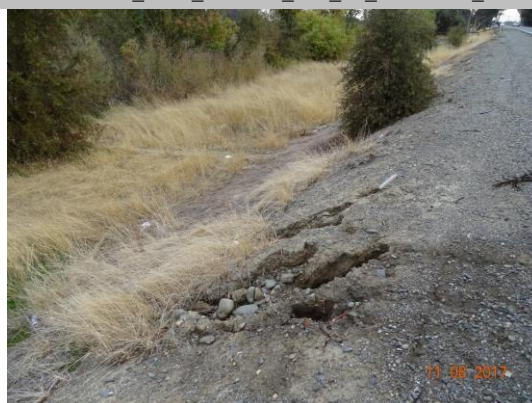
Photo 1 of 1 : FA_2018_RD0785_185_55_20180904_00032.jpg

LM Start	1.51	Rating **	M	Issue No.	55
LM End	1.51	Issue Type +	Ma	Location *	WS
Category	Earthen Levee			GPS Latitude/Longitude	
				Start	End
Item	Erosion / Bank Caving			38.644349 °	38.644349 °
				-121.596506 °	-121.596506 °
DWR ID	DWR_RD0785_01_f_2017_55				
Comment Code					
E2 : Schedule repair of erosion site prior to the next inspection.					
Inspector Comment					
Runoff on waterside slope.

View of the runoff erosion on the waterside slope. Fall 2017.

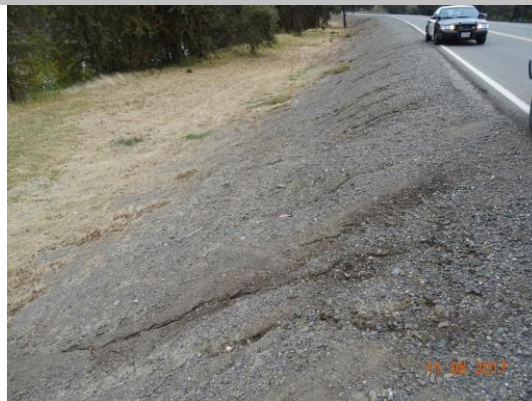
Photo 1 of 1 : FA_2018_RD0785_185_19_20180904_00015.jpg

LM Start	2.23	Rating **	A/W	Issue No.	19
LM End	2.23	Issue Type +	Ma	Location *	WS
Category	Earthen Levee			GPS Latitude/Longitude	
				Start	End
Item	Erosion / Bank Caving			38.642908 °	38.642908 °
				-121.584647 °	-121.584647 °
DWR ID	DWR_RD0785_01_s_2018_19				
Comment Code					
E1 : Note and monitor erosion site.					
Inspector Comment					
Runoff erosion on waterside slope. Recommend monitoring.

View of runoff erosion on the waterside slope. Fall 2017.

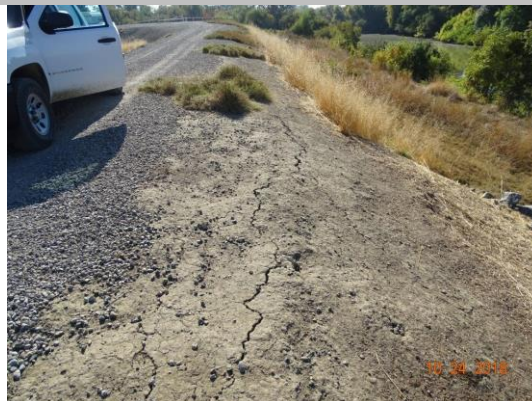
Photo 1 of 1 : FA_2018_RD0785_186_5_20181025_00008.jpg

LM Start	3.26	Rating **	A/W	Issue No.	5
LM End	3.26	Issue Type +	Ma	Location *	WS
Category	Earthen Levee			GPS Latitude/Longitude	
				Start	End
Item	Cracking			38.600148 °	38.600148 °
				-121.590880 °	-121.590880 °
DWR ID	DWR_RD0785_02_f_2018_5				
Comment Code					
CR1 : Monitor and have inspected by geotechnical engineer.					
Inspector Comment					
Cracking on the waterside shoulder. Approximately 50' long. Recommend monitoring.

View of cracks on the waterside shoulder. Fall 2018.
