**Flood Control Project Maintenance  
Levee Inspections**

**Maintenance Issue Types Only, Levee Inspection Report By Mile - Fall 2019**

**Reclamation District No. 0785 Driver**

Waterway	Bank	Unit Miles	Inspection Start/End	Inspector
Unit No. 01 Sacramento River	Right	2.26	11/12/2019 11/12/2019	Zach Jojola

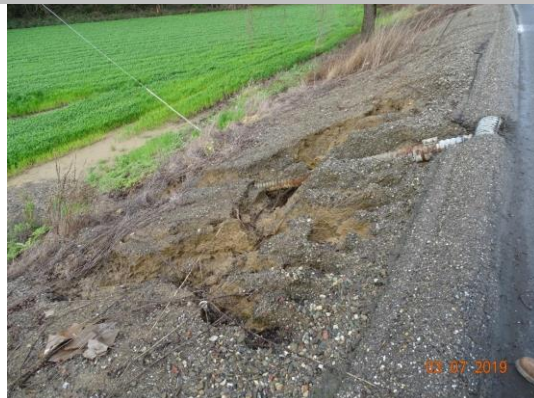
Photo 1 of 6 : FA\_2019\_RD0785\_185\_9\_20190829\_00003.jpg

LM Start	0.11	Rating **	U	Issue No.	9
LM End	0.11	Issue Type +	Ma	Location *	LS
Category	Earthen Levee			GPS Latitude/Longitude	
				Start	End
Item	Erosion / Bank Caving			38.660211°	38.660211°
				-121.611748°	-121.611748°
DWR ID	DWR_RD0785_01_f_2017_9				
Comment Code					
E2 : Schedule repair of erosion site prior to the next inspection.					
Inspector Comment					
Significant runoff erosion on landside slope.

View of erosion on the landside slope. Spring 2019.

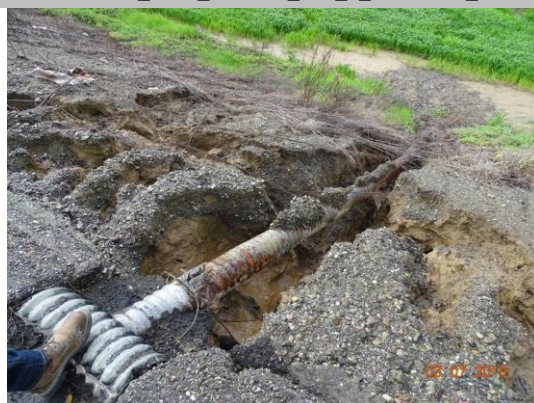
Photo 2 of 6 : FA\_2019\_RD0785\_185\_9\_20190829\_00004.jpg

View of erosion on the landside slope. Spring 2019.

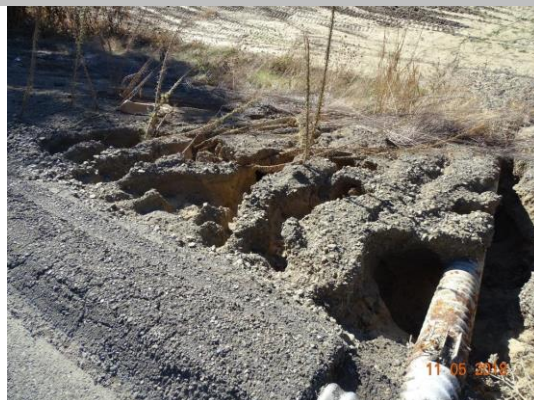
Photo 3 of 6 : FA\_2019\_RD0785\_185\_9\_20190829\_00005.jpg

View of erosion on the landside slope. Fall 2018.

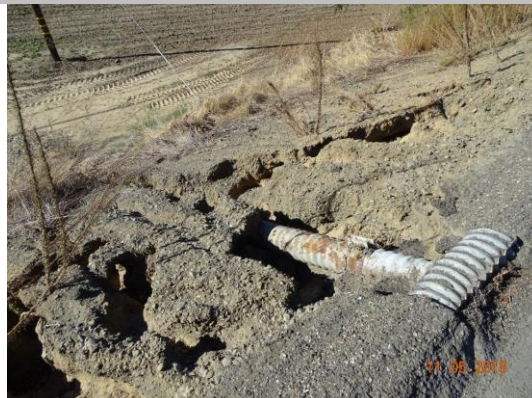
Photo 4 of 6 : FA\_2019\_RD0785\_185\_9\_20190829\_00006.jpg

Additional view of erosion on the landside slope. Fall 2018.

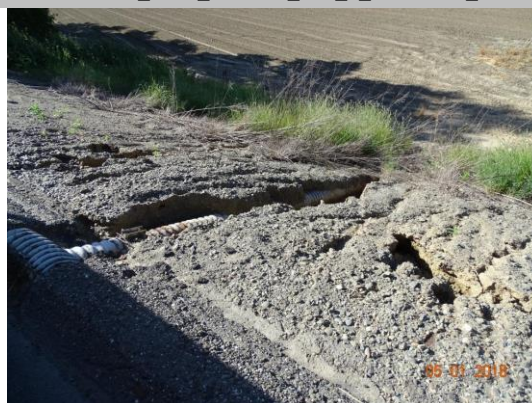
Photo 5 of 6 : FA\_2019\_RD0785\_185\_9\_20190829\_00007.jpg

View of runoff on the landside slope. Spring 2018.

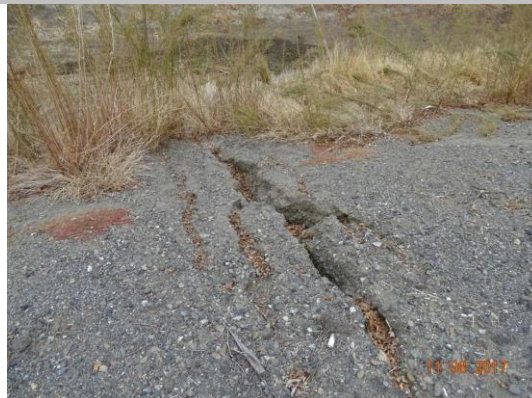
Photo 6 of 6 : FA\_2019\_RD0785\_185\_9\_20190829\_00008.jpg

View of runoff erosion on the landside slope. Fall 2017.

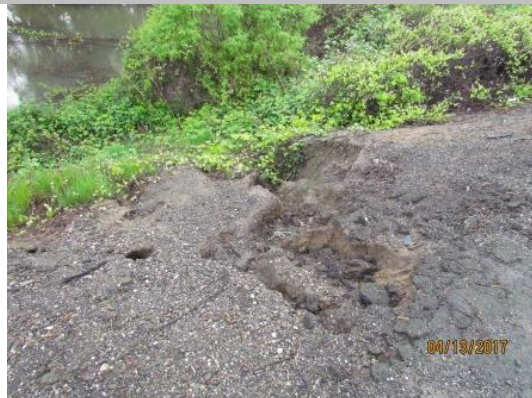
Photo 1 of 1 : FA\_2019\_RD0785\_185\_24\_20190829\_00019.jpg

LM Start	0.24	Rating **	M	Issue No.	24
LM End	0.24	Issue Type +	Ma	Location *	WS
Category	Earthen Levee			GPS Latitude/Longitude	
				Start	End
Item	Erosion / Bank Caving			38.658998 °	38.658998 °
				-121.610081 °	-121.610081 °
DWR ID	DWR_RD0785_01_s_2017_24				
Comment Code					
E2 : Schedule repair of erosion site prior to the next inspection.					
Inspector Comment					
Runnoff erosion on waterside slope.

Runoff erosion on waterside levee slope. Spring 2017.

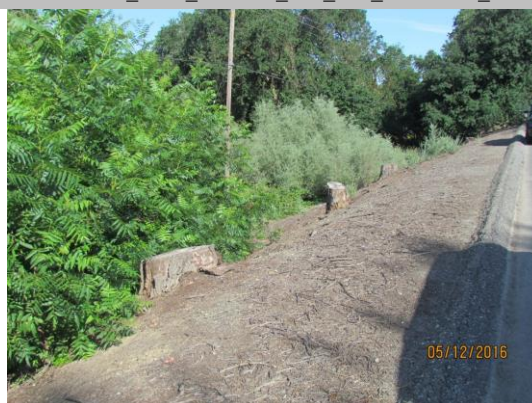
Photo 1 of 1 : FA\_2019\_RD0785\_185\_181\_20190829\_00027.jpg

LM Start	0.76	Rating **	N	Issue No.	181
LM End	0.76	Issue Type +	Ma	Location *	LS
Category	Earthen Levee			GPS Latitude/Longitude	
				Start	End
Item	Trim / Thin Trees			38.653003 °	38.653003 °
				-121.605061 °	-121.605061 °
DWR ID	DWR_RD0785_01_s_2014_181				
Comment Code					
T5 : Tree stumps.					
Inspector Comment

View of the tree stumps on the landward side of the levee looking upstream. Spring 2016.

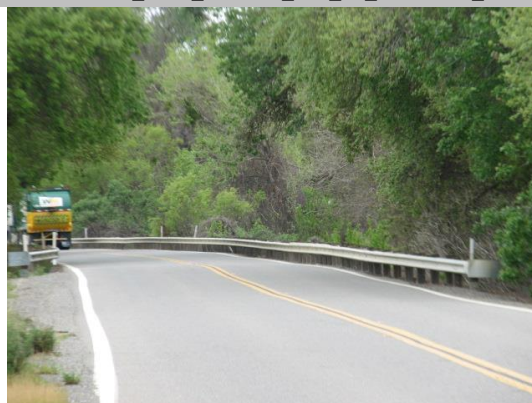
Photo 2 of 2 : FA\_2019\_RD0785\_185\_16\_20190829\_00015.jpg

Brush and other vegetation partially blocks visibility. Spring 2014

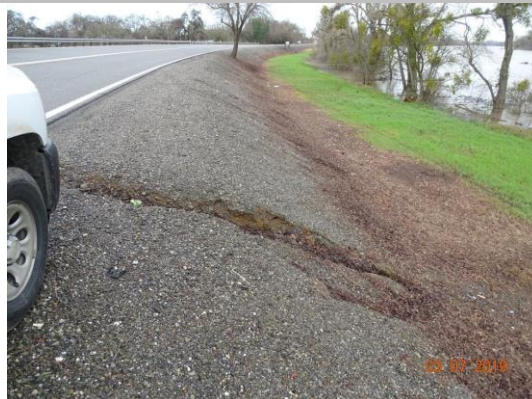
Photo 1 of 1 : FA\_2019\_RD0785\_185\_15\_20190829\_00013.jpg

LM Start	1.78	Rating **	M	Issue No.	15
LM End	1.78	Issue Type +	Ma	Location *	WS
Category	Earthen Levee			GPS Latitude/Longitude	
				Start	End
Item	Erosion / Bank Caving			38.642042°	38.642042°
				-121.592536°	-121.592536°
DWR ID	DWR_RD0785_01_s_2019_15				
Comment Code					
E2 : Schedule repair of erosion site prior to the next inspection.					
Inspector Comment					
Rills on the waterside slope.

View of rill on the waterside slope. Spring 2019.

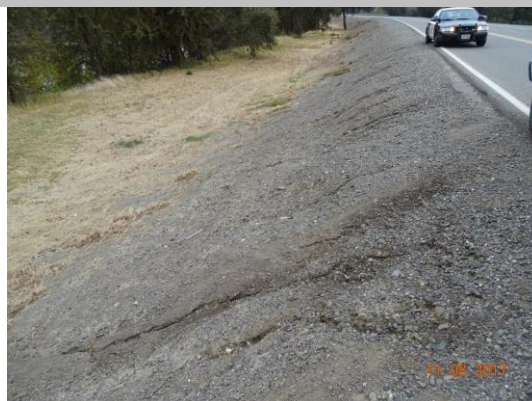
Photo 1 of 1 : FA\_2019\_RD0785\_185\_19\_20190829\_00017.jpg

LM Start	2.24	Rating **	M	Issue No.	19
LM End	2.24	Issue Type +	Ma	Location *	WS
Category	Earthen Levee			GPS Latitude/Longitude	
				Start	End
Item	Erosion / Bank Caving			38.642988 °	38.642988 °
				-121.584481 °	-121.584481 °
DWR ID	DWR_RD0785_01_s_2018_19				
Comment Code					
E1 : Note and monitor erosion site.					
Inspector Comment					
Runoff erosion on waterside slope.

View of runoff erosion on the waterside slope. Fall 2017.

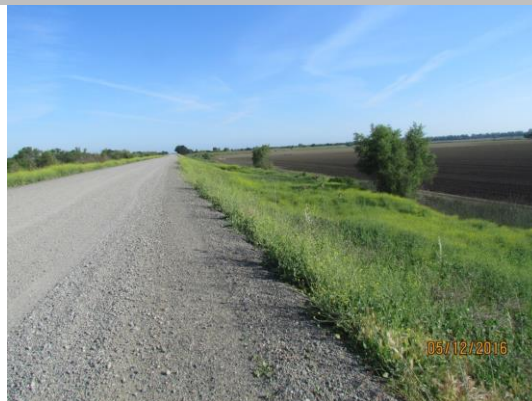
Photo 1 of 1 : FA\_2019\_RD0785\_186\_280\_20190829\_00006.jpg

LM Start	0.38	Rating **	A/W	Issue No.	280
LM End	0.38	Issue Type +	Ma	Location *	LS
Category	Earthen Levee			GPS Latitude/Longitude	
				Start	End
Item	Slope Stability			38.636265 °	38.636265 °
				-121.617422 °	-121.617422 °
DWR ID	DWR_RD0785_02_s_2015_280				
Comment Code					
S1 : Repair slope instability.					
Inspector Comment					
Seems to be a bulge at the toe of the levee. Recommend monitoring.

View of the slope stability on the landward side of the levee looking upstream. Spring 2016.

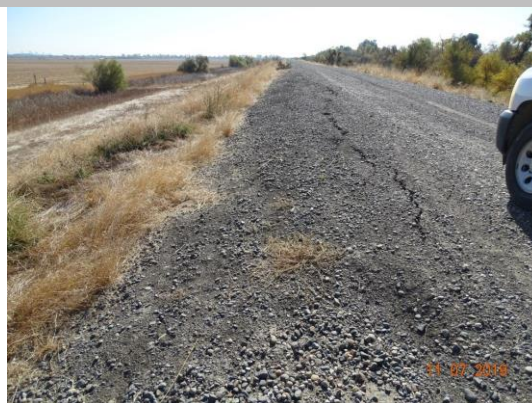
Photo 1 of 1 : FA\_2019\_RD0785\_186\_10\_20191112\_00009.jpg

LM Start	1.85	Rating **	M	Issue No.	10
LM End	1.86	Issue Type +	Ma	Location *	LS
Category	Earthen Levee			GPS Latitude/Longitude	
				Start	End
Item	Cracking			38.617562 °	38.617421 °
				-121.604431 °	-121.604321 °
DWR ID	DWR_RD0785_02_f_2019_10				
Comment Code					
CR1 : Monitor and have inspected by geotechnical engineer.					
Inspector Comment					
Appears to be a 100' longitudinal crack that shows some settlement on the landside shoulder. Recommend having the area inspected by a geotech.

View of cracking and settlement on the crown and landside shoulder.  
Fall 2019.

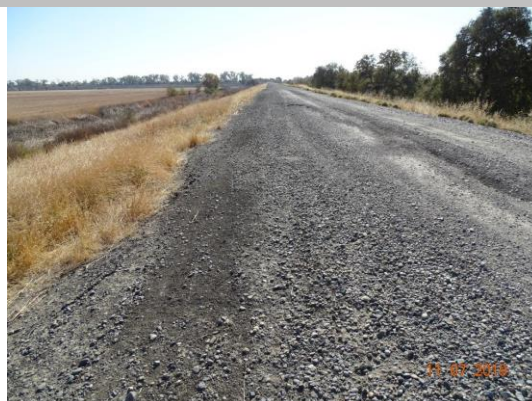
Photo 1 of 1 : FA\_2019\_RD0785\_186\_11\_20191112\_00010.jpg

LM Start	2.82	Rating **	M	Issue No.	11
LM End	2.83	Issue Type +	Ma	Location *	LS
Category	Earthen Levee			GPS Latitude/Longitude	
				Start	End
Item	Cracking			38.605597 °	38.605436 °
				-121.595097 °	-121.594980 °
DWR ID	DWR_RD0785_02_f_2019_11				
Comment Code					
CR1 : Monitor and have inspected by geotechnical engineer.					
Inspector Comment					
Appears to be a 100' longitudinal crack that shows some settlement on the landside shoulder. Recommend having the area inspected by a geotech.

View of cracking and settlement on the crown and landside shoulder.  
Fall 2019.
