**Flood Control Project Maintenance
Levee Inspections**

Maintenance Issue Types Only, Levee Inspection Report By Mile - Fall 2020

Reclamation District No. 0785 Driver

Waterway	Bank	Unit Miles	Inspection Start/End	Inspector
Unit No. 01 Sacramento River	Right	2.26	10/27/2020 10/27/2020	Zach Jojola

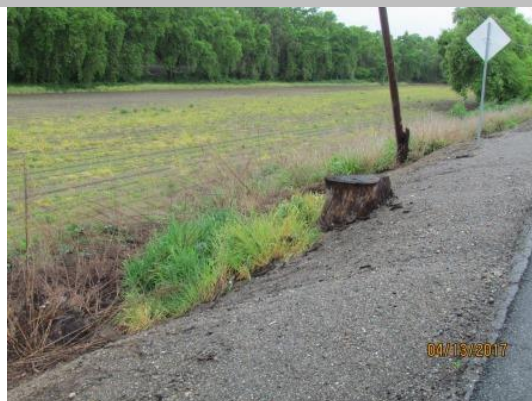
Photo 1 of 1 : FA_2020_RD0785_185_36_20200813_00014.jpg

LM Start	0.28	Rating **	N	Issue No.	36
LM End	0.28	Issue Type +	Ma	Location *	LS
Category	Earthen Levee			GPS Latitude/Longitude	
				Start	End
Item	Trim / Thin Trees			38.658537 °	38.658537 °
				-121.609675 °	-121.609675 °
DWR ID	DWR_RD0785_01_s_2017_36				
Comment Code					
T5 : Tree stumps.					
Inspector Comment

View of stump on landside levee slope. Spring 2017.

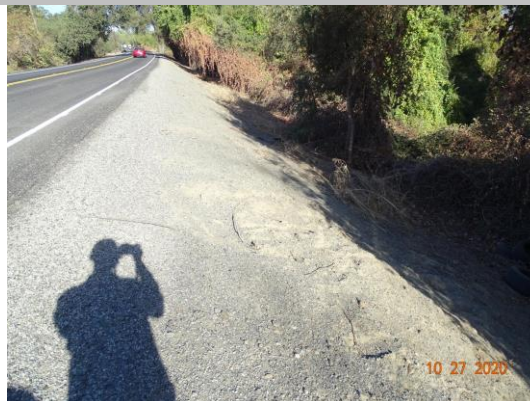
Photo 1 of 1 : FA_2020_RD0785_185_20_20201028_00034.jpg

LM Start	0.46	Rating **	A/W	Issue No.	20
LM End	0.46	Issue Type +	Ma	Location *	WS
Category	Earthen Levee			GPS Latitude/Longitude	
				Start	End
Item	Erosion / Bank Caving			38.656493 °	38.656493 °
				-121.607614 °	-121.607614 °
DWR ID	DWR_RD0785_01_s_2019_20				
Comment Code					
E1 : Note and monitor erosion site.					
Inspector Comment					
Minor runoff on the waterside slope. Recommend monitoring.

View of erosion on waterside slope. Fall 2020.

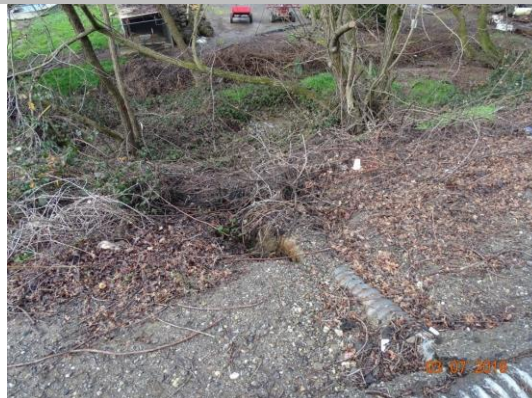
Photo 1 of 1 : FA_2020_RD0785_185_22_20200813_00009.jpg

LM Start	0.64	Rating **	M	Issue No.	22
LM End	0.64	Issue Type +	Ma	Location *	LS
Category	Earthen Levee			GPS Latitude/Longitude	
				Start	End
Item	Erosion / Bank Caving			38.654294 °	38.654294 °
				-121.605949 °	-121.605949 °
DWR ID	DWR_RD0785_01_s_2019_22				
Comment Code					
E2 : Schedule repair of erosion site prior to the next inspection.					
Inspector Comment					
Erosion around drainage pipe.

View of erosion on the landside slope. Spring 2019.

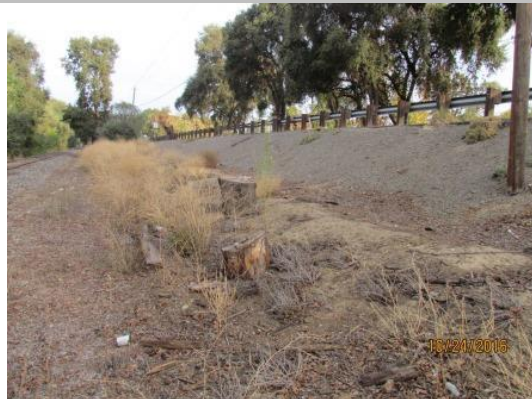
Photo 1 of 1 : FA_2020_RD0785_185_28_20200813_00011.jpg

LM Start	0.99	Rating **	N	Issue No.	28
LM End	0.99	Issue Type +	Ma	Location *	LS
Category	Earthen Levee			GPS Latitude/Longitude	
				Start	End
Item	Trim / Thin Trees			38.650055 °	38.650055 °
				-121.602752 °	-121.602752 °
DWR ID	DWR_RD0785_01_f_2020_28				
Comment Code					
T5 : Tree stumps.					
Inspector Comment

Two tree stumps near levee toe on landside. Fall 2016.

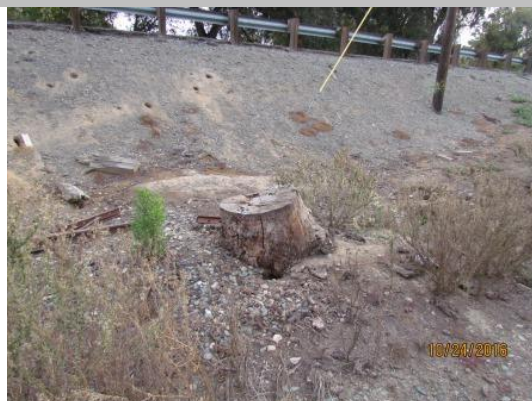
Photo 1 of 1 : FA_2020_RD0785_185_30_20200813_00013.jpg

LM Start	1.02	Rating **	N	Issue No.	30
LM End	1.02	Issue Type +	Ma	Location *	LS
Category	Earthen Levee			GPS Latitude/Longitude	
				Start	End
Item	Trim / Thin Trees			38.649775 °	38.649775 °
				-121.602363 °	-121.602363 °
DWR ID	DWR_RD0785_01_f_2016_30				
Comment Code					
T5 : Tree stumps.					
Inspector Comment					
Tree stump near levee toe

View of a stump near levee toe on landside. Fall 2016.

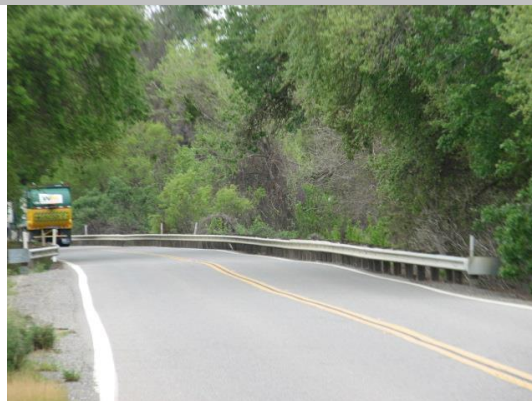
Photo 1 of 1 : FA_2020_RD0785_185_16_20200813_00006.jpg

LM Start	1.11	Rating **	M	Issue No.	16
LM End	1.21	Issue Type +	Ma	Location *	WS
Category	Earthen Levee			GPS Latitude/Longitude	
				Start	End
Item	Vegetation			38.648857 °	38.647805 °
				-121.601213 °	-121.600076 °
DWR ID	DWR_RD0785_01_f_2013_16				
Comment Code					
V2 : Remove the wild growth other than native grasses from the levee slopes.					
Inspector Comment

Brush and other vegetation partially blocks visibility. Spring 2014

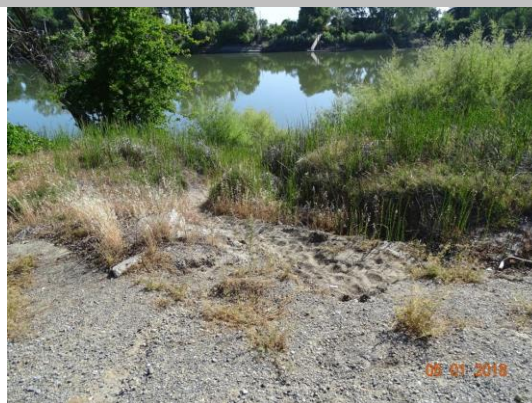
Photo 1 of 1 : FA_2020_RD0785_185_13_20200813_00003.jpg

LM Start	1.31	Rating **	M	Issue No.	13
LM End	1.31	Issue Type +	Ma	Location *	WS
Category	Earthen Levee			GPS Latitude/Longitude	
				Start	End
Item	Erosion / Bank Caving			38.646652 °	38.646652 °
				-121.598907 °	-121.598907 °
DWR ID	DWR_RD0785_01_s_2013_13				
Comment Code					
E2 : Schedule repair of erosion site prior to the next inspection.					
Inspector Comment					
Rills on the waterside slope.

View of runoff on the waterside slope. Spring 2018.

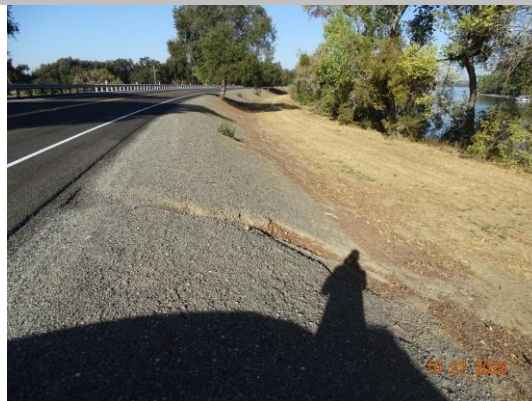
Photo 1 of 1 : FA_2020_RD0785_185_15_20201028_00030.jpg

LM Start	1.78	Rating **	M	Issue No.	15
LM End	1.78	Issue Type +	Ma	Location *	WS
Category	Earthen Levee			GPS Latitude/Longitude	
				Start	End
Item	Erosion / Bank Caving			38.642042 °	38.642042 °
				-121.592536 °	-121.592536 °
DWR ID	DWR_RD0785_01_s_2019_15				
Comment Code					
E2 : Schedule repair of erosion site prior to the next inspection.					
Inspector Comment					
Rills on the waterside slope.

View of erosion on the waterside slope. Fall 2020.

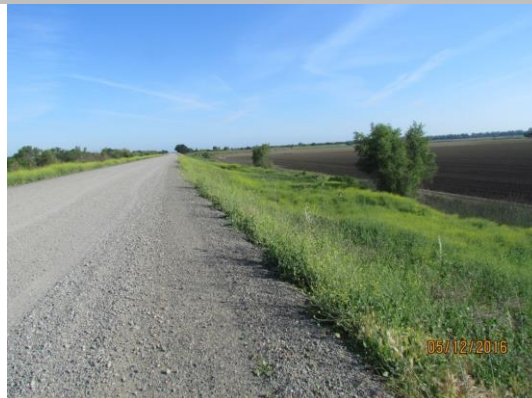
Photo 1 of 1 : FA_2020_RD0785_186_280_20200813_00005.jpg

LM Start	0.38	Rating **	A/W	Issue No.	280
LM End	0.38	Issue Type +	Ma	Location *	LS
Category	Earthen Levee			GPS Latitude/Longitude	
				Start	End
Item	Slope Stability			38.636265 °	38.636265 °
				-121.617422 °	-121.617422 °
DWR ID	DWR_RD0785_02_s_2015_280				
Comment Code					
S1 : Repair slope instability.					
Inspector Comment					
Seems to be a bulge at the toe of the levee. Recommend monitoring.

View of the slope stability on the landward side of the levee looking upstream. Spring 2016.

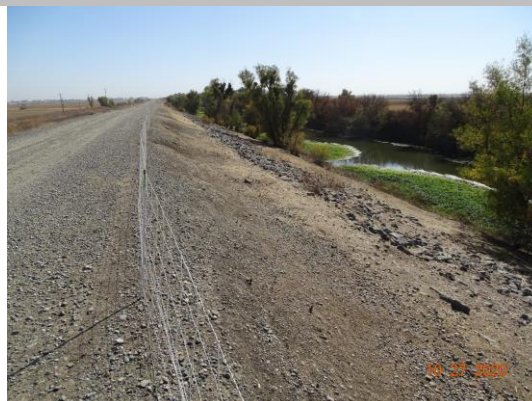
Photo 1 of 1 : FA_2020_RD0785_186_5_20201028_00008.jpg

LM Start	1.24	Rating **	A	Issue No.	5
LM End	1.24	Issue Type +	Ma	Location *	WS
Category	Earthen Levee			GPS Latitude/Longitude	
				Start	End
Item	Vegetation			38.625186 °	38.625186 °
				-121.610187 °	-121.610187 °
DWR ID	DWR_RD0785_02_f_2020_5				
Comment Code					
V1 : Control annual grass and weeds on the levee slopes and easements.					
Inspector Comment					
LMA maintains vegetation at a high level.

View of the maintained waterside slope. Fall 2020.

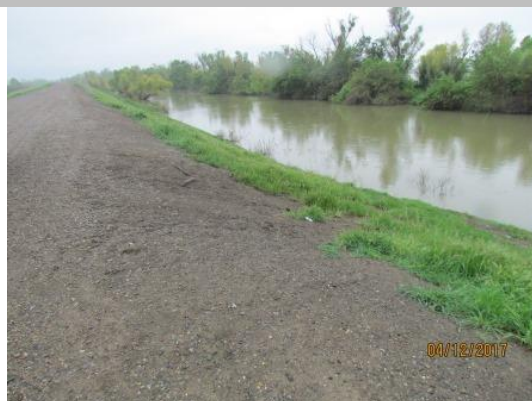
Photo 1 of 1 : FA_2020_RD0785_186_24_20200813_00004.jpg

LM Start	1.52	Rating **	M	Issue No.	24
LM End	1.52	Issue Type +	Ma	Location *	WS
Category	Earthen Levee			GPS Latitude/Longitude	
				Start	End
Item	Slope Stability			38.621694 °	38.621694 °
				-121.607610 °	-121.607610 °
DWR ID	DWR_RD0785_02_s_2017_24				
Comment Code					
S2 : Repair the levee slope damaged by foot traffic and prevent access where possible.					
Inspector Comment					
Footpath for environmental access site. There is a noticeable dip on the waterside slope.

View of slope stability on waterside levee slope. Spring 2017.
