**Flood Control Project Maintenance
Levee Inspections**

Maintenance Issue Types Only, Levee Inspection Report By Mile - Fall 2021

Reclamation District No. 0785 Driver

Waterway	Bank	Unit Miles	Inspection Start/End	Inspector
Unit No. 01 Sacramento River	Right	2.26	10/27/2021 10/27/2021	Zach Jojola

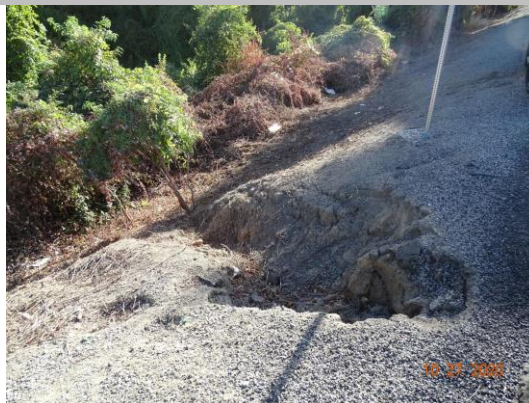
Photo 1 of 1 : FA_2021_RD0785_185_24_20210907_00006.jpg

LM Start	0.24	Rating **	U	Issue No.	24
LM End	0.24	Issue Type +	Ma	Location *	WS
Category	Earthen Levee			GPS Latitude/Longitude	
				Start	End
Item	Erosion / Bank Caving			38.658998 °	38.658998 °
				-121.610081 °	-121.610081 °
DWR ID	DWR_RD0785_01_s_2017_24				
Comment Code					
E2 : Schedule repair of erosion site prior to the next inspection.					
Inspector Comment					
Runnoff erosion on waterside slope.

View of erosion on waterside slope. Fall 2020.

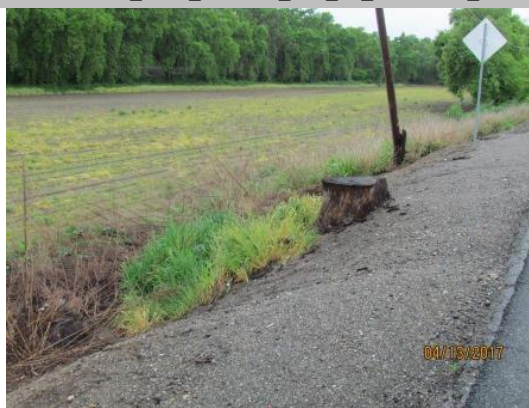
Photo 1 of 1 : FA_2021_RD0785_185_36_20210907_00009.jpg

LM Start	0.28	Rating **	N	Issue No.	36
LM End	0.28	Issue Type +	Ma	Location *	LS
Category	Earthen Levee			GPS Latitude/Longitude	
				Start	End
Item	Trim / Thin Trees			38.658537 °	38.658537 °
				-121.609675 °	-121.609675 °
DWR ID	DWR_RD0785_01_f_2021_36				
Comment Code					
T5 : Tree stumps.					
Inspector Comment

View of stump on landside levee slope. Spring 2017.

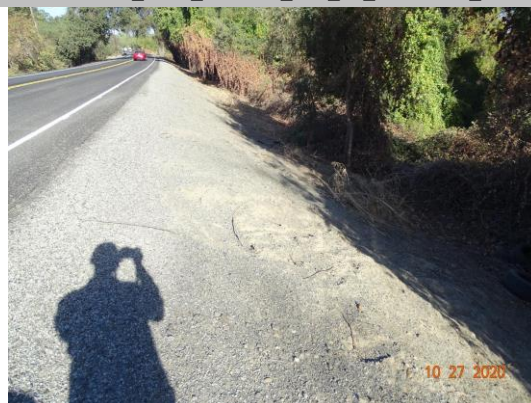
Photo 1 of 1 : FA_2021_RD0785_185_20_20210907_00005.jpg

LM Start	0.46	Rating **	A/W	Issue No.	20
LM End	0.46	Issue Type +	Ma	Location *	WS
Category	Earthen Levee			GPS Latitude/Longitude	
				Start	End
Item	Erosion / Bank Caving			38.656493 °	38.656493 °
				-121.607614 °	-121.607614 °
DWR ID	DWR_RD0785_01_s_2019_20				
Comment Code					
E1 : Note and monitor erosion site.					
Inspector Comment					
Minor runoff on the waterside slope. Recommend monitoring.

View of erosion on waterside slope. Fall 2020.

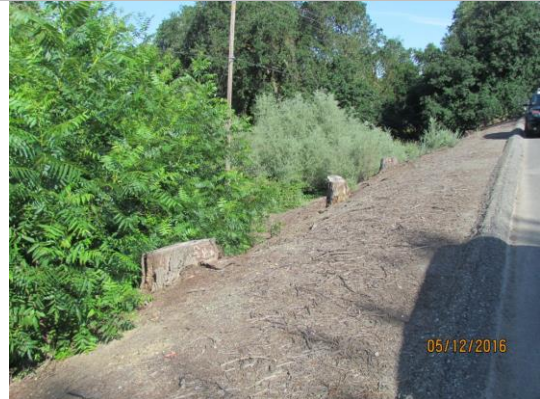
Photo 1 of 1 : FA_2021_RD0785_185_181_20210907_00012.jpg

LM Start	0.76	Rating **	N	Issue No.	181
LM End	0.76	Issue Type +	Ma	Location *	LS
Category	Earthen Levee			GPS Latitude/Longitude	
				Start	End
Item	Trim / Thin Trees			38.653003 °	38.653003 °
				-121.605061 °	-121.605061 °
DWR ID	DWR_RD0785_01_s _ 2021_181				
Comment Code					
T5 : Tree stumps.					
Inspector Comment

View of the tree stumps on the landward side of the levee looking upstream. Spring 2016.

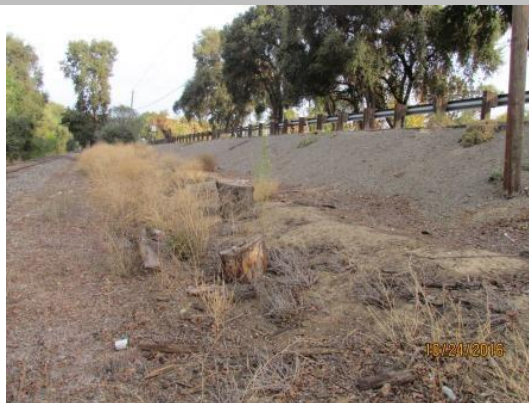
Photo 1 of 1 : FA_2021_RD0785_185_28_20210907_00007.jpg

LM Start	0.99	Rating **	N	Issue No.	28
LM End	0.99	Issue Type +	Ma	Location *	LS
Category	Earthen Levee			GPS Latitude/Longitude	
				Start	End
Item	Trim / Thin Trees			38.650055 °	38.650055 °
				-121.602752 °	-121.602752 °
DWR ID	DWR_RD0785_01_f_2020_28				
Comment Code					
T5 : Tree stumps.					
Inspector Comment

Two tree stumps near levee toe on landside. Fall 2016.

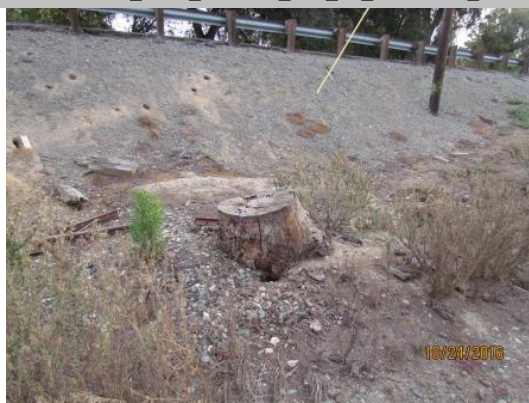
Photo 1 of 1 : FA_2021_RD0785_185_30_20210907_00008.jpg

LM Start	1.02	Rating **	N	Issue No.	30
LM End	1.02	Issue Type +	Ma	Location *	LS
Category	Earthen Levee			GPS Latitude/Longitude	
				Start	End
Item	Trim / Thin Trees			38.649775 °	38.649775 °
				-121.602363 °	-121.602363 °
DWR ID	DWR_RD0785_01_f_2016_30				
Comment Code					
T5 : Tree stumps.					
Inspector Comment					
Tree stump near levee toe

View of a stump near levee toe on landside. Fall 2016.

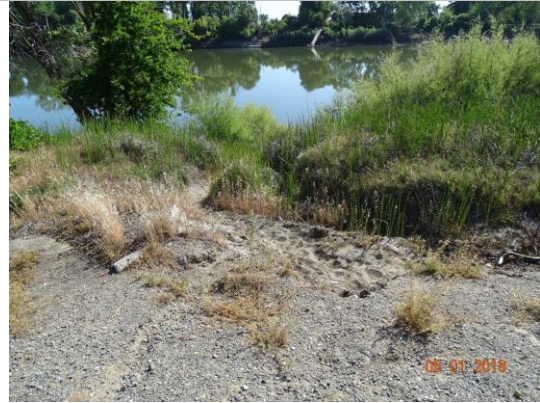
Photo 1 of 1 : FA_2021_RD0785_185_13_20210907_00001.jpg

LM Start	1.31	Rating **	M	Issue No.	13
LM End	1.31	Issue Type +	Ma	Location *	WS
Category	Earthen Levee			GPS Latitude/Longitude	
				Start	End
Item	Erosion / Bank Caving			38.646652 °	38.646652 °
				-121.598907 °	-121.598907 °
DWR ID	DWR_RD0785_01_s_2013_13				
Comment Code					
E2 : Schedule repair of erosion site prior to the next inspection.					
Inspector Comment					
Rills on the waterside slope.

View of runoff on the waterside slope. Spring 2018.

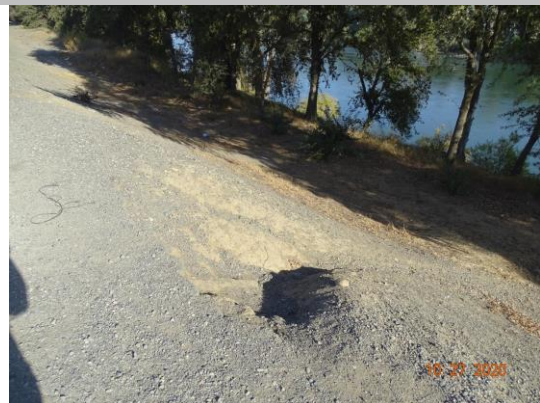
Photo 1 of 1 : FA_2021_RD0785_185_17_20210907_00004.jpg

LM Start	1.42	Rating **	A/W	Issue No.	17
LM End	1.42	Issue Type +	Ma	Location *	WS
Category	Earthen Levee			GPS Latitude/Longitude	
				Start	End
Item	Erosion / Bank Caving			38.645370 °	38.645370 °
				-121.597647 °	-121.597647 °
DWR ID	DWR_RD0785_01_f_2020_17				
Comment Code					
E1 : Note and monitor erosion site.					
Inspector Comment					
Minor rills on the overbuilt shoulder. Recommend monitoring.

View of erosion on waterside slope. Fall 2020.

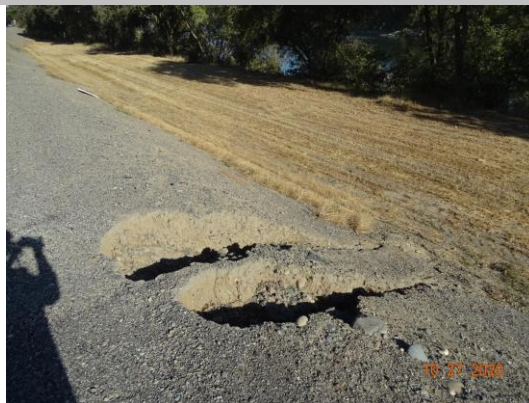
Photo 1 of 1 : FA_2021_RD0785_185_55_20210907_00011.jpg

LM Start	1.50	Rating **	M	Issue No.	55
LM End	1.51	Issue Type +	Ma	Location *	WS
Category	Earthen Levee			GPS Latitude/Longitude	
				Start	End
Item	Erosion / Bank Caving			38.644482 °	38.644349 °
				-121.596640 °	-121.596506 °
DWR ID	DWR_RD0785_01_f_2017_55				
Comment Code					
E2 : Schedule repair of erosion site prior to the next inspection.					
Inspector Comment					
Runoff on waterside slope.

View of erosion on waterside slope at second location. Fall 2020.

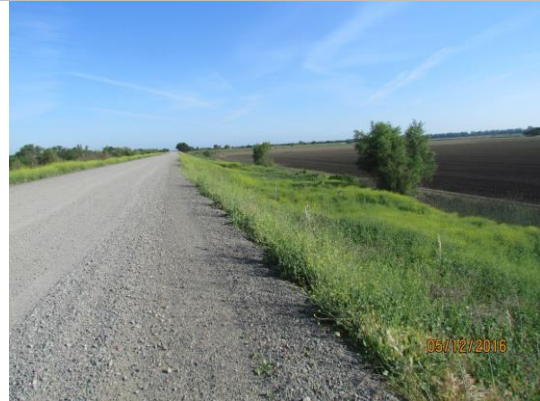
Photo 1 of 1 : FA_2021_RD0785_186_280_20210907_00003.jpg

LM Start	0.38	Rating **	A/W	Issue No.	280
LM End	0.38	Issue Type +	Ma	Location *	LS
Category	Earthen Levee			GPS Latitude/Longitude	
				Start	End
Item	Slope Stability			38.636265 °	38.636265 °
				-121.617422 °	-121.617422 °
DWR ID	DWR_RD0785_02_s_2015_280				
Comment Code					
S1 : Repair slope instability.					
Inspector Comment					
Seems to be a bulge at the toe of the levee. Recommend monitoring.

View of the slope stability on the landward side of the levee looking upstream. Spring 2016.

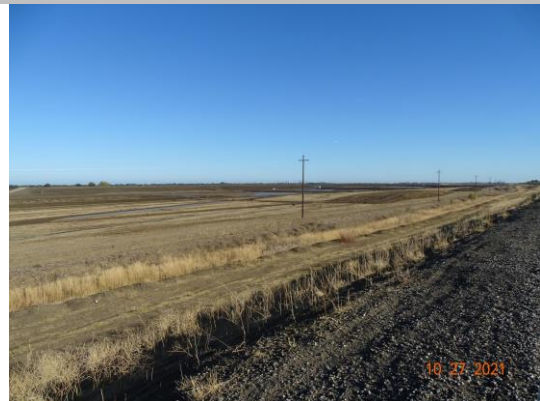
Photo 1 of 1 : FA_2021_RD0785_186_4_20211102_00006.jpg

LM Start	0.72	Rating **	A	Issue No.	4
LM End	0.72	Issue Type +	Ma	Location *	LS
Category	Earthen Levee			GPS Latitude/Longitude	
				Start	End
Item	Vegetation			38.631820 °	38.631820 °
				-121.614762 °	-121.614762 °
DWR ID	DWR_RD0785_02_f_2021_4				
Comment Code					
V1 : Control annual grass and weeds on the levee slopes and easements.					
Inspector Comment					
The LMA maintains the vegetation at a high level.

View of maintained landside slope. Fall 2021.

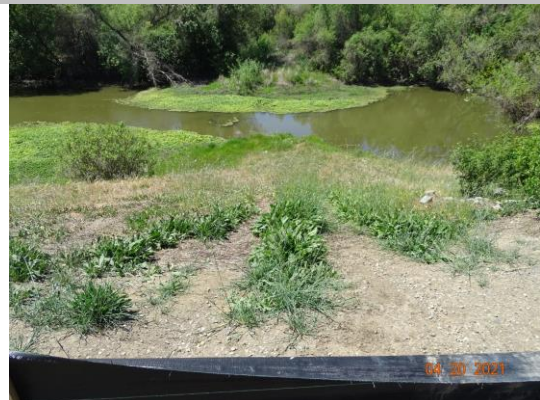
Photo 1 of 1 : FA_2021_RD0785_186_24_20210907_00002.jpg

LM Start	1.52	Rating **	M	Issue No.	24
LM End	1.52	Issue Type +	Ma	Location *	WS
Category	Earthen Levee			GPS Latitude/Longitude	
				Start	End
Item	Slope Stability			38.621694 °	38.621694 °
				-121.607610 °	-121.607610 °
DWR ID	DWR_RD0785_02_s_2017_24				
Comment Code					
S2 : Repair the levee slope damaged by foot traffic and prevent access where possible.					
Inspector Comment					
Footpath for environmental access site. There is a noticeable dip on the waterside slope.

View of footpath on the waterside slope. Spring 2021.
