**Flood Control Project Maintenance  
Levee Inspections**

**Maintenance Issue Types Only, Levee Inspection Report By Mile - Fall 2022**

**Reclamation District No. 0785 Driver**

Waterway	Bank	Unit Miles	Inspection Start/End	Inspector
Unit No. 01 Sacramento River	Right	2.26	11/01/2022 11/01/2022	Zach Jojola

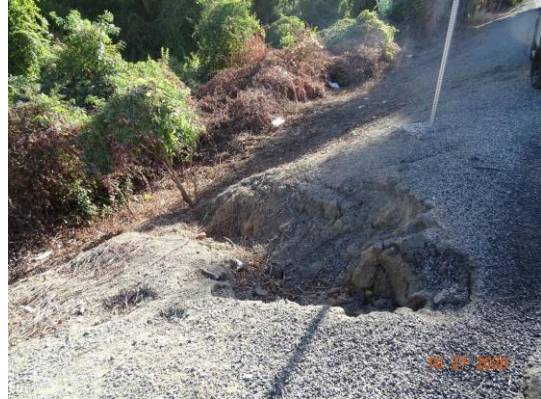
Photo 1 of 1 : FA\_2022\_RD0785\_185\_24\_20220921\_00006.jpg

LM Start	0.24	Rating **	U	Issue No.	24
LM End	0.24	Issue Type +	Ma	Location *	WS
Category	Earthen Levee			GPS Latitude/Longitude	
				Start	End
Item	Erosion / Rills			38.658998 °	38.658998 °
				-121.610081 °	-121.610081 °
DWR ID	DWR_RD0785_01_s_2017_24				
Comment Code					
E5 : Schedule repair of rills prior to the next inspection.					
Inspector Comment					
Runoff erosion on waterside slope.

View of erosion on waterside slope. Fall 2020.

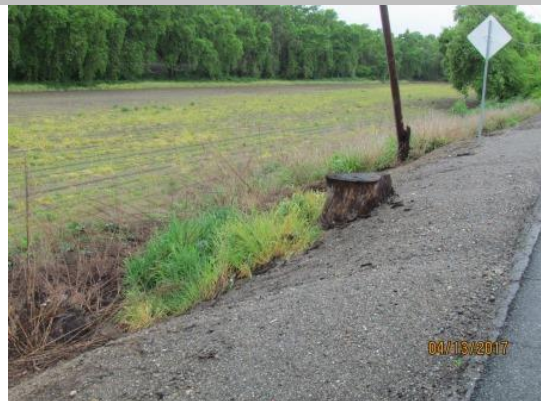
Photo 1 of 1 : FA\_2022\_RD0785\_185\_36\_20220921\_00009.jpg

LM Start	0.28	Rating **	N	Issue No.	36
LM End	0.28	Issue Type +	Ma	Location *	LS
Category	Earthen Levee			GPS Latitude/Longitude	
				Start	End
Item	Trim / Thin Trees			38.658537 °	38.658537 °
				-121.609675 °	-121.609675 °
DWR ID	DWR_RD0785_01_f_2021_36				
Comment Code					
T5 : Tree stumps.					
Inspector Comment

View of stump on landside levee slope. Spring 2017.

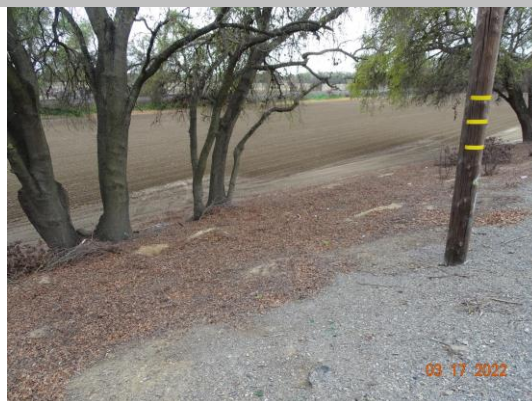
Photo 1 of 1 : FA\_2022\_RD0785\_185\_15\_20220921\_00003.jpg

LM Start	0.50	Rating **	M	Issue No.	15
LM End	0.50	Issue Type +	Ma	Location *	LS
Category	Earthen Levee			GPS Latitude/Longitude	
				Start	End
Item	Animal Control			38.655860 °	38.655860 °
				-121.607249 °	-121.607249 °
DWR ID	DWR_RD0785_01_s_2022_15				
Comment Code					
A3 : No rodents visible, but rodent burrows visible; need to backfill and compact or grout burrows.					
Inspector Comment					
Rodent holes on the landside slope.

View of rodent holes on the landside slope. Spring 2022.

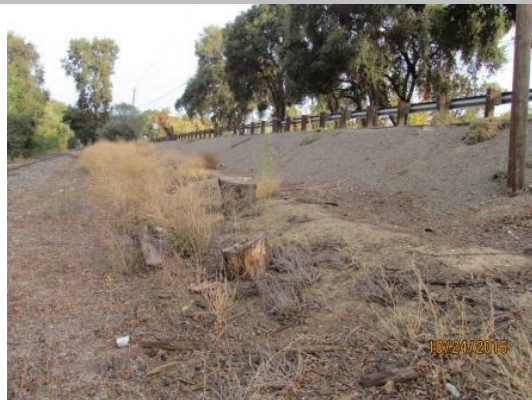
Photo 1 of 1 : FA\_2022\_RD0785\_185\_28\_20220921\_00007.jpg

LM Start	0.99	Rating **	N	Issue No.	28
LM End	0.99	Issue Type +	Ma	Location *	LS
Category	Earthen Levee			GPS Latitude/Longitude	
				Start	End
Item	Trim / Thin Trees			38.650055 °	38.650055 °
				-121.602752 °	-121.602752 °
DWR ID	DWR_RD0785_01_f_2022_28				
Comment Code					
T5 : Tree stumps.					
Inspector Comment

Two tree stumps near levee toe on landside. Fall 2016.

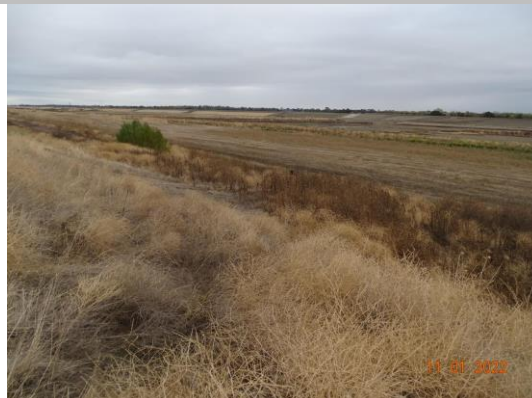
Photo 1 of 1 : FA\_2022\_RD0785\_186\_280\_20221102\_00006.jpg

LM Start	0.38	Rating **	A/W	Issue No.	280
LM End	0.38	Issue Type +	Ma	Location *	LS
Category	Earthen Levee			GPS Latitude/Longitude	
				Start	End
Item	Slope Stability			38.636265 °	38.636265 °
				-121.617422 °	-121.617422 °
DWR ID	DWR_RD0785_02_s_2015_280				
Comment Code					
S1 : Repair slope instability.					
Inspector Comment					
Seems to be a bulge at the toe of the levee. Recommend monitoring.

View of bulge on the landside slope. Fall 2022.

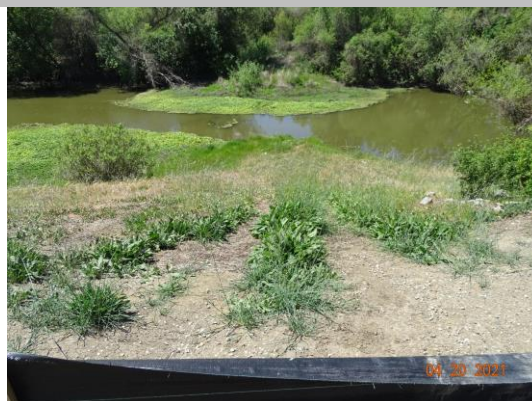
Photo 1 of 1 : FA\_2022\_RD0785\_186\_24\_20220921\_00002.jpg

LM Start	1.52	Rating **	M	Issue No.	24
LM End	1.52	Issue Type +	Ma	Location *	WS
Category	Earthen Levee			GPS Latitude/Longitude	
				Start	End
Item	Erosion / Foot Traffic			38.621694 °	38.621694 °
				-121.607610 °	-121.607610 °
DWR ID	DWR_RD0785_02_s_2017_24				
Comment Code					
E3 : Repair the levee slope damaged by foot traffic and prevent access where possible.					
Inspector Comment					
Footpath for environmental access site. There is a noticeable dip on the waterside slope.

View of footpath on the waterside slope. Spring 2021.
