**Flood Control Project Maintenance
Levee Inspections**

Maintenance Issue Types Only, Levee Inspection Report By Mile - Fall 2023

Reclamation District No. 0785 Driver

Waterway	Bank	Unit Miles	Inspection Start/End	Inspector
Unit No. 01 Sacramento River	Right	2.26	09/28/2023 09/28/2023	Nate Hicks

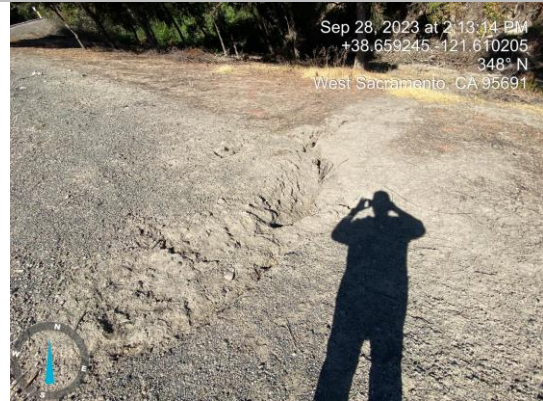
Photo 1 of 1 : FA_2023_RD0785_185_23_20231002_00022.jpg

LM Start	0.22	Rating **	M	Issue No.	23
LM End	0.22	Issue Type +	Ma	Location *	WS
Category	Earthen Levee			GPS Latitude/Longitude	
				Start	End
Item	Erosion / Rills			38.659245°	38.659245°
				-121.610205°	-121.610205°
DWR ID	DWR_RD0785_01_f_2023_23				
Comment Code					
E5 : Schedule repair of rills prior to the next inspection.					
Inspector Comment

View of erosion on waterside slope (Fall 2023).

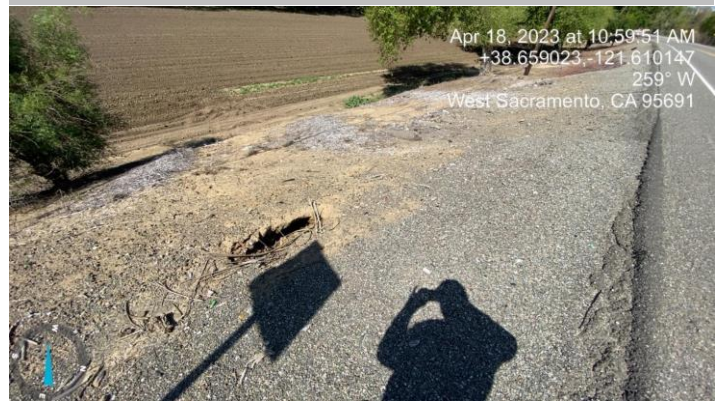
Photo 1 of 1 : FA_2023_RD0785_185_16_20230927_00008.jpg

LM Start	0.23	Rating **	M	Issue No.	16
LM End	0.23	Issue Type +	Ma	Location *	LS
Category	Earthen Levee			GPS Latitude/Longitude	
				Start	End
Item	Animal Control			38.659023°	38.659023°
				-121.610147°	-121.610147°
DWR ID	DWR_RD0785_01_s_2023_16				
Comment Code					
A1 : Exterminate rodents and backfill and compact or grout burrows.					
Inspector Comment

View of rodent holes on the landside slope (Spring 2023).

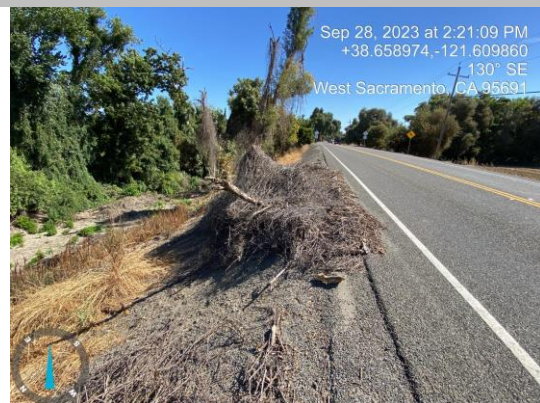
Photo 1 of 1 : FA_2023_RD0785_185_25_20231002_00021.jpg

LM Start	0.25	Rating **	M	Issue No.	25
LM End	0.25	Issue Type +	Ma	Location *	WS
Category	Earthen Levee			GPS Latitude/Longitude	
				Start	End
Item	Vegetation			38.658974°	38.658974°
				-121.609860°	-121.609860°
DWR ID	DWR_RD0785_01_f_2023_25				
Comment Code					
V2 : Remove the wild growth and woody vegetation other than native grasses from the levee slopes.					
Inspector Comment

View of woody vegetation on waterside slope (Fall 2023).

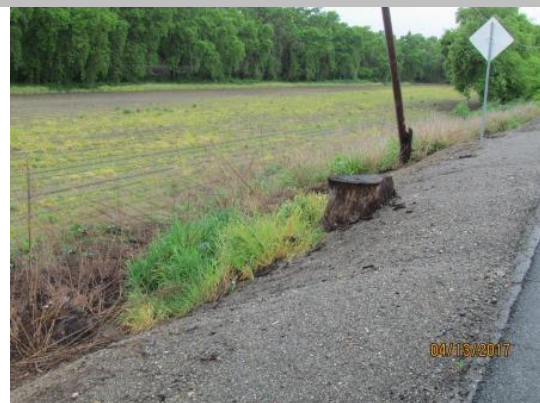
Photo 1 of 1 : FA_2023_RD0785_185_36_20230927_00013.jpg

LM Start	0.28	Rating **	N	Issue No.	36
LM End	0.28	Issue Type +	Ma	Location *	LS
Category	Earthen Levee			GPS Latitude/Longitude	
				Start	End
Item	Trim / Thin Trees			38.658537°	38.658537°
				-121.609675°	-121.609675°
DWR ID	DWR_RD0785_01_f_2021_36				
Comment Code					
T5 : Tree stumps.					
Inspector Comment

View of stump on landside levee slope. Spring 2017.

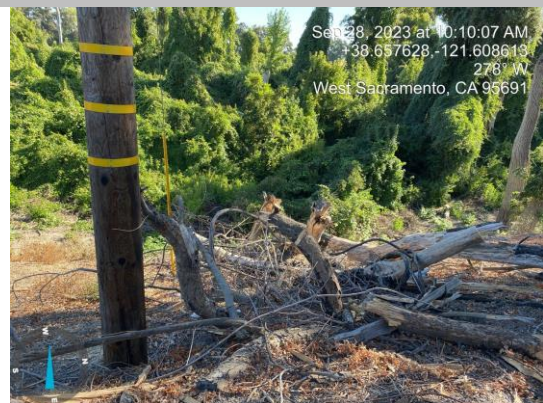
Photo 1 of 1 : FA_2023_RD0785_185_20_20230928_00018.jpg

LM Start	0.36	Rating **	M	Issue No.	20
LM End	0.36	Issue Type +	Ma	Location *	WS
Category	Earthen Levee			GPS Latitude/Longitude	
				Start	End
Item	Trim / Thin Trees			38.657628°	38.657628°
				-121.608613°	-121.608613°
DWR ID	DWR_RD0785_01_f_2023_20				
Comment Code					
T2 : Tree or limb.					
Inspector Comment					
Remove fallen tree and limbs off of levee slope.

View of fallen tree and limbs on waterside slope (Fall 2023).

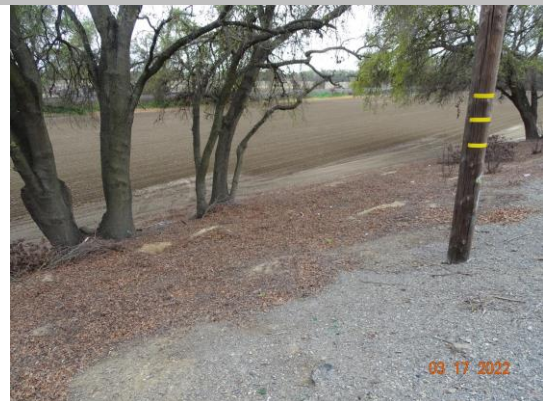
Photo 1 of 1 : FA_2023_RD0785_185_15_20230927_00007.jpg

LM Start	0.50	Rating **	M	Issue No.	15
LM End	0.50	Issue Type +	Ma	Location *	LS
Category	Earthen Levee			GPS Latitude/Longitude	
				Start	End
Item	Animal Control			38.655860°	38.655860°
				-121.607249°	-121.607249°
DWR ID	DWR_RD0785_01_s_2022_15				
Comment Code					
A3 : No rodents visible, but rodent burrows visible; need to backfill and compact or grout burrows.					
Inspector Comment					
Rodent holes on the landside slope.

View of rodent holes on the landside slope. Spring 2022.

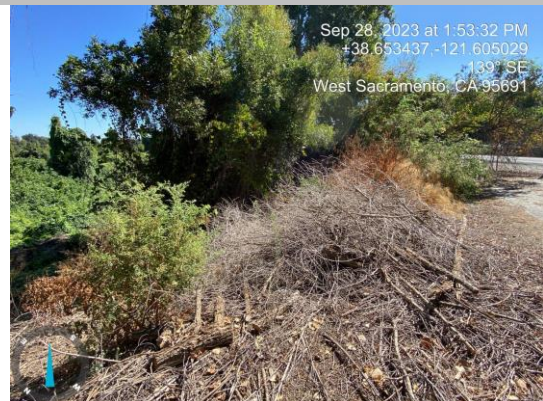
Photo 1 of 1 : FA_2023_RD0785_185_17_20231002_00023.jpg

LM Start	0.73	Rating **	M	Issue No.	17
LM End	0.73	Issue Type +	Ma	Location *	WS
Category	Earthen Levee			GPS Latitude/Longitude	
				Start	End
Item	Vegetation			38.653437°	38.653437°
				-121.605029°	-121.605029°
DWR ID	DWR_RD0785_01_f_2023_17				
Comment Code					
V2 : Remove the wild growth and woody vegetation other than native grasses from the levee slopes.					
Inspector Comment

View of woody vegetation on waterside slope (Fall 2023).

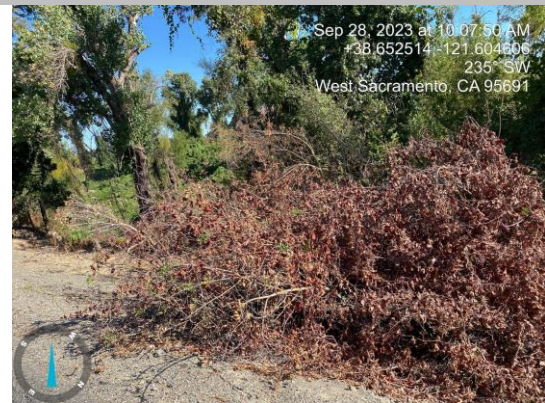
Photo 1 of 1 : FA_2023_RD0785_185_19_20230928_00019.jpg

LM Start	0.80	Rating **	M	Issue No.	19
LM End	0.80	Issue Type +	Ma	Location *	WS
Category	Earthen Levee			GPS Latitude/Longitude	
				Start	End
Item	Vegetation			38.652514°	38.652514°
				-121.604606°	-121.604606°
DWR ID	DWR_RD0785_01_f_2023_19				
Comment Code					
V2 : Remove the wild growth and woody vegetation other than native grasses from the levee slopes.					
Inspector Comment

View of woody vegetation on waterside slope (Fall 2023).

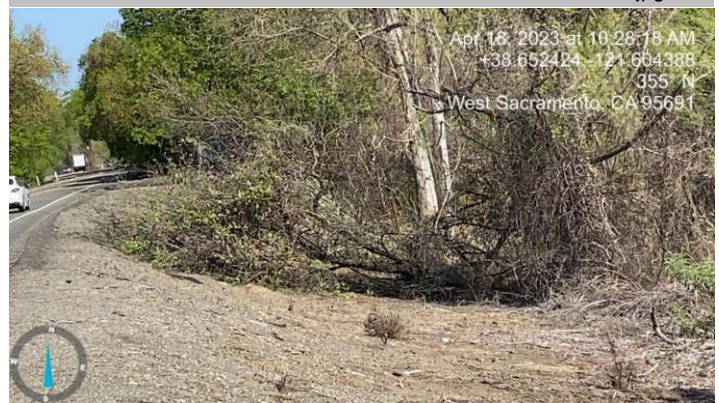
Photo 1 of 1 : FA_2023_RD0785_185_12_20230927_00005.jpg

LM Start	0.81	Rating **	M	Issue No.	12
LM End	0.81	Issue Type +	Ma	Location *	WS
Category	Earthen Levee			GPS Latitude/Longitude	
				Start	End
Item	Trim / Thin Trees			38.652424°	38.652424°
				-121.604388°	-121.604388°
DWR ID	DWR_RD0785_01_s_2023_12				
Comment Code					
T2 : Tree or limb.					
Inspector Comment

View of fallen tree on levee slope (Spring 2023).

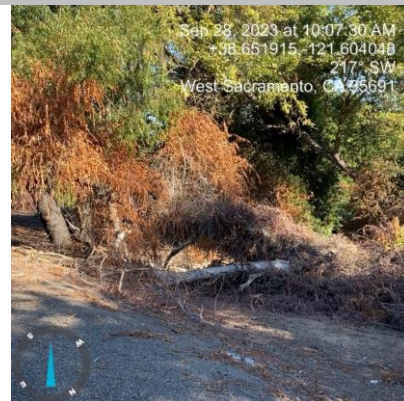
Photo 1 of 1 : FA_2023_RD0785_185_18_20230928_00020.jpg

LM Start	0.85	Rating **	M	Issue No.	18
LM End	0.85	Issue Type +	Ma	Location *	WS
Category	Earthen Levee			GPS Latitude/Longitude	
				Start	End
Item	Trim / Thin Trees			38.651915°	38.651915°
				-121.604048°	-121.604048°
DWR ID	DWR_RD0785_01_f_2023_18				
Comment Code					
T2 : Tree or limb.					
Inspector Comment					
Remove fallen tree and limbs off of levee slope.

View of fallen tree and limbs on waterside slope (Fall 2023).

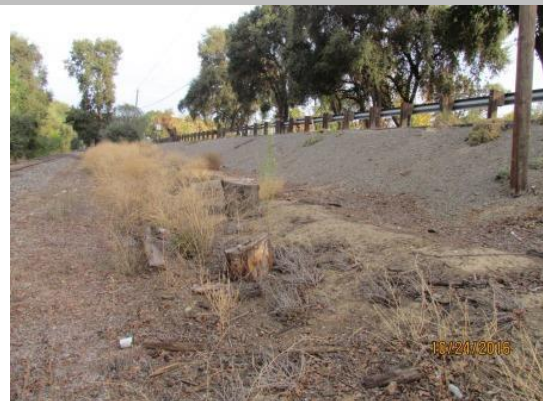
Photo 1 of 1 : FA_2023_RD0785_185_28_20230927_00011.jpg

LM Start	0.99	Rating **	N	Issue No.	28
LM End	0.99	Issue Type +	Ma	Location *	LS
Category	Earthen Levee			GPS Latitude/Longitude	
				Start	End
Item	Trim / Thin Trees			38.650055°	38.650055°
				-121.602752°	-121.602752°
DWR ID	DWR_RD0785_01_f_2022_28				
Comment Code					
T5 : Tree stumps.					
Inspector Comment

Two tree stumps near levee toe on landside. Fall 2016.

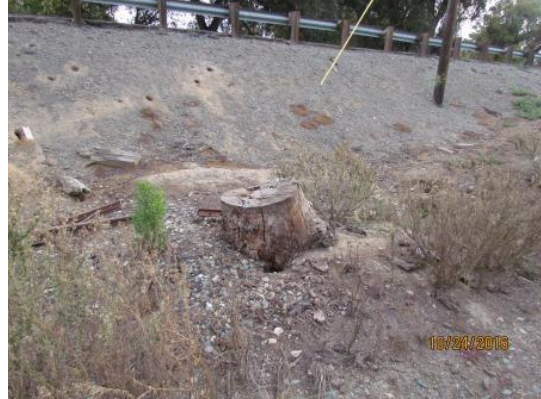
Photo 1 of 1 : FA_2023_RD0785_185_30_20230927_00012.jpg

LM Start	1.02	Rating **	N	Issue No.	30
LM End	1.02	Issue Type +	Ma	Location *	LS
Category	Earthen Levee			GPS Latitude/Longitude	
				Start	End
Item	Trim / Thin Trees			38.649775°	38.649775°
				-121.602363°	-121.602363°
DWR ID	DWR_RD0785_01_f_2016_30				
Comment Code					
T5 : Tree stumps.					
Inspector Comment					
There is a tree stump near the levee toe.

View of a stump near levee toe on landside. Fall 2016.

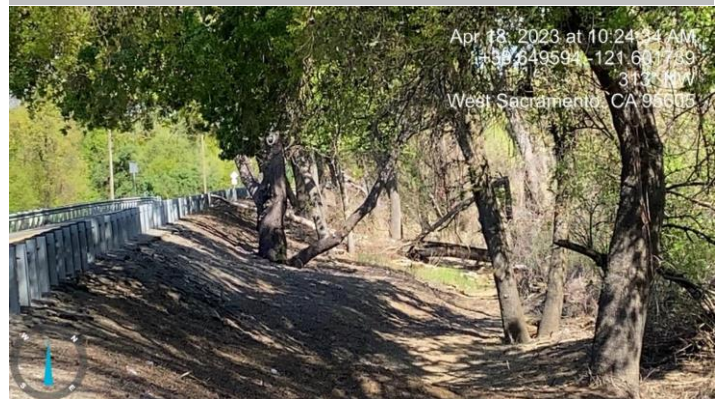
Photo 1 of 1 : FA_2023_RD0785_185_8_20230927_00002.jpg

LM Start	1.05	Rating **	M	Issue No.	8
LM End	1.05	Issue Type +	Ma	Location *	WS
Category	Earthen Levee			GPS Latitude/Longitude	
				Start	End
Item	Trim / Thin Trees			38.649594°	38.649594°
				-121.601739°	-121.601739°
DWR ID	DWR_RD0785_01_s_2023_8				
Comment Code					
T2 : Tree or limb.					
Inspector Comment

View of fallen trees on levee slope (Spring 2023).

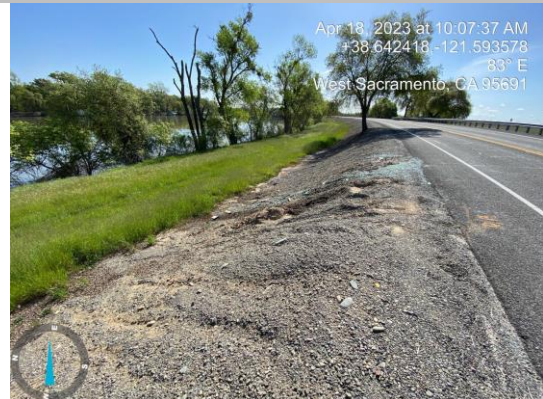
Photo 1 of 1 : FA_2023_RD0785_185_4_20230927_00001.jpg

LM Start	1.72	Rating **	U	Issue No.	4
LM End	1.72	Issue Type +	Ma	Location *	WS
Category	Earthen Levee			GPS Latitude/Longitude	
				Start	End
Item	Erosion / Rills			38.642418°	38.642418°
				-121.593578°	-121.593578°
DWR ID	DWR_RD0785_01_s_2023_4				
Comment Code					
E5 : Schedule repair of rills prior to the next inspection.					
Inspector Comment					
Rills and erosion on the waterside slope.

View of erosion/rills on levee slope (Spring 2023).

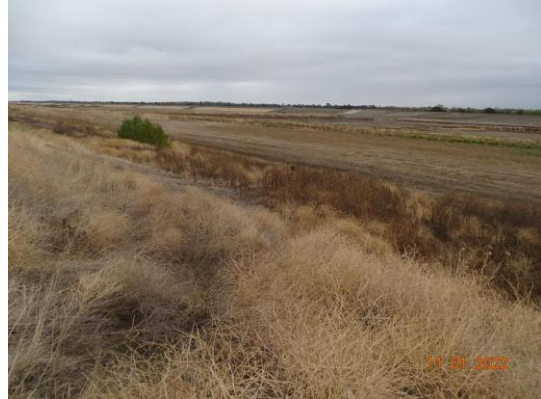
Photo 1 of 1 : FA_2023_RD0785_186_280_20230927_00006.jpg

LM Start	0.38	Rating **	A/W	Issue No.	280
LM End	0.38	Issue Type +	Ma	Location *	LS
Category	Earthen Levee			GPS Latitude/Longitude	
				Start	End
Item	Slope Stability			38.636265°	38.636265°
				-121.617422°	-121.617422°
DWR ID	DWR_RD0785_02_s_2023_280				
Comment Code					
S1 : Repair slope instability.					
Inspector Comment					
Seems to be a bulge at the toe of the levee. Recommend monitoring.

View of bulge on the landside slope. Fall 2022.

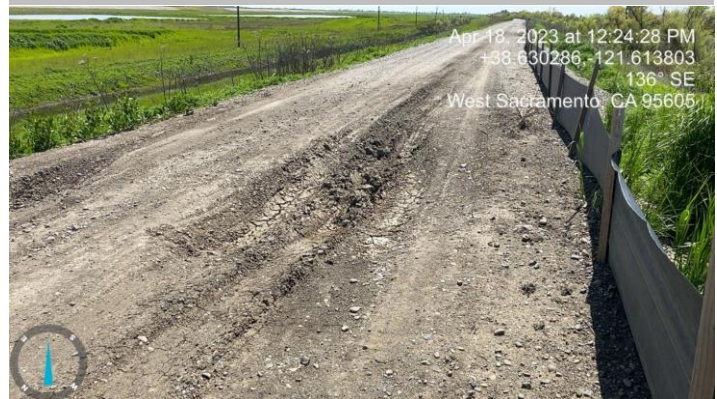
Photo 1 of 1 : FA_2023_RD0785_186_4_20230927_00003.jpg

LM Start	0.84	Rating **	A/W	Issue No.	4
LM End	0.84	Issue Type +	Ma	Location *	CR
Category	Earthen Levee			GPS Latitude/Longitude	
				Start	End
Item	Crown Surface / Depressions / Rutting			38.630286°	38.630286°
				-121.613803°	-121.613803°
DWR ID	DWR_RD0785_02_s_2023_4				
Comment Code					
C2 : Repair depressions or ruts in the crown or slope.					
Inspector Comment

View of rutting on levee crown (Spring 2023).

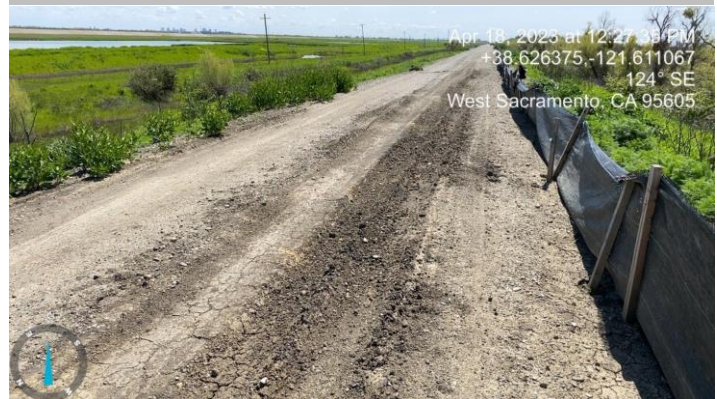
Photo 1 of 1 : FA_2023_RD0785_186_3_20230927_00002.jpg

LM Start	1.14	Rating **	A/W	Issue No.	3
LM End	1.14	Issue Type +	Ma	Location *	CR
Category	Earthen Levee			GPS Latitude/Longitude	
				Start	End
Item	Crown Surface / Depressions / Rutting			38.626375°	38.626375°
				-121.611067°	-121.611067°
DWR ID	DWR_RD0785_02_s_2023_3				
Comment Code					
C2 : Repair depressions or ruts in the crown or slope.					
Inspector Comment

View of rutting on levee crown (Spring 2023).

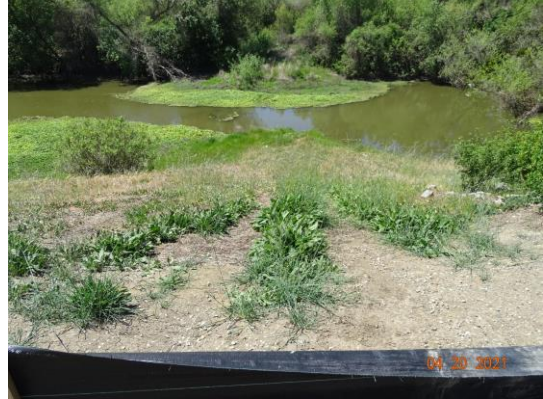
Photo 1 of 1 : FA_2023_RD0785_186_24_20230927_00005.jpg

LM Start	1.52	Rating **	A/W	Issue No.	24
LM End	1.52	Issue Type +	Ma	Location *	WS
Category	Earthen Levee			GPS Latitude/Longitude	
				Start	End
Item	Erosion / Foot Traffic			38.621694°	38.621694°
				-121.607610°	-121.607610°
DWR ID	DWR_RD0785_02_s_2017_24				
Comment Code					
E3 : Repair the levee slope damaged by foot traffic and prevent access where possible.					
Inspector Comment					
Footpath for environmental access site. There is a noticeable dip on the waterside slope.

View of footpath on the waterside slope. Spring 2021.

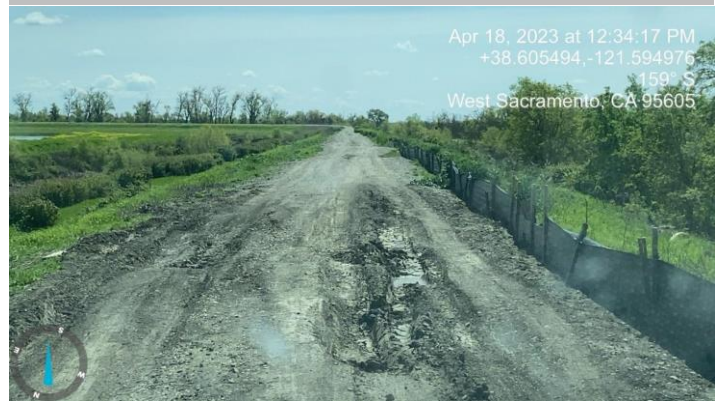
Photo 1 of 1 : FA_2023_RD0785_186_2_20230927_00001.jpg

LM Start	2.83	Rating **	A/W	Issue No.	2
LM End	2.83	Issue Type +	Ma	Location *	CR
Category	Earthen Levee			GPS Latitude/Longitude	
				Start	End
Item	Crown Surface / Depressions / Rutting			38.605494°	38.605494°
				-121.594976°	-121.594976°
DWR ID	DWR_RD0785_02_s_2023_2				
Comment Code					
C2 : Repair depressions or ruts in the crown or slope.					
Inspector Comment

View of rutting on the levee crown (Spring 2023).
