**Flood Control Project Maintenance  
Levee Inspections**

**Fall 2012 Levee Maintenance Deficiency Summary Report**

**Reclamation District No. 0787 Fair**

Waterway	Bank	Unit Miles
Unit No. 01 Colusa Basin Drain	Left	4.40

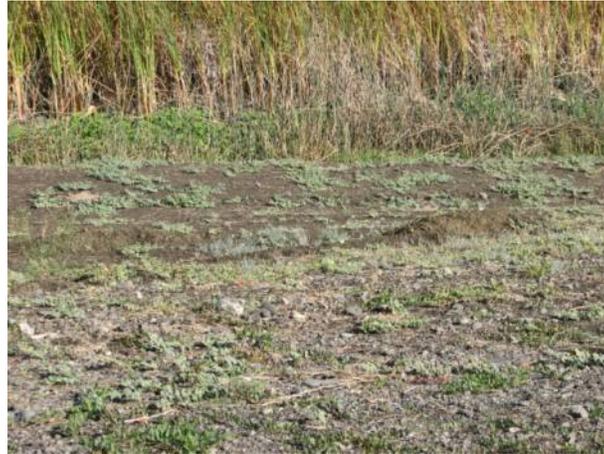
Levee Mile Report Line	6
Start Levee Mile	0.90
End Levee Mile	0.90
Location	Land Side
Category	Earthen Levee
Item	Animal Control

Rodent holes near the toe of the levee slope.  
Photo fall 2012.

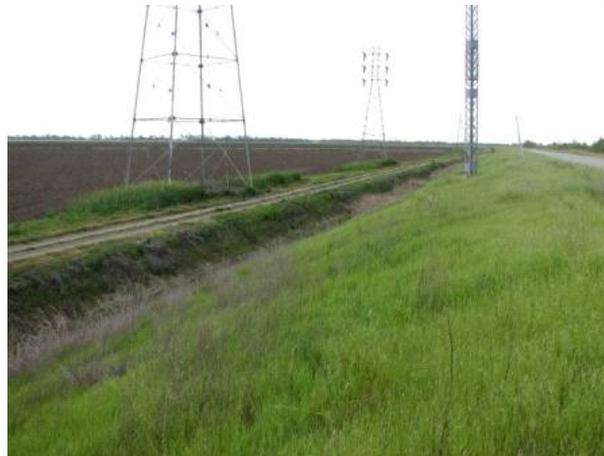
Levee Mile Report Line	8
Start Levee Mile	1.57
End Levee Mile	2.71
Location	Land Side
Category	Earthen Levee
Item	Encroachments

Agricultural ditch runs along land side the  
distance of the district.

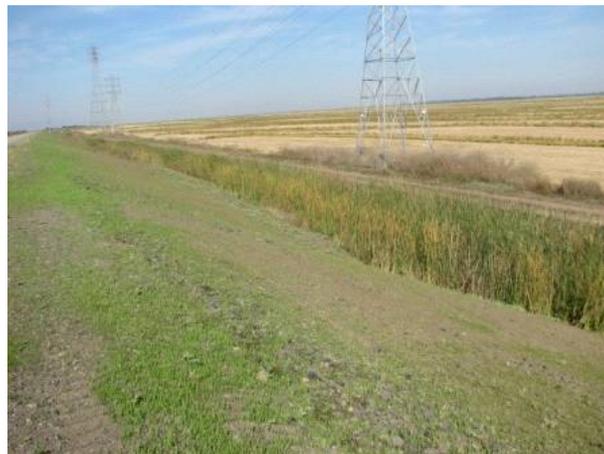
Levee Mile Report Line	8
Start Levee Mile	1.57
End Levee Mile	2.71
Location	Land Side
Category	Earthen Levee
Item	Encroachments

A view of the agricultural ditch in the fall of 2011.

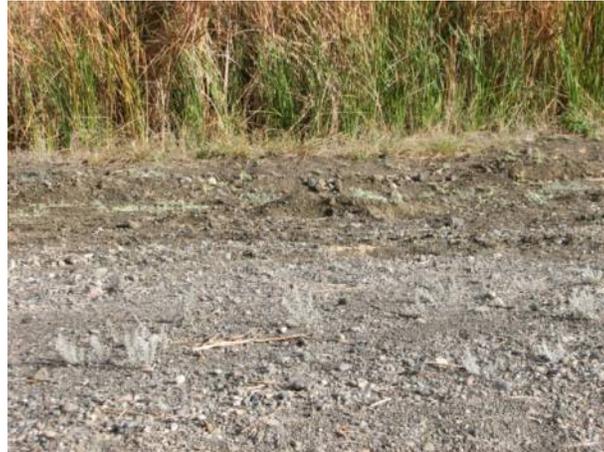
Levee Mile Report Line	9
Start Levee Mile	1.78
End Levee Mile	1.78
Location	Land Side
Category	Earthen Levee
Item	Animal Control
Rodent hole near the toe of the levee slope. Photo fall 2012.	
johngw_f_20121025_818.jpg

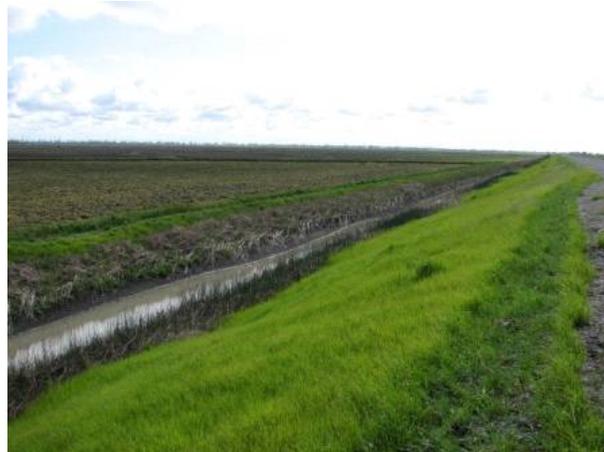
Levee Mile Report Line	10
Start Levee Mile	3.11
End Levee Mile	4.37
Location	Land Side
Category	Earthen Levee
Item	Encroachments
Ditch along landside toe.	
johngw_f_20120911_402.jpg

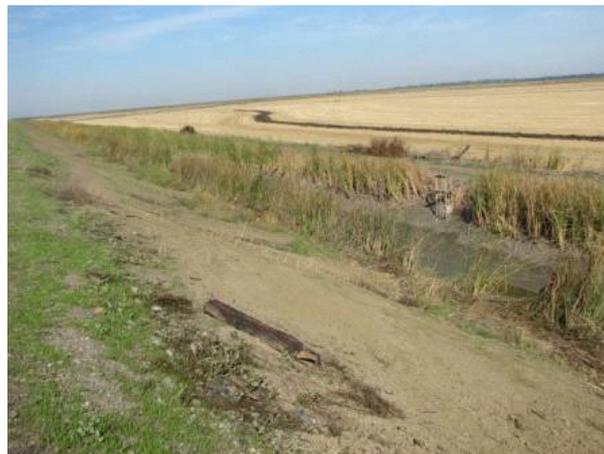
Levee Mile Report Line	10
Start Levee Mile	3.11
End Levee Mile	4.37
Location	Land Side
Category	Earthen Levee
Item	Encroachments
A current view of the agricultural ditch photo taken in fall of 2011.	
johngw_f_20120911_403.jpg
