**Flood Control Project Maintenance  
Levee Inspections**

**Fall 2015 Levee Maintenance Deficiency Summary Report  
Overall LMA & Unit Ratings, including USACE Erosion Survey**

**Reclamation District No. 0787 Fair**

Waterway		Bank	Unit Miles	
Unit No. 01 Colusa Basin Drain		Left	4.45	
	Spring (March - May)	Summer (June - August)	(September - November) Fall	Winter (December - February)
Unit Maintenance Rating (Fall Only)			<b>M</b>	
Date of Inspection	04/23/2015 - 04/23/2015		09/18/2015 - 09/18/2015	
DWR Inspector	Jai Lor		Jai Lor	
Accompanied By	Roger Cornwell Rivergarden Farms RD 787		Roger Cornwell Rivergarden Farms RD 787

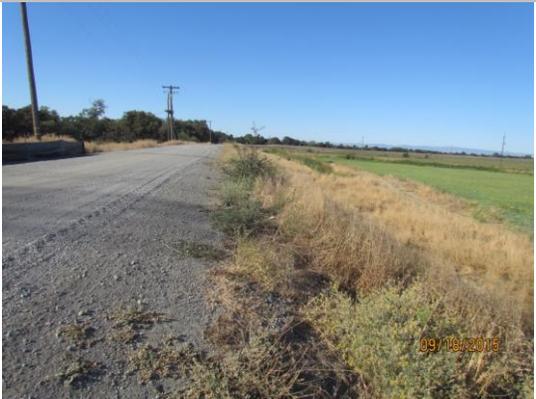
Photo 1 of 1 : FA\_2015\_RD0787\_212\_4\_20150921\_00009.jpg

LM Start	<b>0.01</b>	Rating **	M	Issue No.	<b>4</b>
LM End	<b>0.21</b>	Issue Type +	Ma	Location *	LS
Category	Earthen Levee		GPS Latitude/Longitude		
			Start	End	
Item	Vegetation		38.799591 °	38.797309 °	
			-121.725509 °	-121.727764 °	
DWR ID	DWR_RD0787_01_f_2015_4				
Action/Comments					
Control annual grass and weeds on the levee slopes and easements.

View of the vegetation on the landward side of the levee looking upstream. Fall 2015.

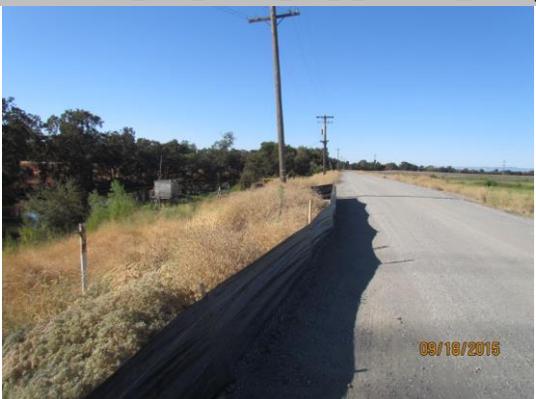
Photo 1 of 1 : FA\_2015\_RD0787\_212\_6\_20150921\_00010.jpg

LM Start	<b>0.03</b>	Rating **	M	Issue No.	<b>6</b>
LM End	<b>0.29</b>	Issue Type +	Ma	Location *	WS
Category	Earthen Levee		GPS Latitude/Longitude		
			Start	End	
Item	Vegetation		38.799382 °	38.796618 °	
			-121.725685 °	-121.729094 °	
DWR ID	DWR_RD0787_01_f_2015_6				
Action/Comments					
Control annual grass and weeds on the levee slopes and easements.

View of the vegetation on the waterward side of the levee looking downstream. Fall 2015.

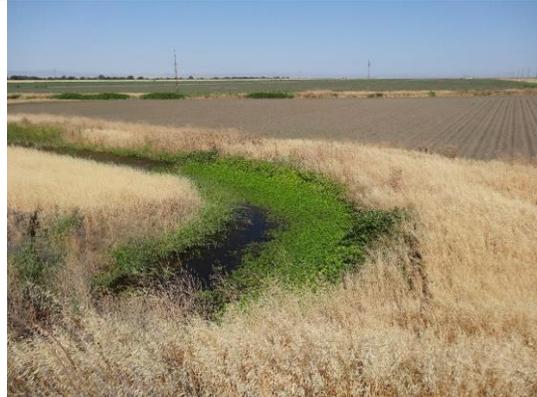
Photo 1 of 3 : UCIP\_FA\_2015\_4862.jpg

Item	DWR UCIP Field Study			38.799159 °	38.799159 °
				-121.725874 °	-121.725874 °
DWR ID					
Action/Comments					
Inspector Comments: FS_ID:37585 DS_ID:22892 EP_NO: 9392 FS_HLM: 0.05 Repair Type: Non-Urgent Crossing Status: Found UCIP Comments: Dense vegetation limits the inspector's visibility to identify signs of pipe failure (leaks) along the slope. Recommend removing vegetation along pipe alignment to conduct proper inspection of structure. FIELD_STRUCT_DESC: 36-inch concrete pipe through the levee 17.0 feet below the crown. Slide gate in 36-inch standpipe on the waterward side (App. 9392 - River Garden Farms). 24-inch pipe from standpipe to pump house mounted on steel structure in channel. Pump and 24-inch steel pipe installed on the waterward side, 1962 (App. 3878 - river Garden Farms). FS Date: 06/10/2014

View of landward side.

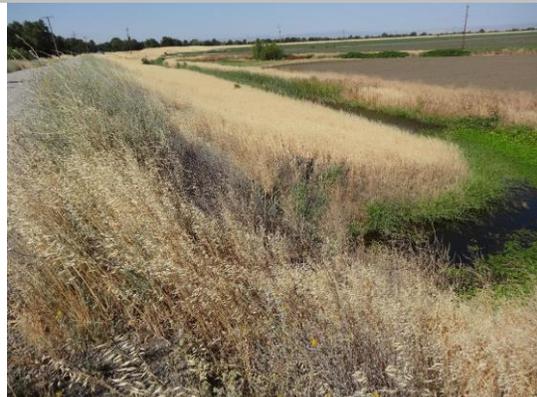
Photo 2 of 3 : UCIP\_FA\_2015\_4863.jpg

View of landward slope.

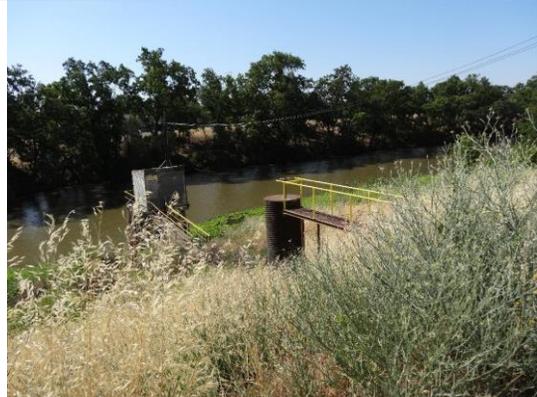
Photo 3 of 3 : UCIP\_FA\_2015\_6478.jpg

LM Start	<b>0.04</b>	Rating **	M	Issue No.	<b>15 (cont)</b>
LM End	<b>0.04</b>	Issue Type +	En	Location *	WS
Category	Supplemental			GPS Latitude/Longitude	
				Start	End
Item	DWR UCIP Field Study			38.799159 °	38.799159 °
				-121.725874 °	-121.725874 °
DWR ID					
Action/Comments					
Inspector Comments: FS_ID:37585 DS_ID:22892 EP_NO: 9392 FS_HLM: 0.05 Repair Type: Non-Urgent Crossing Status: Found

View of waterward side.

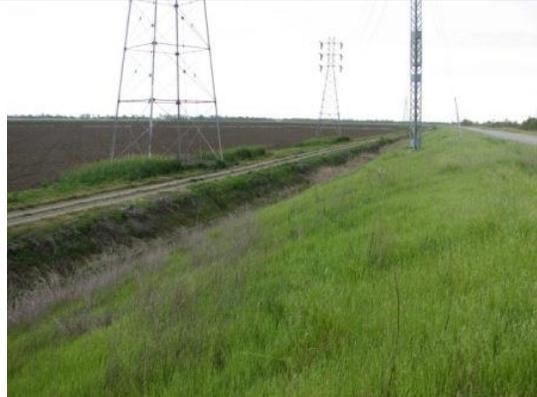
Photo 1 of 3 : FA\_2015\_RD0787\_212\_13\_20150914\_00003.jpg

LM Start	<b>1.58</b>	Rating **	M	Issue No.	<b>13</b>
LM End	<b>2.73</b>	Issue Type +	En	Location *	LS
Category	Earthen Levee		GPS Latitude/Longitude		
			Start	End	
Item	Encroachments		38.801794 °	38.809506 °	
			-121.750204 °	-121.768979 °	
DWR ID	DWR_RD0787_01_s_2012_13				
Action/Comments					
Ditch

Agricultural ditch runs along landside the distance of the district.

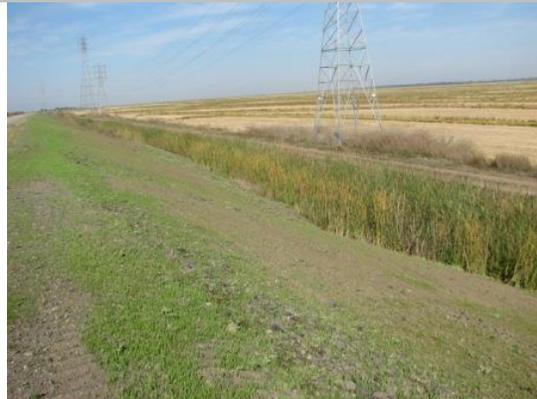
Photo 2 of 3 : FA\_2015\_RD0787\_212\_13\_20150914\_00004.jpg

A view of the agricultural ditch in the fall of 2011.

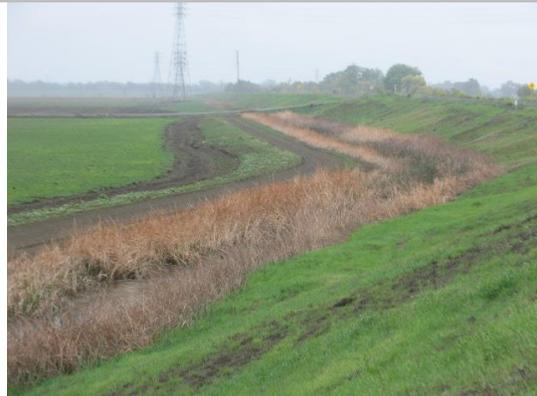
Photo 3 of 3 : FA\_2015\_RD0787\_212\_13\_20150914\_00005.jpg

The agricultural ditch runs along the toe of the levee. Spring 2014

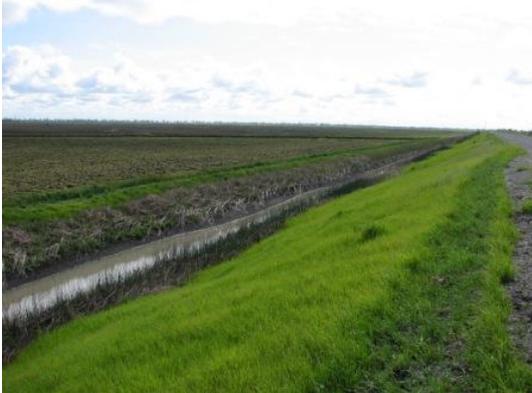
Photo 1 of 3 : FA\_2015\_RD0787\_212\_14\_20150914\_00006.jpg

LM Start	<b>3.13</b>	Rating **	M	Issue No.	<b>14</b>
LM End	<b>4.40</b>	Issue Type +	En	Location *	LS
Category	Earthen Levee		GPS Latitude/Longitude		
			Start	End	
Item	Encroachments		38.812963 °	38.822302 °	
			-121.774880 °	-121.795295 °	
DWR ID	DWR_RD0787_01_s_2012_14				
Action/Comments					
Ditch

Ditch along landside toe.

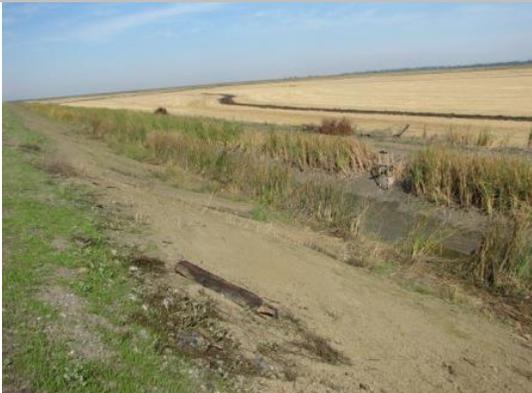
Photo 2 of 3 : FA\_2015\_RD0787\_212\_14\_20150914\_00007.jpg

A current view of the agricultural ditch photo taken in fall of 2011.

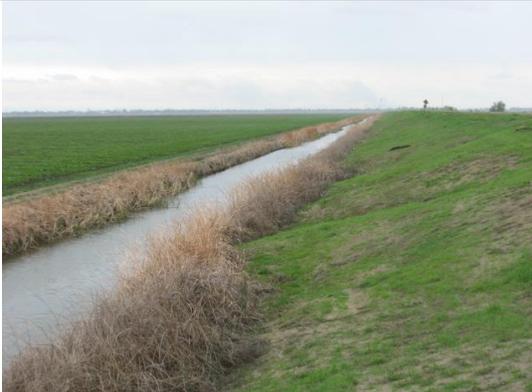
Photo 3 of 3 : FA\_2015\_RD0787\_212\_14\_20150914\_00008.jpg

The agricultural ditch runs along the toe of the levee slope. Spring 2014
