**Flood Control Project Maintenance
Levee Inspections
LMA District Cover Sheet
Spring 2010 Levee Inspection Results**

Levee Inspection Report By Mile - Spring 2010

Waterway	Bank	Unit Miles	Inspection Start/End	Inspector
Unit No. 01 Colusa Basin Drain	Left	4.40	04/05/2010 04/05/2010	John Williamson

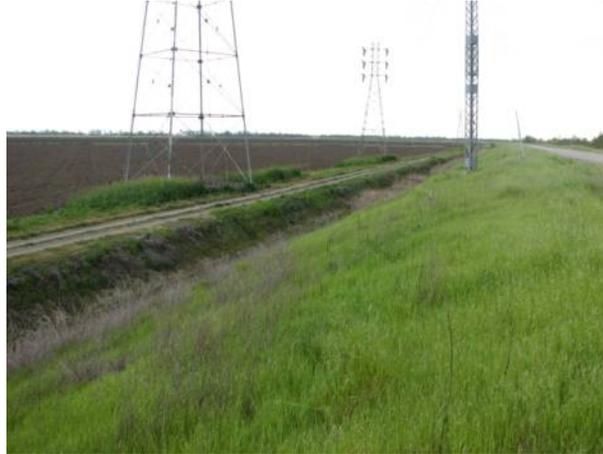
Levee Mile Report Line	3
Start Levee Mile	1.57
End Levee Mile	2.71
Location	Land Side
Category	Earthen Levee
Item	Encroachments
ag. ditch runs along land side the distance of the district	
johnwg_s_20100316_029.jpg

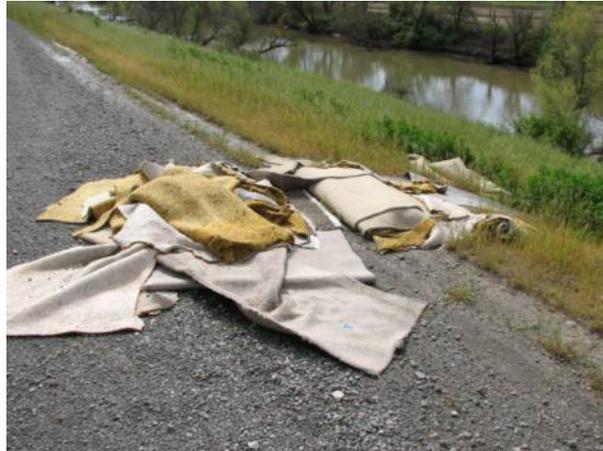
Levee Mile Report Line	4
Start Levee Mile	1.74
End Levee Mile	1.74
Location	Water Side
Category	Earthen Levee
Item	Encroachments
carpet	
johnwg_s_20100405_099.jpg

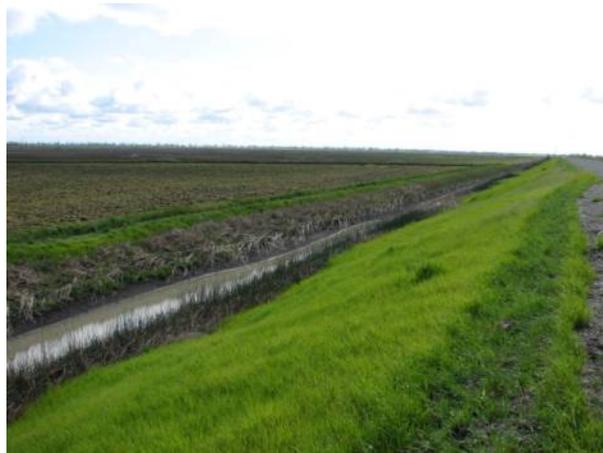
Levee Mile Report Line	5
Start Levee Mile	3.11
End Levee Mile	4.37
Location	Land Side
Category	Earthen Levee
Item	Encroachments
ditch along landside toe	
johnwg_s_20100405_100.jpg
