**Flood Control Project Maintenance
Levee Inspections
LMA District Cover Sheet
Spring 2011 Levee Inspection Results**

Reclamation District No. 0787 Fair

Levee Inspection Report By Mile - Spring 2011

Waterway	Bank	Unit Miles	Inspection Start/End	Inspector
Unit No. 01 Colusa Basin Drain	Left	4.40	03/15/2011 03/15/2011	John Williamson

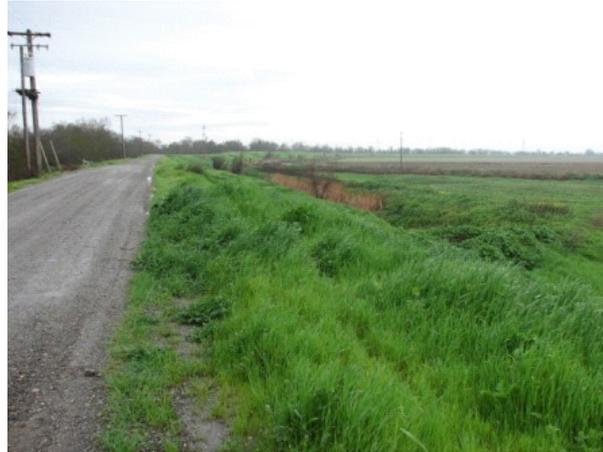
Levee Mile Report Line	1
Start Levee Mile	0.02
End Levee Mile	1.54
Location	Land Side
Category	Earthen Levee
Item	Vegetation
The view is the landside grasses are higher than 12".	
johngw_s_20110316_386.jpg

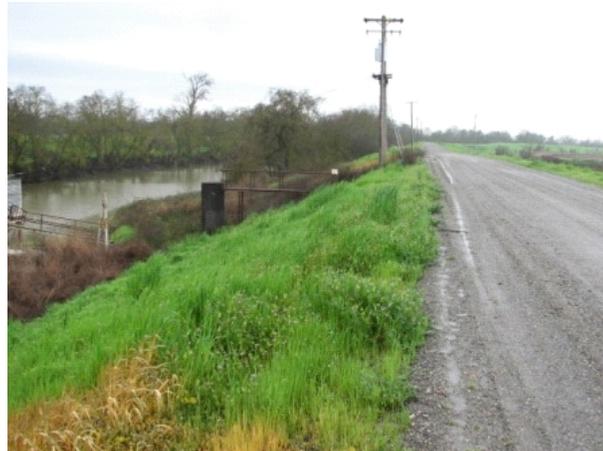
Levee Mile Report Line	2
Start Levee Mile	0.02
End Levee Mile	3.02
Location	Water Side
Category	Earthen Levee
Item	Vegetation
This view is the waterside grasses are higher than 12".	
johngw_s_20110316_387.jpg

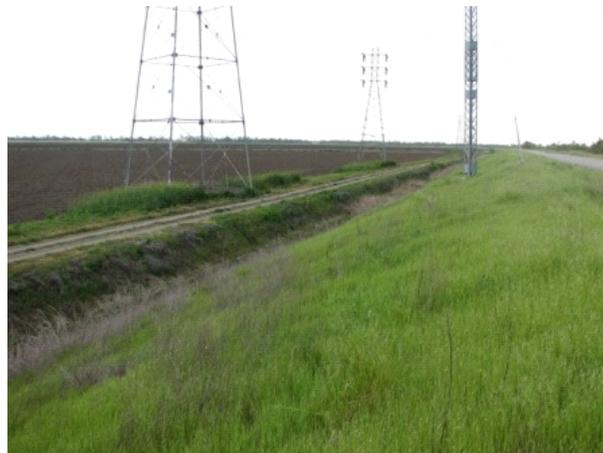
Levee Mile Report Line	3
Start Levee Mile	1.57
End Levee Mile	2.71
Location	Land Side
Category	Earthen Levee
Item	Encroachments
ag. ditch runs along land side the distance of the district	
johngw_s_20110228_209.jpg

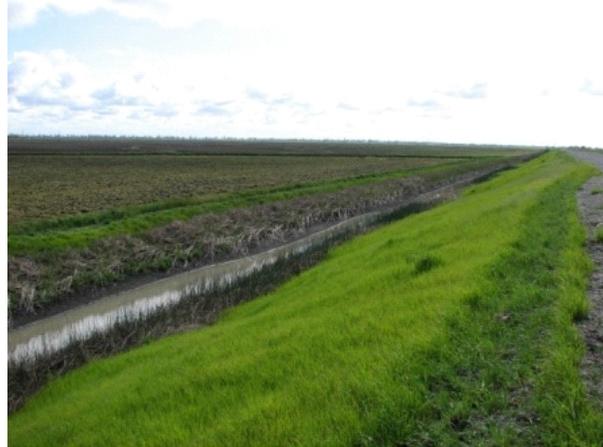
Levee Mile Report Line	5
Start Levee Mile	3.11
End Levee Mile	4.37
Location	Land Side
Category	Earthen Levee
Item	Encroachments
ditch along landside toe	
johngw_s_20110228_210.jpg
