**Flood Control Project Maintenance
Levee Inspections
LMA District Cover Sheet
Spring 2013 Levee Inspection Results**

**Flood Control Project Maintenance
Levee Inspections
Unit Cover Sheet
Spring 2013 Levee Inspection Results
Reclamation District No. 0787 Fair**

Levee Inspection Report By Mile - Spring 2013

Waterway		Bank	Unit Miles	Inspection Start/End	Inspector
Unit No. 01 Colusa Basin Drain		Left	4.40		John Williamson

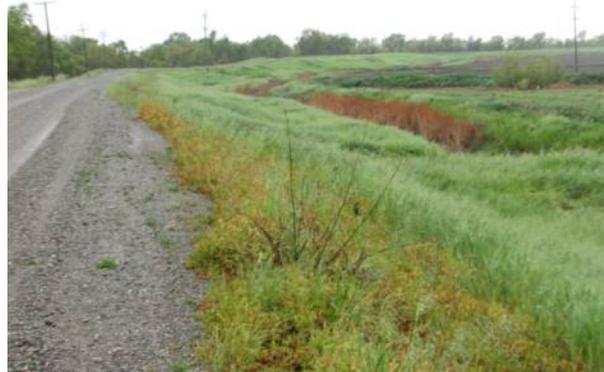
Levee Mile Report Line	4
Start Levee Mile	0.01
End Levee Mile	4.39
Location	Land Side
Category	
Item	Vegetation
The vegetation is taller than 12". Spring 2013	
johngw_s_20130408_921.JPG

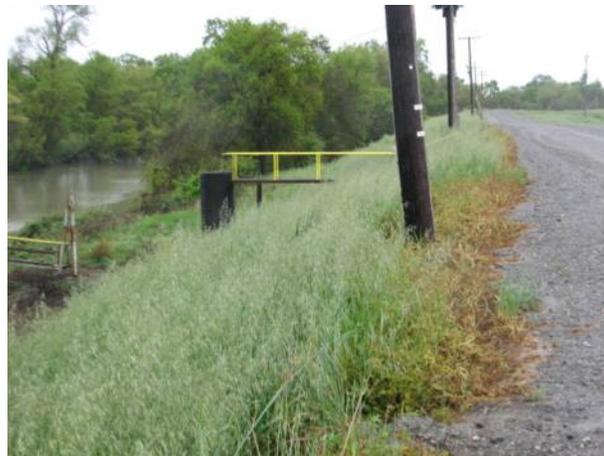
Levee Mile Report Line	5
Start Levee Mile	0.01
End Levee Mile	4.39
Location	Water Side
Category	
Item	Vegetation
The vegetation is taller than 12". Spring 2013	
johngw_s_20130408_922.JPG

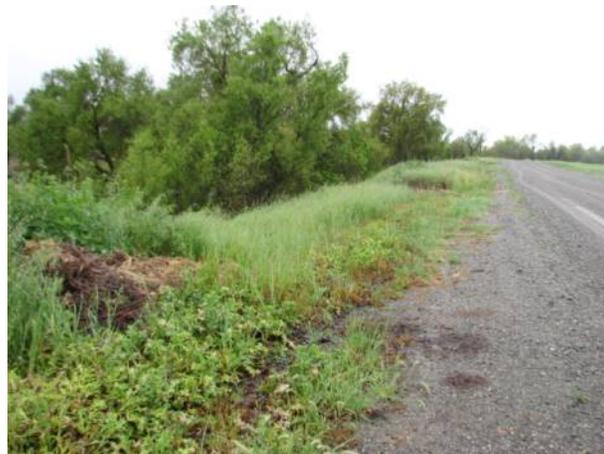
Levee Mile Report Line	6
Start Levee Mile	0.33
End Levee Mile	0.33
Location	Water Side
Category	
Item	Encroachments
Two piles of pruning's and debris on levee shoulder. Spring 2013	
johngw_s_20130408_923.JPG

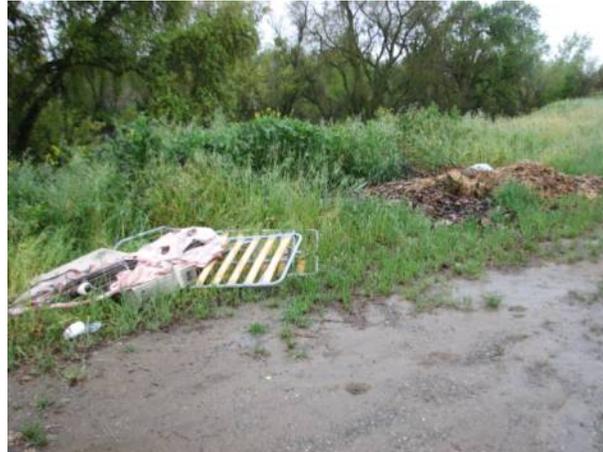
Levee Mile Report Line	8
Start Levee Mile	0.39
End Levee Mile	0.39
Location	Water Side
Category	
Item	Encroachments
Debris along the shoulder of the levee. Spring 2013	
johngw_s_20130408_924.JPG

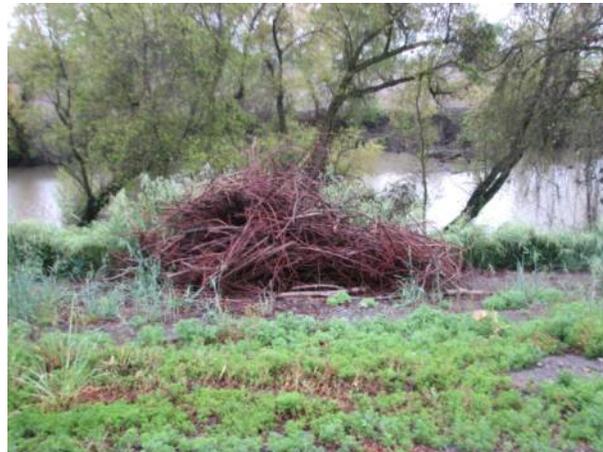
Levee Mile Report Line	9
Start Levee Mile	0.64
End Levee Mile	0.64
Location	Water Side
Category	
Item	Encroachments
Prunings pile along the shoulder of the waterside levee. Spring 2013	
johngw_s_20130408_925.JPG

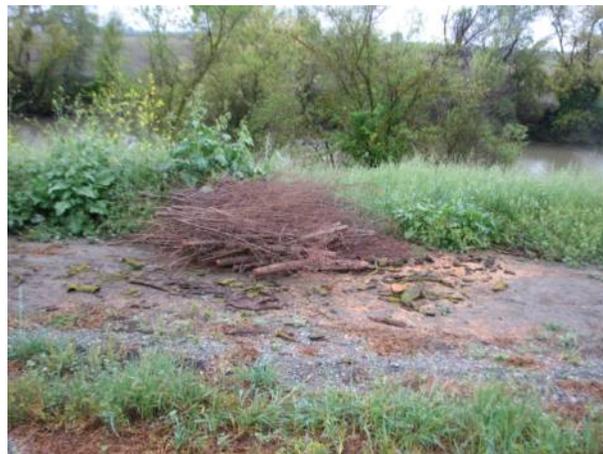
Levee Mile Report Line	12
Start Levee Mile	1.18
End Levee Mile	1.18
Location	Water Side
Category	
Item	Encroachments
Prunings along the waterside shoulder. Spring 2013	
johngw_s_20130408_926.JPG

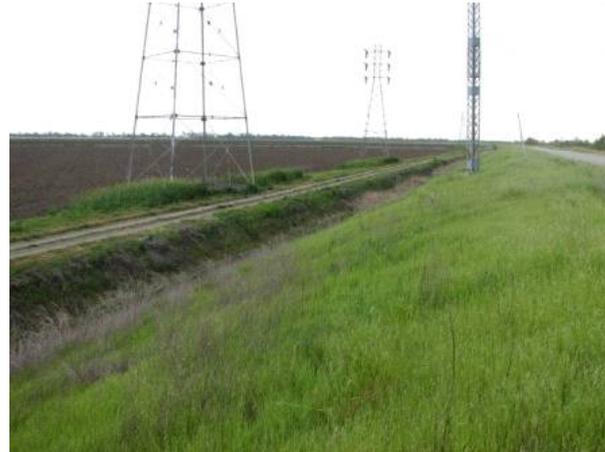
Levee Mile Report Line	13
Start Levee Mile	1.57
End Levee Mile	2.71
Location	Land Side
Category	
Item	Encroachments
Agricultural ditch runs along landside the distance of the district.	
johngw_s_20130221_434.jpg

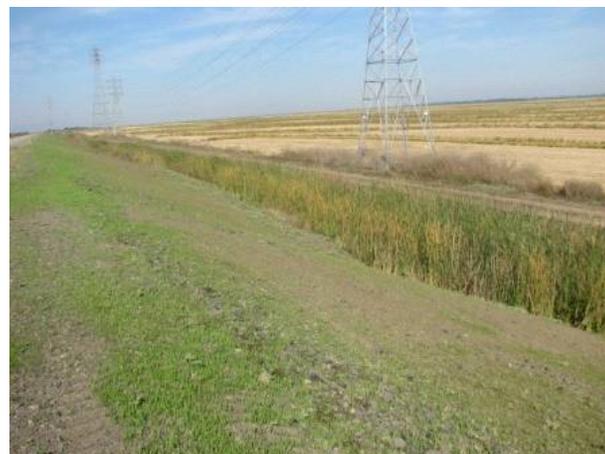
Levee Mile Report Line	13
Start Levee Mile	1.57
End Levee Mile	2.71
Location	Land Side
Category	
Item	Encroachments
A view of the agricultural ditch in the fall of 2011.	
johngw_s_20130221_435.jpg

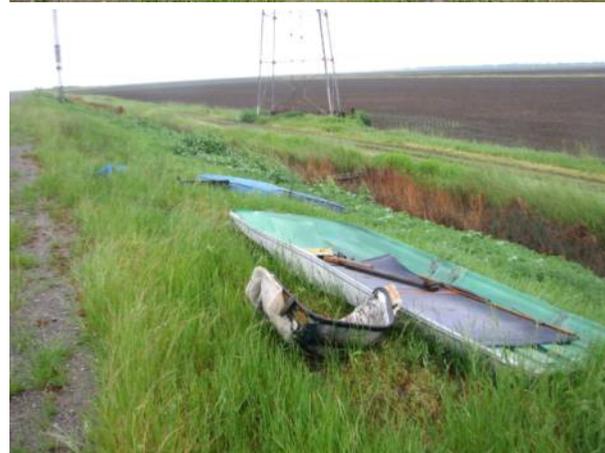
Levee Mile Report Line	15
Start Levee Mile	1.84
End Levee Mile	1.84
Location	Land Side
Category	
Item	Encroachments
Debris dumped along the landside slope. Spring 2013	
johngw_s_20130408_927.JPG

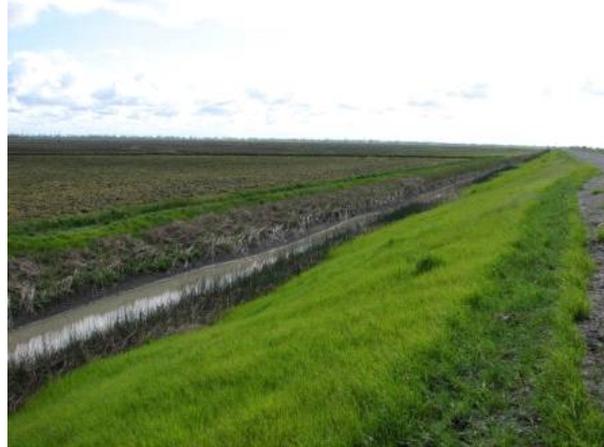
Levee Mile Report Line	16
Start Levee Mile	3.11
End Levee Mile	4.37
Location	Land Side
Category	
Item	Encroachments
Ditch along landside toe.	
johngw_s_20130221_436.jpg

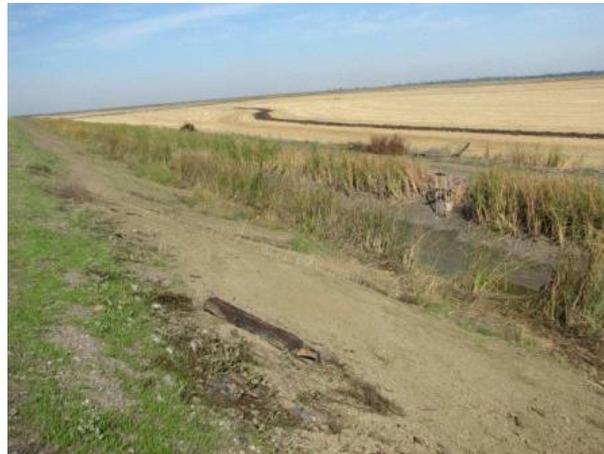
Levee Mile Report Line	16
Start Levee Mile	3.11
End Levee Mile	4.37
Location	Land Side
Category	
Item	Encroachments
A current view of the agricultural ditch photo taken in fall of 2011.	
johngw_s_20130221_437.jpg
