**Flood Control Project Maintenance  
Levee Inspections**  
**LMA District Cover Sheet**  
**Spring 2014 Levee Inspection Results**

**Reclamation District No. 0787 Fair**

**Spring 2014 Levee Inspection Results**

**Levee Inspection Report By Mile - Spring 2014**

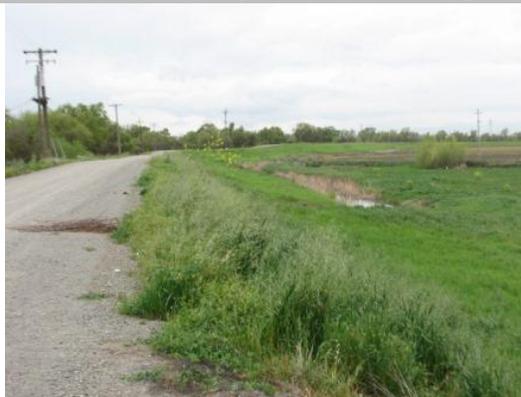
Photo 1 of 1 : johngw\_s\_20140401\_686.jpg

LM Start	<b>0.01</b>	Rating **	M	Issue No.	<b>3</b>
LM End	<b>4.40</b>	Issue Type +	Ma	Location *	LS
Category	Earthen Levee		GPS Latitude/Longitude		
			Start	End	
Item	Vegetation		38.799664 °	38.822441 °	
			-121.725401 °	-121.795729 °	
DWR ID	DWR_RD0787_01_s_2014_3				
Action/Comments					
Control annual grass and weeds on the levee slopes and easements.

Tall grasses, weeds partially blocks visibility. Spring 2014

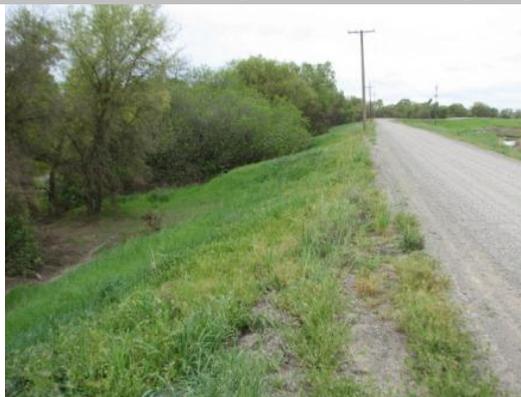
Photo 1 of 1 : johngw\_s\_20140401\_687.jpg

LM Start	<b>0.03</b>	Rating **	M	Issue No.	<b>6</b>
LM End	<b>4.40</b>	Issue Type +	Ma	Location *	WS
Category	Earthen Levee		GPS Latitude/Longitude		
			Start	End	
Item	Vegetation		38.799390 °	38.822442 °	
			-121.725648 °	-121.795729 °	
DWR ID	DWR_RD0787_01_s_2014_6				
Action/Comments					
Control annual grass and weeds on the levee slopes and easements.

Tall grasses, weeds partially blocks visibility. Spring 2014

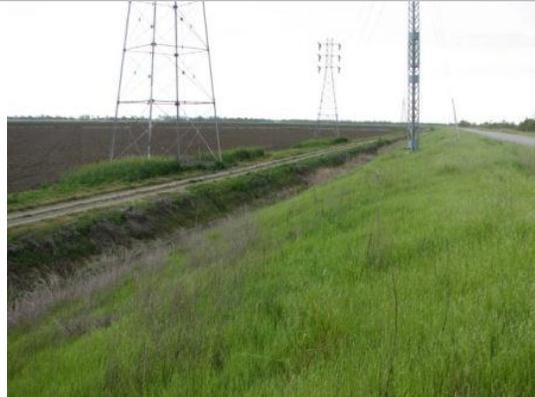
Photo 1 of 3 : johngw\_s\_20140306\_975.jpg

LM Start	<b>1.57</b>	Rating **	M	Issue No.	<b>13</b>
LM End	<b>2.71</b>	Issue Type +	En	Location *	LS
Category	Earthen Levee		GPS Latitude/Longitude		
			Start	End	
Item	Encroachments		38.801794 °	38.809506 °	
			-121.750204 °	-121.768979 °	
DWR ID	DWR_RD0787_01_s_2012_13				
Action/Comments					
Ditch

Agricultural ditch runs along landside the distance of the district.

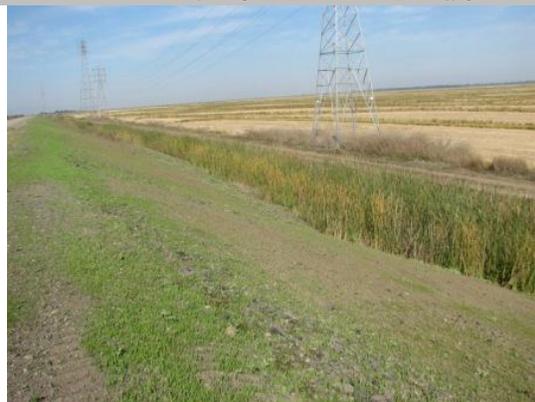
Photo 2 of 3 : johngw\_s\_20140306\_976.jpg

A view of the agricultural ditch in the fall of 2011.

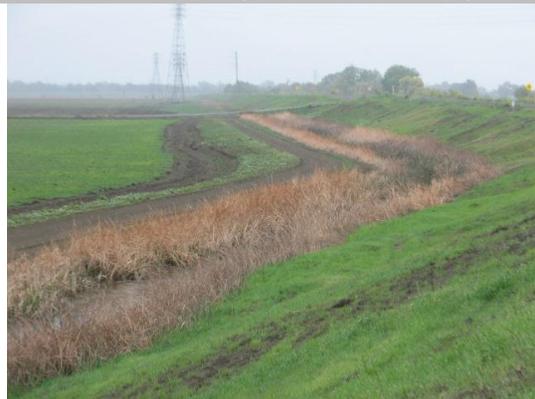
Photo 3 of 3 : johngw\_s\_20140401\_690.jpg

The agricultural ditch runs along the toe of the levee. Spring 2014

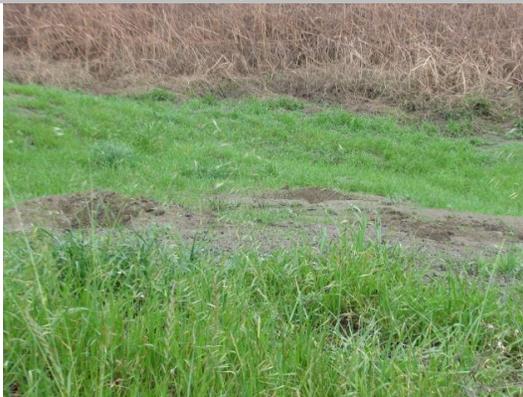
Photo 1 of 1 : johngw\_s\_20140401\_691.jpg

LM Start	<b>2.81</b>	Rating **	M	Issue No.	<b>4</b>
LM End	<b>2.81</b>	Issue Type +	Ma	Location *	LS
Category	Earthen Levee			GPS Latitude/Longitude	
				Start	End
Item	Animal Control			38.810508 °	38.810508 °
				-121.770602 °	-121.770602 °
DWR ID	DWR_RD0787_01_s_2014_4				
Action/Comments					
Exterminate rodents and backfill and compact or grout burrows.

Large rodent burrows on the landside levee slope. Spring 2014

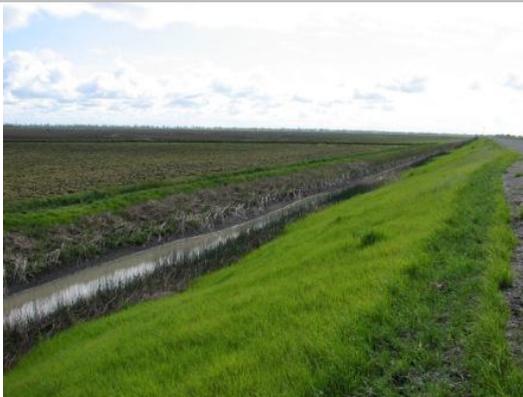
Photo 1 of 3 : johngw\_s\_20140306\_977.jpg

LM Start	<b>3.11</b>	Rating **	M	Issue No.	<b>14</b>
LM End	<b>4.37</b>	Issue Type +	En	Location *	LS
Category	Earthen Levee			GPS Latitude/Longitude	
				Start	End
Item	Encroachments			38.812963 °	38.822302 °
				-121.774880 °	-121.795295 °
DWR ID	DWR_RD0787_01_s_2012_14				
Action/Comments					
Ditch

Ditch along landside toe.

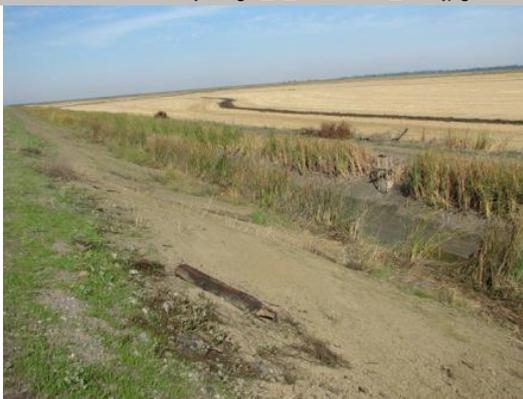
Photo 2 of 3 : johngw\_s\_20140306\_978.jpg

A current view of the agricultural ditch photo taken in fall of 2011.

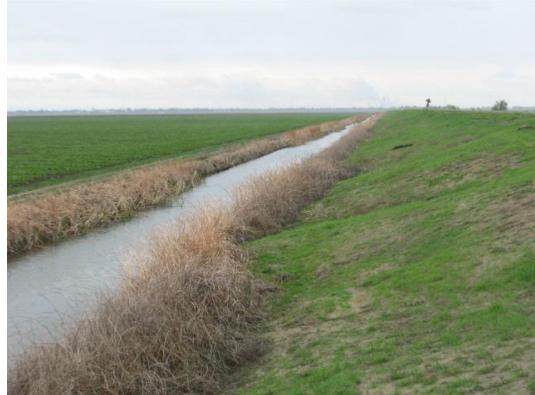
Photo 3 of 3 : johngw\_s\_20140401\_689.jpg

LM Start	<b>3.11</b>	Rating **	M	Issue No.	<b>14 (cont)</b>
LM End	<b>4.37</b>	Issue Type +	En	Location *	LS
Category	Earthen Levee			GPS Latitude/Longitude	
				Start	End
Item	Encroachments			38.812963 °	38.822302 °
				-121.774880 °	-121.795295 °
DWR ID	DWR_RD0787_01_s_2012_14				
Action/Comments					
Ditch

The agricultural ditch runs along the toe of the levee slope. Spring 2014
