**Flood Control Project Maintenance
Levee Inspections**
LMA District Cover Sheet
Spring 2015 Levee Inspection Results

**Flood Control Project Maintenance
Levee Inspections
Unit Cover Sheet
Spring 2015 Levee Inspection Results
Reclamation District No. 0787 Fair**

Spring (March - May)	Summer (June - August)	(September - November) Fall	Winter (December - February)
Unit Maintenance Rating (Fall Only)				
Date of Inspection	04/23/2015 - 04/23/2015			
DWR Inspector	Jai Lor			
Accompanied By	Roger Cornwell Rivergarden Farms RD 787

Levee Inspection Report By Mile - Spring 2015

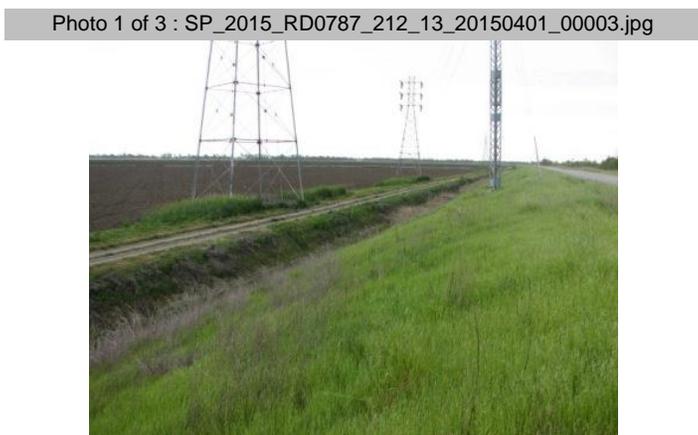
LM Start	1.58	Rating **	M	Issue No.	13
LM End	2.73	Issue Type +	En	Location *	LS
Category	Earthen Levee			GPS Latitude/Longitude	
				Start	End
Item	Encroachments			38.801794 °	38.809506 °
				-121.750204 °	-121.768979 °
DWR ID	DWR_RD0787_01_s_2012_13				
Action/Comments					
Ditch

Agricultural ditch runs along landside the distance of the district.

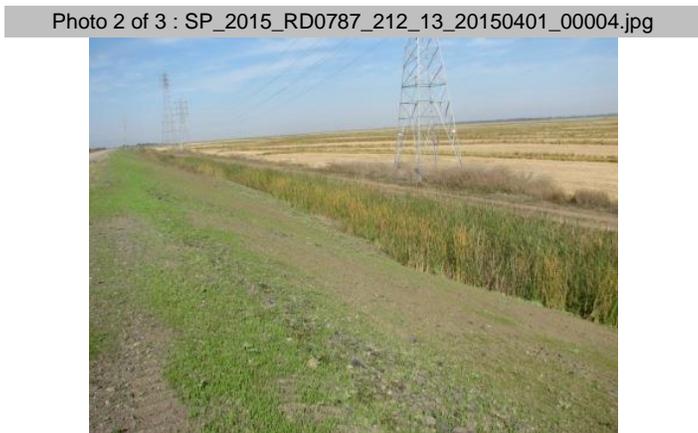
A view of the agricultural ditch in the fall of 2011.

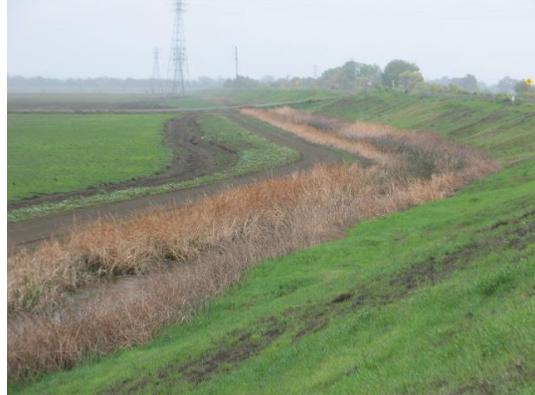
Photo 3 of 3 : SP_2015_RD0787_212_13_20150401_00005.jpg

The agricultural ditch runs along the toe of the levee. Spring 2014

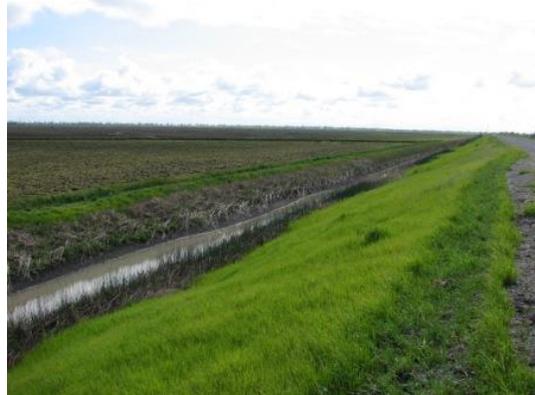
Photo 1 of 3 : SP_2015_RD0787_212_14_20150401_00006.jpg

LM Start	3.13	Rating **	M	Issue No.	14
LM End	4.40	Issue Type +	En	Location *	LS
Category	Earthen Levee		GPS Latitude/Longitude		
			Start	End	
Item	Encroachments		38.812963 °	38.822302 °	
			-121.774880 °	-121.795295 °	
DWR ID	DWR_RD0787_01_s_2012_14				
Action/Comments					
Ditch

Ditch along landside toe.

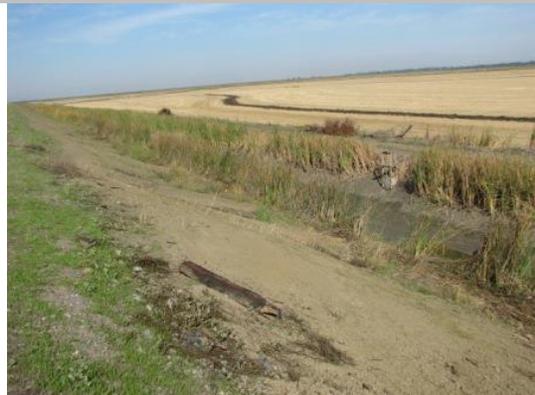
Photo 2 of 3 : SP_2015_RD0787_212_14_20150401_00007.jpg

A current view of the agricultural ditch photo taken in fall of 2011.

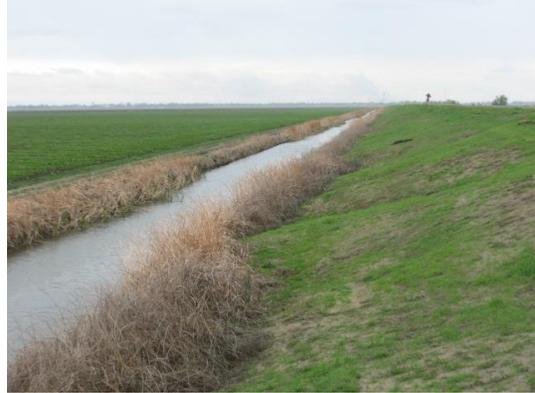
Photo 3 of 3 : SP_2015_RD0787_212_14_20150401_00008.jpg

The agricultural ditch runs along the toe of the levee slope. Spring 2014
