**Flood Control Project Maintenance
Levee Inspections**
LMA District Cover Sheet
Spring 2016 Levee Inspection Results

Reclamation District No. 0787 Fair

Spring 2016 Levee Inspection Results

Levee Inspection Report By Mile - Spring 2016

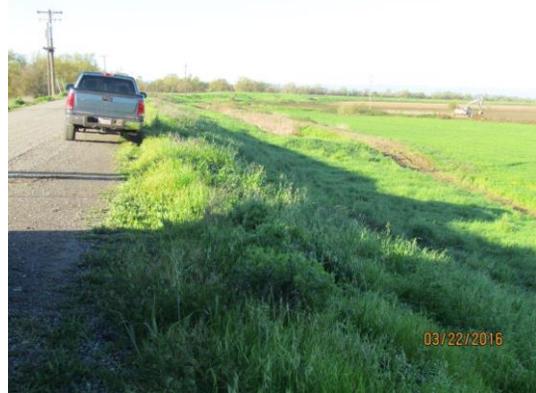
Photo 1 of 1 : SP_2016_RD0787_212_9_20160401_00014.jpg

LM Start	0.00	Rating **	M	Issue No.	9
LM End	4.38	Issue Type +	Ma	Location *	LS
Category	Earthen Levee		GPS Latitude/Longitude		
			Start	End	
Item	Vegetation		38.799650 °	38.822147 °	
			-121.725427 °	-121.795013 °	
DWR ID	DWR_RD0787_01_s_2016_9				
Comment Code					
V1 : Control annual grass and weeds on the levee slopes and easements.					
Inspector Comment

View of the vegetation on the landward side of the levee looking upstream. Spring 2016.

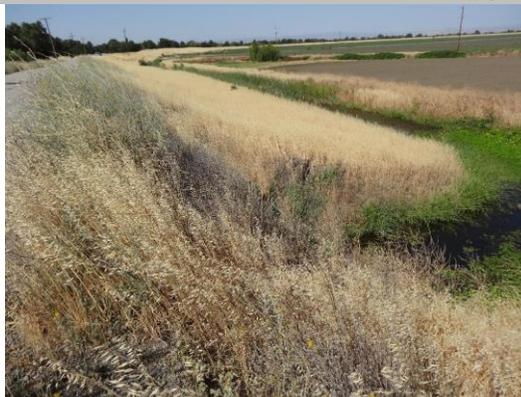
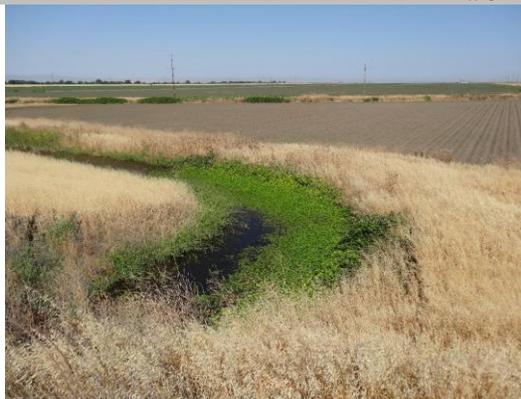
LM Start	0.04	Rating **	M	Issue No.	15
LM End	0.04	Issue Type +	En	Location *	WS
Category	Supplemental			GPS Latitude/Longitude	
				Start	End
Item	DWR UCIP Field Study			38.799159°	38.799159°
				-121.725874°	-121.725874°
DWR ID

Comment Code					
Inspector Comment					
FS_ID:37585 DS_ID:22892 EP_NO: 9392 Repair Type: Non-Urgent Crossing Status: Found UCIP Comments: Dense vegetation limits the inspector's visibility to identify signs of pipe failure (leaks) along the slope. Recommend removing vegetation along pipe alignment to conduct proper inspection of structure. FIELD_STRUCT_DESC: 36-inch concrete pipe through the levee 17.0 feet below the crown. Slide gate in 36-inch standpipe on the waterward side (App. 9392 - River Garden Farms). 24-inch pipe from standpipe to pump house mounted on steel structure in channel. Pump and 24-inch steel pipe installed on the waterward side, 1962 (App. 3878 - river Garden Farms). FS Date: 6/10/2014

View of landward slope.

View of landward side.

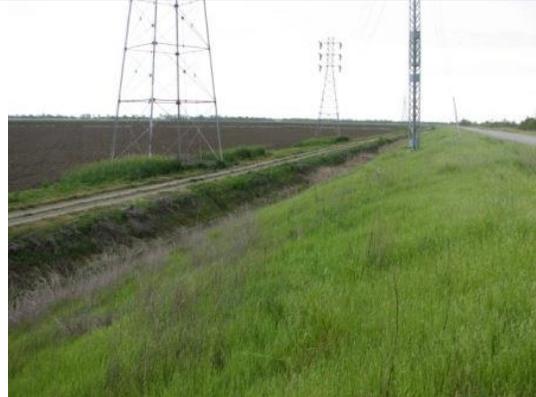
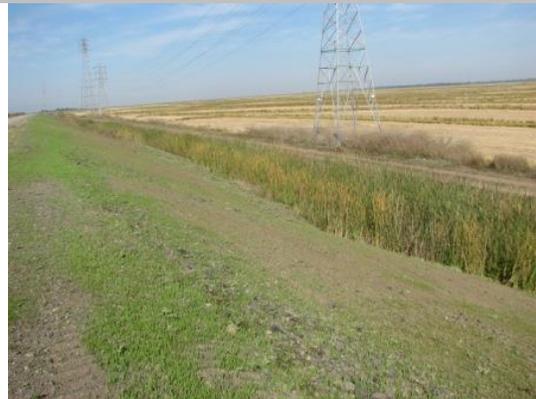
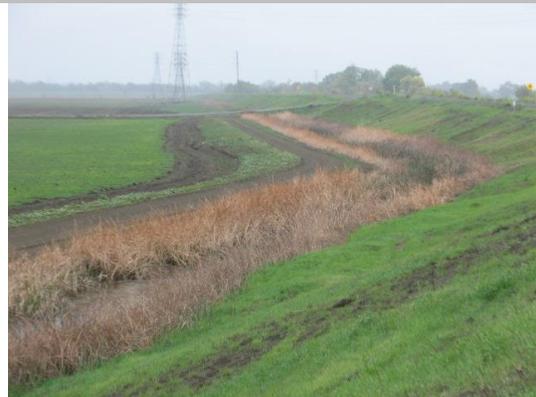
LM Start	1.58	Rating **	M	Issue No.	13
LM End	2.73	Issue Type +	En	Location *	LS
Category	Earthen Levee		GPS Latitude/Longitude		
			Start	End	
Item	Encroachments		38.801794 °	38.809506 °	
			-121.750204 °	-121.768979 °	
DWR ID	DWR_RD0787_01_s_2012_13				
Comment Code					
DT : Ditch					
Inspector Comment

Agricultural ditch runs along landside the distance of the district.

A view of the agricultural ditch in the fall of 2011.

The agricultural ditch runs along the toe of the levee. Spring 2014

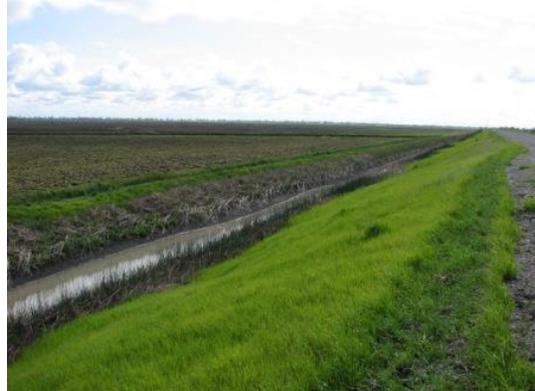
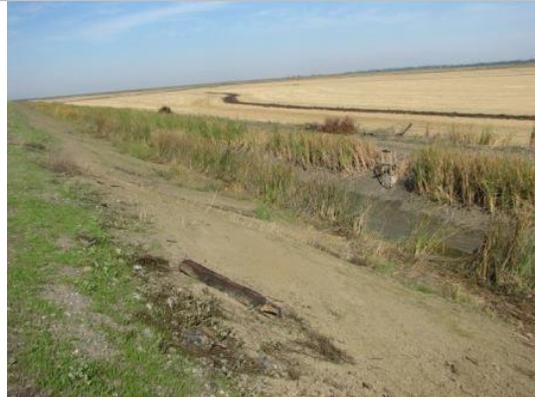
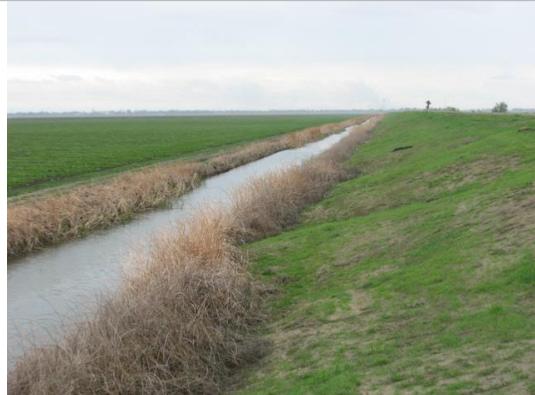
LM Start	3.13	Rating **	M	Issue No.	14
LM End	4.40	Issue Type +	En	Location *	LS
Category	Earthen Levee		GPS Latitude/Longitude		
			Start	End	
Item	Encroachments		38.812963 °	38.822302 °	
			-121.774880 °	-121.795295 °	
DWR ID	DWR_RD0787_01_s_2012_14				
Comment Code					
DT : Ditch					
Inspector Comment

Ditch along landside toe.

A current view of the agricultural ditch photo taken in fall of 2011.

The agricultural ditch runs along the toe of the levee slope. Spring 2014
