**Flood Control Project Maintenance
Levee Inspections**

Maintenance Issue Types Only, Levee Inspection Report By Mile - Fall 2015

Reclamation District No. 0787 Fair

Waterway	Bank	Unit Miles	Inspection Start/End	Inspector
Unit No. 01 Colusa Basin Drain	Left	4.45	09/18/2015 09/18/2015	Jai Lor

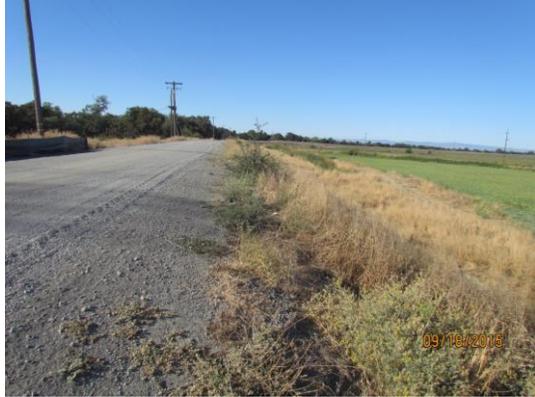
Photo 1 of 1 : FA_2015_RD0787_212_4_20150921_00009.jpg

LM Start	0.01	Rating **	M	Issue No.	4
LM End	0.21	Issue Type +	Ma	Location *	LS
Category	Earthen Levee		GPS Latitude/Longitude		
			Start	End	
Item	Vegetation		38.799591 °	38.797309 °	
			-121.725509 °	-121.727764 °	
DWR ID	DWR_RD0787_01_f_2015_4				
Action/Comments					
Control annual grass and weeds on the levee slopes and easements.

View of the vegetation on the landward side of the levee looking upstream. Fall 2015.

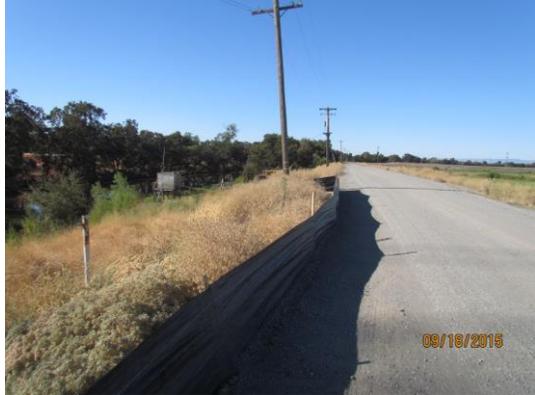
Photo 1 of 1 : FA_2015_RD0787_212_6_20150921_00010.jpg

LM Start	0.03	Rating **	M	Issue No.	6
LM End	0.29	Issue Type +	Ma	Location *	WS
Category	Earthen Levee		GPS Latitude/Longitude		
			Start	End	
Item	Vegetation		38.799382 °	38.796618 °	
			-121.725685 °	-121.729094 °	
DWR ID	DWR_RD0787_01_f_2015_6				
Action/Comments					
Control annual grass and weeds on the levee slopes and easements.

View of the vegetation on the waterward side of the levee looking downstream. Fall 2015.
