**Flood Control Project Maintenance  
Levee Inspections**

## Maintenance Issue Types Only, Levee Inspection Report By Mile - Spring 2015

### Reclamation District No. 0787 Fair

Waterway	Bank	Unit Miles	Inspection Start/End	Inspector
Unit No. 01 Colusa Basin Drain	Left	4.45	04/23/2015 04/23/2015	Jai Lor

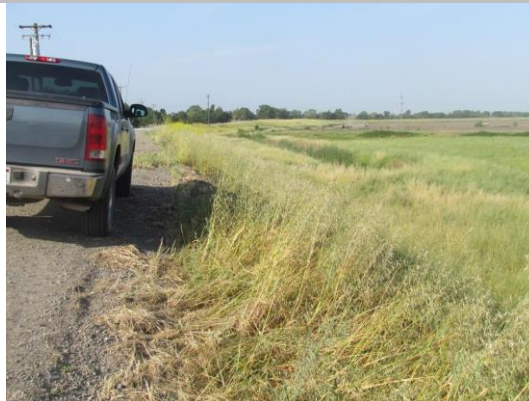
Photo 1 of 1 : SP\_2015\_RD0787\_212\_4\_20150423\_00009.jpg

LM Start	0.01	Rating **	M	Issue No.	4
LM End	4.42	Issue Type +	Ma	Location *	LS
Category	Earthen Levee			GPS Latitude/Longitude	
				Start	End
Item	Vegetation			38.799561 °	38.822437 °
				-121.725530 °	-121.795560 °
DWR ID	DWR_RD0787_01_s_2015_4				
Action/Comments					
Control annual grass and weeds on the levee slopes and easements.

View of the vegetation on the landward side of the levee looking upstream. Spring 2015.
