**Flood Control Project Maintenance
Levee Inspections**

Maintenance Issue Types Only, Levee Inspection Report By Mile - Spring 2016

Reclamation District No. 0787 Fair

Waterway	Bank	Unit Miles	Inspection Start/End	Inspector
Unit No. 01 Colusa Basin Drain	Left	4.45	03/22/2016 03/22/2016	Jai Lor

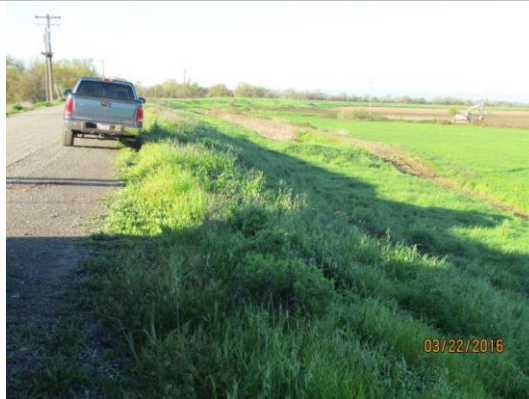
Photo 1 of 1 : SP_2016_RD0787_212_9_20160401_00014.jpg

LM Start	0.00	Rating **	M	Issue No.	9
LM End	4.38	Issue Type +	Ma	Location *	LS
Category	Earthen Levee			GPS Latitude/Longitude	
				Start	End
Item	Vegetation			38.799650 °	38.822147 °
				-121.725427 °	-121.795013 °
DWR ID	DWR_RD0787_01_s_2016_9				
Comment Code					
V1 : Control annual grass and weeds on the levee slopes and easements.					
Inspector Comment

View of the vegetation on the landward side of the levee looking upstream. Spring 2016.
