**Flood Control Project Maintenance  
Levee Inspections**

## Maintenance Issue Types Only, Levee Inspection Report By Mile - Spring 2017

### Reclamation District No. 0787 Fair

Waterway	Bank	Unit Miles	Inspection Start/End	Inspector
Unit No. 01 Colusa Basin Drain	Left	4.45	05/04/2017 05/04/2017	Zach Jojola

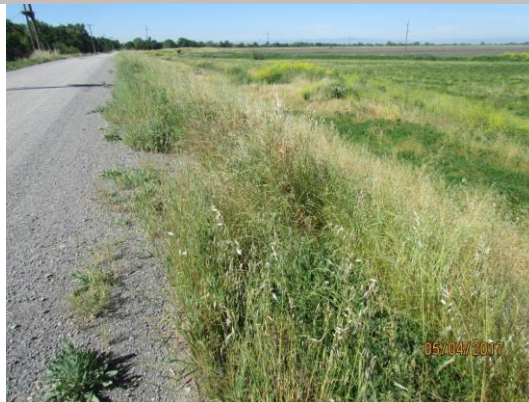
Photo 1 of 1 : SP\_2017\_RD0787\_212\_5\_20170504\_00012.jpg

LM Start	<b>0.01</b>	Rating **	U	Issue No.	<b>5</b>
LM End	<b>4.42</b>	Issue Type +	Ma	Location *	LS
Category	Earthen Levee		GPS Latitude/Longitude		
			Start	End	
Item	Vegetation		38.799538 °	38.822494 °	
			-121.725573 °	-121.795599 °	
DWR ID	DWR_RD0787_01_s_2017_5				
Comment Code					
V1 : Control annual grass and weeds on the levee slopes and easements.					
Inspector Comment

Tall grass on landside levee slope, blocking visibility. Spring 2017.

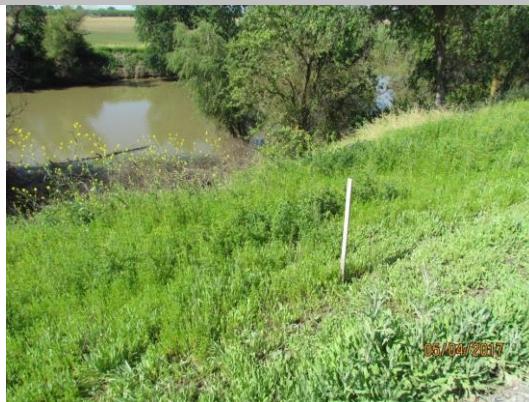
Photo 1 of 1 : SP\_2017\_RD0787\_212\_9\_20170504\_00013.jpg

LM Start	0.73	Rating **	M	Issue No.	9
LM End	0.73	Issue Type +	Ma	Location *	WS
Category	Earthen Levee			GPS Latitude/Longitude	
				Start	End
Item	Slope Stability			38.795814 °	38.795814 °
				-121.736799 °	-121.736799 °
DWR ID	DWR_RD0787_01_s_2017_9				
Comment Code					
S1 : Repair slope instability.					
Inspector Comment					
Multipel cracks visibile on a 50' section of the waterside slope.

View of slope stability location on waterside slope. Spring 2017.

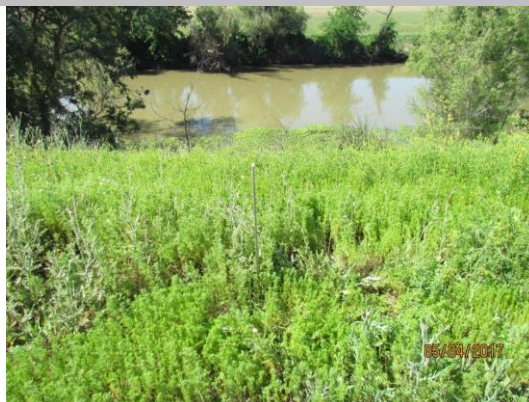
Photo 1 of 1 : SP\_2017\_RD0787\_212\_12\_20170504\_00014.jpg

LM Start	0.75	Rating **	A/W	Issue No.	12
LM End	0.75	Issue Type +	Ma	Location *	WS
Category	Earthen Levee			GPS Latitude/Longitude	
				Start	End
Item	Slope Stability			38.795891 °	38.795891 °
				-121.737098 °	-121.737098 °
DWR ID	DWR_RD0787_01_s_2017_12				
Comment Code					
S1 : Repair slope instability.					
Inspector Comment					
50' crack beginning to develop on wateride slope. Recommend monitoring.

View of slope stability location on waterside slope. Spring 2017.

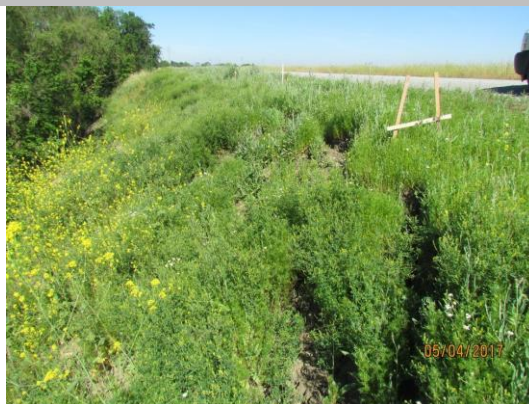
Photo 1 of 1 : SP\_2017\_RD0787\_212\_15\_20170504\_00015.jpg

LM Start	0.77	Rating **	M	Issue No.	15
LM End	0.77	Issue Type +	Ma	Location *	WS
Category	Earthen Levee			GPS Latitude/Longitude	
				Start	End
Item	Slope Stability			38.795996 °	38.795996 °
				-121.737493 °	-121.737493 °
DWR ID	DWR_RD0787_01_s_2017_15				
Comment Code					
S1 : Repair slope instability.					
Inspector Comment					
50' slough section on waterside slope.

View of sloughing on waterside slope. Spring 2017.

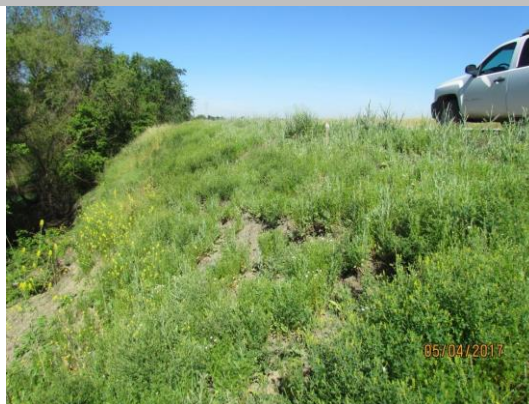
Photo 1 of 1 : SP\_2017\_RD0787\_212\_16\_20170504\_00016.jpg

LM Start	0.78	Rating **	M	Issue No.	16
LM End	0.78	Issue Type +	Ma	Location *	WS
Category	Earthen Levee			GPS Latitude/Longitude	
				Start	End
Item	Slope Stability			38.796042 °	38.796042 °
				-121.737661 °	-121.737661 °
DWR ID	DWR_RD0787_01_s_2017_16				
Comment Code					
S1 : Repair slope instability.					
Inspector Comment					
Sloughing on waterside slope.

View of sloughing on waterside slope. Spring 2017.

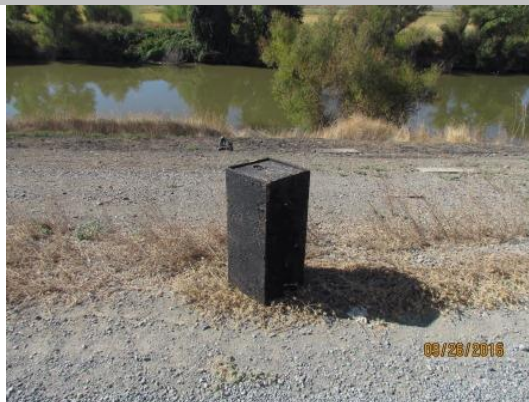
Photo 1 of 1 : SP\_2017\_RD0787\_212\_11\_20170320\_00002.jpg

LM Start	1.73	Rating **	M	Issue No.	11
LM End	1.73	Issue Type +	Ma	Location *	WS
Category	Earthen Levee			GPS Latitude/Longitude	
				Start	End
Item	Encroachments			38.802693 °	38.802693 °
				-121.752672 °	-121.752672 °
DWR ID	DWR_RD0787_01_f_2016_11				
Comment Code					
GA : Garbage					
Inspector Comment

Burnt loudspeaker near levee crown on waterward side. Fall 2016.

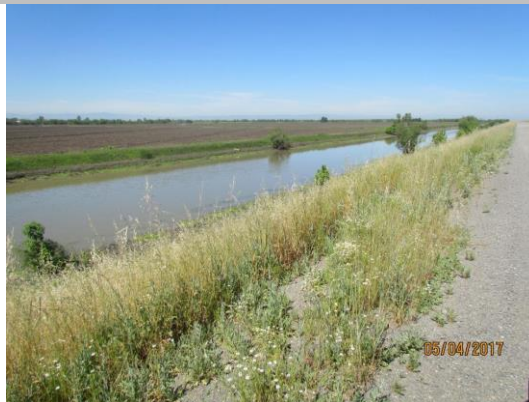
Photo 1 of 1 : SP\_2017\_RD0787\_212\_20\_20170504\_00017.jpg

LM Start	3.58	Rating **	U	Issue No.	20
LM End	4.42	Issue Type +	Ma	Location *	WS
Category	Earthen Levee			GPS Latitude/Longitude	
				Start	End
Item	Vegetation			38.816212 °	38.822494 °
				-121.782124 °	-121.795599 °
DWR ID	DWR_RD0787_01_s_2017_20				
Comment Code					
V1 : Control annual grass and weeds on the levee slopes and easements.					
Inspector Comment

Tall grass on waterside levee slope, blocking visibility. Spring 2017.
