**Flood Control Project Maintenance
Levee Inspections**

Maintenance Issue Types Only, Levee Inspection Report By Mile - Spring 2018

Reclamation District No. 0787 Fair

Waterway	Bank	Unit Miles	Inspection Start/End	Inspector
Unit No. 01 Colusa Basin Drain	Left	4.45	03/16/2018 03/16/2018	Zach Jojola

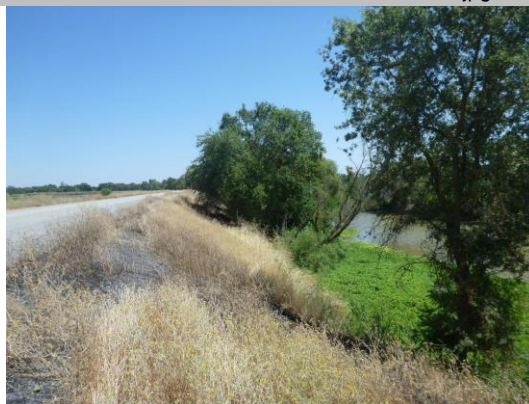
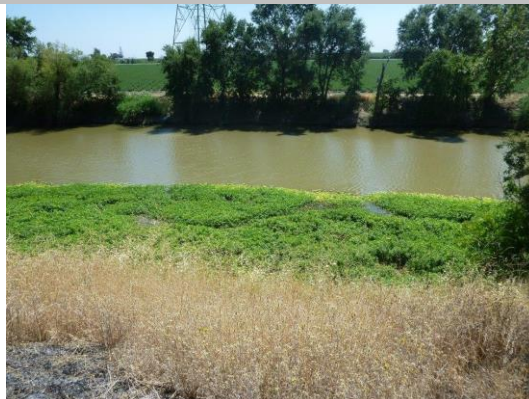
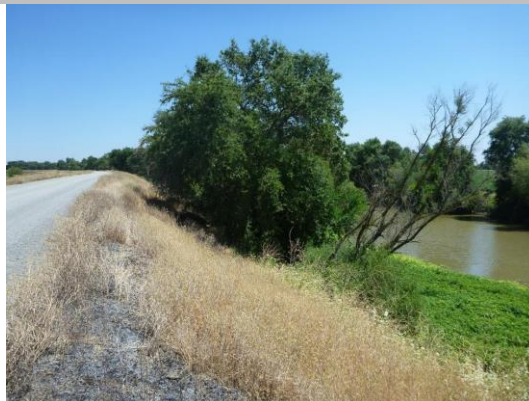
LM Start	0.73	Rating **	M	Issue No.	4
LM End	0.86	Issue Type +	Ma	Location *	
Category	Supplemental			GPS Latitude/Longitude	
				Start	End
Item	2017 Storm Damage			38.795769 °	38.796340 °
				-121.736798 °	-121.738956 °
DWR ID	DWR_RD0787_01_f_2017_4				
Comment Code					
Inspector Comment					
Levee Evaluation Comments					
Description:					
Site ID No:182					
Site Designation:RD 787-01					
Repair Type: Erosion					
Rating:Area of Concern					
Field Date:7/18/2017					
Notes: Sloughing from 2017 storms.

LM Start	0.73	Rating **	M	Issue No.	4 (cont)	
LM End	0.86	Issue Type +	Ma	Location *		
Category	Supplemental			GPS Latitude/Longitude		
				Start	End	
Item	2017 Storm Damage			38.795769 °	38.796340 °	
				-121.736798 °	-121.738956 °	
DWR ID	DWR_RD0787_01_f_2017_4					
Comment Code						
Inspector Comment						
Levee Evaluation Comments						
Description:						
Site ID No:182						
Site Designation:RD 787-01						
Repair Type: Erosion						
Rating:Area of Concern						
Field Date:7/18/2017						
Notes: Sloughing from 2017 storms.

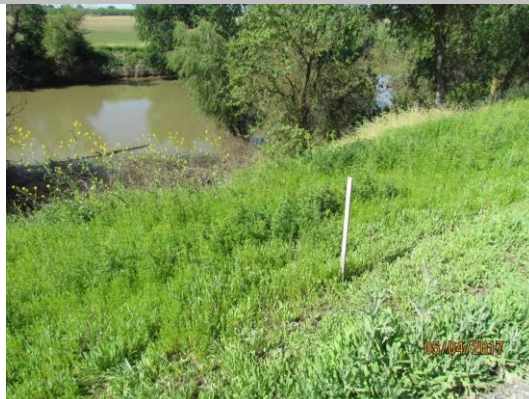
Photo 1 of 1 : SP_2018_RD0787_212_9_20180306_00007.jpg

LM Start	0.73	Rating **	A/W	Issue No.	9
LM End	0.73	Issue Type +	Ma	Location *	WS
Category	Earthen Levee			GPS Latitude/Longitude	
				Start	End
Item	Slope Stability			38.795814 °	38.795814 °
				-121.736799 °	-121.736799 °
DWR ID	DWR_RD0787_01_s_2017_9				
Comment Code					
S1 : Repair slope instability.					
Inspector Comment					
Multipel cracks visibile on a 50' section of the waterside slope.

View of slope stability location on waterside slope. Spring 2017.

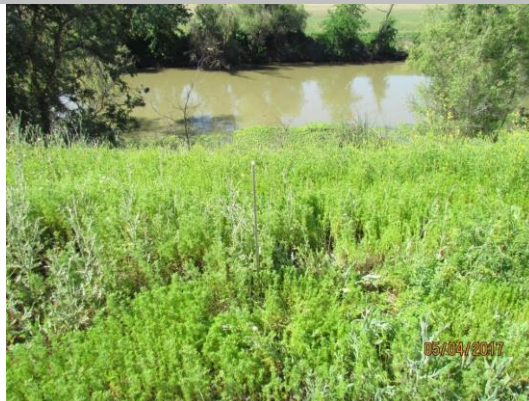
Photo 1 of 1 : SP_2018_RD0787_212_12_20180306_00009.jpg

LM Start	0.75	Rating **	A/W	Issue No.	12
LM End	0.75	Issue Type +	Ma	Location *	WS
Category	Earthen Levee			GPS Latitude/Longitude	
				Start	End
Item	Slope Stability			38.795891 °	38.795891 °
				-121.737098 °	-121.737098 °
DWR ID	DWR_RD0787_01_f_2017_12				
Comment Code					
S1 : Repair slope instability.					
Inspector Comment					
50' crack beginning to develop on wateride slope. Recommend monitoring.

View of slope stability location on waterside slope. Spring 2017.

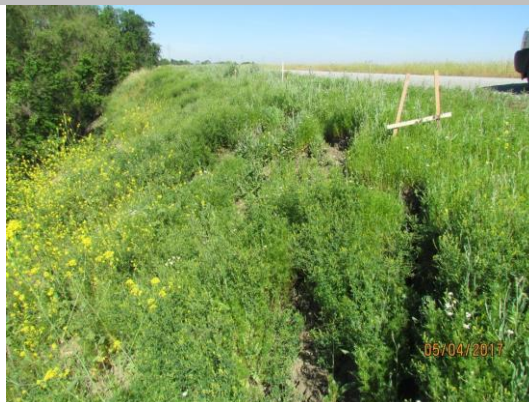
Photo 1 of 1 : SP_2018_RD0787_212_15_20180306_00016.jpg

LM Start	0.77	Rating **	A/W	Issue No.	15
LM End	0.77	Issue Type +	Ma	Location *	WS
Category	Earthen Levee			GPS Latitude/Longitude	
				Start	End
Item	Slope Stability			38.795996 °	38.795996 °
				-121.737493 °	-121.737493 °
DWR ID	DWR_RD0787_01_s_2017_15				
Comment Code					
S1 : Repair slope instability.					
Inspector Comment					
50' slough section on waterside slope.

View of sloughing on waterside slope. Spring 2017.

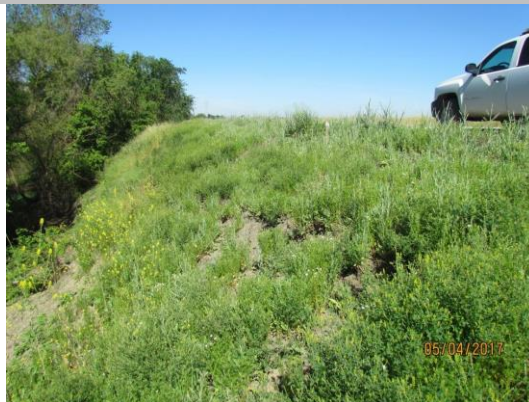
Photo 1 of 1 : SP_2018_RD0787_212_16_20180306_00017.jpg

LM Start	0.78	Rating **	A/W	Issue No.	16
LM End	0.78	Issue Type +	Ma	Location *	WS
Category	Earthen Levee			GPS Latitude/Longitude	
				Start	End
Item	Slope Stability			38.796042 °	38.796042 °
				-121.737661 °	-121.737661 °
DWR ID	DWR_RD0787_01_s_2017_16				
Comment Code					
S1 : Repair slope instability.					
Inspector Comment					
Sloughing on waterside slope.

View of sloughing on waterside slope. Spring 2017.

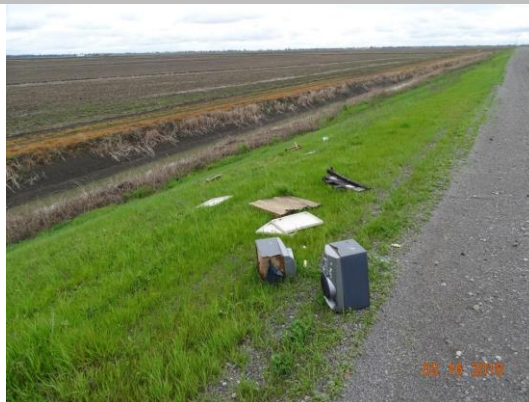
Photo 1 of 1 : SP_2018_RD0787_212_17_20180316_00022.jpg

LM Start	3.37	Rating **	M	Issue No.	17
LM End	3.37	Issue Type +	Ma	Location *	LS
Category	Earthen Levee		GPS Latitude/Longitude		
			Start	End	
Item	Encroachments		38.814743 °	38.814743 °	
			-121.778789 °	-121.778789 °	
DWR ID	DWR_RD0787_01_s_2018_17				
Comment Code					
GA : Garbage					
Inspector Comment					
Speakers on landside slope.

View of speakers on the landside slope. Spring 2018.
