**Flood Control Project Maintenance
Levee Inspections**

Maintenance Issue Types Only, Levee Inspection Report By Mile - Spring 2019

Reclamation District No. 0787 Fair

Waterway	Bank	Unit Miles	Inspection Start/End	Inspector
Unit No. 01 Colusa Basin Drain	Left	4.45	04/08/2019 04/08/2019	Zach Jojola

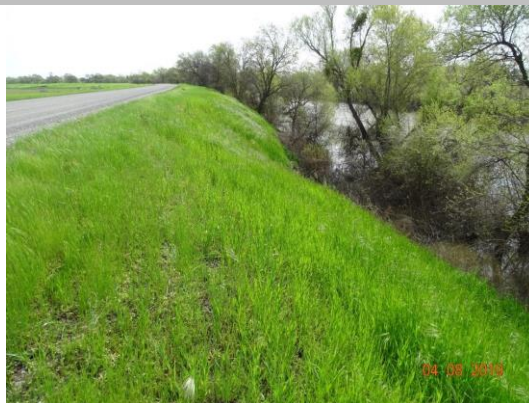
Photo 1 of 4 : SP_2019_RD0787_212_4_20190415_00018.jpg

LM Start	0.73	Rating **	M	Issue No.	4
LM End	0.86	Issue Type +	Ma	Location *	WS
Category	Supplemental			GPS Latitude/Longitude	
				Start	End
Item	2017 Storm Damage			38.795769 °	38.796340 °
				-121.736798 °	-121.738956 °
DWR ID	DWR_RD0787_01_f_2017_4				
Comment Code					
Inspector Comment					
Levee Evaluation Comments					
Description:					
Site ID No:182					
Site Designation:RD 787-01					
Repair Type: Erosion					
Rating:Area of Concern					
Field Date:7/18/2017					
Notes:

View of bank caving on the waterside slope, facing downstream. Spring 2019.

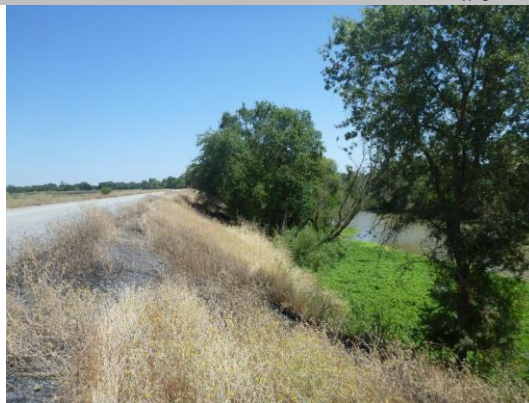
Photo 2 of 4 : LEVAL_SP_2019_182_1520.jpg

LM Start	0.73	Rating **	M	Issue No.	4 (cont)	
LM End	0.86	Issue Type +	Ma	Location *	WS	
Category	Supplemental			GPS Latitude/Longitude		
				Start		End
Item	2017 Storm Damage			38.795769 °		38.796340 °
				-121.736798 °		-121.738956 °
DWR ID	DWR_RD0787_01_f_2017_4					
Comment Code						
Inspector Comment						
Levee Evaluation Comments						
Description:						
Site ID No:182						
Site Designation:RD 787-01						
Repair Type: Erosion						
Rating:Area of Concern						
Field Date:7/18/2017						
Notes:

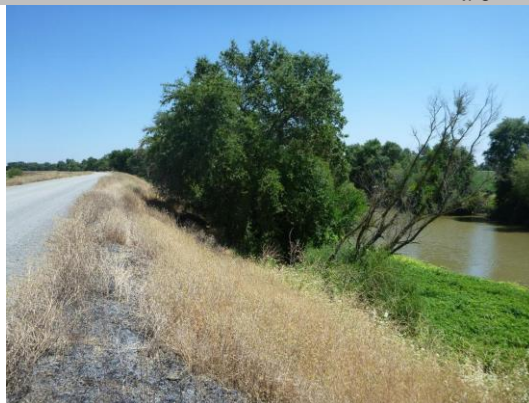
Photo 4 of 4 : LEVAL_SP_2019_182_1523.jpg

LM Start	0.73	Rating **	M	Issue No.	4 (cont)	
LM End	0.86	Issue Type +	Ma	Location *	WS	
Category	Supplemental			GPS Latitude/Longitude		
				Start	End	
Item	2017 Storm Damage			38.795769 °	38.796340 °	
				-121.736798 °	-121.738956 °	
DWR ID	DWR_RD0787_01_f_2017_4					
Comment Code						
Inspector Comment						
Levee Evaluation Comments						
Description:						
Site ID No:182						
Site Designation:RD 787-01						
Repair Type: Erosion						
Rating:Area of Concern						
Field Date:7/18/2017						
Notes:

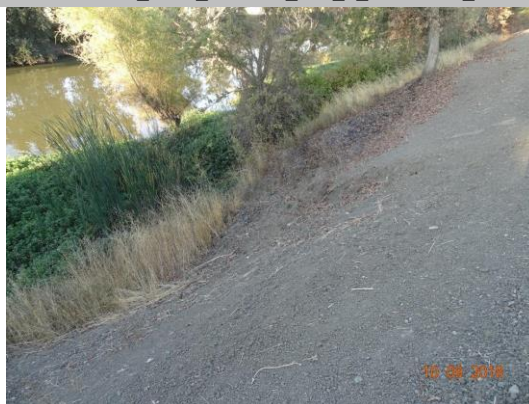
Photo 1 of 4 : SP_2019_RD0787_212_9_20190304_00004.jpg

LM Start	0.73	Rating **	A/W	Issue No.	9
LM End	0.73	Issue Type +	Ma	Location *	WS
Category	Earthen Levee			GPS Latitude/Longitude	
				Start	End
Item	Erosion / Bank Caving			38.795814 °	38.795814 °
				-121.736799 °	-121.736799 °
DWR ID	DWR_RD0787_01_s_2017_9				
Comment Code					
E1 : Note and monitor erosion site.					
Inspector Comment					
Erosion on the waterside slope from 2017 storms. Recommend monitoring.

View of erosion on the waterside slope, facing upstream. Fall 2018.

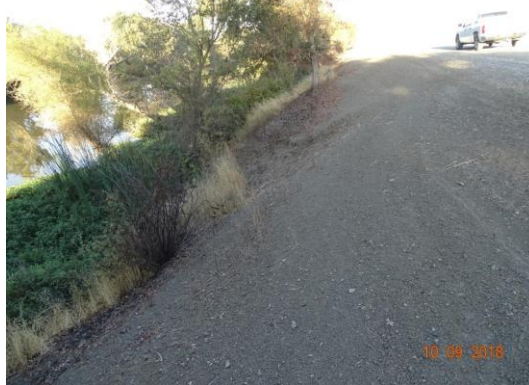
Photo 2 of 4 : SP_2019_RD0787_212_9_20190304_00005.jpg

LM Start	0.73	Rating **	A/W	Issue No.	9 (cont)	
LM End	0.73	Issue Type +	Ma	Location *	WS	
Category	Earthen Levee			GPS Latitude/Longitude		
				Start		End
Item	Erosion / Bank Caving			38.795814 °		38.795814 °
				-121.736799 °		-121.736799 °
DWR ID	DWR_RD0787_01_s_2017_9					
Comment Code						
E1 : Note and monitor erosion site.						
Inspector Comment						
Erosion on the waterside slope from 2017 storms. Recommend monitoring.

Additional view of erosion, facing upstream. Fall 2018.

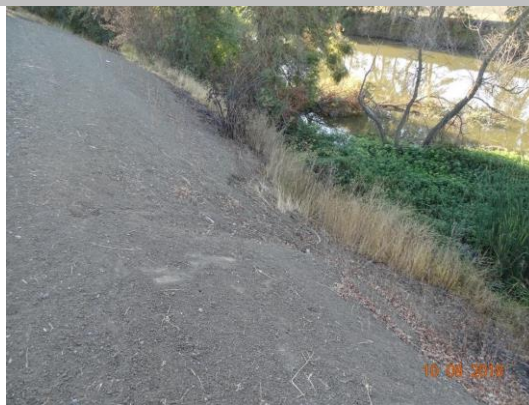
Photo 3 of 4 : SP_2019_RD0787_212_9_20190304_00006.jpg

View of erosion, facing downstream. Fall 2018.

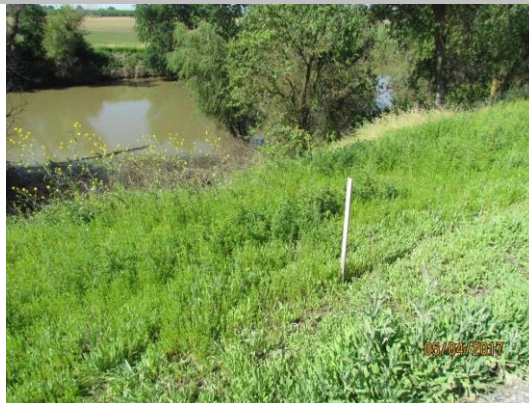
Photo 4 of 4 : SP_2019_RD0787_212_9_20190304_00007.jpg

View of what appears to be a slope stability issue on waterside slope. Spring 2017.

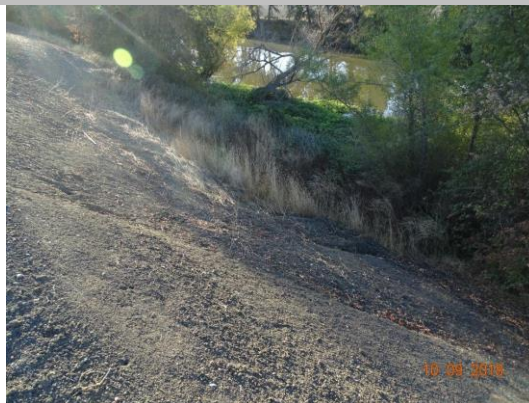
Photo 1 of 3 : SP_2019_RD0787_212_12_20190304_00008.jpg

LM Start	0.75	Rating **	A/W	Issue No.	12
LM End	0.75	Issue Type +	Ma	Location *	WS
Category	Earthen Levee			GPS Latitude/Longitude	
				Start	End
Item	Erosion / Bank Caving			38.795891 °	38.795891 °
				-121.737098 °	-121.737098 °
DWR ID	DWR_RD0787_01_f_2017_12				
Comment Code					
E1 : Note and monitor erosion site.					
Inspector Comment					
Erosion on the waterside slope from 2017 storms. Recommend monitoring.

View of erosion on the waterside slope, facing downstream. Fall 2018.

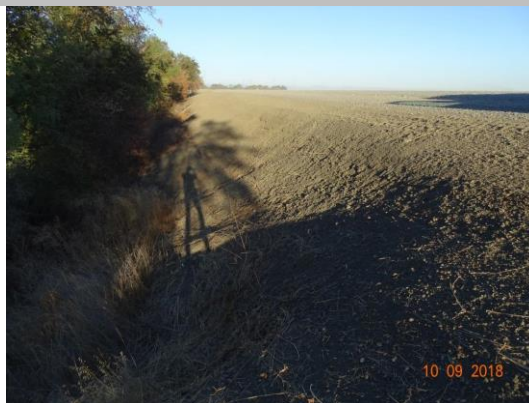
Photo 2 of 3 : SP_2019_RD0787_212_12_20190304_00009.jpg

View of the erosion the waterside slope, facing upstream. Fall 2018.

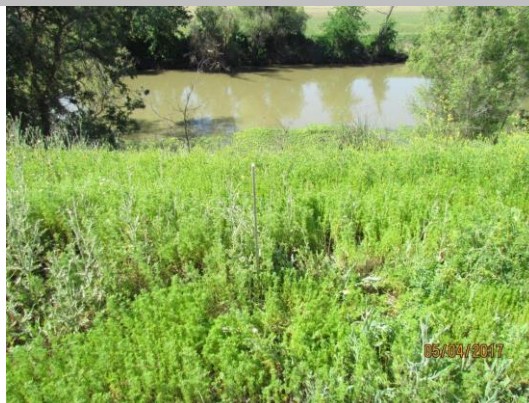
Photo 3 of 3 : SP_2019_RD0787_212_12_20190304_00010.jpg

View of what appears to be a slope stability issue on waterside slope. Spring 2017.

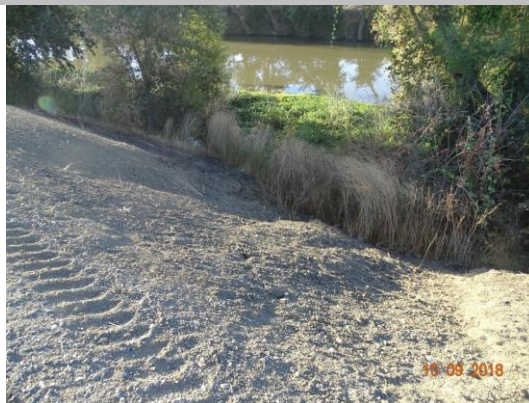
Photo 1 of 2 : SP_2019_RD0787_212_15_20190304_00011.jpg

LM Start	0.77	Rating **	A/W	Issue No.	15
LM End	0.77	Issue Type +	Ma	Location *	WS
Category	Earthen Levee			GPS Latitude/Longitude	
				Start	End
Item	Erosion / Bank Caving			38.795996 °	38.795996 °
				-121.737493 °	-121.737493 °
DWR ID	DWR_RD0787_01_f_2018_15				
Comment Code					
E1 : Note and monitor erosion site.					
Inspector Comment					
Erosion on the waterside slope from 2017 storms. Recommend monitoring.

View of erosion on the waterside slope, facing downstream. Fall 2018.

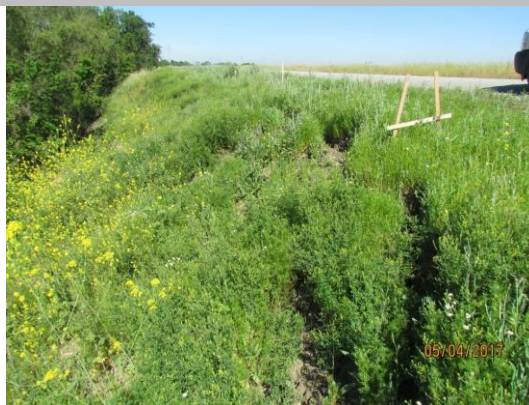
Photo 2 of 2 : SP_2019_RD0787_212_15_20190304_00012.jpg

View of sloughing on waterside slope. Spring 2017.

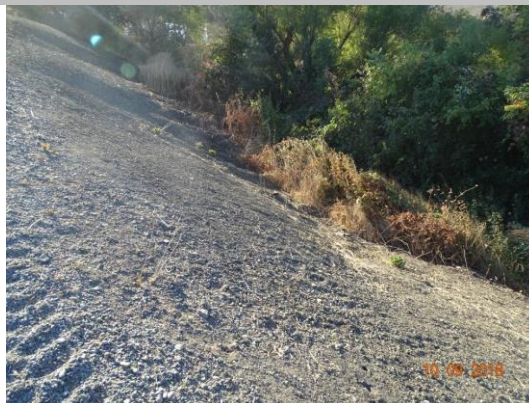
Photo 1 of 2 : SP_2019_RD0787_212_16_20190304_00013.jpg

LM Start	0.78	Rating **	A/W	Issue No.	16
LM End	0.78	Issue Type +	Ma	Location *	WS
Category	Earthen Levee			GPS Latitude/Longitude	
				Start	End
Item	Erosion / Bank Caving			38.796042 °	38.796042 °
				-121.737661 °	-121.737661 °
DWR ID	DWR_RD0787_01_s_2017_16				
Comment Code					
E1 : Note and monitor erosion site.					
Inspector Comment					
Erosion on the waterside slope from 2017 storms. Recommend monitoring.

View of erosion on the waterside slope, facing downstream. Fall 2018.
