**Flood Control Project Maintenance
Levee Inspections**

Maintenance Issue Types Only, Levee Inspection Report By Mile - Spring 2020

Reclamation District No. 0787 Fair

Waterway	Bank	Unit Miles	Inspection Start/End	Inspector
Unit No. 01 Colusa Basin Drain	Left	4.45	04/01/2020 04/01/2020	Zach Jojola

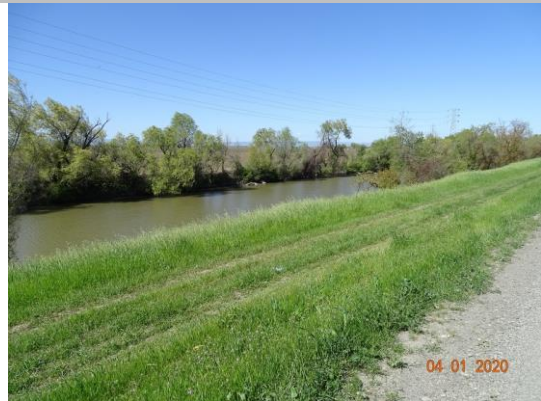
Photo 1 of 1 : SP_2020_RD0787_212_13_20200401_00022.jpg

LM Start	0.02	Rating **	M	Issue No.	13
LM End	4.44	Issue Type +	Ma	Location *	WS
Category	Earthen Levee			GPS Latitude/Longitude	
				Start	End
Item	Vegetation			38.799447 °	38.822495 °
				-121.725596 °	-121.795881 °
DWR ID	DWR_RD0787_01_s_2020_13				
Comment Code					
V1 : Control annual grass and weeds on the levee slopes and easements.					
Inspector Comment

View of vegetation on waterside slope adjacent to waterside toe road.
Spring 2020.

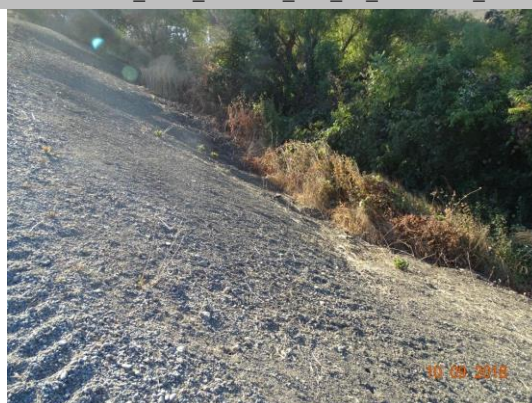
Photo 1 of 1 : SP_2020_RD0787_212_16_20200228_00015.jpg

Erosion on the waterside slope from 2017 storms.

View of erosion on the waterside slope, facing downstream. Fall 2018.

E2 : Schedule repair of erosion site prior to the next inspection.
