**Flood Control Project Maintenance  
Levee Inspections**

## Maintenance Issue Types Only, Levee Inspection Report By Mile - Spring 2021

### Reclamation District No. 0787 Fair

Waterway	Bank	Unit Miles	Inspection Start/End	Inspector
Unit No. 01 Colusa Basin Drain	Left	4.45	03/23/2021 03/23/2021	Zach Jojola

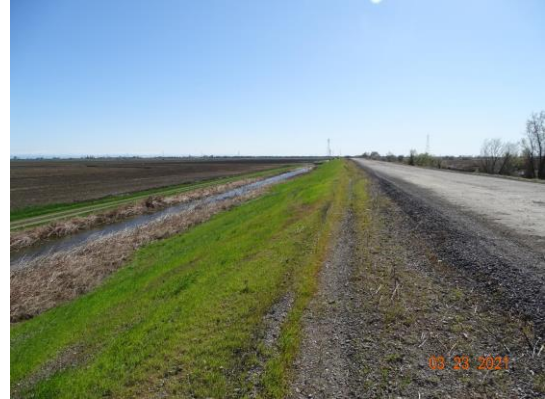
Photo 1 of 1 : SP\_2021\_RD0787\_212\_5\_20210323\_00012.jpg

LM Start	2.48	Rating **	A	Issue No.	5
LM End	2.48	Issue Type +	Ma	Location *	LS
Category	Earthen Levee			GPS Latitude/Longitude	
				Start	End
Item	Vegetation			38.807430 °	38.807430 °
				-121.765313 °	-121.765313 °
DWR ID	DWR_RD0787_01_s_2021_5				
Comment Code					
V1 : Control annual grass and weeds on the levee slopes and easements.					
Inspector Comment					
The LMA maintains the vegetation at a high level.

View of maintained landside slope. Spring 2021.
