**Flood Control Project Maintenance
Levee Inspections**

Maintenance Issue Types Only, Levee Inspection Report By Mile - Spring 2022

Reclamation District No. 0787 Fair

Waterway	Bank	Unit Miles	Inspection Start/End	Inspector
Unit No. 01 Colusa Basin Drain	Left	4.45	03/16/2022 03/16/2022	Zach Jojola

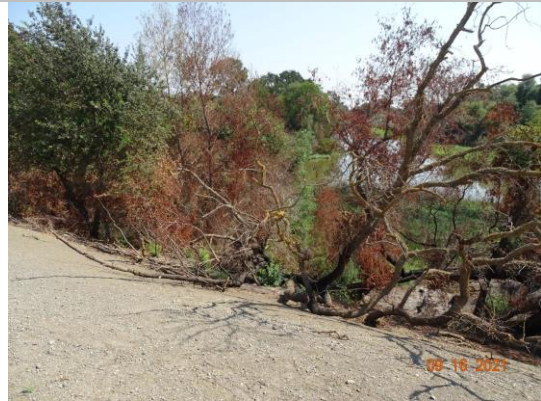
Photo 1 of 1 : SP_2022_RD0787_212_5_20220308_00001.jpg

LM Start	0.34	Rating **	M	Issue No.	5
LM End	0.34	Issue Type +	Ma	Location *	WS
Category	Earthen Levee			GPS Latitude/Longitude	
				Start	End
Item	Encroachments			38.796231 °	38.796231 °
				-121.729874 °	-121.729874 °
DWR ID	DWR_RD0787_01_f_2021_5				
Comment Code					
TR : Tree or limb					
Inspector Comment					
Remove fallen tree on the waterside slope.

View of the fallen tree on the waterside slope. Fall 2021.

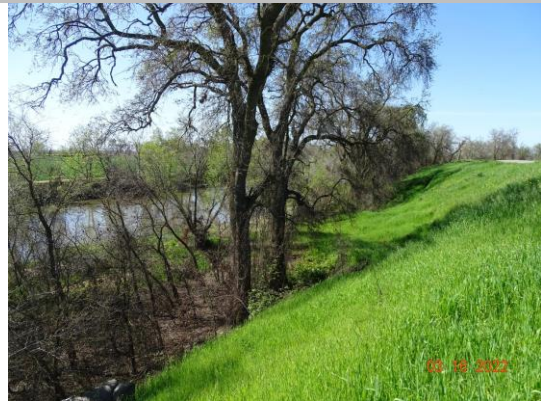
Photo 1 of 1 : SP_2022_RD0787_212_2_20220316_00008.jpg

LM Start	0.39	Rating **	A/W	Issue No.	2
LM End	0.50	Issue Type +	Ma	Location *	WS
Category	Supplemental			GPS Latitude/Longitude	
				Start	End
Item	2018 USACE Erosion Survey			38.795931 °	38.795268 °
				-121.730627 °	-121.732566 °
DWR ID	DWR_RD0787_01_s_2022_2				
Comment Code					
Inspector Comment					
2018 Site ID: CBD 0.5 L					
Status: Eroding					
2018 Field Notes: Last observed in 2017.					
Site History: 2011 - Large scallops throughout the entire reach. Toe scour due to tree pop-outs, resulting in a steepening slope. The reduced resistive forces plus clay levee may increase the loading.					
Additional erosion due to human use. The embankment is oversized, 40 ft levee crown.

View of beginning of erosion, looking upstream. Spring 2022.

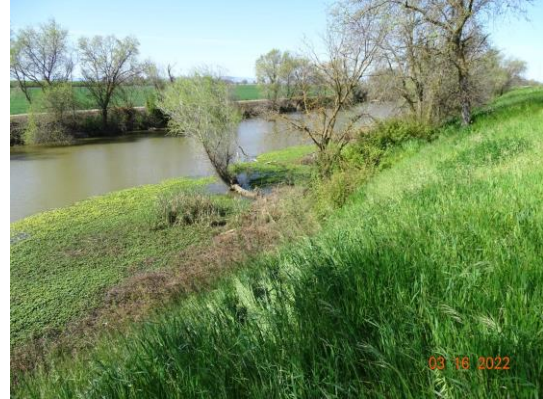
Photo 1 of 1 : SP_2022_RD0787_212_3_20220316_00009.jpg

LM Start	0.67	Rating **	A/W	Issue No.	3
LM End	0.85	Issue Type +	Ma	Location *	WS
Category	Supplemental			GPS Latitude/Longitude	
				Start	End
Item	2018 USACE Erosion Survey			38.795486 °	38.796225 °
				-121.735647 °	-121.738902 °
DWR ID	DWR_RD0787_01_s_2022_3				
Comment Code					
Inspector Comment					
2018 Site ID: CBD 0.9 L					
Status: Eroding					
2018 Field Notes: Last observed in 2017.					
Site History: 2011 - Large scallops throughout the entire reach. Toe scour due to tree pop-outs, resulting in a steepening slope. The reduced resistive forces plus clay levee may increase the loading. Oversized embankment.

View of erosion from the crown. Spring 2022.
