**Flood Control Project Maintenance
Levee Inspections**

Maintenance Issue Types Only, Levee Inspection Report By Mile - Spring 2023

Reclamation District No. 0787 Fair

Waterway	Bank	Unit Miles	Inspection Start/End	Inspector
Unit No. 01 Colusa Basin Drain	Left	4.45	04/04/2023 04/04/2023	Zach Jojola

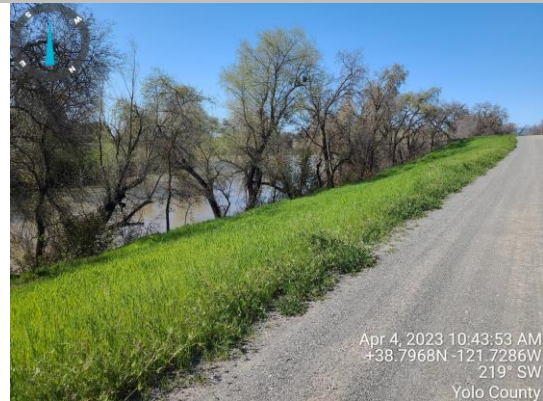
Photo 1 of 1 : SP_2023_RD0787_212_5_20230404_00007.jpg

LM Start	0.00	Rating **	M	Issue No.	5
LM End	0.84	Issue Type +	Ma	Location *	WS
Category	Earthen Levee			GPS Latitude/Longitude	
				Start	End
Item	Vegetation			38.799661°	38.796295°
				-121.725374°	-121.738743°
DWR ID	DWR_RD0787_01_f_2022_5				
Comment Code					
V1 : Control annual grass and weeds on the levee slopes and easements.					
Inspector Comment

View of vegetation on the waterside slope. Spring 2023.

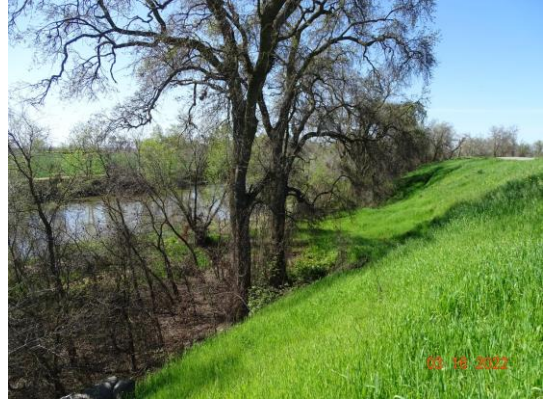
Photo 1 of 1 : SP_2023_RD0787_212_2_20230403_00001.jpg

LM Start	0.39	Rating **	A/W	Issue No.	2
LM End	0.50	Issue Type +	Ma	Location *	WS
Category	Supplemental			GPS Latitude/Longitude	
				Start	End
Item	2018 USACE Erosion Survey			38.795931°	38.795268°
				-121.730627°	-121.732566°
DWR ID	DWR_RD0787_01_f_2018_2				
Comment Code					
Inspector Comment					
2017 Site ID: CBD 0.5 L					
Status: Eroding					
2017 Field Notes: Wide levee section, roughly 40 ft.					
Site History: 2011 - Large scallops throughout the entire reach. Toe scour due to tree pop-outs, resulting in a steepening slope. The reduced resistive forces plus clay levee may increase the loading.					
Additional erosion due to human use.

View of beginning of erosion, looking upstream. Spring 2022.

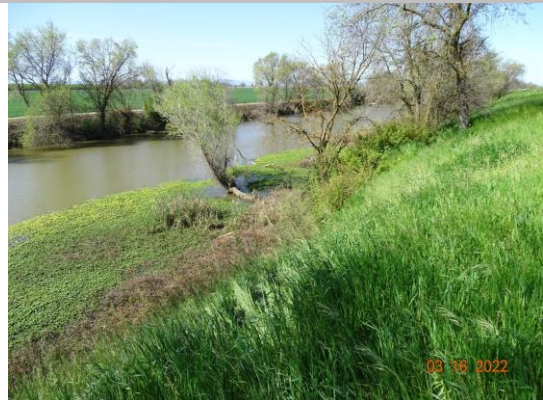
Photo 1 of 1 : SP_2023_RD0787_212_3_20230403_00002.jpg

LM Start	0.67	Rating **	A/W	Issue No.	3
LM End	0.85	Issue Type +	Ma	Location *	WS
Category	Supplemental			GPS Latitude/Longitude	
				Start	End
Item	2018 USACE Erosion Survey			38.795486°	38.796225°
				-121.735647°	-121.738902°
DWR ID	DWR_RD0787_01_f_2018_3				
Comment Code					
Inspector Comment					
2017 Site ID: CBD 0.9 L					
Status: Eroding					
2017 Field Notes: Oversized embankment.					
Site History: 2011 - Large scallops throughout the entire reach. Toe scour due to tree pop-outs, resulting in a steepening slope. The reduced resistive forces plus clay levee may increase the loading.

View of erosion from the crown. Spring 2022.
