**Flood Control Project Maintenance  
Levee Inspections**

## Maintenance Issue Types Only, Levee Inspection Report By Mile - Spring 2024

### Reclamation District No. 0787 Fair

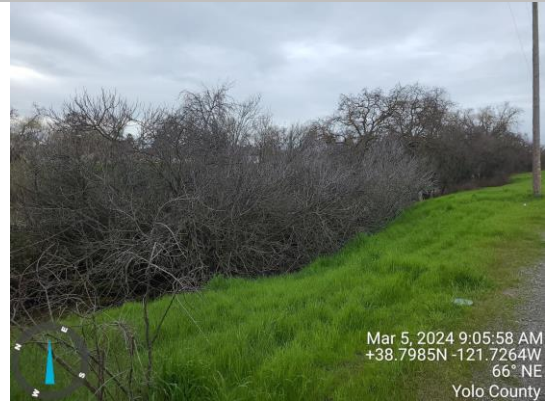
Photo 1 of 1 : SP\_2024\_RD0787\_212\_4\_20240305\_00006.jpg

| LM Start | 0.11 | Rating ** | M | Issue No. | 4 |
| Item | Vegetation | | | 38.798435° | 38.798435° |

View of woody vegetation on the waterside slope. Spring 2024.

| V2 : Remove the wild growth and woody vegetation other than native grasses from the levee slopes. | | | | | |
| Thin out woody vegetation on the waterside slope. | | | | | |

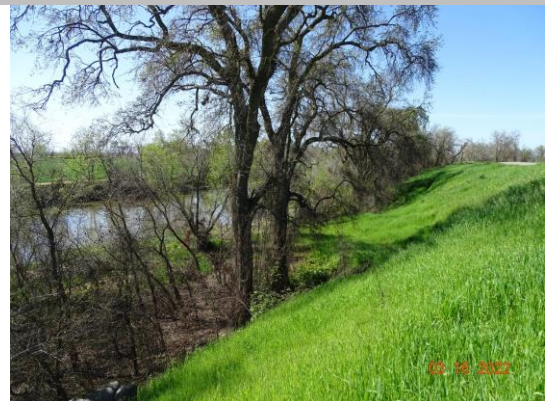
Photo 1 of 1 : SP\_2024\_RD0787\_212\_2\_20240304\_00001.jpg

| Status: Eroding | | | | | |
| Site History: 2011 - Large scallops throughout the entire reach. Toe scour due to tree pop-outs, resulting in a steepening slope. The reduced resistive forces plus clay levee may increase the loading. | | | | | |
| Additional erosion due to human use. | | | | | |

View of beginning of erosion, looking upstream. Spring 2022.

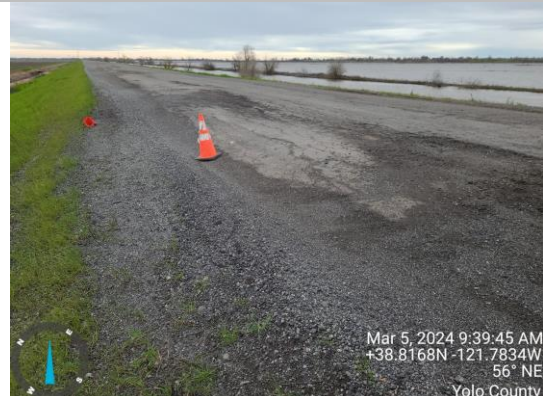
Photo 1 of 2 : SP\_2024\_RD0787\_212\_5\_20240305\_00007.jpg

| There is approximately 1' of settlement on the landside shoulder with slight bulging on the landside slope near the toe. The district and their engineer are monitoring this location for further movement. | | | | | |

View of settlement on the landside shoulder. Spring 2024.

| S1 : Repair slope instability. | | | | | |

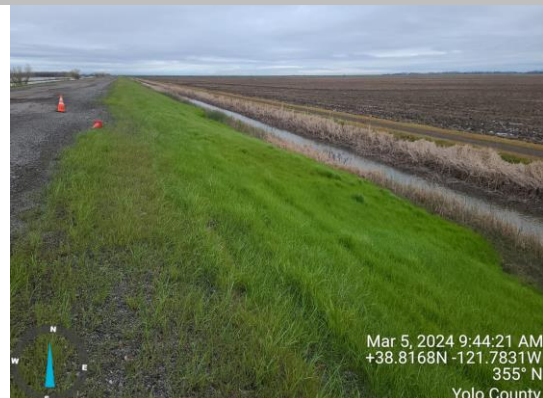
Photo 2 of 2 : SP\_2024\_RD0787\_212\_5\_20240305\_00008.jpg

View of bulging at the landside toe. Spring 2024.
