**Flood Control Project Maintenance  
Levee Inspections**  
**LMA District Cover Sheet**  
**Spring 2012 Levee Inspection Results**

**Reclamation District No. 0787 Fair**

**Levee Inspection Report By Mile - Spring 2012**

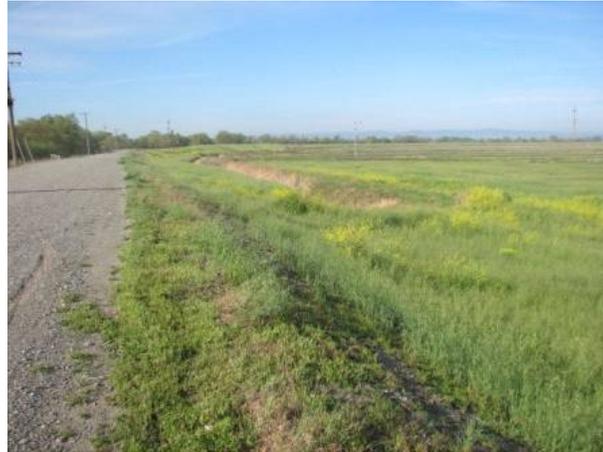
Levee Mile Report Line	4
Start Levee Mile	0.01
End Levee Mile	4.39
Location	Land Side
Category	Earthen Levee
Item	Vegetation
The grasses are taller than 12". Photo taken spring 2012.	
johngw_s_20120419_707.jpg

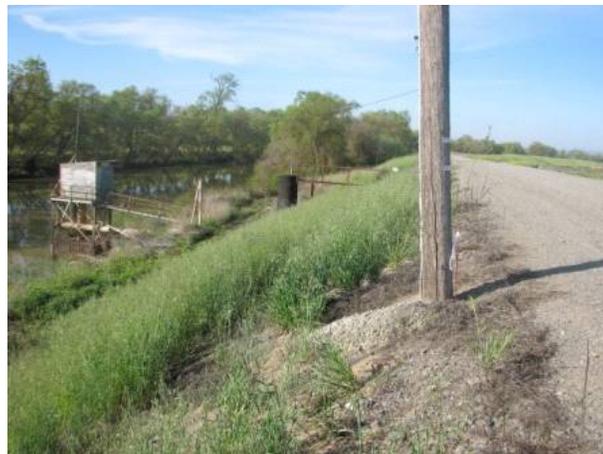
Levee Mile Report Line	5
Start Levee Mile	0.01
End Levee Mile	4.39
Location	Water Side
Category	Earthen Levee
Item	Vegetation
Grasses are taller than 12", photo taken spring 2012.	
johngw_s_20120419_708.jpg

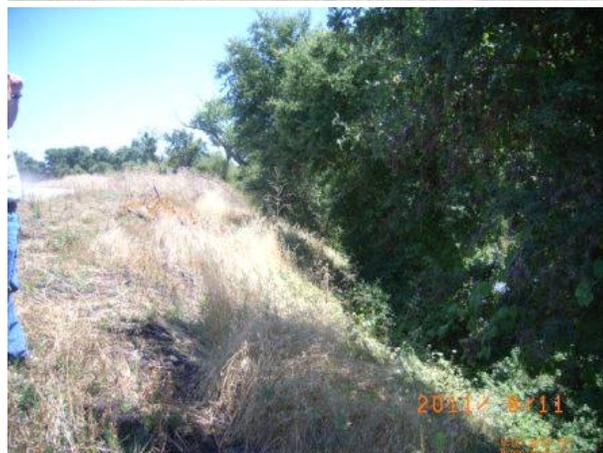
Levee Mile Report Line	8
Start Levee Mile	0.30
End Levee Mile	0.30
Location	Water Side
Category	Supplemental
Item	USACE Erosion Survey
USACE 2011 Photo #1	
johngw_s_20120313_318.jpg

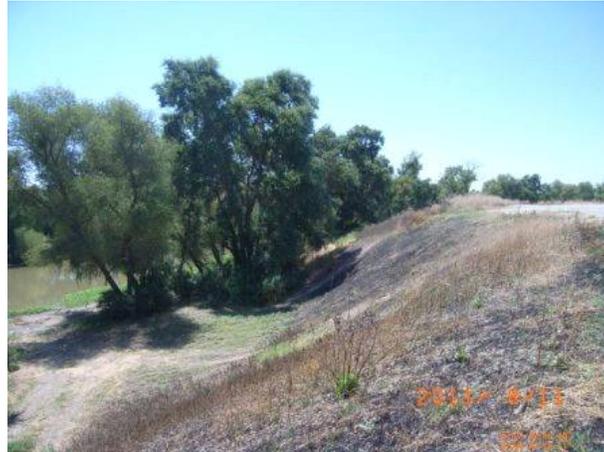
Levee Mile Report Line	8
Start Levee Mile	0.30
End Levee Mile	0.30
Location	Water Side
Category	Supplemental
Item	USACE Erosion Survey
USACE 2011 Photo #2	
johngw_s_20120313_319.jpg

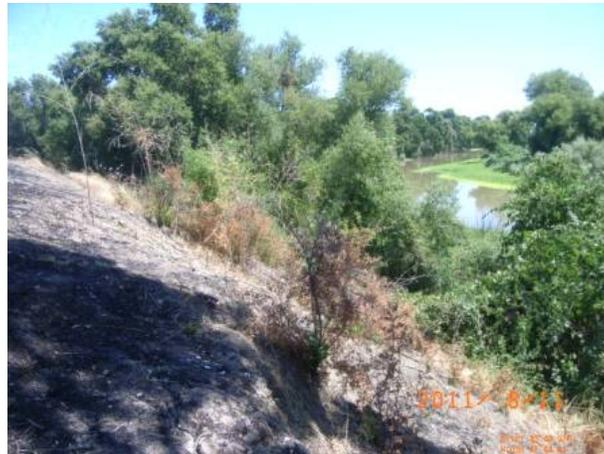
Levee Mile Report Line	8
Start Levee Mile	0.30
End Levee Mile	0.30
Location	Water Side
Category	Supplemental
Item	USACE Erosion Survey
USACE 2011 Photo #3	
johngw_s_20120313_320.jpg

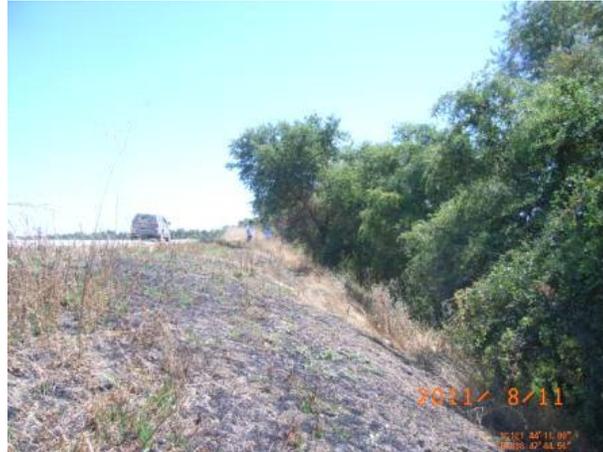
Levee Mile Report Line	9
Start Levee Mile	0.58
End Levee Mile	0.58
Location	Water Side
Category	Supplemental
Item	USACE Erosion Survey
USACE 2011 Photo #2	
johngw_s_20120313_322.jpg

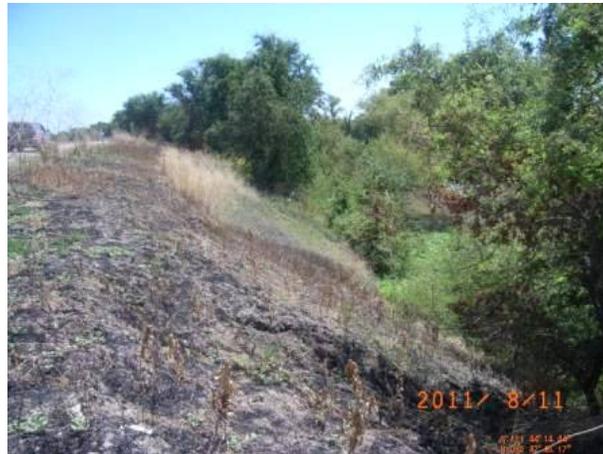
Levee Mile Report Line	9
Start Levee Mile	0.58
End Levee Mile	0.58
Location	Water Side
Category	Supplemental
Item	USACE Erosion Survey
USACE 2011 Photo #3	
johngw_s_20120313_323.jpg

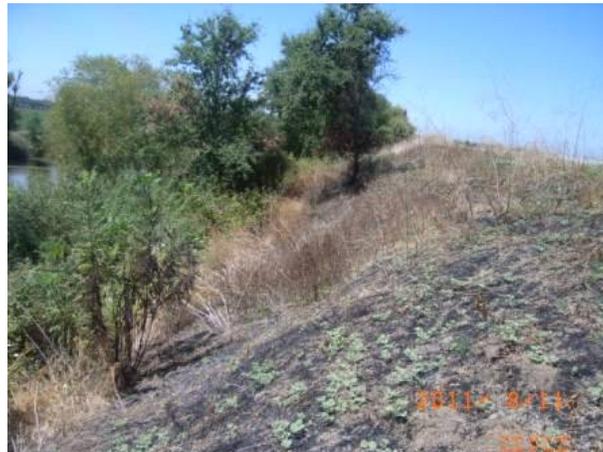
Levee Mile Report Line	9
Start Levee Mile	0.58
End Levee Mile	0.58
Location	Water Side
Category	Supplemental
Item	USACE Erosion Survey
USACE 2011 Photo #4	
johngw_s_20120313_324.jpg

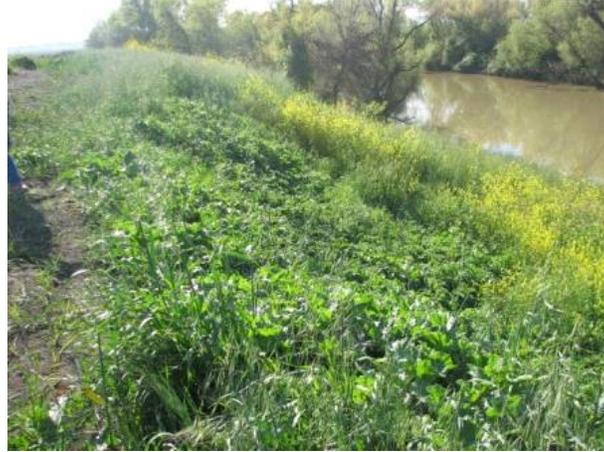
Levee Mile Report Line	10
Start Levee Mile	1.48
End Levee Mile	1.48
Location	Water Side
Category	Earthen Levee
Item	Slope Stability
The levee slope has slipped down. Photo taken spring 2012.	
johngw_s_20120419_709.jpg

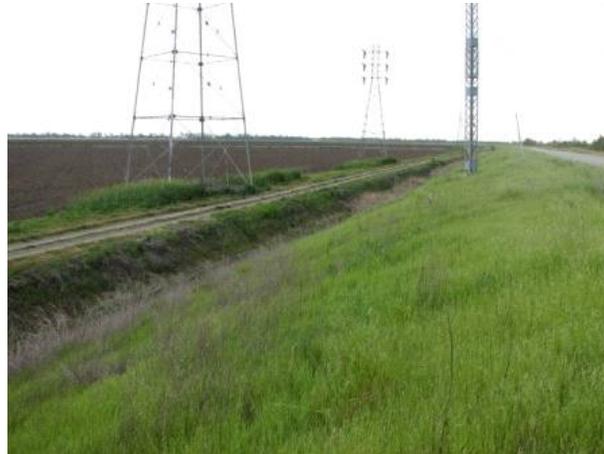
Levee Mile Report Line	11
Start Levee Mile	1.57
End Levee Mile	2.71
Location	Land Side
Category	Earthen Levee
Item	Encroachments
Agricultural ditch runs along land side the distance of the district.	
johngw_s_20120313_325.jpg

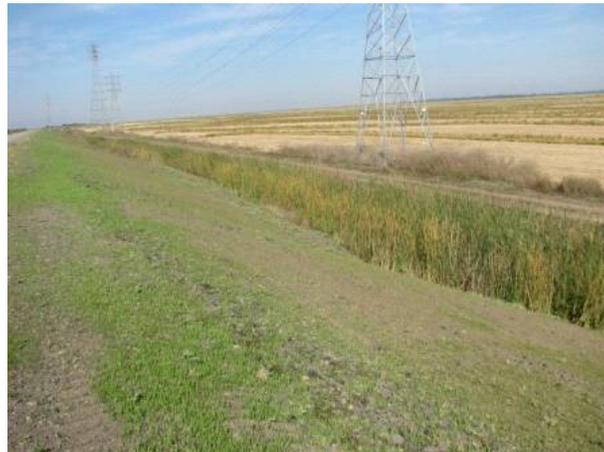
Levee Mile Report Line	11
Start Levee Mile	1.57
End Levee Mile	2.71
Location	Land Side
Category	Earthen Levee
Item	Encroachments
A view of the agricultural ditch in the fall of 2011.	
johngw_s_20120313_326.jpg

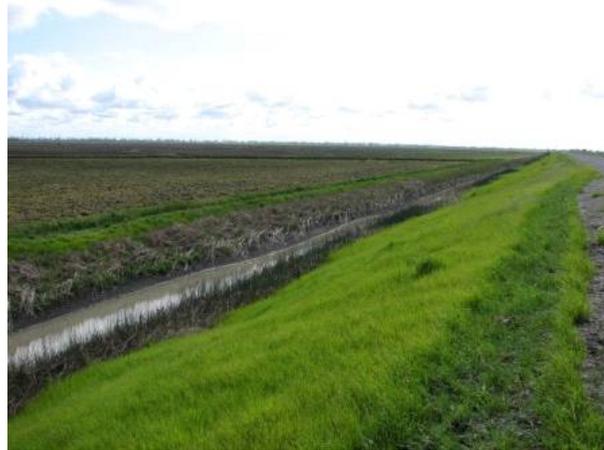
Levee Mile Report Line	12
Start Levee Mile	3.11
End Levee Mile	4.37
Location	Land Side
Category	Earthen Levee
Item	Encroachments
Ditch along landside toe.	
johngw_s_20120313_327.jpg
