**Flood Control Project Maintenance  
Levee Inspections**

**Fall 2014 Levee Maintenance Deficiency Summary Report**

**Reclamation District No. 0817 Carlin**

**Levee Inspection Report By Mile - Fall 2014**

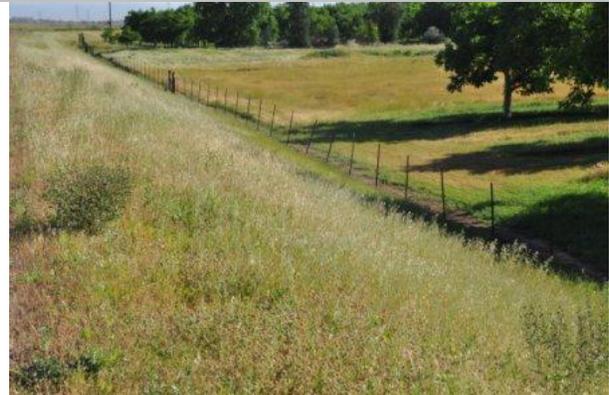
Photo 1 of 1 : FA\_2014\_RD0817\_12\_8\_20141013\_00002.jpg

LM Start	<b>1.74</b>	Rating **	M	Issue No.	<b>8</b>
LM End	<b>3.81</b>	Issue Type +	En	Location *	LS
Category	Earthen Levee		GPS Latitude/Longitude		
			Start	End	
Item	Encroachments		39.002941 °	39.019763 °	
			-121.484856 °	-121.454151 °	
DWR ID	DWR_RD0817_01_s_2013_8				
Action/Comments					
Fence Inspector Comments: Wire fence at L/S levee toe.

Wire fence at L/S levee toe.

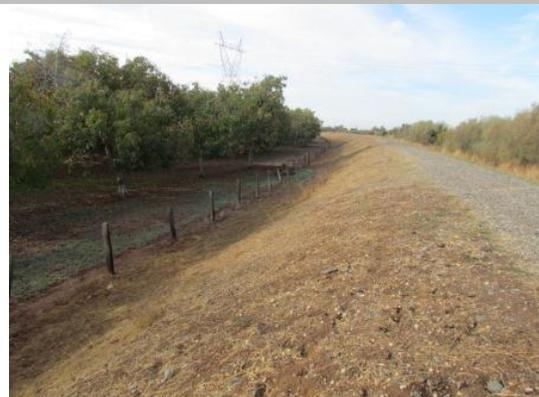
Photo 1 of 1 : FA\_2014\_RD0817\_12\_2\_20141017\_00005.jpg

LM Start	<b>2.10</b>	Rating **	A	Issue No.	<b>2</b>
LM End	<b>2.10</b>	Issue Type +	Ma	Location *	LS
Category	Earthen Levee		GPS Latitude/Longitude		
			Start	End	
Item	Vegetation		39.007115 °	39.007115 °	
			-121.481094 °	-121.481094 °	
DWR ID	DWR_RD0817_01_f_2014_2				
Action/Comments					
Control annual grass and weeds on the levee slopes and easements.

This photo was taken from the crown facing west looking down the landward levee slope at acceptable vegetation maintenance. Fall 2014.

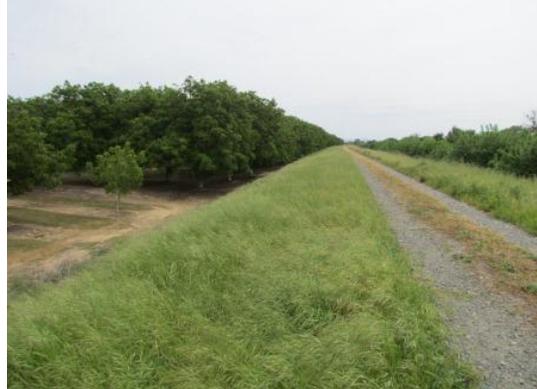
Photo 1 of 1 : FA\_2014\_RD0817\_13\_5\_20141013\_00001.jpg

LM Start	<b>0.01</b>	Rating **	A/W	Issue No.	<b>5</b>
LM End	<b>1.19</b>	Issue Type +	Ma	Location *	LS
Category	Earthen Levee		GPS Latitude/Longitude		
			Start	End	
Item	Vegetation		38.984502 °	38.985971 °	
			-121.505957 °	-121.484564 °	
DWR ID	DWR_RD0817_02_f_2012_5				
Action/Comments					
Remove the wild growth other than native grasses from the levee slopes.

This photo was taken from the levee crown facing east looking down the landward levee slope at vegetation requiring maintenance. Spring 2014.

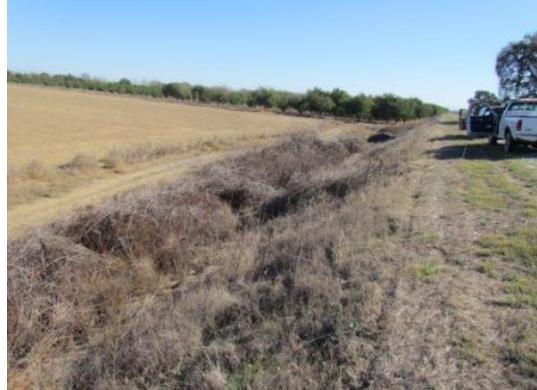
Photo 1 of 1 : FA\_2014\_RD0817\_13\_9\_20141013\_00003.jpg

LM Start	<b>0.27</b>	Rating **	U	Issue No.	<b>9</b>
LM End	<b>0.27</b>	Issue Type +	Ma	Location *	LS
Category	Earthen Levee		GPS Latitude/Longitude		
			Start	End	
Item	Vegetation		38.984308 °	38.984308 °	
			-121.501561 °	-121.501561 °	
DWR ID	DWR_RD0817_02_f_2013_9				
Action/Comments					
Remove the wild growth other than native grasses from the levee slopes. Inspector Comments: Berry bushes have been sprayed but still need to be removed.

This photo was taken from the crown of the levee facing east looking at the blackberry bushes on the landward slope of the levee. They have been sprayed but still need to be removed.

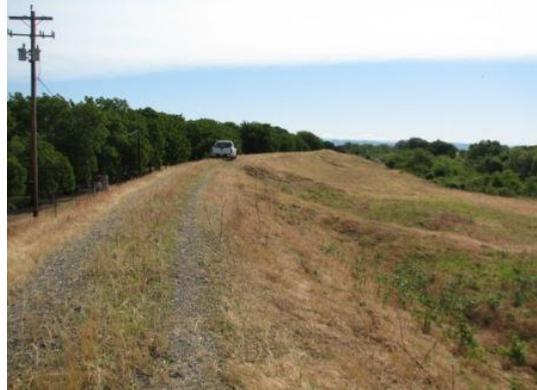
Photo 1 of 1 : FA\_2014\_RD0817\_13\_10\_20141013\_00004.jpg

LM Start	<b>2.08</b>	Rating **	<b>M</b>	Issue No.	<b>10</b>
LM End	<b>3.19</b>	Issue Type +	<b>Ob</b>	Location *	<b>N/A</b>
Category	Earthen Levee		GPS Latitude/Longitude		
			Start	End	
Item	Slope Stability		38.989338 °	38.994124 °	
			-121.468640 °	-121.449448 °	
DWR ID	DWR_RD0817_02_s_2012_10				
Action/Comments					
Repair slope instability. Inspector Comments: The levee is oversteepend at this location. The LMA states that it has always been like this and the USACE did not finish constructing the levee here.

Levee mile 2.08, this photo shows the slope is less than required, this is the downstream limit of the site, this is the waterside slope.

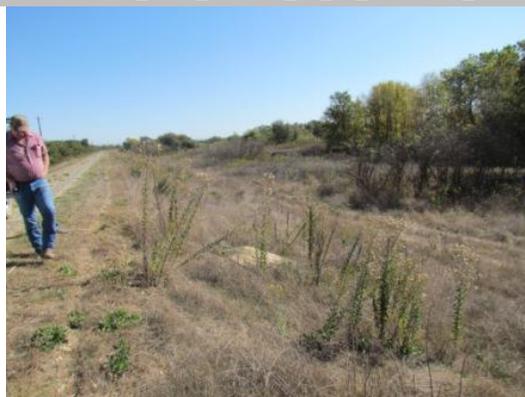
Photo 1 of 1 : FA\_2014\_RD0817\_13\_14\_20141013\_00006.jpg

LM Start	<b>2.17</b>	Rating **	U	Issue No.	<b>14</b>
LM End	<b>2.17</b>	Issue Type +	Ma	Location *	WS
Category	Earthen Levee		GPS Latitude/Longitude		
			Start	End	
Item	Animal Control		38.989727 °	38.989727 °	
			-121.467162 °	-121.467162 °	
DWR ID	DWR_RD0817_02_f_2013_14				
Action/Comments					
Exterminate rodents and backfill and compact or grout burrows. Inspector Comments: Medium sized animal burrow in the the waterward side of the levee slope.

This photo was taken from the crown of the levee facing east looking at a medium sized animal burrow in the the waterward side of the levee slope.

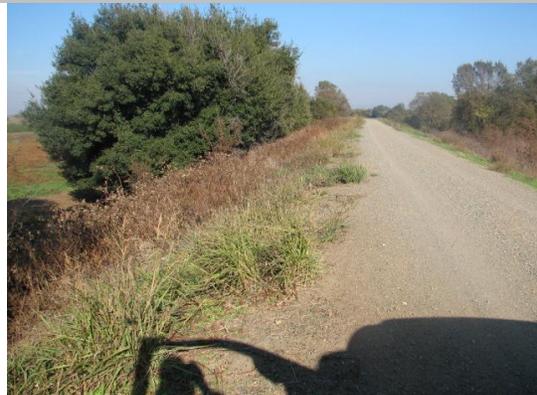
Photo 1 of 1 : FA\_2014\_RD0784\_183\_8\_20140929\_00001.jpg

LM Start	<b>0.54</b>	Rating **	U	Issue No.	<b>8</b>
LM End	<b>0.79</b>	Issue Type +	Ma	Location *	LS
Category	Earthen Levee		GPS Latitude/Longitude		
			Start	End	
Item	Vegetation		38.989961 °	38.992220 °	
			-121.502009 °	-121.498198 °	
DWR ID	DWR_RD0784_06_f_2012_8				
Action/Comments					
Remove the wild growth other than native grasses from the levee slopes. Inspector Comments: Dense berry bushes along lower slope.

Levee mile 0.54, the landside slope.

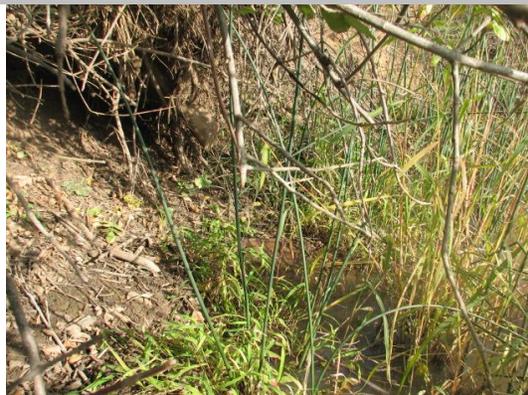
Photo 1 of 3 : FA\_2014\_RD0784\_183\_11\_20140929\_00004.jpg

LM Start	<b>0.68</b>	Rating **	U	Issue No.	<b>11</b>
LM End	<b>0.68</b>	Issue Type +	Ma	Location *	WS
Category	Interior Drainage & Piping Systems			GPS Latitude/Longitude	
				Start	End
Item	Culverts: Breaks / Holes / Cracks			38.991084 °	38.991084 °
				-121.499871 °	-121.499871 °
DWR ID	DWR_RD0784_06_f_2012_11				
Action/Comments

Levee mile 0.68, this is located near the low flow channel, the flap gate is lying on the ground, the end of the pipe was not located.

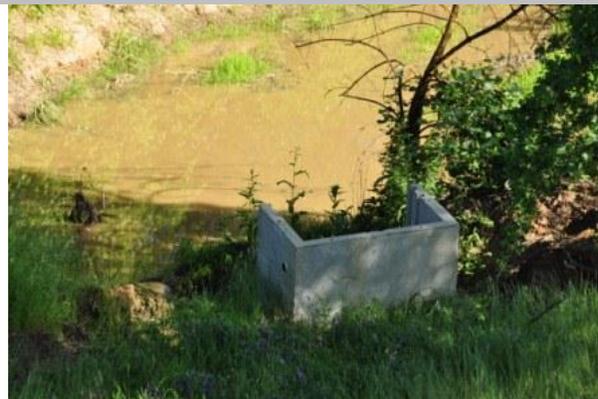
Photo 2 of 3 : FA\_2014\_RD0784\_183\_11\_20140929\_00005.jpg

L/S Intake at LM 0.68

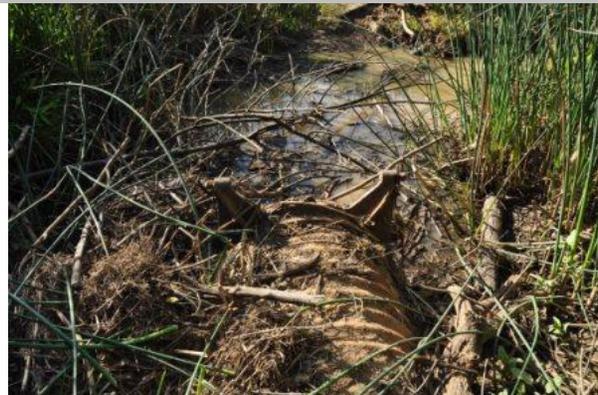
Photo 3 of 3 : FA\_2014\_RD0784\_183\_11\_20140929\_00006.jpg

CMP is rusting and has numerous holes but flap gate is in place.  
4/25/13 - Burnett

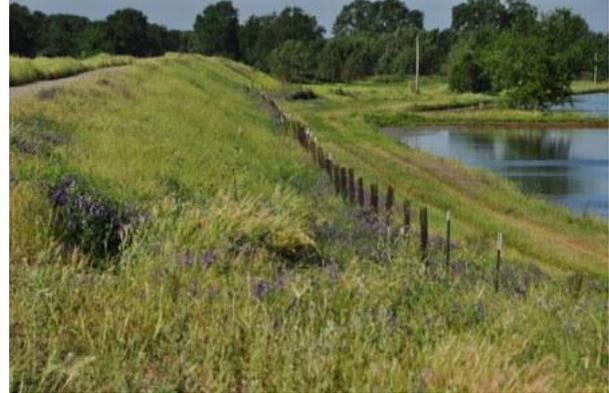
Photo 1 of 1 : FA\_2014\_RD0784\_183\_15\_20140929\_00008.jpg

LM Start	<b>0.85</b>	Rating **	M	Issue No.	<b>15</b>
LM End	<b>1.26</b>	Issue Type +	En	Location *	LS
Category	Earthen Levee		GPS Latitude/Longitude		
			Start	End	
Item	Encroachments		38.992669 °	38.996885 °	
			-121.497525 °	-121.491956 °	
DWR ID	DWR_RD0784_06_s_2013_15				
Action/Comments					
Fence

Wire fence along L/S toe.

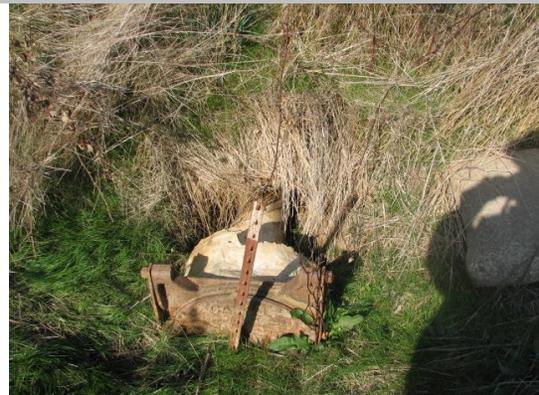
Photo 1 of 1 : FA\_2014\_RD0784\_183\_10\_20140929\_00003.jpg

LM Start	<b>1.17</b>	Rating **	U	Issue No.	<b>10</b>
LM End	<b>1.17</b>	Issue Type +	Ma	Location *	WS
Category	Interior Drainage & Piping Systems		GPS Latitude/Longitude		
			Start	End	
Item	Culverts: Breaks / Holes / Cracks		38.995856 °	38.995856 °	
			-121.493110 °	-121.493110 °	
DWR ID	DWR_RD0784_06_f_2012_10				
Action/Comments

Levee mile 1.17 near the low flow channel, it appears a smaller pipe has been sleeved into the larger pipe, the flap gate does not make contact with the smaller pipe.

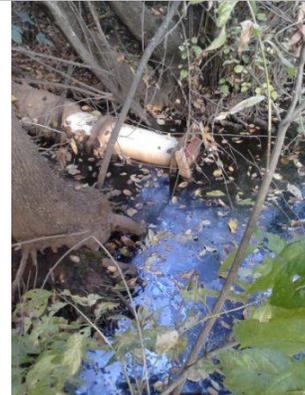
Photo 1 of 1 : FA\_2014\_RD0784\_183\_16\_20140929\_00009.jpg

LM Start	<b>1.26</b>	Rating **	M	Issue No.	<b>16</b>
LM End	<b>1.33</b>	Issue Type +	Ma	Location *	WS
Category	Interior Drainage & Piping Systems			GPS Latitude/Longitude	
				Start	End
Item	Culverts: Inlets / Outlets				
DWR ID	DWR_RD0784_06_f_2012_16				
Action/Comments

Levee mile 1.33 waterside of the levee, this pipe appears to be sleeved into a larger pipe, access to both ends is limited.

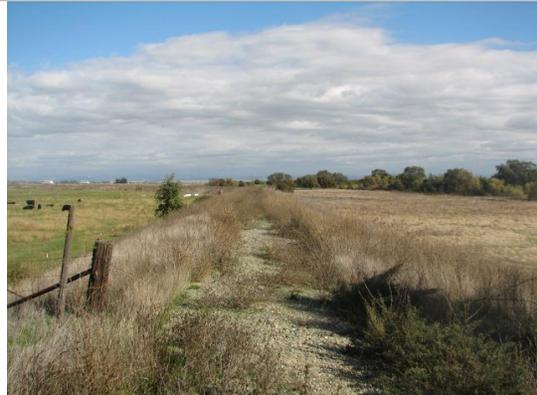
Photo 1 of 1 : FA\_2014\_RD0784\_183\_14\_20140929\_00007.jpg

LM Start	<b>1.27</b>	Rating **	<b>U</b>	Issue No.	<b>14</b>
LM End	<b>1.50</b>	Issue Type +	<b>Ma</b>	Location *	<b>CR</b>
Category	Earthen Levee		GPS Latitude/Longitude		
			Start	End	
Item	Vegetation		38.997019 °	38.999719 °	
			-121.491802 °	-121.490147 °	
DWR ID	DWR_RD0784_06_f_2012_14				
Action/Comments					
Remove the wild growth other than native grasses from the levee slopes.

Levee mile 1.27 looking upstream, typical of the levee from 1.27 to 1.50.
