**Flood Control Project Maintenance
Levee Inspections**
LMA District Cover Sheet
Spring 2014 Levee Inspection Results

Reclamation District No. 0817 Carlin

Levee Inspection Report By Mile - Spring 2014

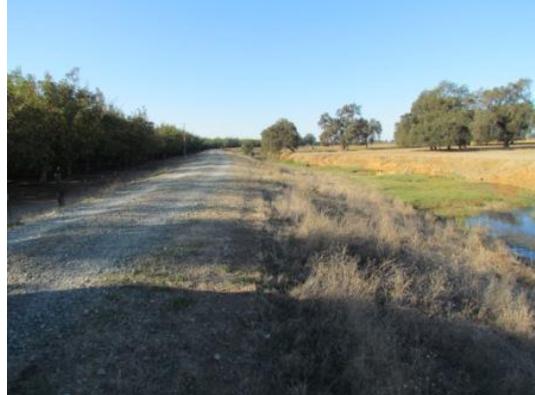
Photo 1 of 1 : mhoffman_s_20140401_300.jpg

LM Start	0.00	Rating **	A/W	Issue No.	7
LM End	3.75	Issue Type +	Ma	Location *	WS
Category	Earthen Levee		GPS Latitude/Longitude		
			Start	End	
Item	Vegetation		38.984695 °	39.019369 °	
			-121.506115 °	-121.455139 °	
DWR ID	DWR_RD0817_01_f_2013_7				
Action/Comments					
Remove the wild growth other than native grasses from the levee slopes.

This photo was taken from the crown of the levee facing west looking at the vegetation on the waterward side of the levee.

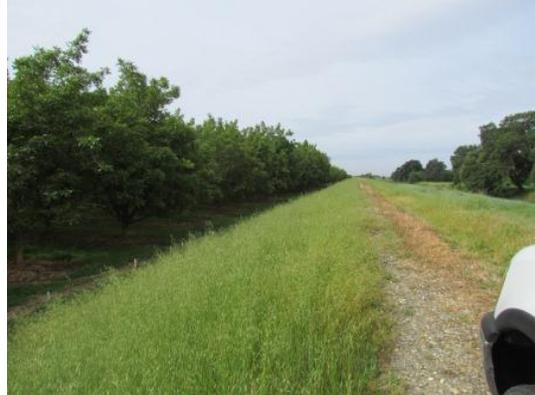
Photo 1 of 1 : mhoffman_s_20140428_486.jpg

LM Start	0.00	Rating **	A/W	Issue No.	11
LM End	3.75	Issue Type +	Ma	Location *	LS
Category	Earthen Levee		GPS Latitude/Longitude		
			Start	End	
Item	Vegetation		38.984695 °	39.019369 °	
			-121.506115 °	-121.455139 °	
DWR ID	DWR_RD0817_01_f_2013_11				
Action/Comments					
Remove the wild growth other than native grasses from the levee slopes.

This photo was taken from the levee crown facing west looking down the landward levee slope at vegetation requiring maintenance. Spring 2014.

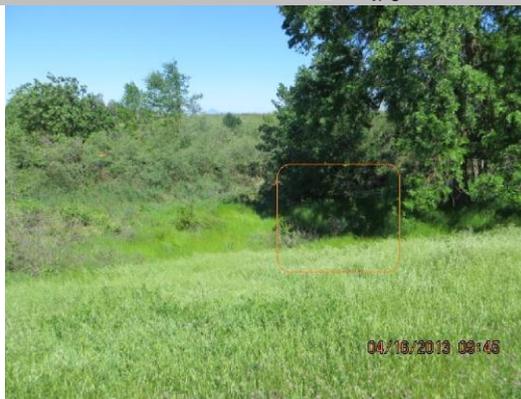
Photo 1 of 1 : UCIP_573.jpg

LM Start	1.34	Rating **	M	Issue No.	1
LM End	1.34	Issue Type +	En	Location *	LS
Category	Supplemental			GPS Latitude/Longitude	
				Start	End
Item	DWR UCIP Field Study			38.997961 °	38.997961 °
				-121.488455 °	-121.488455 °
DWR ID	DWR_RD0817_01_s_2014_1				
Action/Comments					
Inspector Comments: FS_ID:12286 EP_NO: N/A Repair Type: Crossing Status: UCIP Comments: Damaged slide gate on WS of the levee not properly abandoned. FIELD_STRUCT_DESC: Abandoned 18-inch corrugated metal drainpipe through levee, 14.9 feet below the crown. Slide gate on the waterward end. O&M Manual Sac 146, November 1962. FS Date: 4/16/2013

WS- overview of WS area

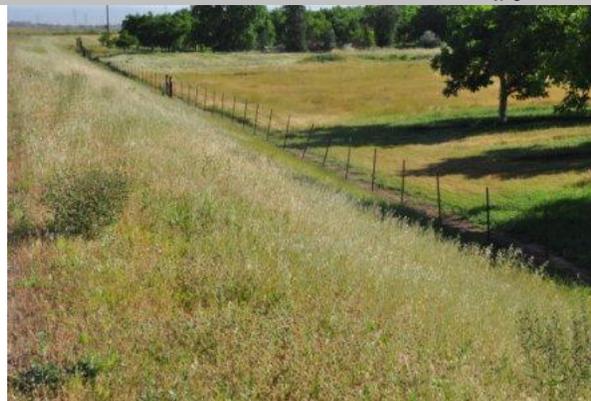
Photo 1 of 1 : mhoffman_s_20140401_301.jpg

LM Start	1.74	Rating **	M	Issue No.	8
LM End	3.81	Issue Type +	En	Location *	LS
Category	Earthen Levee			GPS Latitude/Longitude	
				Start	End
Item	Encroachments			39.002941 °	39.019763 °
				-121.484856 °	-121.454151 °
DWR ID	DWR_RD0817_01_s_2013_8				
Action/Comments					
Fence Inspector Comments: Wire fence at L/S levee toe.

Wire fence at L/S levee toe.

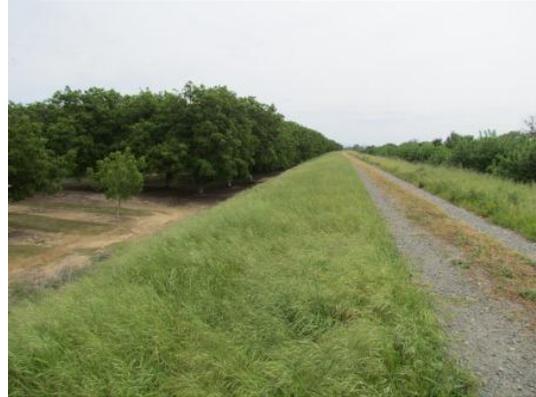
Photo 1 of 1 : mhoffman_s_20140428_487.jpg

LM Start	0.01	Rating **	A/W	Issue No.	5
LM End	1.66	Issue Type +	Ma	Location *	LS
Category	Earthen Levee		GPS Latitude/Longitude		
			Start	End	
Item	Vegetation		38.984502 °	38.987405 °	
			-121.505957 °	-121.476167 °	
DWR ID	DWR_RD0817_02_f_2012_5				
Action/Comments					
Remove the wild growth other than native grasses from the levee slopes.

This photo was taken from the levee crown facing east looking down the landward levee slope at vegetation requiring maintenance. Spring 2014.

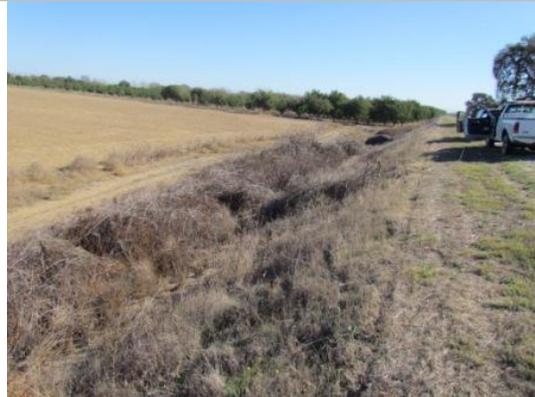
Photo 1 of 1 : mhoffman_s_20140401_295.jpg

LM Start	0.27	Rating **	U	Issue No.	9
LM End	0.27	Issue Type +	Ma	Location *	LS
Category	Earthen Levee		GPS Latitude/Longitude		
			Start	End	
Item	Vegetation		38.984308 °	38.984308 °	
			-121.501561 °	-121.501561 °	
DWR ID	DWR_RD0817_02_f_2013_9				
Action/Comments					
Remove the wild growth other than native grasses from the levee slopes. Inspector Comments: Berry bushes have been sprayed but still need to be removed.

This photo was taken from the crown of the levee facing east looking at the blackberry bushes on the landward slope of the levee. They have been sprayed but still need to be removed.

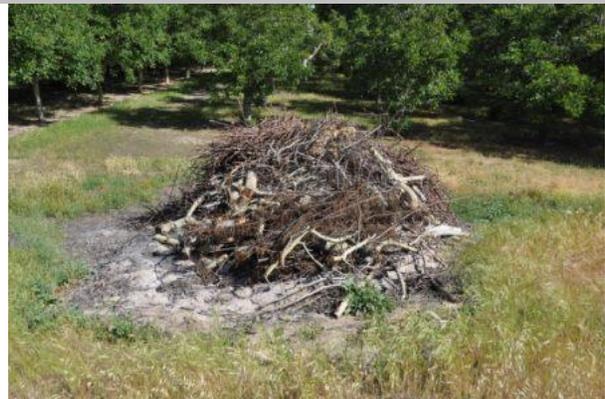
Photo 1 of 1 : mhoffman_s_20140401_297.jpg

LM Start	1.54	Rating **	M	Issue No.	11
LM End	1.54	Issue Type +	En	Location *	LS
Category	Earthen Levee		GPS Latitude/Longitude		
			Start	End	
Item	Encroachments		38.986864 °	38.986864 °	
			-121.478243 °	-121.478243 °	
DWR ID	DWR_RD0817_02_s_2013_11				
Action/Comments					
Prunings

Pruning pile at L/S levee toe.

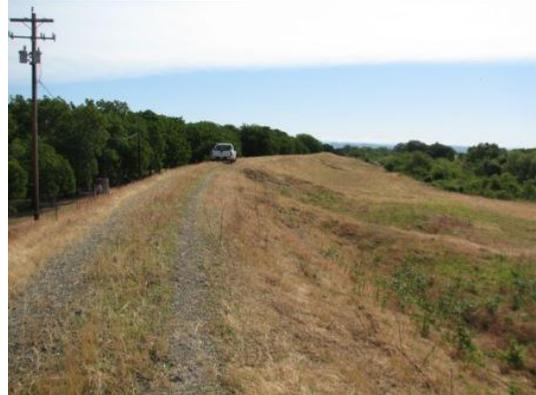
Photo 1 of 1 : mhoffman_s_20140401_296.jpg

LM Start	2.08	Rating **	M	Issue No.	10
LM End	3.19	Issue Type +	Ob	Location *	LS
Category	Earthen Levee		GPS Latitude/Longitude		
			Start	End	
Item	Slope Stability		38.989338 °	38.994124 °	
			-121.468640 °	-121.449448 °	
DWR ID	DWR_RD0817_02_s_2012_10				
Action/Comments					
Repair slope instability.

Levee mile 2.08, this photo shows the slope is less than required, this is the downstream limit of the site, this is the waterside slope.

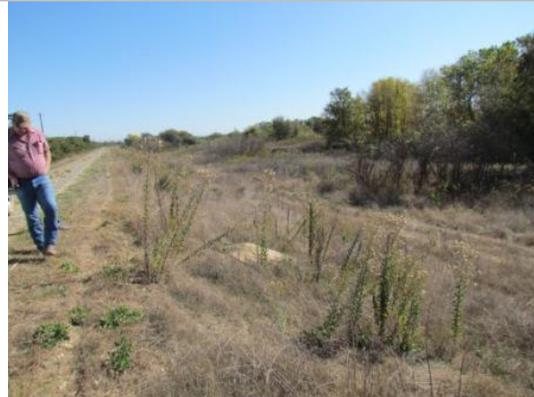
Photo 1 of 1 : mhoffman_s_20140401_298.jpg

LM Start	2.17	Rating **	U	Issue No.	14
LM End	2.17	Issue Type +	Ma	Location *	WS
Category	Earthen Levee		GPS Latitude/Longitude		
			Start	End	
Item	Animal Control		38.989727 °	38.989727 °	
			-121.467162 °	-121.467162 °	
DWR ID	DWR_RD0817_02_f_2013_14				
Action/Comments					
Exterminate rodents and backfill and compact or grout burrows. Inspector Comments: Medium sized animal burrow in the the waterward side of the levee slope.

This photo was taken from the crown of the levee facing east looking at a medium sized animal burrow in the the waterward side of the levee slope.

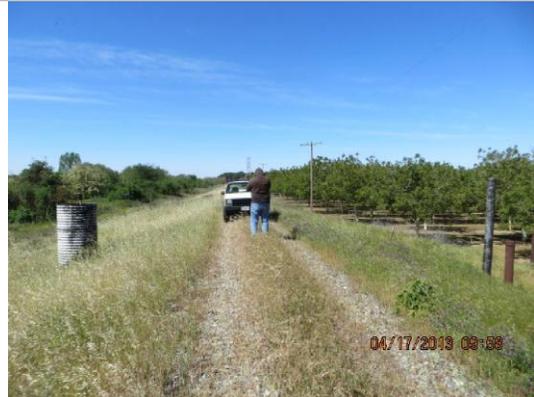
Photo 1 of 1 : UCIP_581.jpg

LM Start	2.40	Rating **	M	Issue No.	1
LM End	2.40	Issue Type +	En	Location *	WS
Category	Supplemental			GPS Latitude/Longitude	
				Start	End
Item	DWR UCIP Field Study			38.990705 °	38.990705 °
				-121.463377 °	-121.463377 °
DWR ID	DWR_RD0817_02_s_2014_1				
Action/Comments					
Inspector Comments: FS_ID:12328 EP_NO: N/A Repair Type: Crossing Status: UCIP Comments: Not properly abandoned crossing. FIELD_STRUCT_DESC: An abandoned 24-inch pipe through the levee, 12.0 feet below the crown. Slide gate in corrugated metal pipe riser on the waterward slope. Abandoned pump and concrete riser on the bank. A tall CMP riser with 8-inch siphon breaker pipe at the landward toe. FS Date: 4/17/2013

Levee Crown: CMP riser with slide gate on WS and slender CMP riser with siphon breaker on LS.

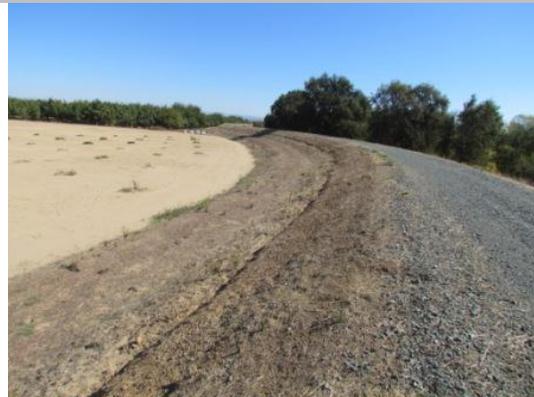
Photo 1 of 1 : mhoffman_s_20140401_294.jpg

LM Start	3.74	Rating **	A/W	Issue No.	6
LM End	3.74	Issue Type +	Ob	Location *	LS
Category	Earthen Levee			GPS Latitude/Longitude	
				Start	End
Item	Slope Stability			38.992656 °	38.992656 °
				-121.439508 °	-121.439508 °
DWR ID	DWR_RD0817_02_f_2013_6				
Action/Comments					
Repair slope instability. Inspector Comments: Separation line in the soil on the landward side between the clay and the sand.

This photo was taken from the crown of the levee facing east looking at the separation line in the soil on the land ward side between the clay and the sand.
