**Flood Control Project Maintenance
Levee Inspections**
LMA District Cover Sheet
Spring 2015 Levee Inspection Results

Reclamation District No. 0817 Carlin

Spring 2015 Levee Inspection Results

Waterway	Bank	Unit Miles
Unit No. 01 South Dry Creek	Left	3.81

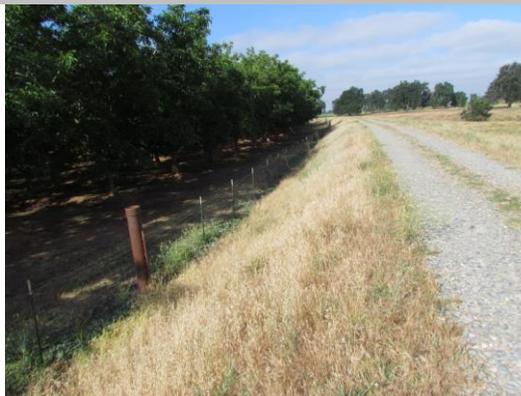
Photo 1 of 1 : SP_2015_RD0817_12_2_20150529_00005.jpg

LM Start	0.00	Rating **	M	Issue No.	2
LM End	3.80	Issue Type +	Ma	Location *	LS
Category	Earthen Levee		GPS Latitude/Longitude		
			Start	End	
Item	Vegetation		38.984611 °	39.019712 °	
			-121.506089 °	-121.454278 °	
DWR ID	DWR_RD0817_01_s_2015_2				
Action/Comments					
Control annual grass and weeds on the levee slopes and easements.

View of the vegetation on the landside of the levee facing downstream.

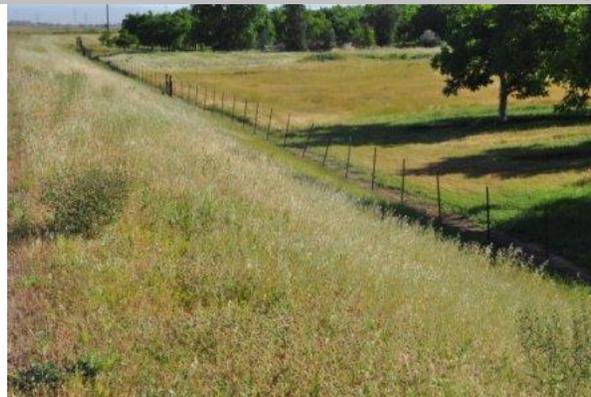
Photo 1 of 1 : SP_2015_RD0817_12_8_20150318_00002.jpg

LM Start	1.74	Rating **	M	Issue No.	8
LM End	3.81	Issue Type +	En	Location *	LS
Category	Earthen Levee		GPS Latitude/Longitude		
			Start	End	
Item	Encroachments		39.002941 °	39.019763 °	
			-121.484856 °	-121.454151 °	
DWR ID	DWR_RD0817_01_s_2013_8				
Action/Comments					
Fence Inspector Comments: Wire fence at L/S levee toe.

Wire fence at L/S levee toe.

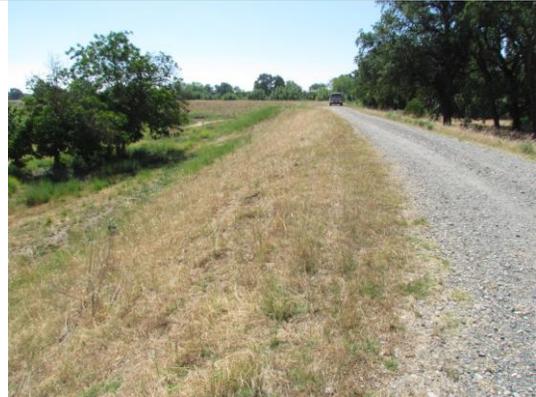
Photo 1 of 1 : SP_2015_RD0817_13_3_20150529_00007.jpg

LM Start	0.00	Rating **	M	Issue No.	3
LM End	1.38	Issue Type +	Ma	Location *	LS
Category	Earthen Levee		GPS Latitude/Longitude		
			Start	End	
Item	Vegetation		38.984608 °	38.986357 °	
			-121.506089 °	-121.481006 °	
DWR ID	DWR_RD0817_02_s_2015_3				
Action/Comments					
Control annual grass and weeds on the levee slopes and easements.

View of the vegetation on the landside of the levee facing upstream.

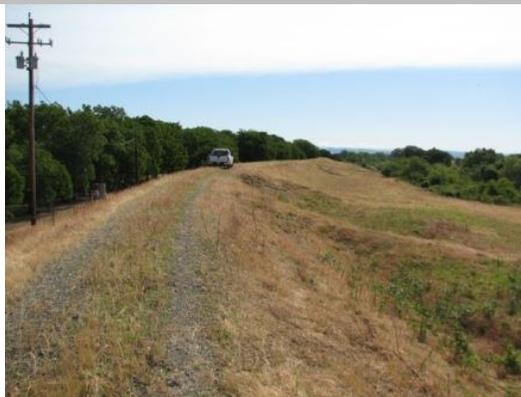
Photo 1 of 1 : SP_2015_RD0817_13_10_20150401_00004.jpg

LM Start	2.08	Rating **	U	Issue No.	10
LM End	3.18	Issue Type +	Ob	Location *	N/A
Category	Earthen Levee		GPS Latitude/Longitude		
			Start	End	
Item	Slope Stability		38.989338 °	38.994124 °	
			-121.468640 °	-121.449448 °	
DWR ID	DWR_RD0817_02_s_2012_10				
Action/Comments					
Repair slope instability. Inspector Comments: The levee is oversteepend at this location. The LMA states that it has always been like this and the USACE did not finish constructing the levee here.

Levee mile 2.08, this photo shows the slope is less than required, this is the downstream limit of the site, this is the waterside slope.

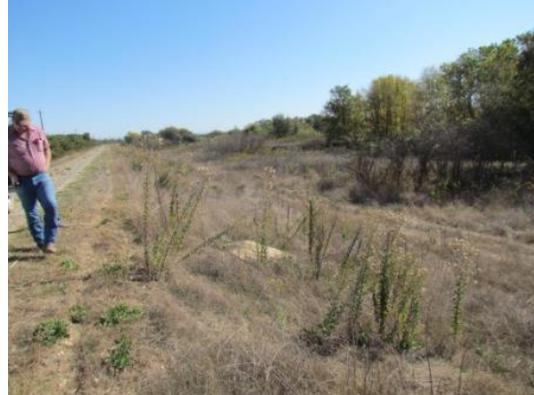
Photo 1 of 1 : SP_2015_RD0817_13_14_20150401_00005.jpg

LM Start	2.17	Rating **	U	Issue No.	14
LM End	2.17	Issue Type +	Ma	Location *	WS
Category	Earthen Levee			GPS Latitude/Longitude	
				Start	End
Item	Animal Control			38.989727 °	38.989727 °
				-121.467162 °	-121.467162 °
DWR ID	DWR_RD0817_02_f_2013_14				
Action/Comments					
Exterminate rodents and backfill and compact or grout burrows. Inspector Comments: Medium sized animal burrow in the the waterward side of the levee slope.

This photo was taken from the crown of the levee facing east looking at a medium sized animal burrow in the the waterward side of the levee slope.

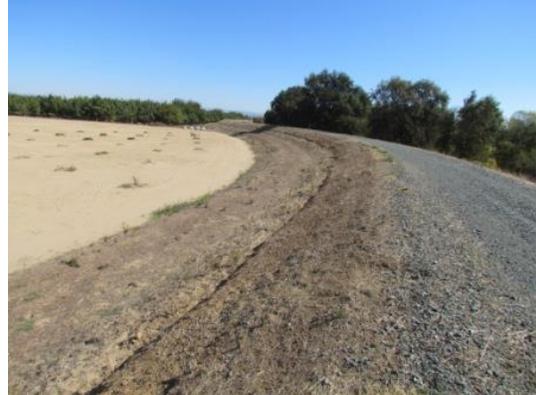
Photo 1 of 1 : SP_2015_RD0817_13_6_20150401_00002.jpg

LM Start	3.73	Rating **	U	Issue No.	6
LM End	3.73	Issue Type +	Ob	Location *	LS
Category	Earthen Levee		GPS Latitude/Longitude		
			Start	End	
Item	Slope Stability		38.992656 °	38.992656 °	
			-121.439508 °	-121.439508 °	
DWR ID	DWR_RD0817_02_f_2013_6				
Action/Comments					
Repair slope instability. Inspector Comments: Separation line in the soil on the landward side between the clay and the sand.

This photo was taken from the crown of the levee facing east looking at the separation line in the soil on the landward side between the clay and the sand.

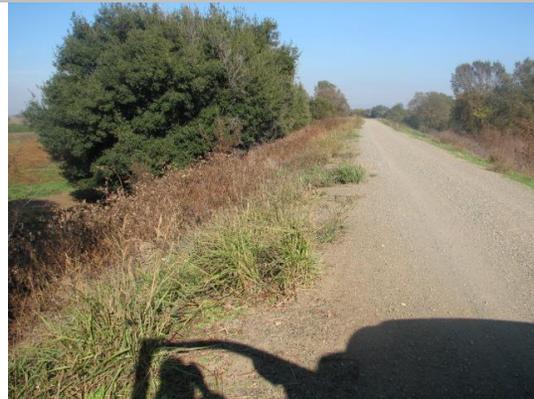
Photo 1 of 1 : SP_2015_RD0817_14_8_20150401_00001.jpg

LM Start	0.55	Rating **	U	Issue No.	8
LM End	0.81	Issue Type +	Ma	Location *	LS
Category	Earthen Levee			GPS Latitude/Longitude	
				Start	End
Item	Vegetation			38.989961 °	38.992220 °
				-121.502009 °	-121.498198 °
DWR ID	DWR_RD0784_06_f_2012_8				
Action/Comments					
Remove the wild growth other than native grasses from the levee slopes. Inspector Comments: Dense berry bushes along lower slope.

Levee mile 0.54, the landside slope.

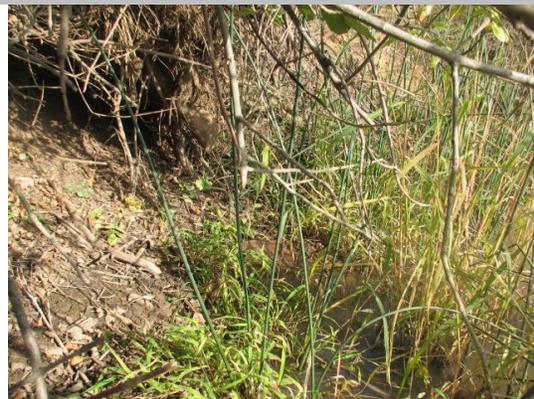
Photo 1 of 3 : SP_2015_RD0817_14_11_20150401_00003.jpg

LM Start	0.69	Rating **	U	Issue No.	11
LM End	0.69	Issue Type +	Ma	Location *	WS
Category	Interior Drainage & Piping Systems		GPS Latitude/Longitude		
			Start	End	
Item	Culverts: Breaks / Holes / Cracks		38.991084 °	38.991084 °	
			-121.499871 °	-121.499871 °	
DWR ID	DWR_RD0784_06_f_2012_11				
Action/Comments

Levee mile 0.68, this is located near the low flow channel, the flap gate is lying on the ground, the end of the pipe was not located.

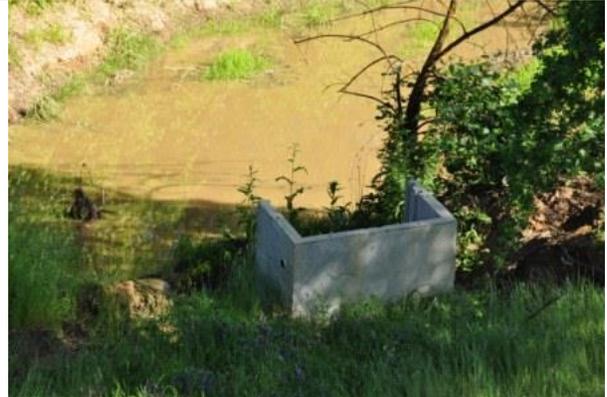
Photo 2 of 3 : SP_2015_RD0817_14_11_20150401_00004.jpg

LM Start	0.69	Rating **	U	Issue No.	11 (cont)
LM End	0.69	Issue Type +	Ma	Location *	WS
Category	Interior Drainage & Piping Systems			GPS Latitude/Longitude	
				Start	End
Item	Culverts: Breaks / Holes / Cracks			38.991084 °	38.991084 °
				-121.499871 °	-121.499871 °
DWR ID	DWR_RD0784_06_f_2012_11				
Action/Comments

L/S Intake at LM 0.68

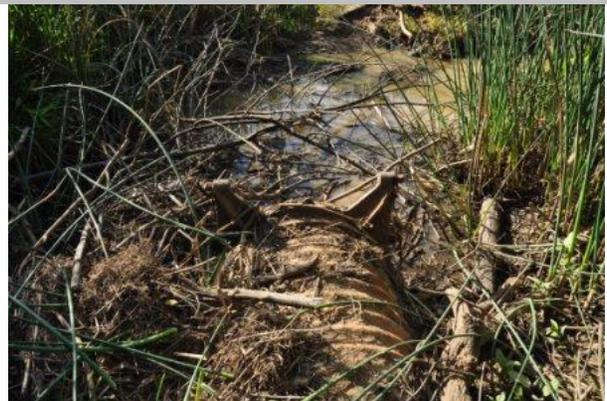
Photo 3 of 3 : SP_2015_RD0817_14_11_20150401_00005.jpg

LM Start	0.69	Rating **	U	Issue No.	11 (cont)
LM End	0.69	Issue Type +	Ma	Location *	WS

CMP is rusting and has numerous holes but flap gate is in place.
4/25/13 - Burnett

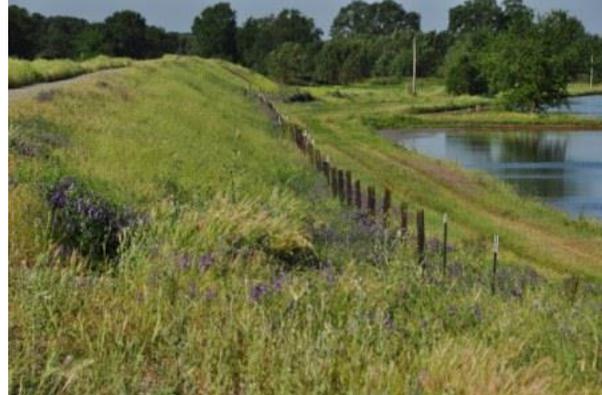
Photo 1 of 1 : SP_2015_RD0817_14_15_20150401_00007.jpg

LM Start	0.85	Rating **	M	Issue No.	15
LM End	1.27	Issue Type +	En	Location *	LS
Category	Earthen Levee			GPS Latitude/Longitude	
				Start	End
Item	Encroachments			38.992669 °	38.996885 °
				-121.497525 °	-121.491956 °
DWR ID	DWR_RD0784_06_s_2013_15				
Action/Comments					
Fence

Wire fence along L/S toe.

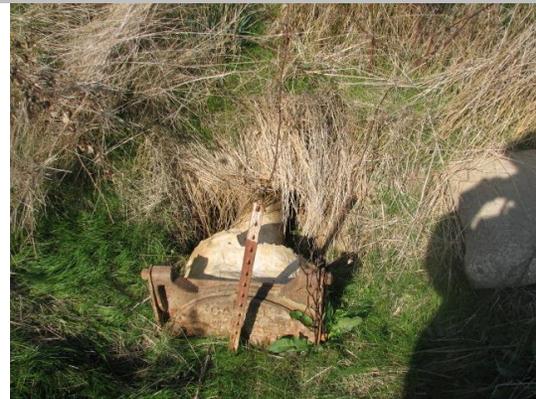
Photo 1 of 1 : SP_2015_RD0817_14_10_20150401_00002.jpg

LM Start	1.18	Rating **	U	Issue No.	10
LM End	1.18	Issue Type +	Ma	Location *	WS
Category	Interior Drainage & Piping Systems			GPS Latitude/Longitude	
				Start	End
Item	Culverts: Breaks / Holes / Cracks			38.995856 °	38.995856 °
				-121.493110 °	-121.493110 °
DWR ID	DWR_RD0784_06_f_2012_10				
Action/Comments

Levee mile 1.17 near the low flow channel, it appears a smaller pipe has been sleeved into the larger pipe, the flap gate does not make contact with the smaller pipe.

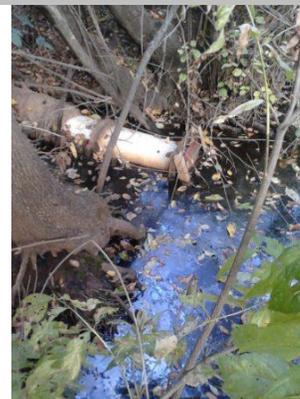
Photo 1 of 1 : SP_2015_RD0817_14_16_20150401_00008.jpg

LM Start	1.26	Rating **	M	Issue No.	16
LM End	1.33	Issue Type +	Ma	Location *	WS
Category	Interior Drainage & Piping Systems			GPS Latitude/Longitude	
				Start	End
Item	Culverts: Inlets / Outlets				
DWR ID	DWR_RD0784_06_f_2012_16				
Action/Comments

Levee mile 1.33 waterside of the levee, this pipe appears to be sleeved into a larger pipe, access to both ends is limited.

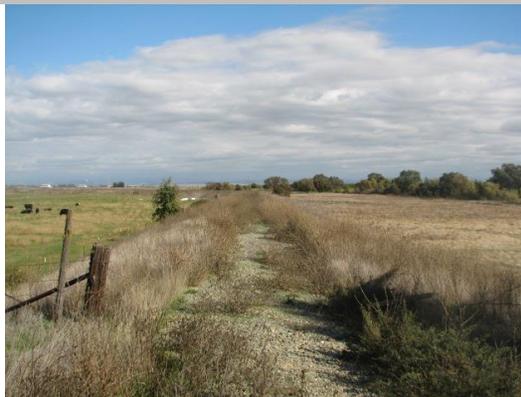
Photo 1 of 1 : SP_2015_RD0817_14_14_20150401_00006.jpg

LM Start	1.28	Rating **	U	Issue No.	14
LM End	1.50	Issue Type +	Ma	Location *	CR
Category	Earthen Levee		GPS Latitude/Longitude		
			Start	End	
Item	Vegetation		38.997019 °	38.999719 °	
			-121.491802 °	-121.490147 °	
DWR ID	DWR_RD0784_06_f_2012_14				
Action/Comments					
Remove the wild growth other than native grasses from the levee slopes.

Levee mile 1.27 looking upstream, typical of the levee in this section.
