**Flood Control Project Maintenance
Levee Inspections**

Fall 2010 Levee Maintenance Deficiency Summary Report

Sacramento River Basin

Reclamation District No. 0827 Elkhorn

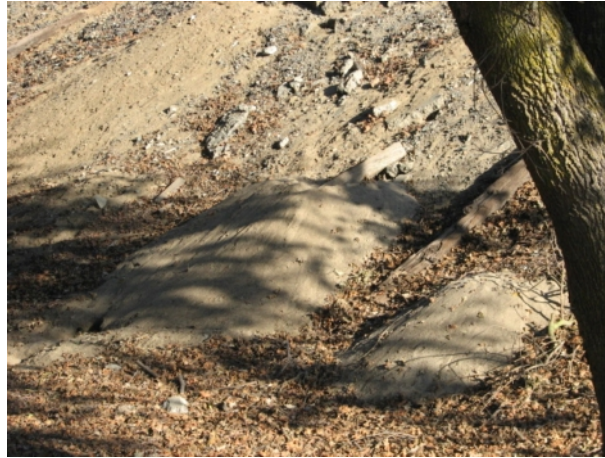
Levee Mile Report Line	2
Start Levee Mile	0.29
End Levee Mile	0.29
Location	Land Side
Category	Earthen Levee
Item	Animal Control

Rodent burrows on the landside levee a large amount of material.

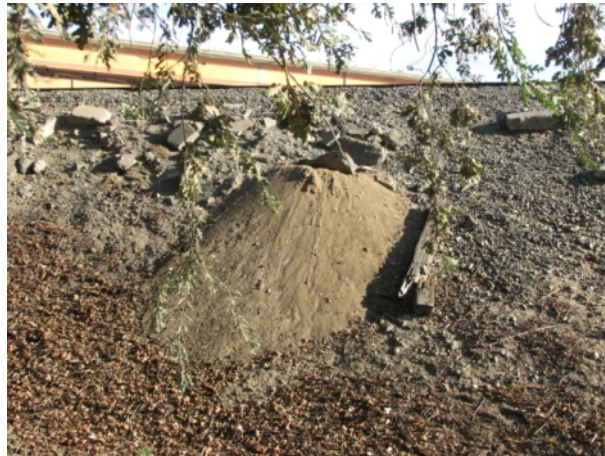
Levee Mile Report Line	2
Start Levee Mile	0.29
End Levee Mile	0.29
Location	Land Side
Category	Earthen Levee
Item	Animal Control

More rodents in the same area with large quantities of material excavated.

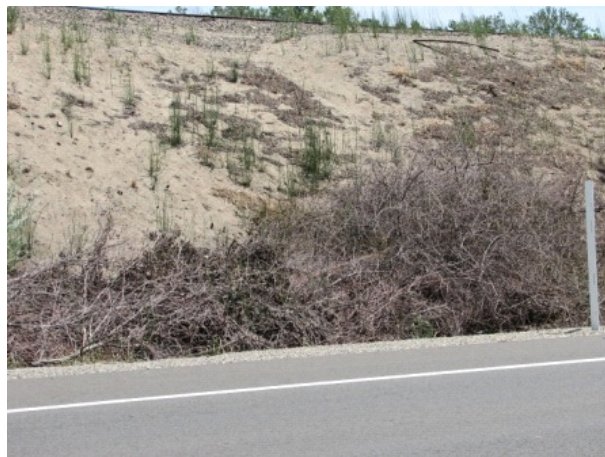
Levee Mile Report Line	6
Start Levee Mile	0.60
End Levee Mile	0.60
Location	Land Side
Category	Earthen Levee
Item	Encroachments

prunings at toe of levee

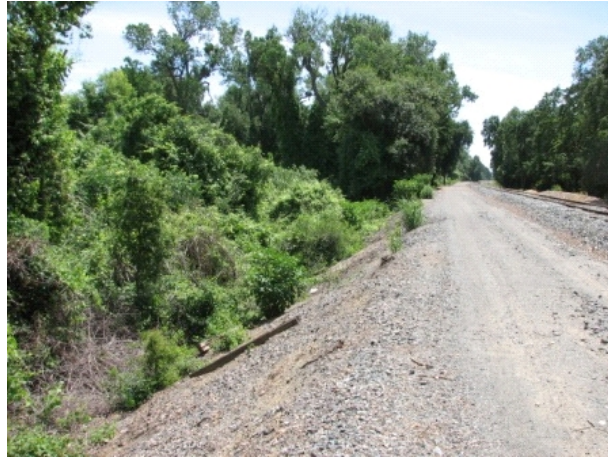
Levee Mile Report Line	13
Start Levee Mile	0.97
End Levee Mile	1.03
Location	Water Side
Category	Earthen Levee
Item	Vegetation

Vegetation is spotty most of the levee is clear.

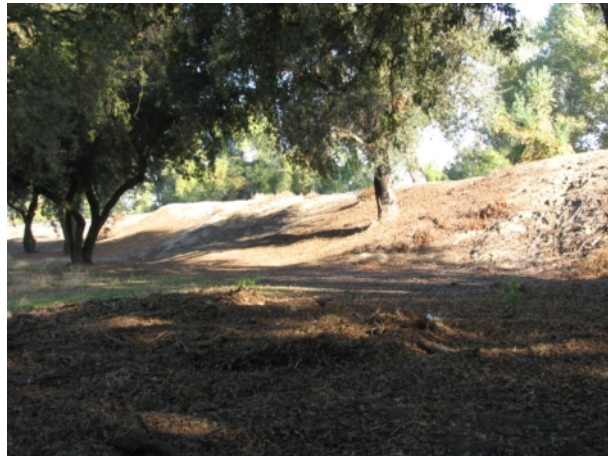
Levee Mile Report Line	14
Start Levee Mile	0.99
End Levee Mile	0.99
Location	Land Side
Category	Earthen Levee
Item	Vegetation

Landside levee slope is clean of all vegetation.

14	0.99	0.99	Earthen Levee	Vegetation	LS	A	Remove the wild growth other than native grasses from the levee slopes.	38.664670 ° -121.617879 °	38.664670 ° -121.617879 °	3 Y
15	1.07	1.19	Earthen Levee	Vegetation	WS	M	Remove the wild growth other than native grasses from the levee slopes. Inspector Comments: Continue to make great progress with the use of chemicals and brush cutting. Still need to brush cut farther down the waterside slope.	38.664196 ° -121.616765 °	38.662856 ° -121.615347 °	4 Y

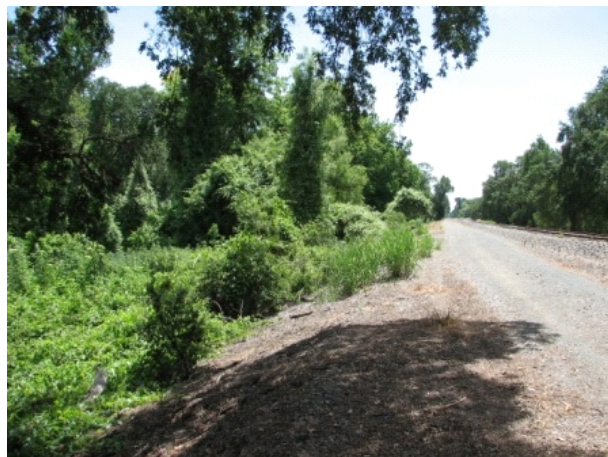
Levee Mile Report Line	15
Start Levee Mile	1.07
End Levee Mile	1.19
Location	Water Side
Category	Earthen Levee
Item	Vegetation

vegetation

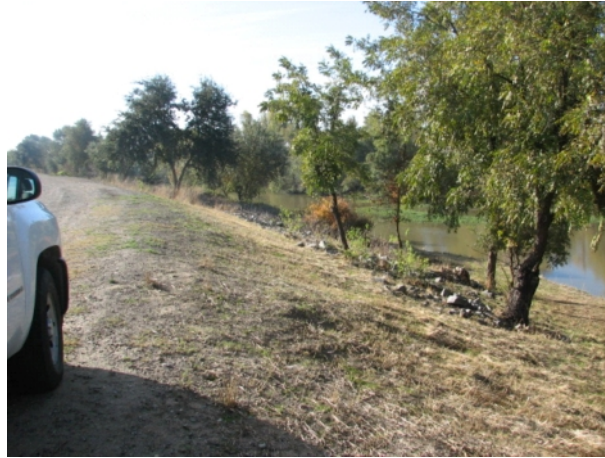
Levee Mile Report Line	1
Start Levee Mile	0.05
End Levee Mile	0.05
Location	Water Side
Category	Earthen Levee
Item	Vegetation

After the goats have gone through the area vegetation is under control.

Waterway							Bank	Unit Miles	Inspection Start/End	Inspector
Unit No. 02 Yolo Bypass							Left	2.84	11/03/2010 11/03/2010	John Williamson
LMR No.	Levee Mile		Category	Item	* Location	* Rating	Action/Comment	GPS Latitude/Longitude		Issue No.
	Start	End						Start	End	Photo
1	0.05	0.05	Earthen Levee	Vegetation	WS	W	Remove the wild growth other than native grasses from the levee slopes.	38.675962 ° -121.643085 °	38.675962 ° -121.643085 °	8 Y
2	0.11	0.11	Earthen Levee	Trim / Thin Trees	WS	N	Tree stumps.	38.675236 ° -121.642985 °	38.675236 ° -121.642985 °	4
3	0.26	0.26	Earthen Levee	Encroachments	LS	C	Prunings	38.673640 ° -121.642370 °	38.673640 ° -121.642370 °	5
4	0.27	0.51	Earthen Levee	Encroachments	LS	PO	Agricultural Ditch	38.673035 ° -121.642390 °	38.669597 ° -121.641600 °	1
5	0.33	0.33	Earthen Levee	Vegetation	LS	W	Remove the wild growth other than native grasses from the levee slopes.	38.672231 ° -121.642218 °	38.672231 ° -121.642218 °	9 Y

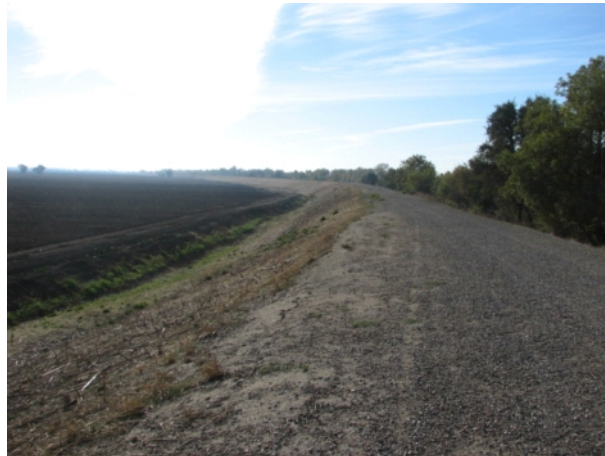
Levee Mile Report Line	5
Start Levee Mile	0.33
End Levee Mile	0.33
Location	Land Side
Category	Earthen Levee
Item	Vegetation

Photo of the landside slope after the goats have worked the area.

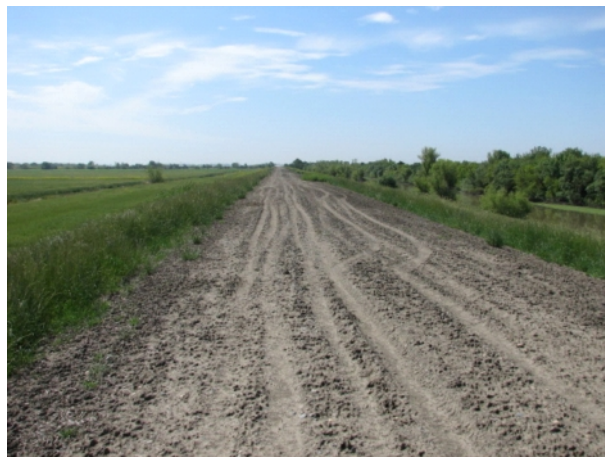
Levee Mile Report Line	6
Start Levee Mile	0.80
End Levee Mile	2.41
Location	Crown
Category	Earthen Levee
Item	Crown Surface / Depressions / Rutting

crown needs grading and AB added

6	0.80	2.41	Earthen Levee	Crown Surface / Depressions / Rutting	CR	M	Add appropriate gravel or road base. Grade and compact.	38.665917 ° -121.639188 °	38.646564 ° -121.623705 °	6 Y
7	1.83	1.83	Earthen Levee	Animal Control	LS	C	Exterminate rodents and backfill and compact or grout burrows.	38.653799 ° -121.628175 °	38.653799 ° -121.628175 °	7
