**Flood Control Project Maintenance
Levee Inspections**

Fall 2011 Levee Maintenance Deficiency Summary Report

Sacramento River Basin

Reclamation District No. 0827 Elkhorn

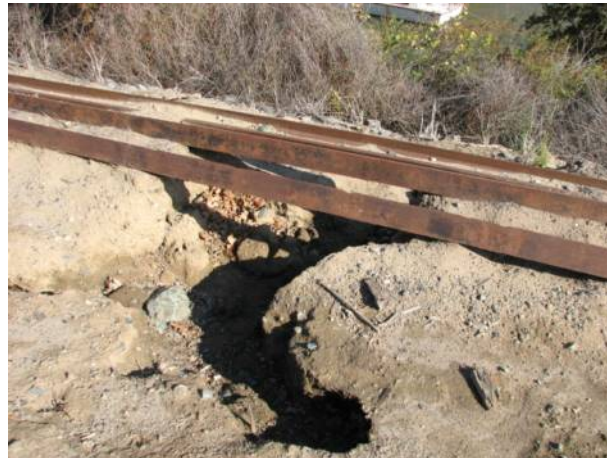
Levee Mile Report Line	1
Start Levee Mile	0.27
End Levee Mile	0.27
Location	Water Side
Category	Earthen Levee
Item	Erosion / Bank Caving

There is erosion on the waterside shoulder. Fall 2011

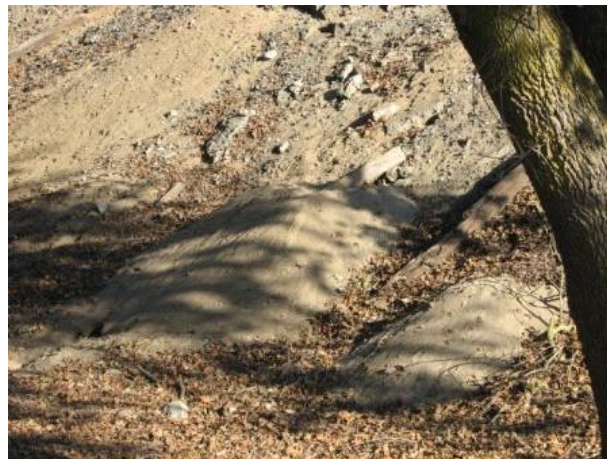
Levee Mile Report Line	2
Start Levee Mile	0.29
End Levee Mile	0.29
Location	Land Side
Category	Earthen Levee
Item	Animal Control

Rodent burrows on the landside levee a large amount of material.

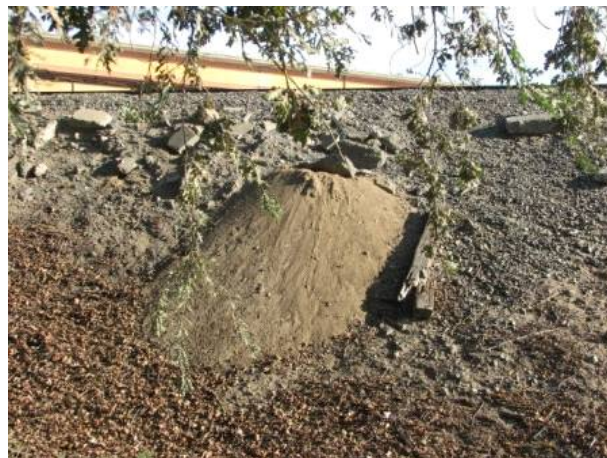
Levee Mile Report Line	2
Start Levee Mile	0.29
End Levee Mile	0.29
Location	Land Side
Category	Earthen Levee
Item	Animal Control

More rodents in the same area with large quantities of material excavated.

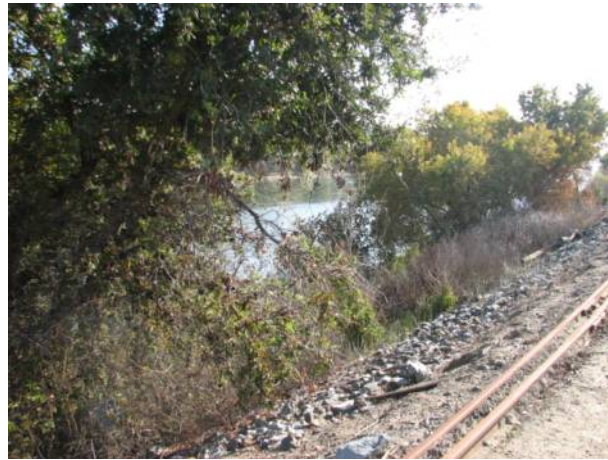
Levee Mile Report Line	3
Start Levee Mile	0.31
End Levee Mile	0.37
Location	Water Side
Category	Earthen Levee
Item	Trim / Thin Trees

Thick vegetation on the waterside. Fall 2011

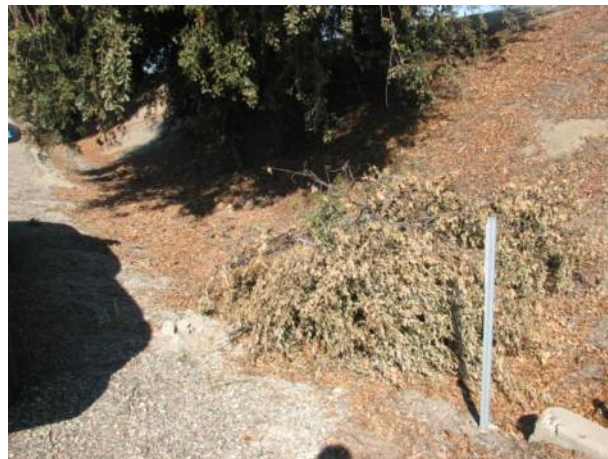
Levee Mile Report Line	5
Start Levee Mile	0.60
End Levee Mile	0.60
Location	Land Side
Category	Earthen Levee
Item	Encroachments

Prunings along the toe of the levee. Fall 2011

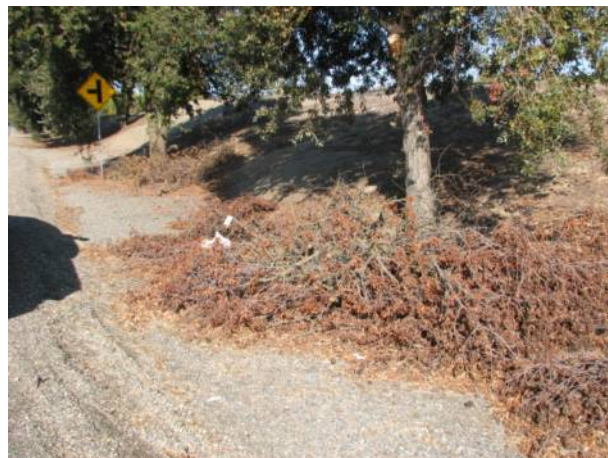
Levee Mile Report Line	8
Start Levee Mile	0.83
End Levee Mile	0.83
Location	Land Side
Category	Earthen Levee
Item	Encroachments

Piles of prunings along the roadside at the toe. Fall 2011

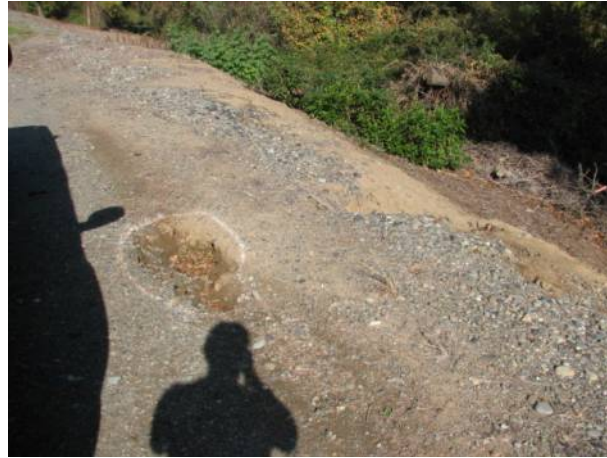
Levee Mile Report Line	11
Start Levee Mile	1.13
End Levee Mile	1.13
Location	Water Side
Category	Earthen Levee
Item	Erosion / Bank Caving

Erosion on the crown that followed a rodent tunnel and eroded the shoulder. Fall 2011

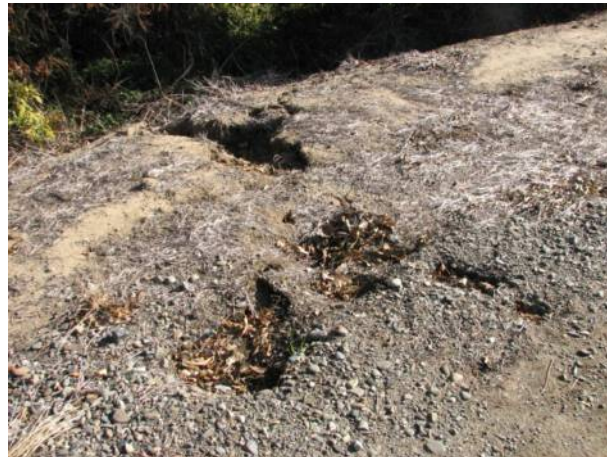
Levee Mile Report Line	11
Start Levee Mile	1.13
End Levee Mile	1.13
Location	Water Side
Category	Earthen Levee
Item	Erosion / Bank Caving

More erosion caused by rodents in the area. Fall 2011

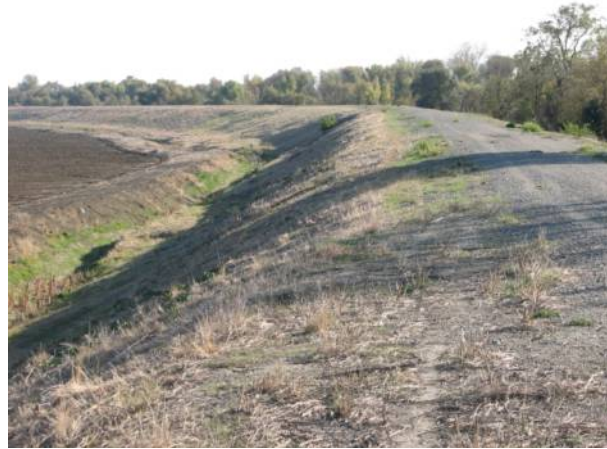
Levee Mile Report Line	4
Start Levee Mile	0.34
End Levee Mile	2.78
Location	Land Side
Category	Earthen Levee
Item	Vegetation

The vegetation after the goats have grazed on the levee. Fall 2011

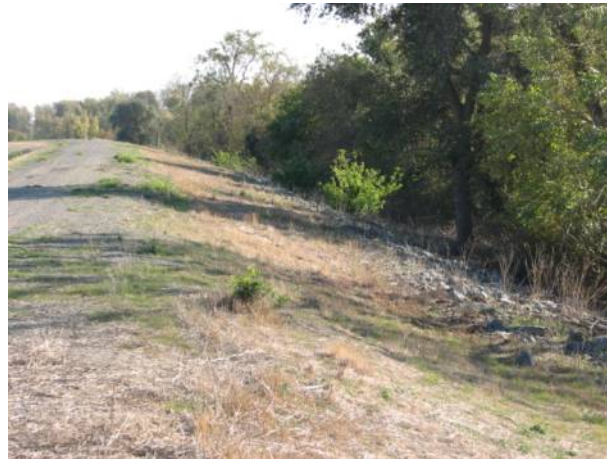
Levee Mile Report Line	5
Start Levee Mile	0.34
End Levee Mile	2.78
Location	Water Side
Category	Earthen Levee
Item	Vegetation

The levee after the goats have grazed. Fall 2011

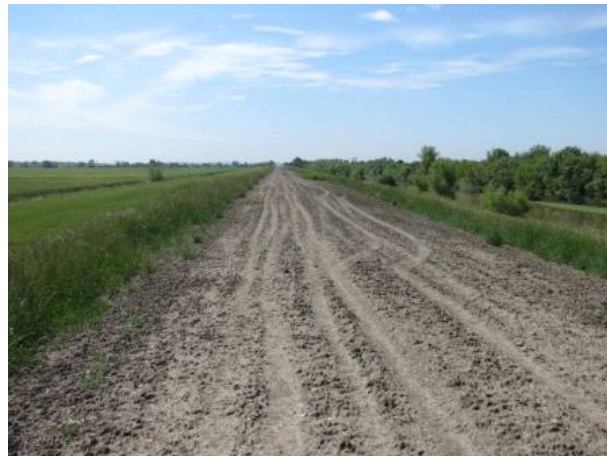
Levee Mile Report Line	7
Start Levee Mile	0.80
End Levee Mile	2.41
Location	Crown
Category	Earthen Levee
Item	Crown Surface / Depressions / Rutting

Crown needs grading and AB added.

7	0.80	2.41	Earthen Levee	Crown Surface / Depressions / Rutting	CR	M	Add appropriate gravel or road base. Grade and compact.	38.665917 ° -121.639188 °	38.646564 ° -121.623705 °	6 Y
