**Flood Control Project Maintenance
Levee Inspections**

Fall 2012 Levee Maintenance Deficiency Summary Report

Sacramento River Basin

Reclamation District No. 0827 Elkhorn

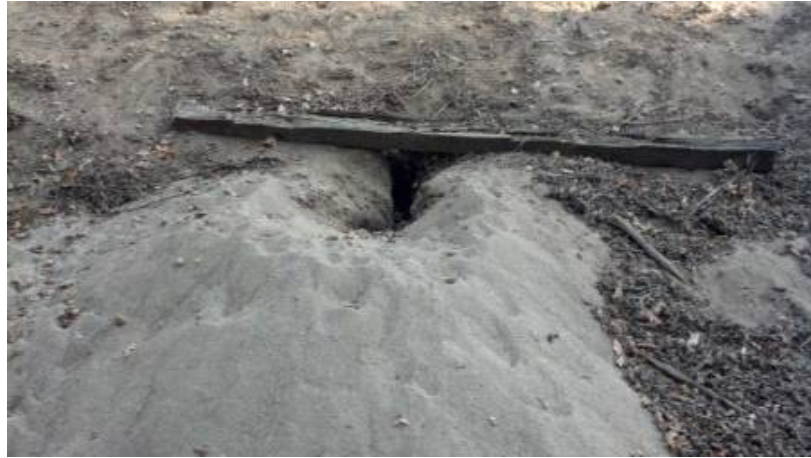
Levee Mile Report Line	4
Start Levee Mile	0.27
End Levee Mile	0.27
Location	Land Side
Category	Earthen Levee
Item	Animal Control

A large rodent hole on the levee slope. Photo fall 2012.

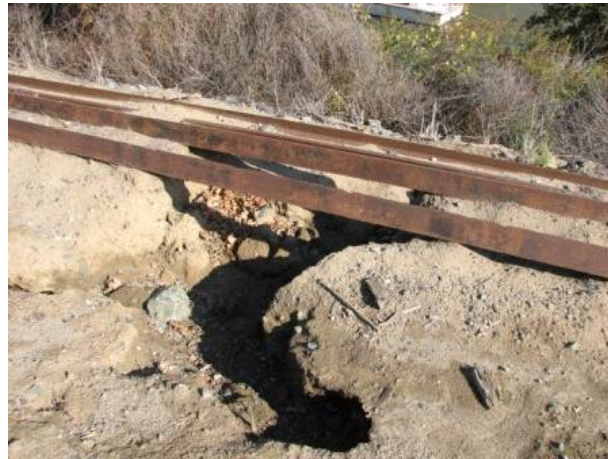
Levee Mile Report Line	5
Start Levee Mile	0.27
End Levee Mile	0.27
Location	Water Side
Category	Earthen Levee
Item	Erosion / Bank Caving

There is erosion on the waterside shoulder. Fall 2011

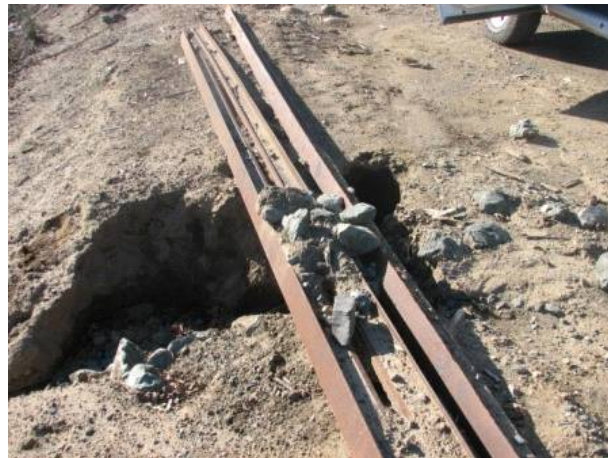
Levee Mile Report Line	5
Start Levee Mile	0.27
End Levee Mile	0.27
Location	Water Side
Category	Earthen Levee
Item	Erosion / Bank Caving

A current view of the erosion caused by surface run off. Photo taken spring 2012.

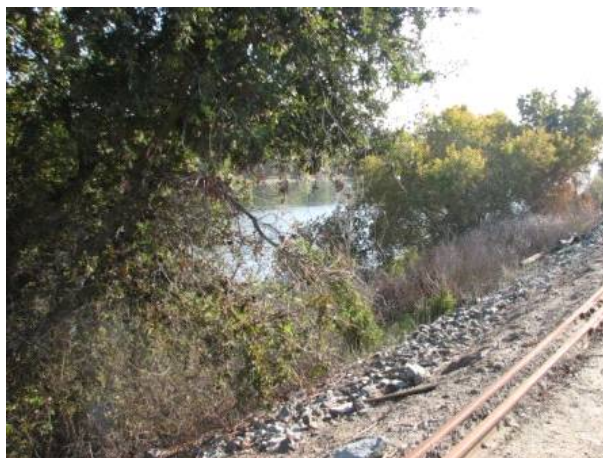
Levee Mile Report Line	6
Start Levee Mile	0.31
End Levee Mile	0.37
Location	Water Side
Category	Earthen Levee
Item	Trim / Thin Trees

Thick vegetation on the waterside. Fall 2011

6	0.31	0.37	Earthen Levee	Trim / Thin Trees	WSA/W Ma	T2 : Thin trees to allow visibility of the ground and room to flood fight.	38.671959 ° -121.626305 °	38.671376 ° -121.625608 °	2 Y
DWR ID: DWR_RD0827_01_s_2012_2									
7	0.54	0.54	Earthen Levee	Trim / Thin Trees	LS N Ma	T5 : Tree stumps.	38.669445 ° -121.623574 °	38.669445 ° -121.623574 °	13 Y
DWR ID: DWR_RD0827_01_s_2012_13									
8	0.60	0.60	Earthen Levee	Encroachments	LS M Ma	PR : Prunings	38.668820 ° -121.622829 °	38.668820 ° -121.622829 °	8 Y
DWR ID: DWR_RD0827_01_s_2012_8									
9	0.61	0.92	Earthen Levee	Vegetation	WSA/W Ob	V8 : Environmental Requirements.	38.668873 ° -121.622513 °	38.665750 ° -121.618523 °	22 Y
DWR ID: DWR_RD0827_01_s_2012_22									
10	0.83	0.83	Earthen Levee	Encroachments	LS M Ma	PR : Prunings	38.666475 ° -121.619835 °	38.666475 ° -121.619835 °	6 Y
DWR ID: DWR_RD0827_01_s_2012_6									
11	0.92	1.33	Earthen Levee	Vegetation	WSA/W Ma	V7 : Trees / Woody Vegetation	38.665777 ° -121.618523 °	38.661267 ° -121.613803 °	23 Y

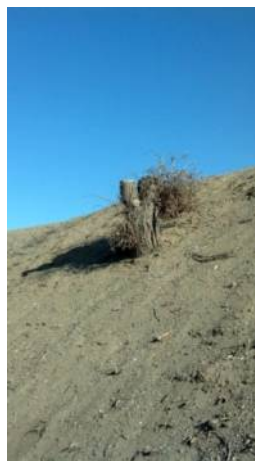
Levee Mile Report Line	7
Start Levee Mile	0.54
End Levee Mile	0.54
Location	Land Side
Category	Earthen Levee
Item	Trim / Thin Trees

A tree stump on the levee slope. Photo fall 2012.

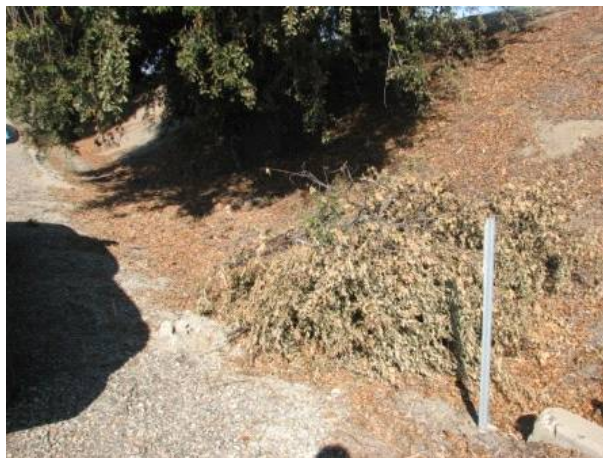
Levee Mile Report Line	8
Start Levee Mile	0.60
End Levee Mile	0.60
Location	Land Side
Category	Earthen Levee
Item	Encroachments

Prunings along the toe of the levee. Fall 2011

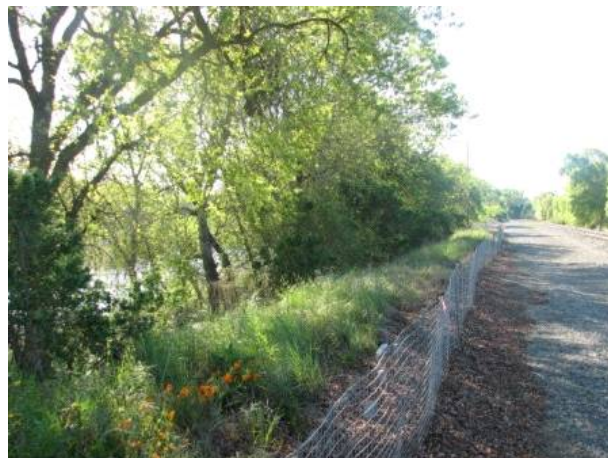
Levee Mile Report Line	9
Start Levee Mile	0.61
End Levee Mile	0.92
Location	Water Side
Category	Earthen Levee
Item	Vegetation
This view shows some of the larger trees in the site. Photo taken spring 2012.	
johngw_f_20120911_415.jpg

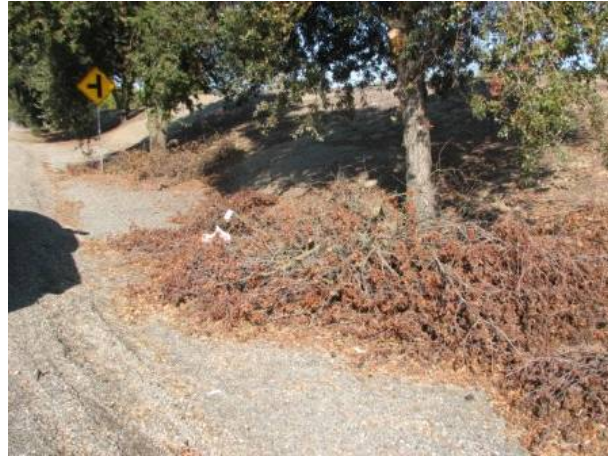
Levee Mile Report Line	10
Start Levee Mile	0.83
End Levee Mile	0.83
Location	Land Side
Category	Earthen Levee
Item	Encroachments

Piles of prunings along the roadside at the toe.
Fall 2011

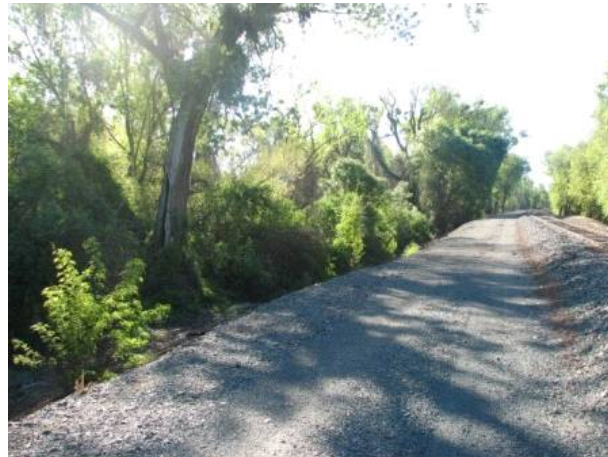
Levee Mile Report Line	11
Start Levee Mile	0.92
End Levee Mile	1.33
Location	Water Side
Category	Earthen Levee
Item	Vegetation

Trees on the very wide waterside berm. Photo
taken spring 2012.

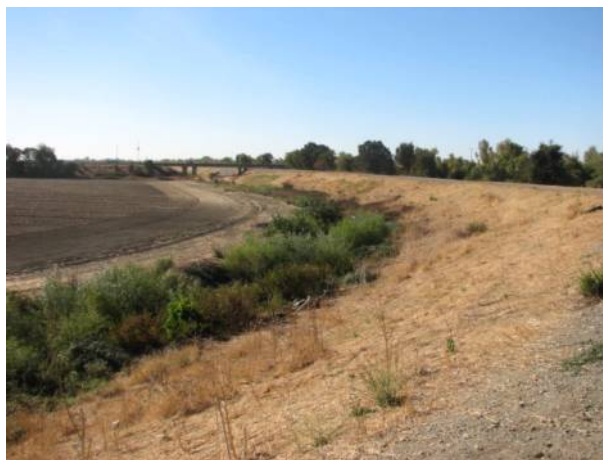
Levee Mile Report Line	1
Start Levee Mile	0.01
End Levee Mile	0.53
Location	Land Side
Category	Earthen Levee
Item	Encroachments

Ditch runs along the landside toe. Photo fall 2012.

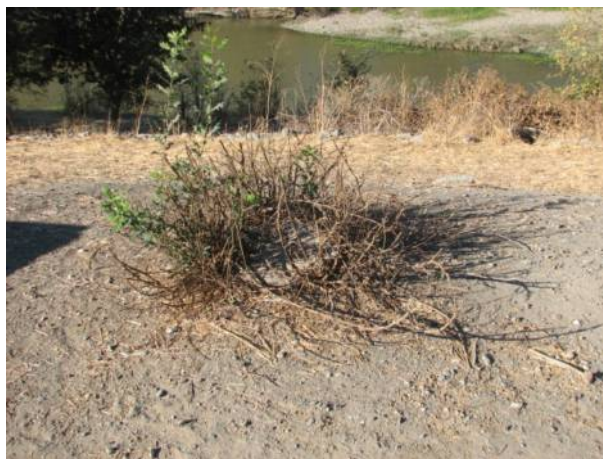
Levee Mile Report Line	2
Start Levee Mile	0.11
End Levee Mile	0.11
Location	Crown
Category	Earthen Levee
Item	Trim / Thin Trees

A tree stump on the levee shoulder. Photo fall 2012.

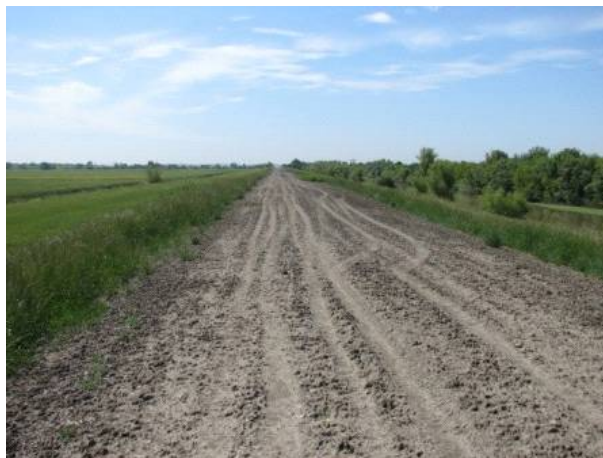
Levee Mile Report Line	3
Start Levee Mile	0.80
End Levee Mile	2.41
Location	Crown
Category	Earthen Levee
Item	Crown Surface / Depressions / Rutting

Crown needs grading and AB added.

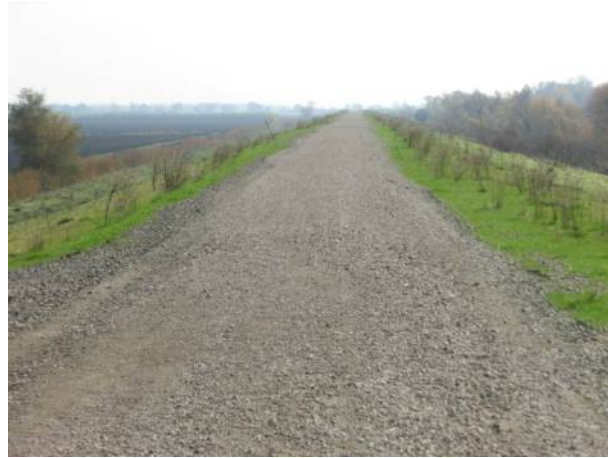
Levee Mile Report Line	3
Start Levee Mile	0.80
End Levee Mile	2.41
Location	Crown
Category	Earthen Levee
Item	Crown Surface / Depressions / Rutting

The crown has been graded and gravel has been added.

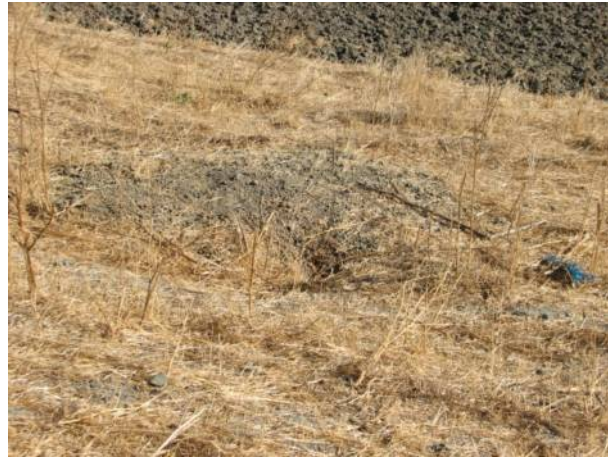
Levee Mile Report Line	4
Start Levee Mile	1.98
End Levee Mile	1.98
Location	Land Side
Category	Earthen Levee
Item	Animal Control

Rodent hole on the levee slope. Photo fall 2012.

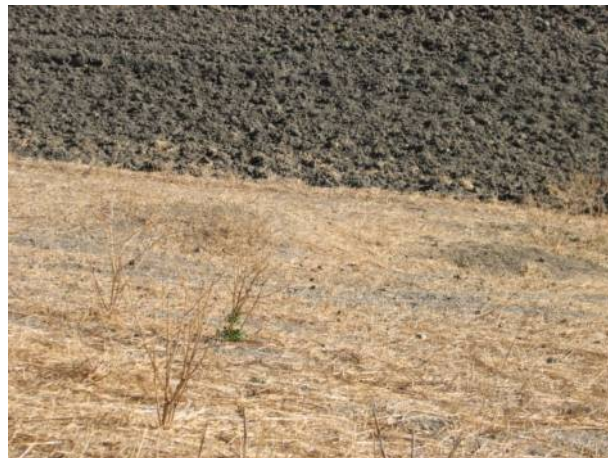
Levee Mile Report Line	5
Start Levee Mile	2.08
End Levee Mile	2.08
Location	Land Side
Category	Earthen Levee
Item	Animal Control

Rodent holes on the levee slope. Photo fall 2012.

5	2.08	2.08	Earthen Levee	Animal Control	LS	M Ma	A3 : No rodents visible, but rodent burrows visible; need to backfill and compact or grout burrows.	38.650867 ° -121.626385 °	38.650867 ° -121.626385 °	5 Y
DWR ID: DWR_RD0827_02_f_2012_5										
6	2.16	2.16	Earthen Levee	Cracking	LS	M Ma	CR1 : Monitor and have inspected by geotechnical engineer.	38.649765 ° -121.625699 °	38.649765 ° -121.625699 °	7 Y
DWR ID: DWR_RD0827_02_f_2012_7										
7	2.31	2.31	Earthen Levee	Slope Stability	LS	M Ma	S1 : Repair slope instability. Inspector Comments: There is cracking along the levee slope not greater than 200 feet. Need to monitor.	38.647703 ° -121.624450 °	38.647703 ° -121.624450 °	24 Y
DWR ID: DWR_RD0827_02_s_2012_24										
8	2.76	2.76	Earthen Levee	Erosion / Bank Caving	CR	M Ma	Inspector Comments: Hole in crown at pipe crossing maybe leak in pipe.	38.641904 ° -121.620859 °	38.641904 ° -121.620859 °	8 Y

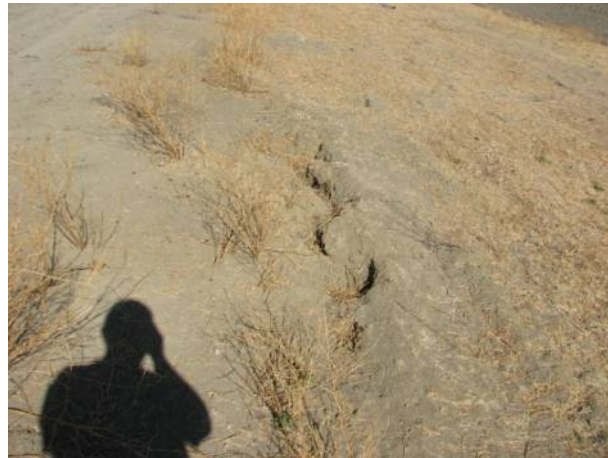
Levee Mile Report Line	6
Start Levee Mile	2.16
End Levee Mile	2.16
Location	Land Side
Category	Earthen Levee
Item	Cracking
Some deep cracking along the shoulder. Photo fall 2012.	
johngw_f_20121022_799.jpg

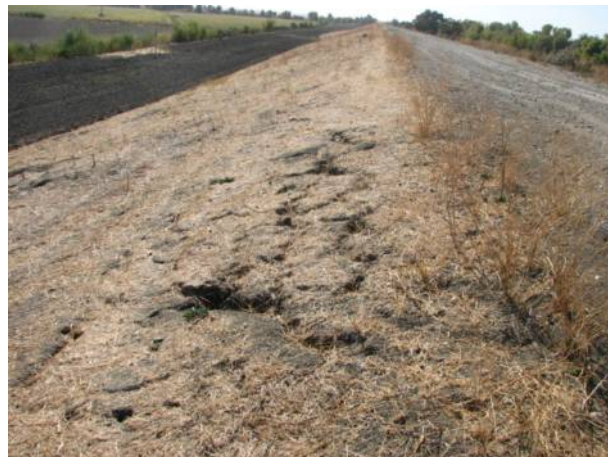
Levee Mile Report Line	6
Start Levee Mile	2.16
End Levee Mile	2.16
Location	Land Side
Category	Earthen Levee
Item	Cracking
Deep cracking along the shoulder of the levee. Photo fall 2012.	
johngw_f_20121022_800.jpg

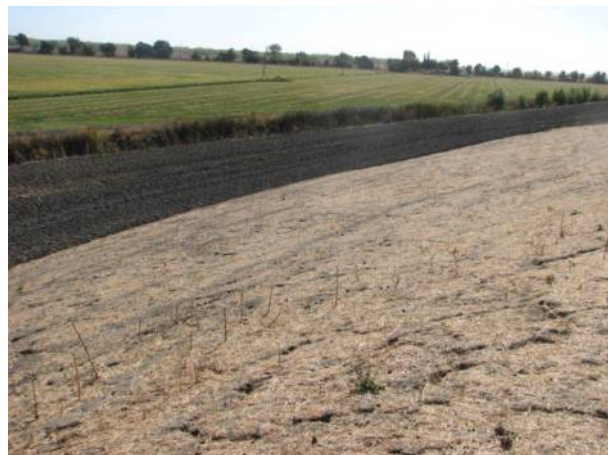
Levee Mile Report Line	7
Start Levee Mile	2.31
End Levee Mile	2.31
Location	Land Side
Category	Earthen Levee
Item	Slope Stability
A buldge in the levee slope. Photo fall 2012.	
johngw_f_20121022_801.jpg

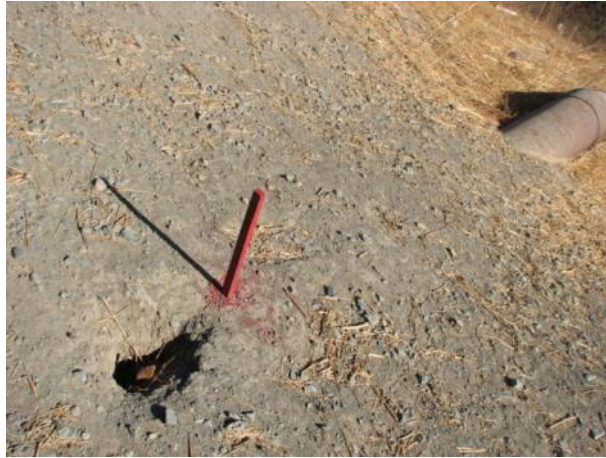
Levee Mile Report Line	8
Start Levee Mile	2.76
End Levee Mile	2.76
Location	Crown
Category	Earthen Levee
Item	Erosion / Bank Caving

A hole in the crown above the irrigation pipe may have a leak. Photo fall 2012.
