**Flood Control Project Maintenance
Levee Inspections**

Fall 2013 Levee Maintenance Deficiency Summary Report

Reclamation District No. 0827 Elkhorn

Levee Inspection Report By Mile - Fall 2013

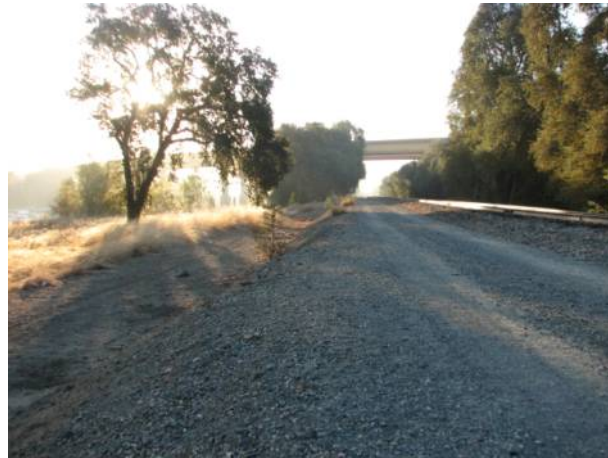
Levee Mile Report Line	4
Start Levee Mile	0.01
End Levee Mile	1.32
Location	Water Side
Category	Earthen Levee
Item	Vegetation
No unwanted vegetation blocking visibility of the levee slope. Fall 2013	
johngw_f_20131104_285.JPG

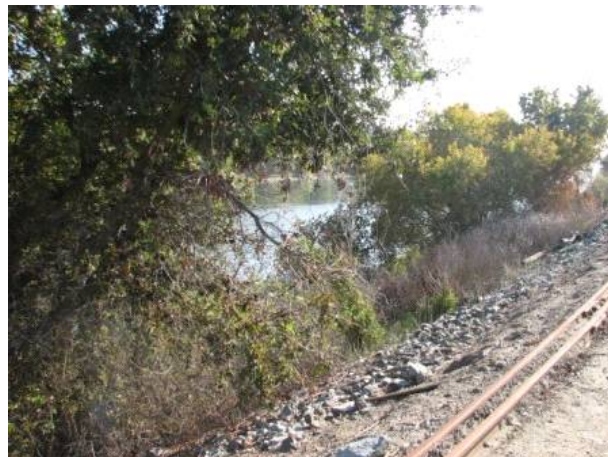
Levee Mile Report Line	6
Start Levee Mile	0.31
End Levee Mile	0.37
Location	Water Side
Category	Earthen Levee
Item	Trim / Thin Trees
Thick vegetation on the waterside. Fall 2011	
johngw_f_20131021_583.jpg

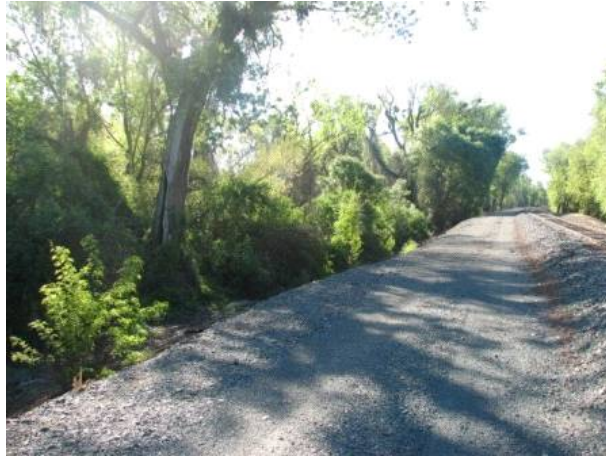
Levee Mile Report Line	12
Start Levee Mile	0.92
End Levee Mile	1.33
Location	Water Side
Category	Earthen Levee
Item	Vegetation

Trees on the very wide waterside berm. Photo taken spring 2012.

12	0.92	1.33	Earthen Levee	Vegetation	WSA/W	Ma	V7 : Trees / Woody Vegetation	38.665777 ° -121.618523 °	38.661267 ° -121.613803 °	23 Y
								DWR ID: DWR_RD0827_01_s_2012_23

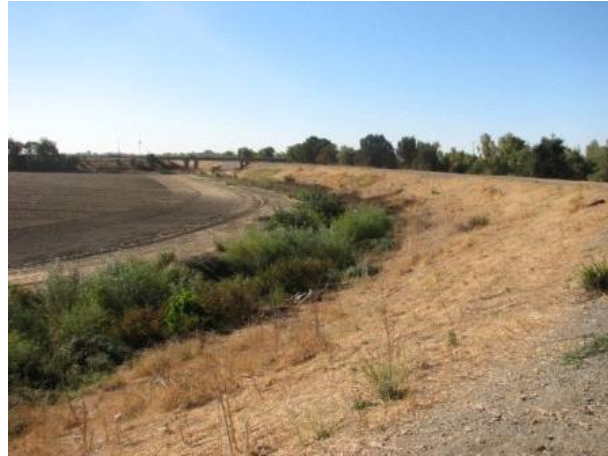
Levee Mile Report Line	1
Start Levee Mile	0.01
End Levee Mile	0.53
Location	Land Side
Category	Earthen Levee
Item	Encroachments

Ditch runs along the landside toe. Photo fall 2012.

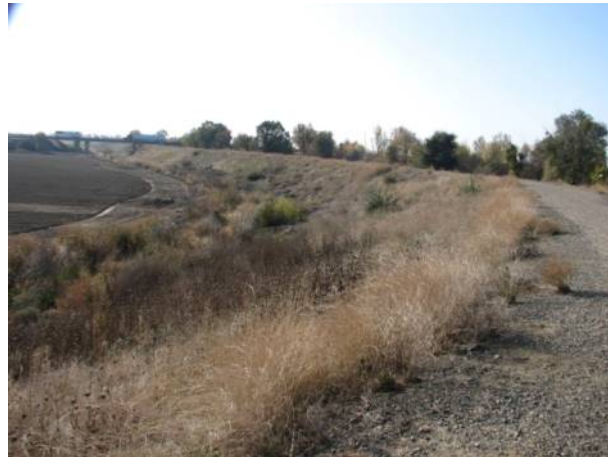
Levee Mile Report Line	2
Start Levee Mile	0.02
End Levee Mile	2.78
Location	Land Side
Category	Earthen Levee
Item	Vegetation

Tall grasses and weeds block visibility of the levee slope. Fall 2013

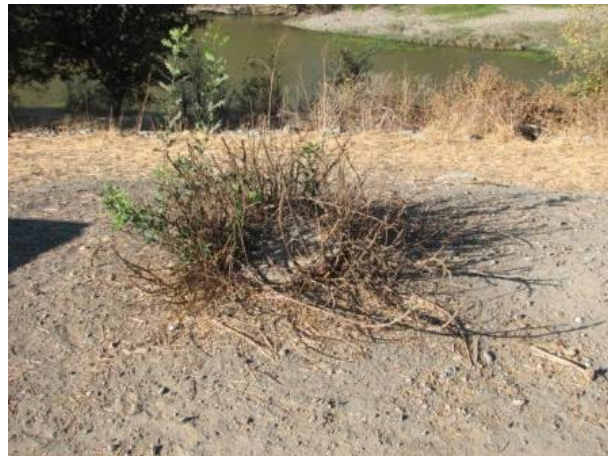
Levee Mile Report Line	3
Start Levee Mile	0.11
End Levee Mile	0.11
Location	Crown
Category	Earthen Levee
Item	Trim / Thin Trees

A tree stump on the levee shoulder. Photo fall 2012.

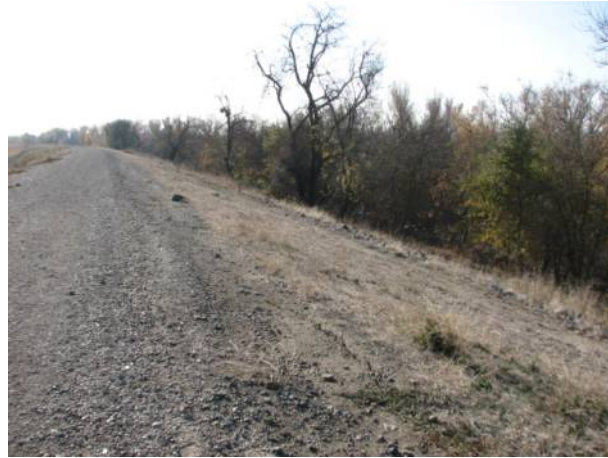
Levee Mile Report Line	4
Start Levee Mile	0.33
End Levee Mile	2.78
Location	Water Side
Category	Earthen Levee
Item	Vegetation

The levee has good visibility of the slope. Grasses and weeds have been grazed. Fall 2013

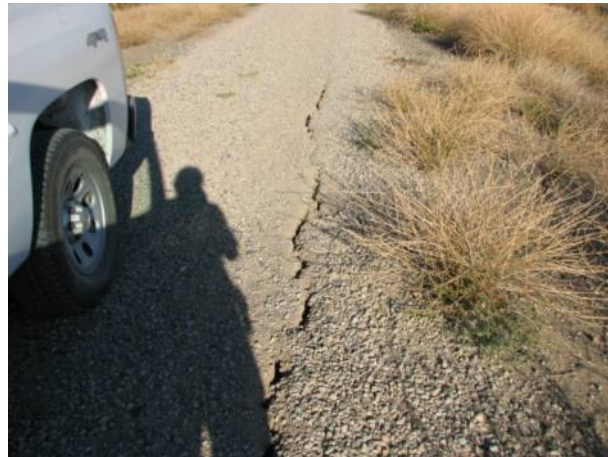
Levee Mile Report Line	5
Start Levee Mile	1.55
End Levee Mile	1.55
Location	Crown
Category	Earthen Levee
Item	Cracking

A crack along the shoulder is 12 inches deep and runs for 20 feet. Fall 2013

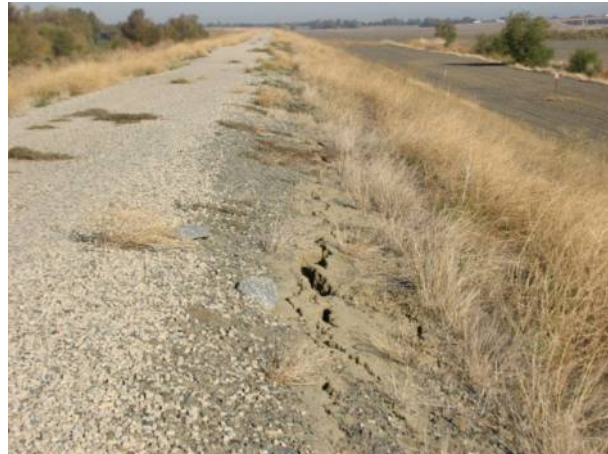
Levee Mile Report Line	6
Start Levee Mile	2.14
End Levee Mile	2.14
Location	Crown
Category	Earthen Levee
Item	Cracking

The crack is 4-6 inches wide and 3 feet deep with a length of 6 feet. Fall 2013

DWR ID: DWR_RD0827_02_f_2013_1										
6	2.14	2.14	Earthen Levee	Cracking	CR	U Ob	CR1 : Monitor and have inspected by geotechnical engineer.	38.649993 ° -121.625860 °	38.649993 ° -121.625860 °	5 Y
DWR ID: DWR_RD0827_02_f_2013_5										
7	2.31	2.31	Earthen Levee	Slope Stability	LS	M Ma	S1 : Repair slope instability. Inspector Comments: There is cracking along the levee slope not greater than 200 feet. Need to monitor.	38.647703 ° -121.624450 °	38.647703 ° -121.624450 °	24 Y
DWR ID: DWR_RD0827_02_s_2012_24

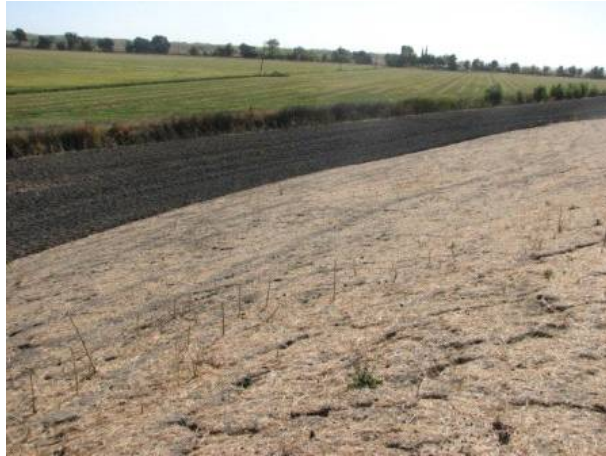
Levee Mile Report Line	7
Start Levee Mile	2.31
End Levee Mile	2.31
Location	Land Side
Category	Earthen Levee
Item	Slope Stability

A buldge in the levee slope. Photo fall 2012.
