**Flood Control Project Maintenance  
Levee Inspections**

**Fall 2014 Levee Maintenance Deficiency Summary Report**

**Reclamation District No. 0827 Elkhorn**

**Levee Inspection Report By Mile - Fall 2014**

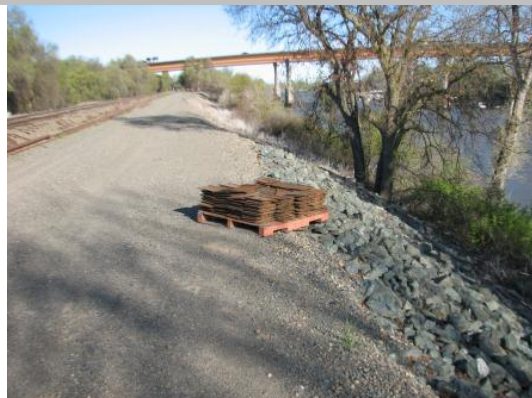
Photo 1 of 1 : FA\_2014\_RD0827\_187\_110\_20141014\_00012.jpg

LM Start	0.42	Rating **	M	Issue No.	110
LM End	0.42	Issue Type +	En	Location *	CR
Category	Earthen Levee			GPS Latitude/Longitude	
				Start	End
Item	Encroachments			38.670829 °	38.670829 °
				-121.624921 °	-121.624921 °
DWR ID	DWR_RD0827_01_s_2014_110				
Action/Comments					
Debris

Debris from the railroad is stacked along the crown shoulder. Spring 2014

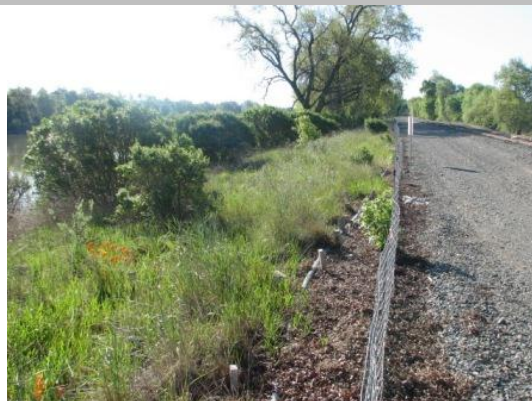
Photo 1 of 5 : FA\_2014\_RD0827\_187\_22\_20141014\_00004.jpg

LM Start	0.61	Rating **	A/W	Issue No.	22
LM End	0.92	Issue Type +	Ma	Location *	WS
Category	Earthen Levee			GPS Latitude/Longitude	
				Start	End
Item	Vegetation			38.668873 °	38.665750 °
				-121.622513 °	-121.618523 °
DWR ID	DWR_RD0827_01_s_2012_22				
Action/Comments					
Environmental Requirements.

Revegetation site with fencing, irrigation and stakes to hold netting.  
Photo taken spring 2012.

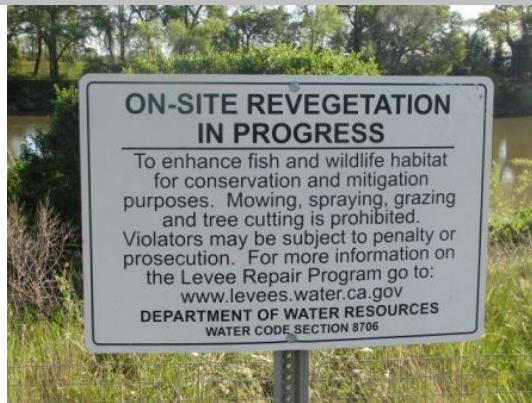
Photo 2 of 5 : FA\_2014\_RD0827\_187\_22\_20141014\_00005.jpg

Revegetation site spring 2012.

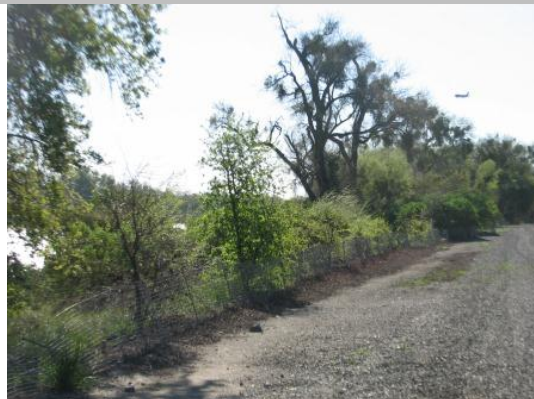
Photo 3 of 5 : FA\_2014\_RD0827\_187\_22\_20141014\_00006.jpg

Another view of the revegetation site. Spring 2014

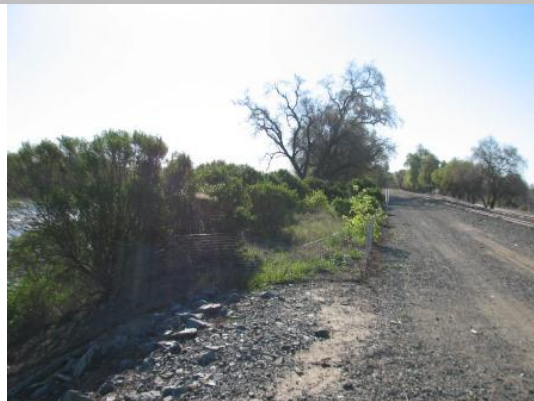
Photo 4 of 5 : FA\_2014\_RD0827\_187\_22\_20141014\_00007.jpg

The vegetation continues to grow taller. It makes visibility hard. Spring 2014

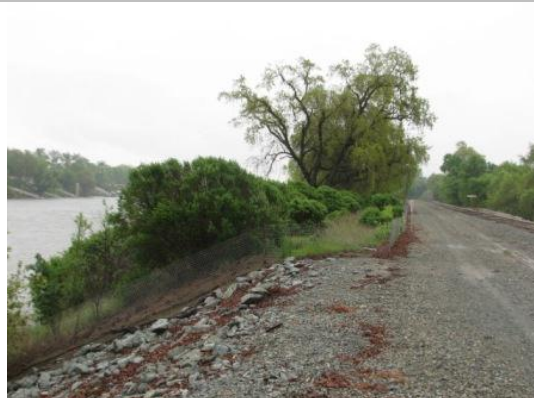
Photo 5 of 5 : FA\_2014\_RD0827\_187\_22\_20141014\_00008.jpg

The revegetation site has grown and blocks visibility. Spring 2013

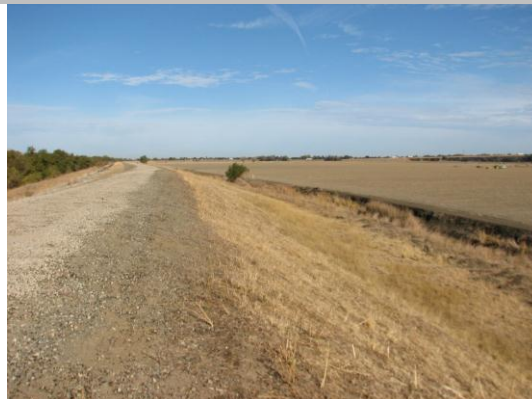
Photo 1 of 1 : FA\_2014\_RD0827\_188\_8\_20141022\_00011.jpg

LM Start	0.00	Rating **	A	Issue No.	8
LM End	2.80	Issue Type +	Ma	Location *	LS
Category	Earthen Levee			GPS Latitude/Longitude	
				Start	End
Item	Vegetation				°
					°
DWR ID	DWR_RD0827_02_f_2014_8				
Action/Comments					
Control annual grass and weeds on the levee slopes and easements. Inspector Comments: The land side slope at levee mile 1.71.

The land side levee slope at levee mile 1.71. Fall 2014.

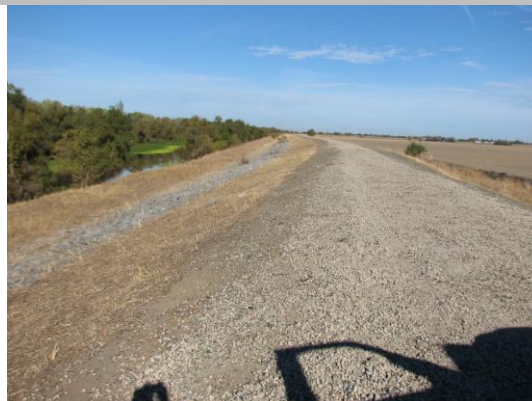
Photo 1 of 1 : FA\_2014\_RD0827\_188\_9\_20141106\_00012.jpg

LM Start	0.00	Rating **	A	Issue No.	9
LM End	2.80	Issue Type +	Ma	Location *	WS
Category	Earthen Levee			GPS Latitude/Longitude	
				Start	End
Item	Vegetation				°
					°
DWR ID	DWR_RD0827_02_f_2014_9				
Action/Comments					
Control annual grass and weeds on the levee slopes and easements. Inspector Comments: The water side levee slope at levee mile 1.71.

Levee mile 1.71, vegetation on the water side slope. Fall 2014.

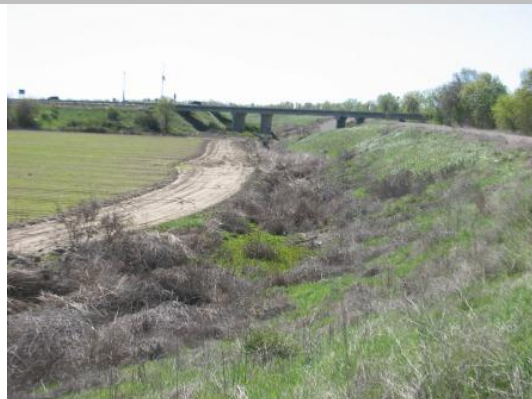
Photo 1 of 2 : FA\_2014\_RD0827\_188\_2\_20141014\_00001.jpg

LM Start	0.01	Rating **	M	Issue No.	2
LM End	0.53	Issue Type +	En	Location *	LS
Category	Earthen Levee			GPS Latitude/Longitude	
				Start	End
Item	Encroachments			38.676440 °	38.669401 °
				-121.642747 °	-121.641417 °
DWR ID	DWR_RD0827_02_f_2012_2				
Action/Comments					
Ditch

The ditch run along the landside slope. Spring 2014

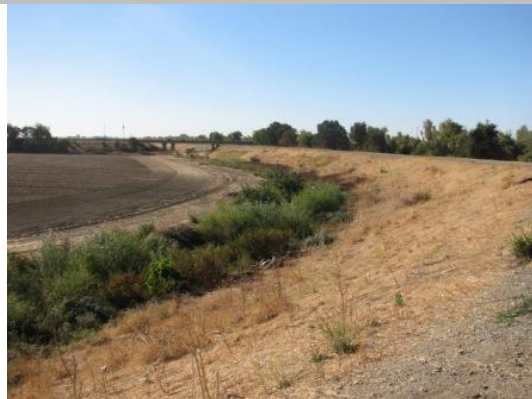
Photo 2 of 2 : FA\_2014\_RD0827\_188\_2\_20141014\_00002.jpg

LM Start	0.01	Rating **	M	Issue No.	2 (cont)	
LM End	0.53	Issue Type +	En	Location *	LS	
Category	Earthen Levee			GPS Latitude/Longitude		
				Start		End
Item	Encroachments			38.676440 °		38.669401 °
				-121.642747 °		-121.641417 °
DWR ID	DWR_RD0827_02_f_2012_2					
Action/Comments						
Ditch

Ditch runs along the landside toe. Photo fall 2012.

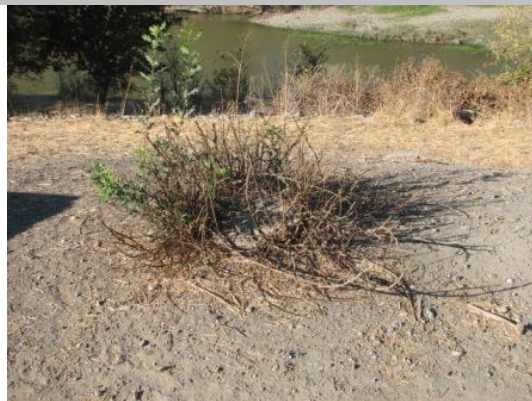
Photo 1 of 1 : FA\_2014\_RD0827\_188\_4\_20141014\_00005.jpg

LM Start	0.11	Rating **	N	Issue No.	4
LM End	0.11	Issue Type +	Ma	Location *	CR
Category	Earthen Levee			GPS Latitude/Longitude	
				Start	End
Item	Trim / Thin Trees			38.675236 °	38.675236 °
				-121.642985 °	-121.642985 °
DWR ID	DWR_RD0827_02_s_2012_4				
Action/Comments					
Tree stumps.

A tree stump on the levee shoulder. Photo fall 2012.

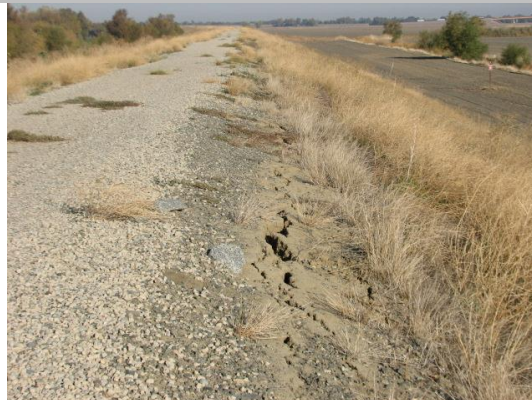
Photo 1 of 1 : FA\_2014\_RD0827\_188\_5\_20141014\_00006.jpg

The crack is 4-6 inches wide and 3 feet deep with a length of 6 feet. Fall 2013

LM Start	2.03	Rating **	U	Issue No.	5
LM End	2.16	Issue Type +	Ob	Location *	CR
Category	Earthen Levee			GPS Latitude/Longitude	
				Start	End
Item	Cracking			38.651316 °	38.649804 °
				-121.626680 °	-121.625759 °
DWR ID	DWR_RD0827_02_f_2013_5				
Action/Comments					
Monitor and have inspected by geotechnical engineer.
