**Flood Control Project Maintenance  
Levee Inspections**

**Fall 2015 Levee Maintenance Deficiency Summary Report**

**Reclamation District No. 0827 Elkhorn**

**Levee Inspection Report By Mile - Fall 2015**

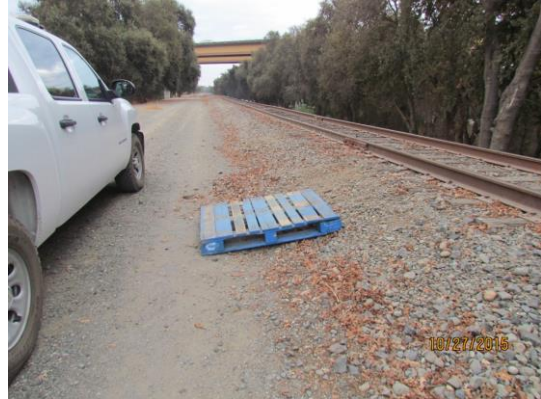
Photo 1 of 1 : FA\_2015\_RD0827\_187\_3\_20151102\_00011.jpg

LM Start	0.08	Rating **	M	Issue No.	3
LM End	0.08	Issue Type +	En	Location *	CR
Category	Earthen Levee			GPS Latitude/Longitude	
				Start	End
Item	Encroachments			38.674402 °	38.674402 °
				-121.629469 °	-121.629469 °
DWR ID	DWR_RD0827_01_f_2015_3				
Action/Comments					
Debris

View of the pallet on the crown of the levee looking downstream. Fall 2015.

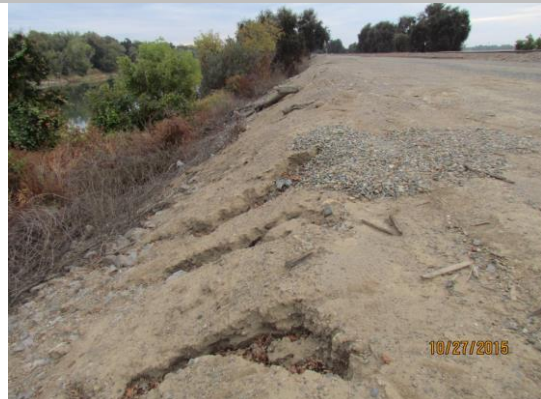
Photo 1 of 1 : FA\_2015\_RD0827\_187\_109\_20151102\_00012.jpg

LM Start	0.28	Rating **	M	Issue No.	109
LM End	0.28	Issue Type +	Ma	Location *	WS
Category	Earthen Levee			GPS Latitude/Longitude	
				Start	End
Item	Erosion / Bank Caving			38.672406 °	38.672406 °
				-121.626828 °	-121.626828 °
DWR ID	DWR_RD0827_01_s_2014_109				
Action/Comments					
Note and monitor erosion site.					
Inspector Comments: Some fill placed on slope.

View of the erosion on the waterward side of the levee looking downstream. Fall 2015.

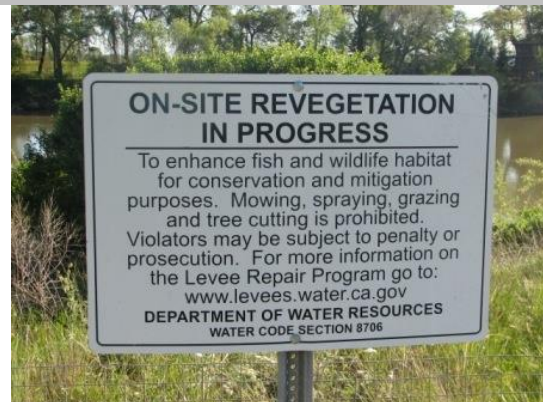
Photo 1 of 2 : FA\_2015\_RD0827\_187\_22\_20150914\_00002.jpg

LM Start	0.61	Rating **	A/W	Issue No.	22
LM End	0.92	Issue Type +	Ma	Location *	WS
Category	Earthen Levee			GPS Latitude/Longitude	
				Start	End
Item	Vegetation			38.668873 °	38.665750 °
				-121.622513 °	-121.618523 °
DWR ID	DWR_RD0827_01_s_2012_22				
Action/Comments					
Environmental Requirements.

Revegetation site spring 2012.

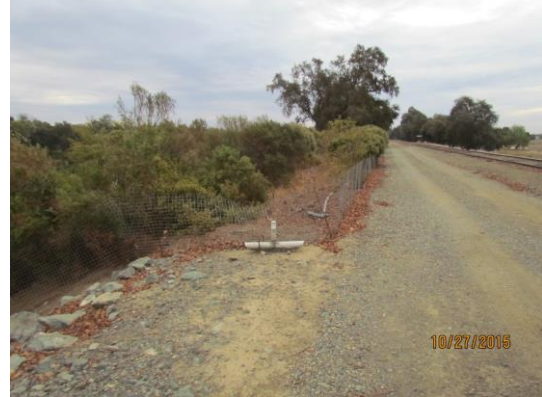
Photo 2 of 2 : FA\_2015\_RD0827\_187\_22\_20151102\_00013.jpg

LM Start	0.61	Rating **	A/W	Issue No.	22 (cont)	
LM End	0.92	Issue Type +	Ma	Location *	WS	
Category	Earthen Levee			GPS Latitude/Longitude		
				Start		End
Item	Vegetation			38.668873 °		38.665750 °
				-121.622513 °		-121.618523 °
DWR ID	DWR_RD0827_01_s _ 2012_22					
Action/Comments						
Environmental Requirements.

View of the revegetation site on the waterward side of the levee looking downstream. Fall 2015.

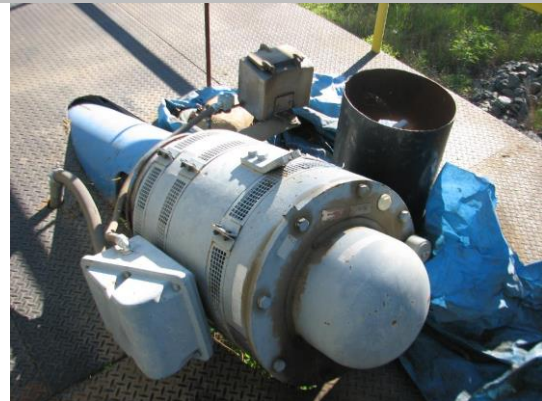
Photo 1 of 3 : UCIP\_FA\_2015\_3488.jpg

LM Start	0.73	Rating **	M	Issue No.	215
LM End	0.73	Issue Type +	En	Location *	WS
Category	Supplemental			GPS Latitude/Longitude	
				Start	End
Item	DWR UCIP Field Study			38.667731 °	38.667731 °
				-121.620992 °	-121.620992 °
DWR ID					
Action/Comments					
Inspector Comments: FS_ID:38983 DS_ID:21147 EP_NO: N/A FS_HLM: 0.73 Repair Type: Non-Urgent Crossing Status: Found UCIP Comments: Need to contact owner to obtain additional information for this crossing. This crossing does not match original description listed in desk study. Need to coordinate with owner to obtain permit number authorizing modification. FIELD_STRUCT_DESC: 14-inch (not 16-inch as listed in desk study) pipe through the levee, 10.3 feet below the crown. 10-inch bypass pipe on waterward side. Siphon breaker on landward (not waterward) shoulder. Pump on platform (not mounted on 48-inch concrete pipe as described in desk study) on waterward bank. Metal (not wooden) walkway to the pump. 3/4-inch conduit through levee at unknown depth. FS Date: 03/18/2014

Slant pump located on waterward side.

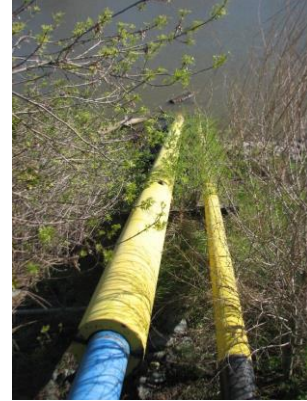
Photo 2 of 3 : UCIP\_FA\_2015\_3489.jpg

Action/Comments					
Inspector Comments: FS_ID:38983 DS_ID:21147 EP_NO: N/A FS_HLM: 0.73 Repair Type: Non-Urgent Crossing Status: Found UCIP Comments: Need to contact owner to obtain additional information for this crossing. This crossing does not match original description listed in desk study. Need to coordinate with owner to obtain permit number authorizing modification. FIELD_STRUCT_DESC: 14-inch (not 16-inch as listed in desk study) pipe through the levee, 10.3 feet below the crown. 10-inch bypass pipe on waterward side. Siphon breaker on landward (not waterward) shoulder. Pump on platform (not mounted on 48-inch concrete pipe as described in desk study) on waterward bank. Metal (not wooden) walkway to the pump. 3/4-inch conduit through levee at unknown depth. FS Date: 03/18/2014

Pipe visible on waterward side.

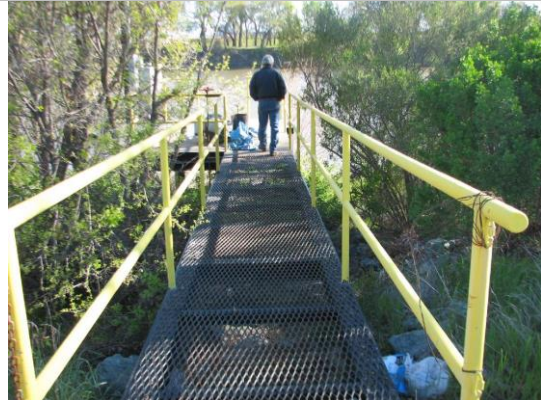
Photo 3 of 3 : UCIP\_FA\_2015\_3490.jpg

Platform for pump located on waterward side.

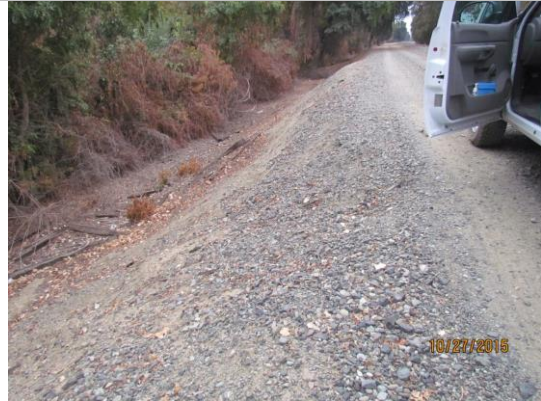
Photo 1 of 1 : FA\_2015\_RD0827\_187\_213\_20151102\_00014.jpg

LM Start	0.96	Rating **	M	Issue No.	213
LM End	0.96	Issue Type +	Ma	Location *	WS
Category	Earthen Levee			GPS Latitude/Longitude	
				Start	End
Item	Slope Stability			38.665287 °	38.665287 °
				-121.617981 °	-121.617981 °
DWR ID	DWR_RD0827_01_s _ 2015_213				
Action/Comments					
Repair slope instability.

View of the depression on the waterward side of the levee looking downstream. Fall 2015.

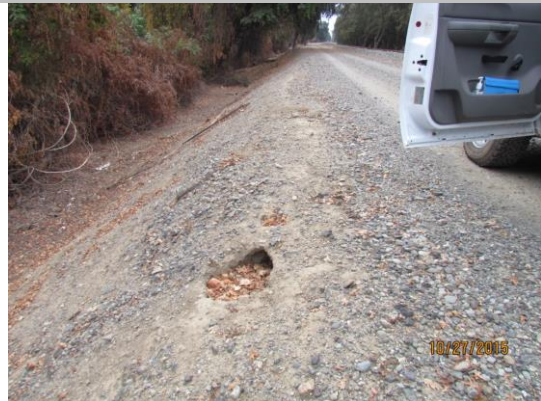
Photo 1 of 1 : FA\_2015\_RD0827\_187\_8\_20151102\_00015.jpg

LM Start	0.97	Rating **	M	Issue No.	8
LM End	0.97	Issue Type +	Ma	Location *	WS
Category	Earthen Levee			GPS Latitude/Longitude	
				Start	End
Item	Animal Control			38.665213 °	38.665213 °
				-121.617886 °	-121.617886 °
DWR ID	DWR_RD0827_01_f _ 2015_8				
Action/Comments					
No rodents visible, but rodent burrows visible; need to backfill and compact or grout burrows.

View of the rodent hole on the waterward side of the levee looking downstream. Fall 2015.

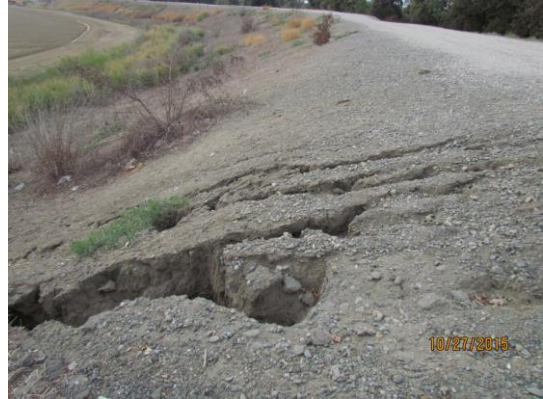
Photo 1 of 2 : FA\_2015\_RD0827\_188\_10\_20151102\_00015.jpg

LM Start	0.02	Rating **	U	Issue No.	10
LM End	0.02	Issue Type +	Ma	Location *	LS
Category	Earthen Levee			GPS Latitude/Longitude	
				Start	End
Item	Erosion / Bank Caving			38.676549 °	38.676549 °
				-121.642703 °	-121.642703 °
DWR ID	DWR_RD0827_02_f_2015_10				
Action/Comments					
Schedule repair of erosion site prior to the next inspection. Inspector Comments: It seems like someone poured water onto the levee slope and caused an erosion on the slope.

View of the erosion on the landward side of the levee looking downstream. Fall 2015.

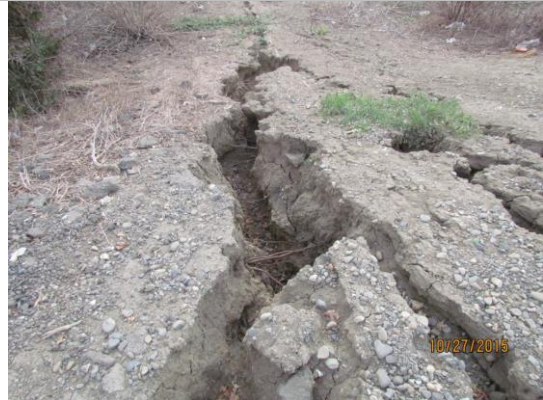
Photo 2 of 2 : FA\_2015\_RD0827\_188\_10\_20151102\_00016.jpg

It seems someone poured a large amount of water over the levee slope and caused the erosion. Fall 2015.

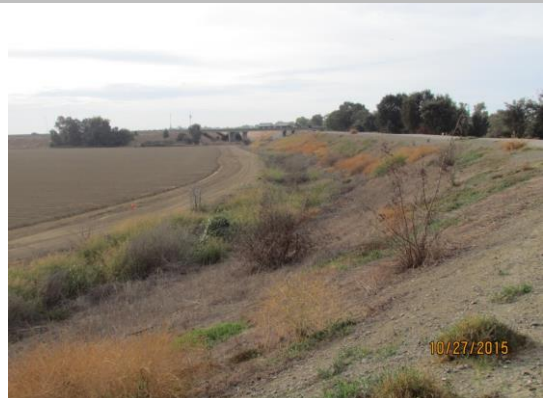
Photo 1 of 1 : FA\_2015\_RD0827\_188\_2\_20151102\_00014.jpg

LM Start	0.02	Rating **	M	Issue No.	2
LM End	0.52	Issue Type +	En	Location *	LS
Category	Earthen Levee			GPS Latitude/Longitude	
				Start	End
Item	Encroachments			38.676440 °	38.669401 °
				-121.642747 °	-121.641417 °
DWR ID	DWR_RD0827_02_f_2012_2				
Action/Comments					
Ditch

View of the ditch on the landward side of the levee looking downstream. Fall 2015.

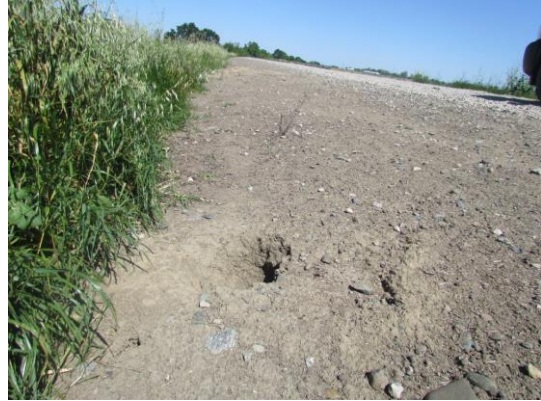
Photo 1 of 1 : FA\_2015\_RD0827\_188\_390\_20150914\_00009.jpg

LM Start	0.64	Rating **	M	Issue No.	390
LM End	0.64	Issue Type +	Ma	Location *	WS
Category	Earthen Levee			GPS Latitude/Longitude	
				Start	End
Item	Animal Control			38.667880 °	38.667880 °
				-121.640587 °	-121.640587 °
DWR ID	DWR_RD0827_02_s _ 2015_390				
Action/Comments					
No rodents visible, but rodent burrows visible; need to backfill and compact or grout burrows.

View of the burrow on the water ward side of the levee looking upstream. Spring 2015.

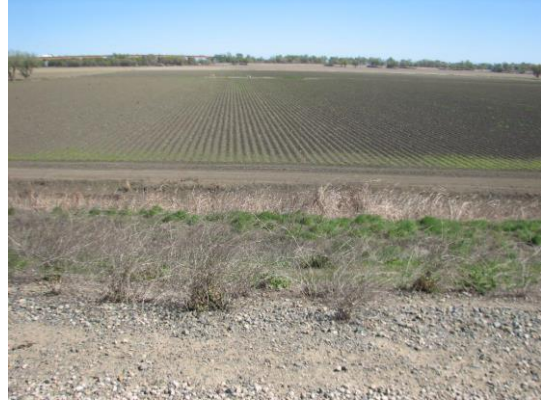
Photo 1 of 3 : UCIP\_FA\_2015\_1232.jpg

Inspector Comments: FS\_ID:38982  
 DS\_ID:24844  
 EP\_NO: 17403  
 FS\_HLM: 1.059  
 Repair Type: Urgent  
 Crossing Status: Indicator Found  
 UCIP Comments: No markers visible on either banks. Need to contact owner to determine status of crossing. Need date of last inspection and confirmation that crossing is still in operable condition.  
 FIELD\_STRUCT\_DESC: 2.375-inch diameter steel natural gas pipeline across and under (bored) the left (east) bank levee of Yolo Bypass and Tule Canal. (Permit No. 17403-2007)  
 FS Date: 03/18/2014

View of landward side.

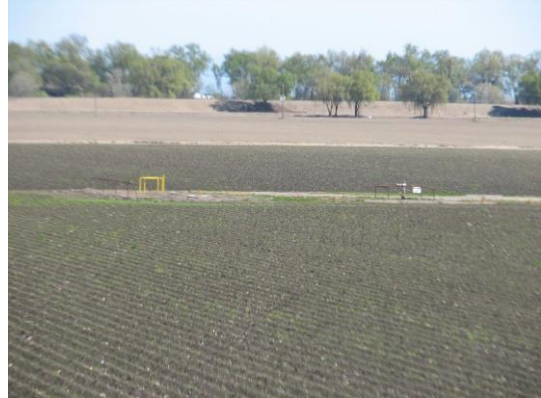
Photo 2 of 3 : UCIP\_FA\_2015\_1233.jpg

Appurtenances for gas line located approximately 993 feet from levee crown.

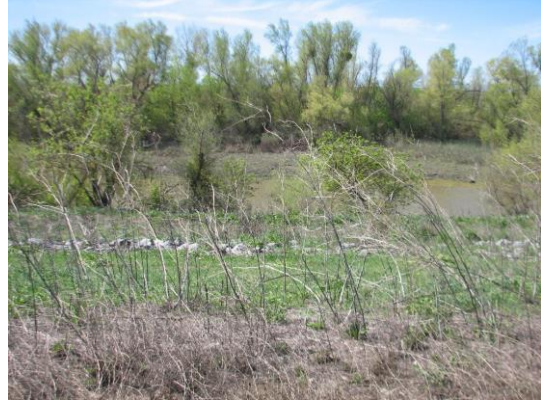
Photo 3 of 3 : UCIP\_FA\_2015\_4119.jpg

LM Start	1.04	Rating **	U	Issue No.	392 (cont)
LM End	1.04	Issue Type +	En	Location *	WS
Category	Supplemental			GPS Latitude/Longitude	
				Start	End
Item	DWR UCIP Field Study			38.662955 °	38.662955 °
				-121.636489 °	-121.636489 °
DWR ID					
Action/Comments					
Inspector Comments: FS_ID:38982					
DS_ID:24844					
EP_NO: 17403					
FS_HLM: 1.059					
Repair Type: Urgent					
Crossing Status: Indicator Found

View of waterward side.

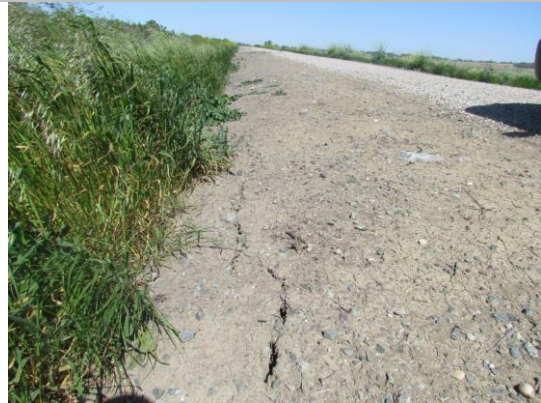
Photo 1 of 1 : FA\_2015\_RD0827\_188\_389\_20150914\_00008.jpg

LM Start	1.40	Rating **	M	Issue No.	389
LM End	1.40	Issue Type +	Ob	Location *	WS
Category	Earthen Levee			GPS Latitude/Longitude	
				Start	End
Item	Cracking			38.658877 °	38.658877 °
				-121.632550 °	-121.632550 °
DWR ID	DWR_RD0827_02_s_2015_389				
Action/Comments					
Monitor and have inspected by geotechnical engineer.

View of the crack on the water ward side of the levee looking upstream.  
Spring 2015.

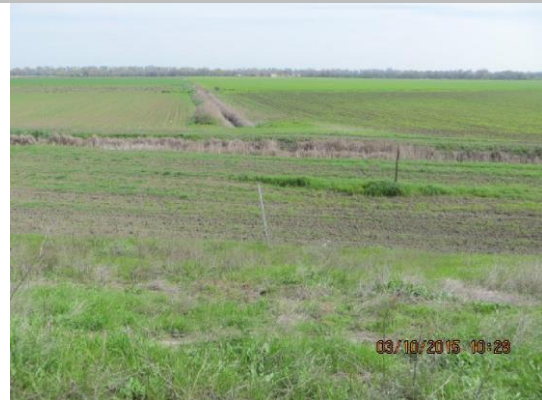
Photo 1 of 3 : UCIP\_FA\_2015\_6092.jpg

LM Start	2.03	Rating **	U	Issue No.	393
LM End	2.03	Issue Type +	En	Location *	CR
Category	Supplemental			GPS Latitude/Longitude	
				Start	End
Item	DWR UCIP Field Study			38.651052 °	38.651052 °
				-121.626501 °	-121.626501 °
DWR ID					
Action/Comments					
Inspector Comments: FS_ID:43843 DS_ID:21159 EP_NO: 15904 FS_HLM: 2.06 Repair Type: Urgent Crossing Status: Indicator Found UCIP Comments: Sign missing on WS and LS. Need to confirm status of crossing with permittee. Appears abandoned. FIELD_STRUCT_DESC: 3-inch steel pipe through the levee, 20.0 feet below the crown. Sign on waterward side. Yellow pipe visible east of ditch appr. 150 ft off LS toe. (Permit No. 15904-1992) FS Date: 03/10/2015

View of LS.

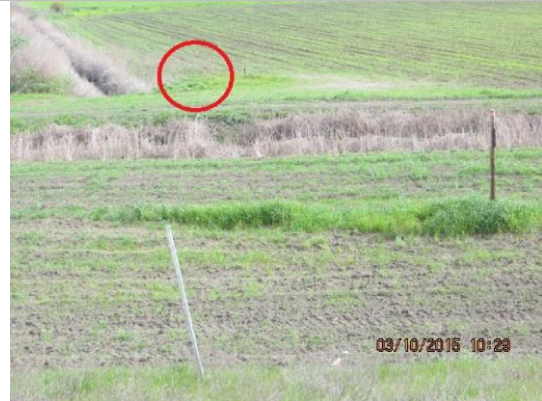
Photo 2 of 3 : UCIP\_FA\_2015\_6093.jpg

Inspector Comments: FS\_ID:43843  
 DS\_ID:21159  
 EP\_NO: 15904  
 FS\_HLM: 2.06  
 Repair Type: Urgent  
 Crossing Status: Indicator Found  
 UCIP Comments: Sign missing on WS and LS. Need to confirm status of crossing with permittee. Appears abandoned.  
 FIELD\_STRUCT\_DESC: 3-inch steel pipe through the levee, 20.0 feet below the crown. Sign on waterward side. Yellow pipe visible east of ditch appr. 150 ft off LS toe. (Permit No. 15904-1992)  
 FS Date: 03/10/2015

Pipe visible east of ditch appr. 150 ft off LS toe.

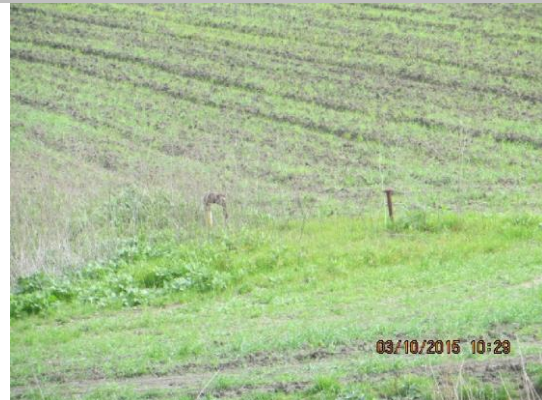
Photo 3 of 3 : UCIP\_FA\_2015\_6094.jpg

Yellow pipe visible off LS toe.

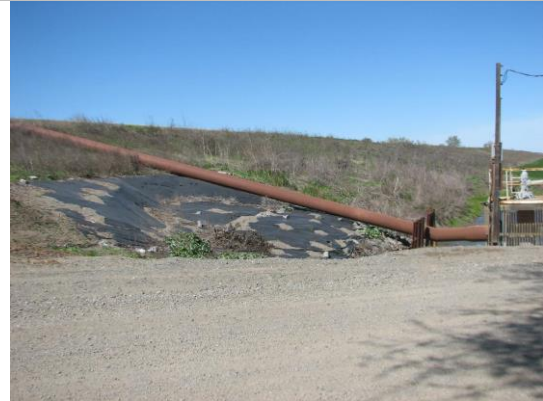
Photo 1 of 3 : UCIP\_FA\_2015\_3491.jpg

Action/Comments					
Inspector Comments: FS_ID:38984 DS_ID:21151 EP_NO: 3277 FS_HLM: 2.76 Repair Type: Non-Urgent Crossing Status: Found UCIP Comments: Crossing appears to have been removed and replaced under maintenance back in 2008. No permit has been found--need to contact owner to obtain additional information about replacement. Landward slope sloughing--does not appear to be associated with crossing. Landward slope is being monitored by LMA. FIELD_STRUCT_DESC: 18-inch (not 20-inch as noted in desk study) steel drainpipe through the levee, 4.0 feet below the crown. Cutoff wall around pipe at center of levee. Siphon breaker on apex of pipe at waterward shoulder. Pump on pipe structure in drainage ditch at landward toe. Rock revetment on waterward slope. Pipe retained through levee and updates required to crossing under Permit No. 3277 (1960). FS Date: 03/18/2014

Pipe exposed on landward side.

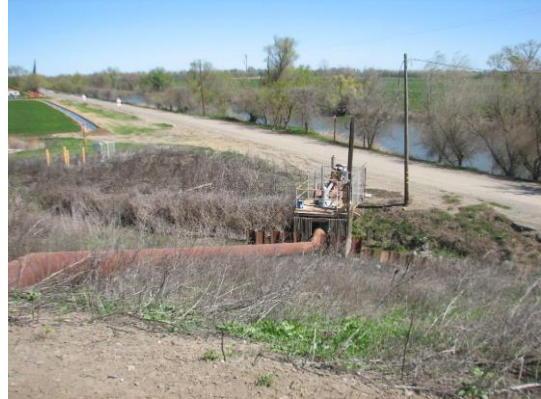
Photo 2 of 3 : UCIP\_FA\_2015\_3492.jpg

Action/Comments					
Inspector Comments: FS_ID:38984 DS_ID:21151 EP_NO: 3277 FS_HLM: 2.76 Repair Type: Non-Urgent Crossing Status: Found UCIP Comments: Crossing appears to have been removed and replaced under maintenance back in 2008. No permit has been found--need to contact owner to obtain additional information about replacement. Landward slope sloughing--does not appear to be associated with crossing. Landward slope is being monitored by LMA. FIELD_STRUCT_DESC: 18-inch (not 20-inch as noted in desk study) steel drainpipe through the levee, 4.0 feet below the crown. Cutoff wall around pipe at center of levee. Siphon breaker on apex of pipe at waterward shoulder. Pump on pipe structure in drainage ditch at landward toe. Rock revetment on waterward slope. Pipe retained through levee and updates required to crossing under Permit No. 3277 (1960). FS Date: 03/18/2014

View of landward side.

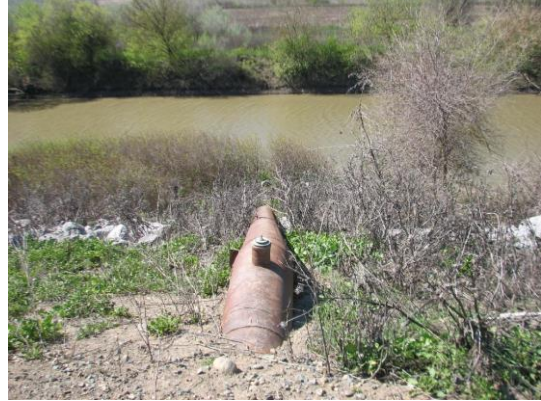
Photo 3 of 3 : UCIP\_FA\_2015\_3493.jpg

Action/Comments					
Inspector Comments: FS_ID:38984 DS_ID:21151 EP_NO: 3277 FS_HLM: 2.76 Repair Type: Non-Urgent Crossing Status: Found UCIP Comments: Crossing appears to have been removed and replaced under maintenance back in 2008. No permit has been found--need to contact owner to obtain additional information about replacement. Landward slope sloughing--does not appear to be associated with crossing. Landward slope is being monitored by LMA. FIELD_STRUCT_DESC: 18-inch (not 20-inch as noted in desk study) steel drainpipe through the levee, 4.0 feet below the crown. Cutoff wall around pipe at center of levee. Siphon breaker on apex of pipe at waterward shoulder. Pump on pipe structure in drainage ditch at landward toe. Rock revetment on waterward slope. Pipe retained through levee and updates required to crossing under Permit No. 3277 (1960). FS Date: 03/18/2014

View of pipe visible on waterward side.

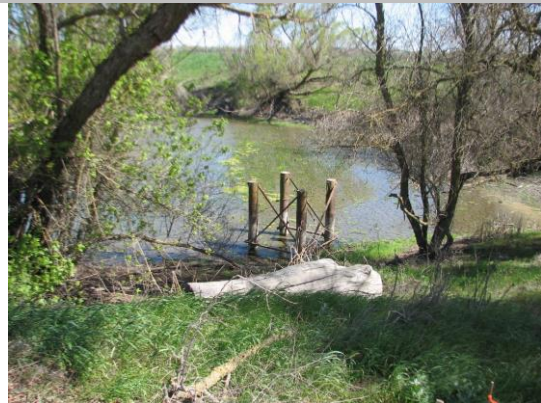
Photo 1 of 3 : UCIP\_FA\_2015\_3626.jpg

Action/Comments					
Inspector Comments: FS_ID:33032 DS_ID:21169 EP_NO: 5611 FS_HLM: 2.79 Repair Type: Non-Urgent Crossing Status: Found UCIP Comments: Crossing appears to have been removed and replaced under maintenance back in 2008. No permit has been found--need to contact owner to obtain additional information about replacement. FIELD_STRUCT_DESC: [RD No. 827 Pumping Plant] 22-inch (not 24-inch as mentioned in desk study) steel drainpipe through the levee, 8.0 feet below the crown. CM cutoff wall around pipe at center of levee. Siphon breaker on waterward slope. Flap gate on waterward end. Pipe is exposed along waterward slope. (USACE-1955). This entry matches the Drainage or Irrigation Structure referenced in O&M manual (Station 3+75). Portion of pipe was removed and replaced, from landward side to waterward shoulder, under Permit No. 5611 (1968). FS Date: 03/18/2014

Remininse piles located on landward side.

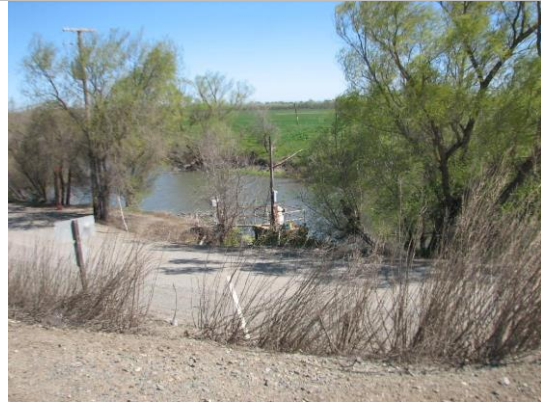
Photo 2 of 3 : UCIP\_FA\_2015\_3627.jpg

Action/Comments					
Inspector Comments: FS_ID:33032 DS_ID:21169 EP_NO: 5611 FS_HLM: 2.79 Repair Type: Non-Urgent Crossing Status: Found UCIP Comments: Crossing appears to have been removed and replaced under maintenance back in 2008. No permit has been found--need to contact owner to obtain additional information about replacement. FIELD_STRUCT_DESC: [RD No. 827 Pumping Plant] 22-inch (not 24-inch as mentioned in desk study) steel drainpipe through the levee, 8.0 feet below the crown. CM cutoff wall around pipe at center of levee. Siphon breaker on waterward slope. Flap gate on waterward end. Pipe is exposed along waterward slope. (USACE-1955). This entry matches the Drainage or Irrigation Structure referenced in O&M manual (Station 3+75). Portion of pipe was removed and replaced, from landward side to waterward shoulder, under Permit No. 5611 (1968). FS Date: 03/18/2014

Pump station located on landward side.

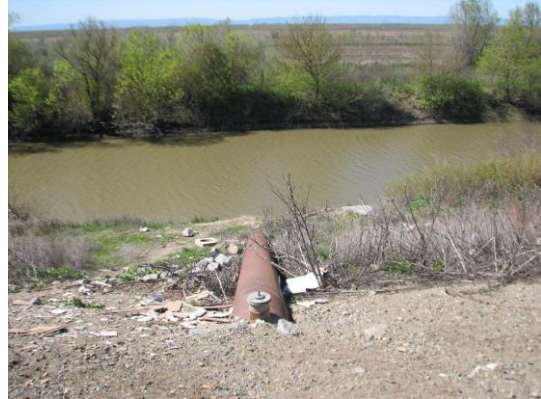
Photo 3 of 3 : UCIP\_FA\_2015\_3628.jpg

Item	DWR UCIP Field Study			38.641633 °	38.641633 °	
				-121.620725 °	-121.620725 °	
DWR ID						
Action/Comments						
Inspector Comments: FS_ID:33032 DS_ID:21169 EP_NO: 5611 FS_HLM: 2.79 Repair Type: Non-Urgent Crossing Status: Found UCIP Comments: Crossing appears to have been removed and replaced under maintenance back in 2008. No permit has been found--need to contact owner to obtain additional information about replacement. FIELD_STRUCT_DESC: [RD No. 827 Pumping Plant] 22-inch (not 24-inch as mentioned in desk study) steel drainpipe through the levee, 8.0 feet below the crown. CM cutoff wall around pipe at center of levee. Siphon breaker on waterward slope. Flap gate on waterward end. Pipe is exposed along waterward slope. (USACE-1955). This entry matches the Drainage or Irrigation Structure referenced in O&M manual (Station 3+75). Portion of pipe was removed and replaced, from landward side to waterward shoulder, under Permit No. 5611 (1968). FS Date: 03/18/2014

Pipe exposed on waterward side.

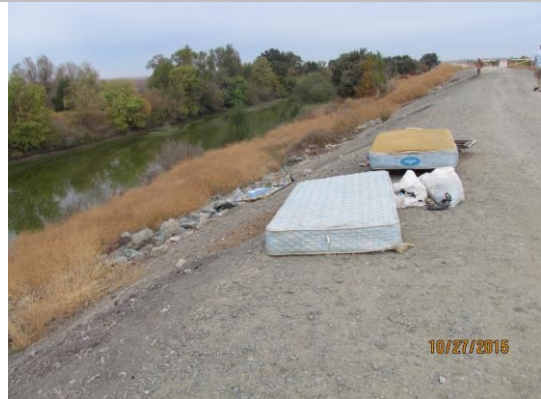
Photo 1 of 1 : FA\_2015\_RD0827\_188\_7\_20151102\_00010.jpg

LM Start	2.77	Rating **	M	Issue No.	7
LM End	2.77	Issue Type +	En	Location *	CR
Category	Earthen Levee			GPS Latitude/Longitude	
				Start	End
Item	Encroachments			38.641337 °	38.641337 °
				-121.620586 °	-121.620586 °
DWR ID	DWR_RD0827_02_f_2015_7				
Action/Comments					
Debris

View of the debris dumped on the crown and waterward side of the levee looking upstream. Fall 2015.
