**Flood Control Project Maintenance
Levee Inspections**

Fall 2016 Levee Maintenance Deficiency Summary Report

Reclamation District No. 0827 Elkhorn

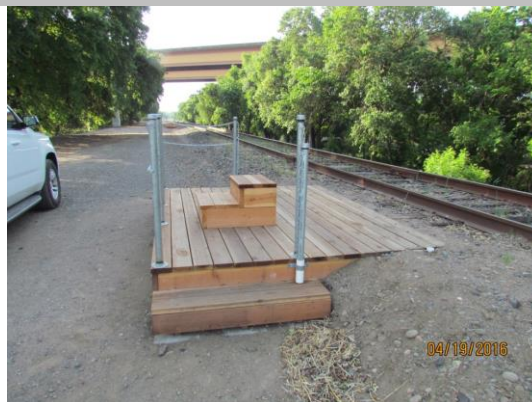
Photo 1 of 1 : FA_2016_RD0827_187_10_20160913_00002.jpg

LM Start	0.11	Rating **	M	Issue No.	10
LM End	0.11	Issue Type +	En	Location *	CR
Category	Earthen Levee			GPS Latitude/Longitude	
				Start	End
Item	Encroachments			38.674133 °	38.674133 °
				-121.629097 °	-121.629097 °
DWR ID	DWR_RD0827_01_s_2016_10				
Comment Code					
ST : Stairway					
Inspector Comment					
Railroad has put steps on the crown for the tourist train from the West City of Sac water plant. Stairs are not permitted and was placed this year Spring 2016.

View of the stairs on the crown of the levee looking downstream. Spring 2016.

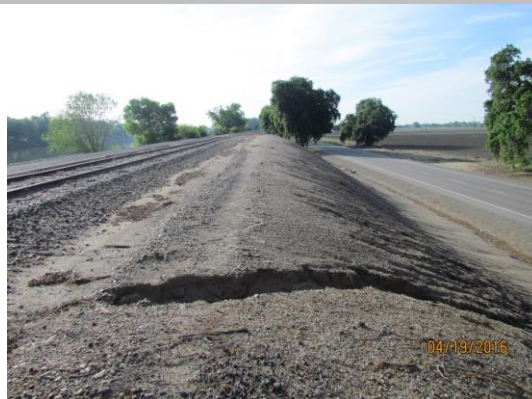
Photo 1 of 2 : FA_2016_RD0827_187_13_20160913_00005.jpg

LM Start	0.51	Rating **	M	Issue No.	13
LM End	0.51	Issue Type +	Ma	Location *	LS
Category	Earthen Levee			GPS Latitude/Longitude	
				Start	End
Item	Erosion / Bank Caving			38.669929 °	38.669929 °
				-121.623776 °	-121.623776 °
DWR ID	DWR_RD0827_01_s_2016_13				
Comment Code					
E2 : Schedule repair of erosion site prior to the next inspection.					
Inspector Comment					
Rills caused by rain.

View of the erosion on the landward side of the levee looking downstream. Spring 2016.

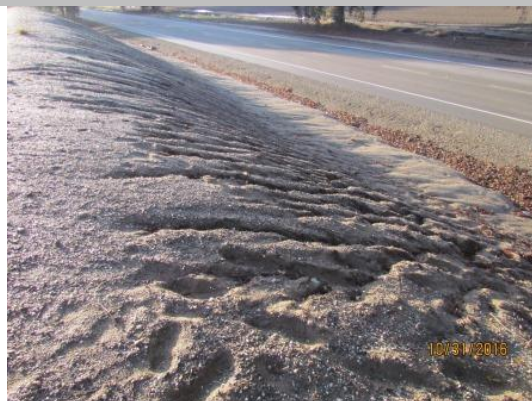
Photo 2 of 2 : FA_2016_RD0827_187_13_20161031_00014.jpg

Updated view of runoff erosion site. LS slope. Fall 2016.

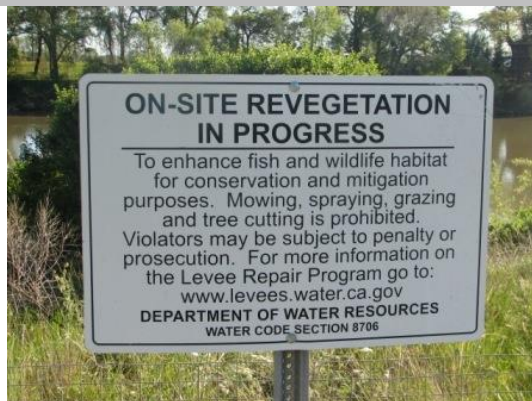
Photo 1 of 2 : FA_2016_RD0827_187_22_20160913_00006.jpg

LM Start	0.61	Rating **	A/W	Issue No.	22
LM End	0.92	Issue Type +	Ma	Location *	WS
Category	Earthen Levee			GPS Latitude/Longitude	
				Start	End
Item	Vegetation			38.668873 °	38.665750 °
				-121.622513 °	-121.618523 °
DWR ID	DWR_RD0827_01_s_2012_22				
Comment Code					
V8 : Environmental Requirements.					
Inspector Comment

Revegetation site spring 2012.

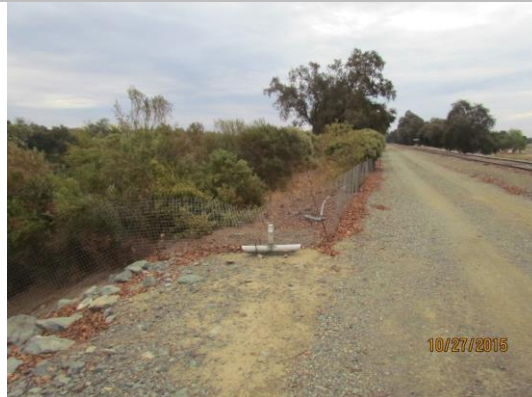
Photo 2 of 2 : FA_2016_RD0827_187_22_20160913_00007.jpg

LM Start	0.61	Rating **	A/W	Issue No.	22 (cont)
LM End	0.92	Issue Type +	Ma	Location *	WS
Category	Earthen Levee			GPS Latitude/Longitude	
				Start	End
Item	Vegetation			38.668873 °	38.665750 °
				-121.622513 °	-121.618523 °
DWR ID	DWR_RD0827_01_s_2012_22				
Comment Code					
V8 : Environmental Requirements.					
Inspector Comment

View of the revegetation site on the waterward side of the levee looking downstream. Fall 2015.

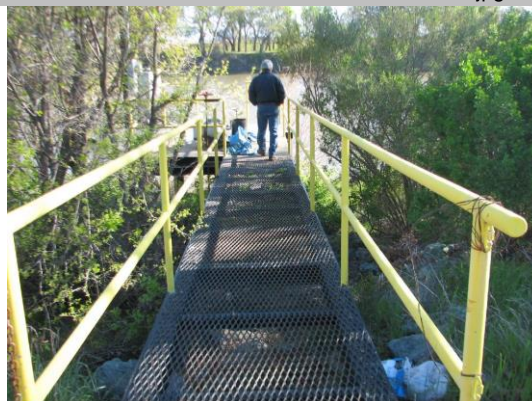
Photo 1 of 2 : UCIP_FA_2016_38983_59737.jpg

Comment Code						
Inspector Comment						
FS_ID:38983						
DS_ID:21147						
EP_NO: N/A						
Repair Type: Non-Urgent						
Crossing Status: Found						
UCIP Comments: Need to contact owner to obtain additional information for this crossing. This crossing does not match original description listed in desk study. Need to coordinate with owner to obtain permit number authorizing modification.						
FIELD_STRUCT_DESC: 14-inch (not 16-inch as listed in desk study) pipe through the levee, 10.3 feet below the crown. 10-inch bypass pipe on waterward side. Siphon breaker on landward (not waterward) shoulder. Pump on platform (not mounted on 48-inch concrete pipe as described in desk study) on waterward bank. Metal (not wooden) walkway to the pump. 3/4-inch conduit through levee at unknown depth.						
FS Date: 3/18/2014

Platform for pump located on waterward side.

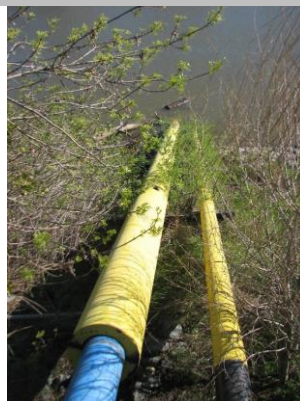
Photo 2 of 2 : UCIP_FA_2016_38983_59736.jpg

Item	DWR UCIP Field Study			38.667731 °	38.667731 °	
				-121.620992 °	-121.620992 °	
DWR ID						
Comment Code						
Inspector Comment						
FS_ID:38983						
DS_ID:21147						
EP_NO: N/A						
Repair Type: Non-Urgent						
Crossing Status: Found						
UCIP Comments: Need to contact owner to obtain additional information for this crossing. This crossing does not match original description listed in desk study. Need to coordinate with owner to obtain permit number authorizing modification.						
FIELD_STRUCT_DESC: 14-inch (not 16-inch as listed in desk study) pipe through the levee, 10.3 feet below the crown. 10-inch bypass pipe on waterward side. Siphon breaker on landward (not waterward) shoulder. Pump on platform (not mounted on 48-inch concrete pipe as described in desk study) on waterward bank. Metal (not wooden) walkway to the pump. 3/4-inch conduit through levee at unknown depth.						
FS Date: 3/18/2014

Pipe visible on waterward side.

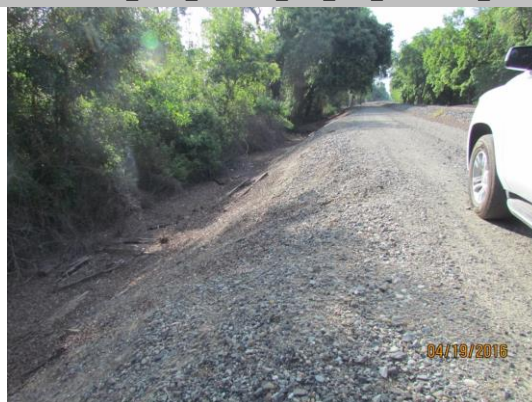
Photo 1 of 1 : FA_2016_RD0827_187_213_20160913_00009.jpg

LM Start	0.96	Rating **	M	Issue No.	213
LM End	0.96	Issue Type +	Ma	Location *	WS
Category	Earthen Levee			GPS Latitude/Longitude	
				Start	End
Item	Slope Stability			38.665307 °	38.665307 °
				-121.617982 °	-121.617982 °
DWR ID	DWR_RD0827_01_s_2015_213				
Comment Code					
S1 : Repair slope instability.					
Inspector Comment

View of the slope instability on the waterward side of the levee looking downstream. Spring 2016.

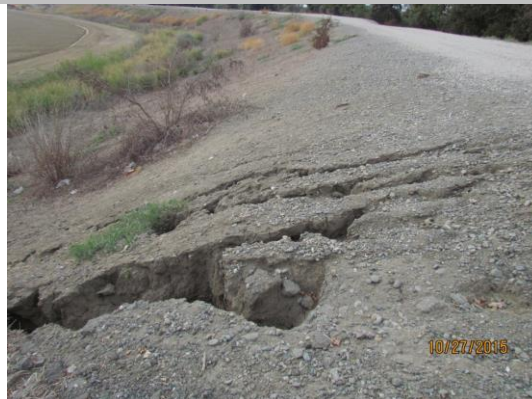
Photo 1 of 2 : FA_2016_RD0827_188_10_20160913_00004.jpg

LM Start	0.02	Rating **	U	Issue No.	10
LM End	0.02	Issue Type +	Ma	Location *	LS
Category	Earthen Levee			GPS Latitude/Longitude	
				Start	End
Item	Erosion / Bank Caving			38.676549 °	38.676549 °
				-121.642703 °	-121.642703 °
DWR ID	DWR_RD0827_02_f_2015_10				
Comment Code					
E2 : Schedule repair of erosion site prior to the next inspection.					
Inspector Comment					
It seems like someone poured water onto the levee slope and caused an erosion on the slope.

View of the erosion on the landward side of the levee looking downstream. Fall 2015.

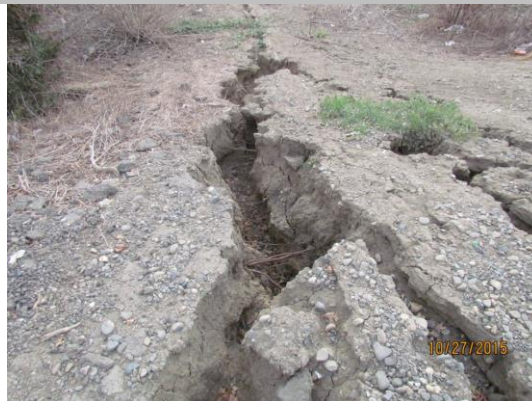
Photo 2 of 2 : FA_2016_RD0827_188_10_20160913_00005.jpg

It seems someone poured a large amount of water over the levee slope and caused the erosion. Fall 2015.

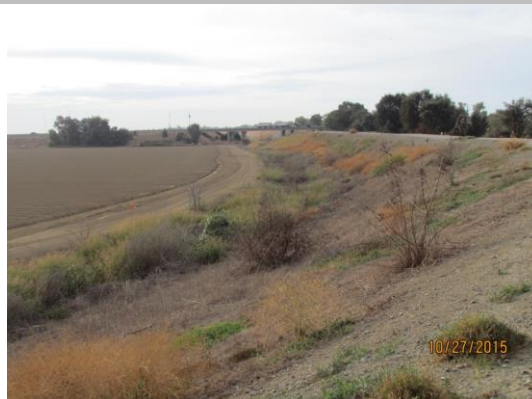
Photo 1 of 1 : FA_2016_RD0827_188_2_20160913_00001.jpg

LM Start	0.02	Rating **	M	Issue No.	2
LM End	0.52	Issue Type +	En	Location *	LS
Category	Earthen Levee			GPS Latitude/Longitude	
				Start	End
Item	Encroachments			38.676440 °	38.669401 °
				-121.642747 °	-121.641417 °
DWR ID	DWR_RD0827_02_f_2012_2				
Comment Code					
DT : Ditch					
Inspector Comment

View of the ditch on the landward side of the levee looking downstream. Fall 2015.

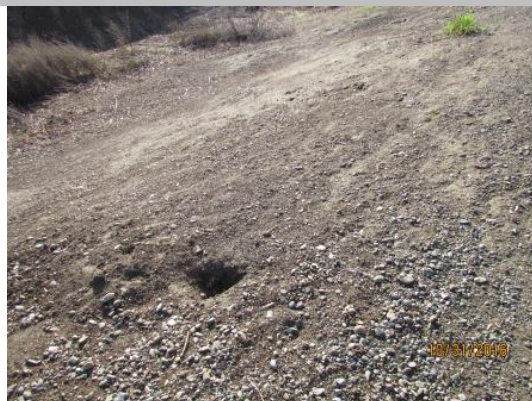
Photo 1 of 1 : FA_2016_RD0827_188_7_20161031_00021.jpg

LM Start	0.11	Rating **	M	Issue No.	7
LM End	0.11	Issue Type +	Ma	Location *	LS
Category	Earthen Levee			GPS Latitude/Longitude	
				Start	End
Item	Animal Control			38.675326 °	38.675326 °
				-121.643042 °	-121.643042 °
DWR ID	DWR_RD0827_02_f_2016_7				
Comment Code					
A1 : Exterminate rodents and backfill and compact or grout burrows.					
Inspector Comment

Rodent holes on LS levee slope. Fall 2016.

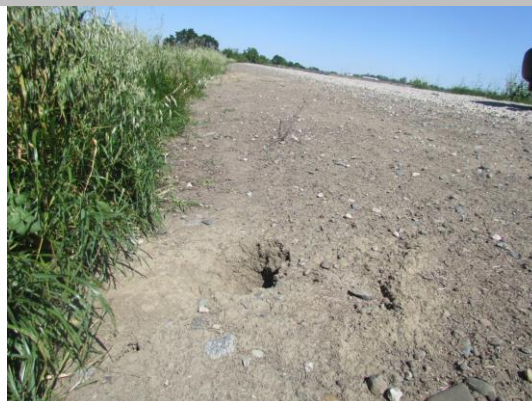
Photo 1 of 1 : FA_2016_RD0827_188_390_20160913_00008.jpg

LM Start	0.64	Rating **	M	Issue No.	390
LM End	0.64	Issue Type +	Ma	Location *	WS
Category	Earthen Levee			GPS Latitude/Longitude	
				Start	End
Item	Animal Control			38.667880 °	38.667880 °
				-121.640587 °	-121.640587 °
DWR ID	DWR_RD0827_02_s_2015_390				
Comment Code					
A3 : No rodents visible, but rodent burrows visible; need to backfill and compact or grout burrows.					
Inspector Comment

View of the burrow on the water ward side of the levee looking upstream.
Spring 2015.

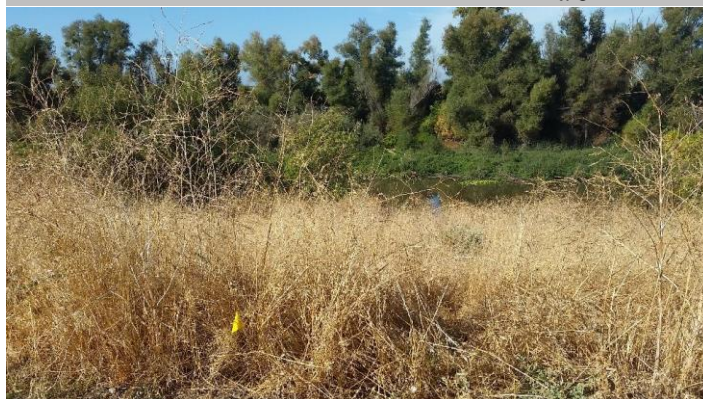
Photo 1 of 2 : UCIP_FA_2016_50065_75673.jpg

FS_ID:50065
DS_ID:24844
EP_NO: 17403
Repair Type: Non-Urgent
Crossing Status: Indicator Found
UCIP Comments: 9/27/2016 Need to coordinate with Greg Lucas (gregory.lucas@crc.com) with California Resources Corporation to determine if line will be brought online. Crossing was downgraded from Urgent to Non-Urgent--new owner has not brought the pipe online. New owner will need to update permit name and if line becomes active markers will be required per Title 23. (DWR UCIP - omagana)9/02/2016 Meet with Jimmy Preston from California Resources Corporation at site. Alignment of crossing was confirmed (new location is approximately 290 feet upstream from previous point)--report has been updated. Pending action -- Name Change (DWR UCIP - omagana)9/01/2016 Email was sent to Greg Lucas from California Resources Corporation with an updated UCIP detailed report and Central Valley Flood Protection Board (CVFPB) name change form. New owner will need to update permit information with the CVFPB to be compliant with Title 23 requirements. (DWR UCIP - omagana)8/31/2016 New owner--California Resources Corporation. Gas line is currently not in use. Meet with Greg Lucas, Assistant Production Coordinator from California Resources Corporation and Steve Stein from Noble Methan, Inc. to clarify current status of crossing and determine crossing alignment. Gas well is part of the gas line appurtenances. Gas line alignment is still pending--California Resources Corporation will send out someone to confirm alignment. Crossing is missing markers, if line becomes active markers will be needed on both the WS and LS to comply with Title 23--encouraged owner to contact CVFPB. (DWR UCIP - omagana)8/30/2016 Coordinating with AA Production Services, Inc. to determine location of where crossing goes through levee. It appears that the gas well located on LS is not part of this crossing. (DWR UCIP - omagana)8/04/2016 Meet with Bill Mattos, representative of RD 827, and he took me to the gas well visible from levee crown. Mr. Mattos was unable to confirm if gas well and pipeline that goes through the levee were connected. 3/18/2014 No markers visible on either banks. Need to contact owner to determine status of crossing. Need date of last inspection and confirmation that crossing is still in operable condition. (DWR UCIP - omagana)

FIELD_STRUCT_DESC: [Hanks 34-2] 2.375-inch steel natural gas pipe through the levee, 30 feet below the crown and under (bored) Tule Canal. Gas well is located on the landside (LS) approximately 994 feet from levee crown. California Resources Corporation acquired AA Production Services, Inc. The new owner of the 2.375-inch gas pipe is California Resources Corporation. (Permit No. 17403, 2001 - AA Production Services, Inc.)

View of WS--Tule Canal.

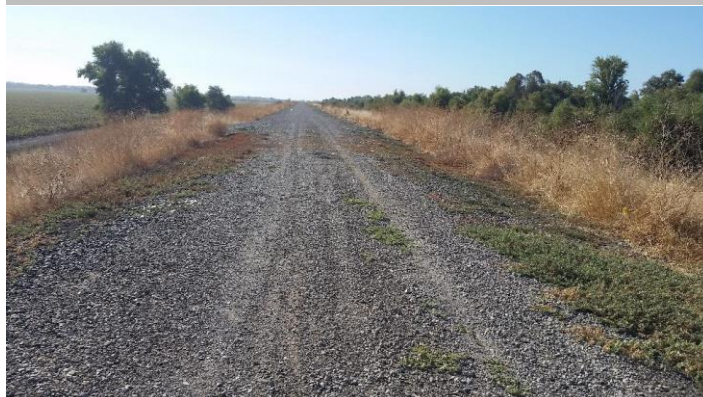
Photo 2 of 2 : UCIP_FA_2016_50065_75672.jpg

View of levee crown at crossing--yellow flag markers visible on both WS and LS shoulder.

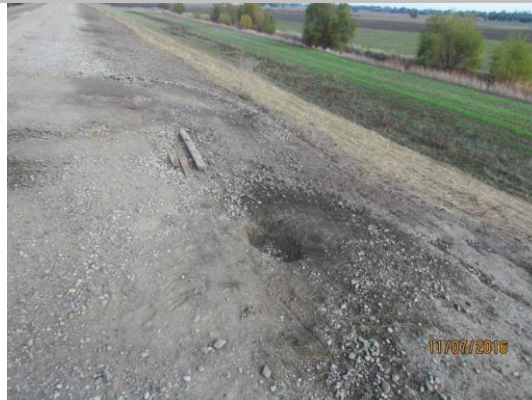
Photo 1 of 1 : FA_2016_RD0827_188_9_20161107_00023.jpg

LM Start	2.01	Rating **	M	Issue No.	9
LM End	2.01	Issue Type +	Ma	Location *	CR
Category	Earthen Levee			GPS Latitude/Longitude	
				Start	End
Item	Crown Surface / Depressions / Rutting			38.651270 °	38.651270 °
				-121.626661 °	-121.626661 °
DWR ID	DWR_RD0827_02_f_2016_9				
Comment Code					
C2 : Repair depressions or ruts in the crown or slope.					
Inspector Comment

View of crown depression site. Fall 2016.

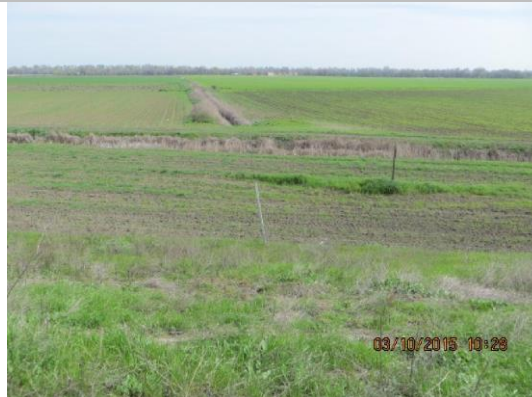
Photo 1 of 2 : UCIP_FA_2016_50030_73360.jpg

FS_ID:50030
DS_ID:21159
EP_NO: 15904
Repair Type: Urgent
Crossing Status: Indicator Found
UCIP Comments: 8/31/2016 Meet with Greg Lucas, Assistant Production Coordinator from California Resources Corporation and Steve Steim from Noble Methan, Inc. to discuss the status of a different line upstream. Mr. Steve Steim was aware of the 3-inch line by Two Bay Petroleum as known as a PG&E old pipe at this location. According to Steve Stein the appurtenances previously located on the landside have been removed and the 3-inch line abandoned. Need to contact owner to confirm status of crossing. If crossing is no longer in use the owner will need to coordinate with CVFPB to comply with Title 23. (DWR UCIP - omagana)8/04/2016 No markers found on either WS or LS. Need to coordinate with owner to determine status of crossing. (DWR UCIP - omagana)3/10/2015 Sign missing on WS and LS. Need to confirm status of crossing with permittee. Appears abandoned. (DWR UCIP - omagana)

FIELD_STRUCT_DESC: 3-inch steel pipe through the levee, 20 feet below the crown. Sign on waterside (WS) (not found 2015). Yellow pipe visible east of ditch approximately 150 feet off landside (LS) toe.
Contact Number 415-459-3445 for Two Bay Petroleum also referred as Pacific Energetics, Inc. (Permit No. 15904, 1992 - Two Bay Petroleum)
FS Date: 8/4/2016

View of LS.

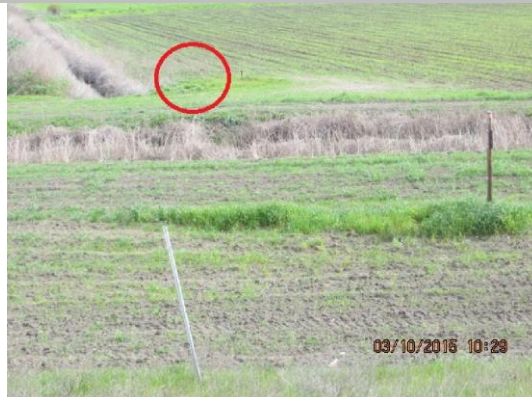
Photo 2 of 2 : UCIP_FA_2016_50030_73361.jpg

Pipe visible east of ditch approximately 150 ft off LS toe.

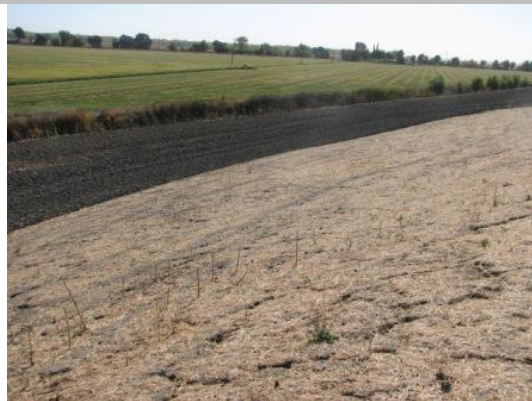
Photo 1 of 1 : FA_2016_RD0827_188_24_20160913_00007.jpg

LM Start	2.29	Rating **	M	Issue No.	24
LM End	2.29	Issue Type +	Ma	Location *	LS
Category	Earthen Levee			GPS Latitude/Longitude	
				Start	End
Item	Slope Stability			38.647703 °	38.647703 °
				-121.624450 °	-121.624450 °
DWR ID	DWR_RD0827_02_s_2012_24				
Comment Code					
S1 : Repair slope instability.					
Inspector Comment					
Cracking along the levee slope is less than 200 feet in length. Monitor the slope for changes in cracking.

A bulge in the levee slope. Photo fall 2012.

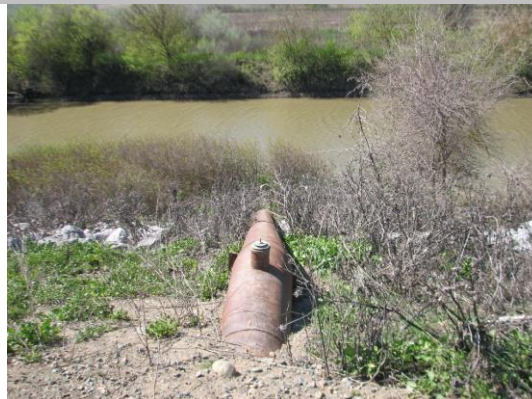
Photo 1 of 2 : UCIP_FA_2016_38984_59769.jpg

FS_ID:38984
DS_ID:21151
EP_NO: 3277
Repair Type: Non-Urgent
Crossing Status: Found
UCIP Comments: Crossing appears to have been removed and replaced under maintenance back in 2008. No permit has been found--need to contact owner to obtain additional information about replacement. Landward slope sloughing--does not appear to be associated with crossing. Landward slope is being monitored by LMA.
FIELD_STRUCT_DESC: 18-inch (not 20-inch as noted in desk study) steel drainpipe through the levee, 4.0 feet below the crown. Cutoff wall around pipe at center of levee. Siphon breaker on apex of pipe at waterward shoulder. Pump on pipe structure in drainage ditch at landward toe. Rock revetment on waterward slope. Pipe retained through levee and updates required to crossing under Permit No. 3277 (1960).
FS Date: 3/18/2014

View of pipe visible on waterward side.

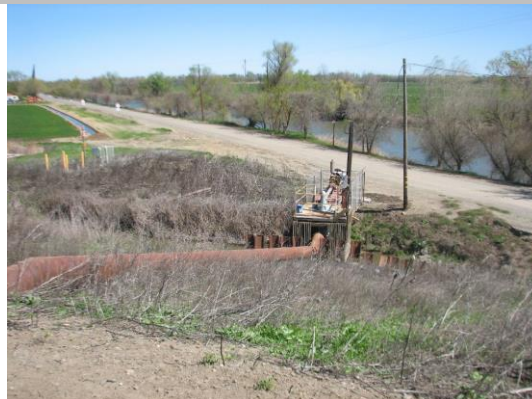
Photo 2 of 2 : UCIP_FA_2016_38984_59768.jpg

View of landward side.

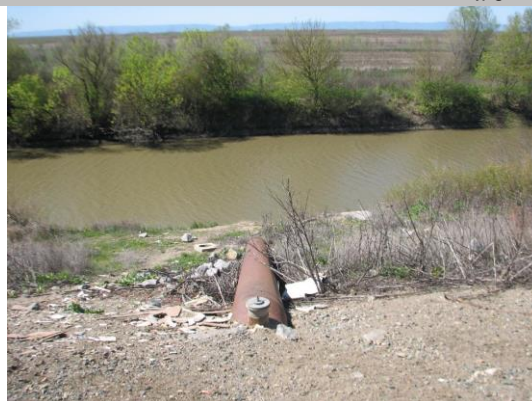
Photo 1 of 2 : UCIP_FA_2016_33032_59778.jpg

FS_ID:33032
DS_ID:21169
EP_NO: 5611
Repair Type: Non-Urgent
Crossing Status: Found
UCIP Comments: Crossing appears to have been removed and replaced under maintenance back in 2008. No permit has been found--need to contact owner to obtain additional information about replacement.
FIELD_STRUCT_DESC: [RD No. 827 Pumping Plant] 22-inch (not 24-inch as mentioned in desk study) steel drainpipe through the levee, 8.0 feet below the crown. CM cutoff wall around pipe at center of levee. Siphon breaker on waterward slope. Flap gate on waterward end. Pipe is exposed along waterward slope. (USACE-1955). This entry matches the Drainage or Irrigation Structure referenced in O&M manual (Station 3+75). Portion of pipe was removed and replaced, from landward side to waterward shoulder, under Permit No. 5611 (1968).
FS Date: 3/18/2014

Pipe exposed on waterward side.

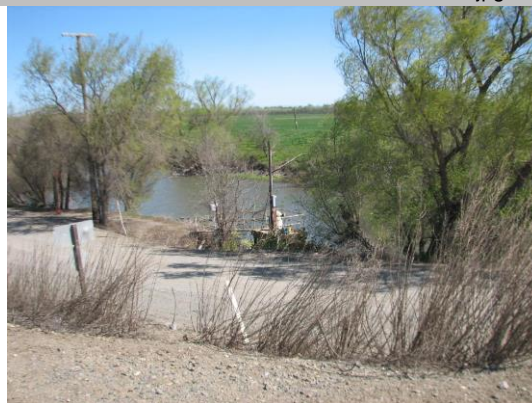
Photo 2 of 2 : UCIP_FA_2016_33032_59777.jpg

Pump station located on landward side.

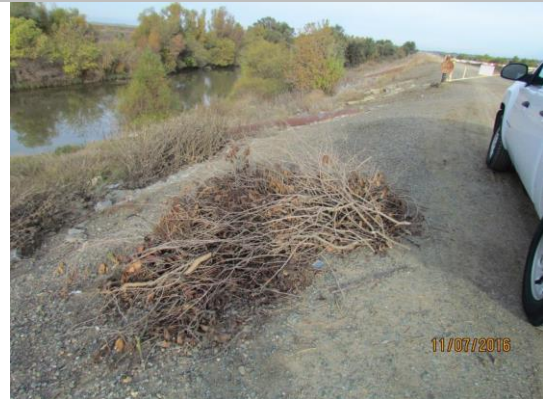
Photo 1 of 1 : FA_2016_RD0827_188_8_20161107_00022.jpg

LM Start	2.76	Rating **	M	Issue No.	8
LM End	2.76	Issue Type +	En	Location *	WS
Category	Earthen Levee			GPS Latitude/Longitude	
				Start	End
Item	Encroachments			38.641516 °	38.641516 °
				-121.620674 °	-121.620674 °
DWR ID	DWR_RD0827_02_f_2016_8				
Comment Code					
PR : Prunings					
Inspector Comment

Prunings on waterside slope. Fall 2016.
