**Flood Control Project Maintenance
Levee Inspections**

Fall 2017 Levee Maintenance Deficiency Summary Report

Sacramento River Basin

Reclamation District No. 0827 Elkhorn

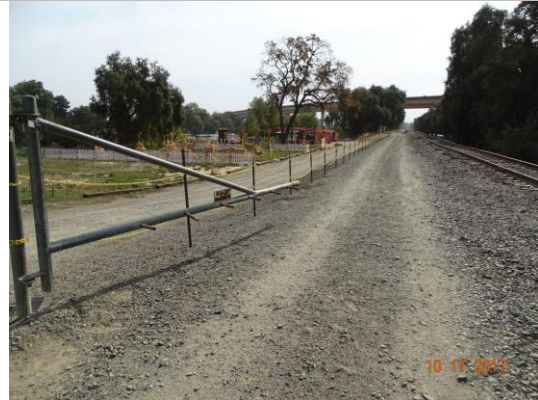
Photo 1 of 1 : FA_2017_RD0827_187_16_20171017_00016.jpg

LM Start	0.00	Rating **	M	Issue No.	23
LM End	0.00	Issue Type +	En	Location *	
Category	Supplemental			GPS Latitude/Longitude	
				Start	End
Item	DWR UCIP Field Study			38.661210 °	38.661210 °
				-121.613030 °	-121.613030 °
DWR ID					
Comment Code					
Inspector Comment					
FS_ID:39703 DS_ID:21163 EP_NO: N/A Repair Type: Non-Urgent Crossing Status: Not Found UCIP Comments: No pipe was found only what appears to be an abandoned pump house on landward side. Need to contact owner to determine status of crossing. FIELD_STRUCT_DESC: 30-inch steel pipe through the levee, 9.1 feet below the crown. Pump in pump house on landward side not waterward side as mentioned in desk study. (USACE-1955). This entry matches the Drainage or Irrigation Structure referenced in O&M manual (RM 69.50). FS Date: 3/18/2014

View of fence on crown. Fall 2017.

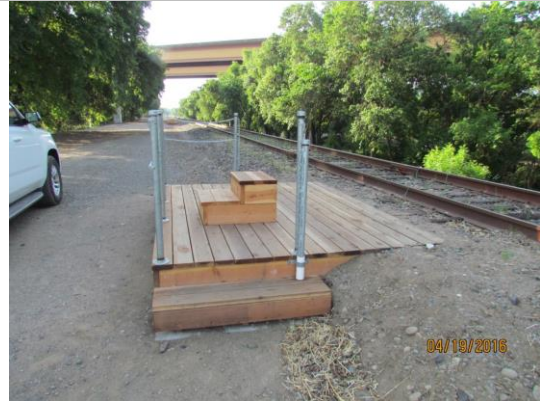
Photo 1 of 1 : FA_2017_RD0827_187_10_20170911_00005.jpg

View of the stairs on the crown of the levee looking downstream. Spring 2016.

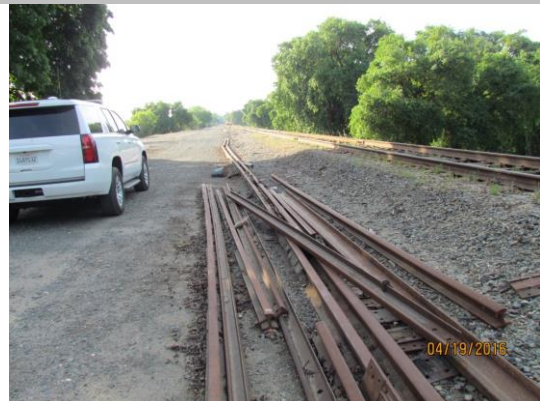
Photo 1 of 1 : FA_2017_RD0827_187_12_20170911_00006.jpg

LM Start	0.24	Rating **	M	Issue No.	12
LM End	0.53	Issue Type +	En	Location *	CR
Category	Earthen Levee			GPS Latitude/Longitude	
				Start	End
Item	Encroachments			38.672749 °	38.669781 °
				-121.627333 °	-121.623587 °
DWR ID	DWR_RD0827_01_s_2016_12				
Comment Code					
MA : Material					
Inspector Comment					
RR rails and ties on the levee crown.

View of the rails on the crown of the levee looking downstream. Spring 2016.

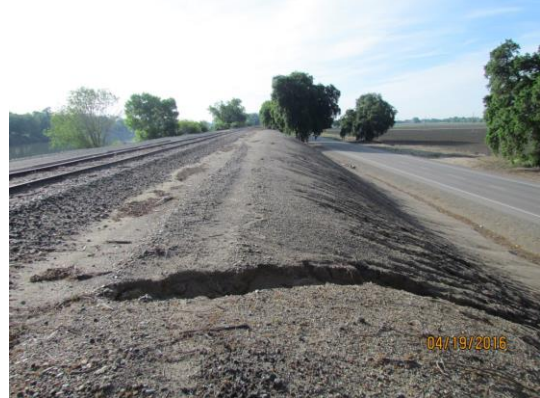
Photo 1 of 2 : FA_2017_RD0827_187_13_20170911_00007.jpg

LM Start	0.51	Rating **	M	Issue No.	13
LM End	0.51	Issue Type +	Ma	Location *	LS
Category	Earthen Levee			GPS Latitude/Longitude	
				Start	End
Item	Erosion / Bank Caving			38.669929 °	38.669929 °
				-121.623776 °	-121.623776 °
DWR ID	DWR_RD0827_01_s_2016_13				
Comment Code					
E2 : Schedule repair of erosion site prior to the next inspection.					
Inspector Comment					
Rills caused by rain.

View of the erosion on the landward side of the levee looking downstream. Spring 2016.

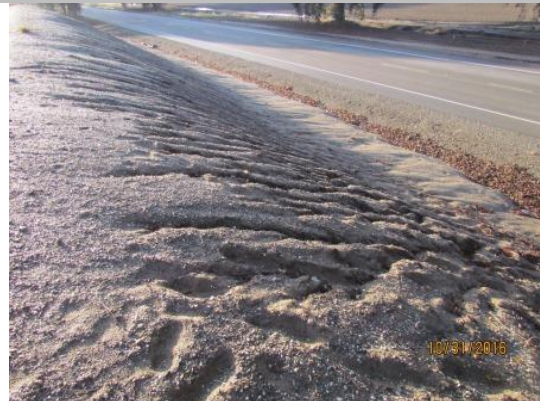
Photo 2 of 2 : FA_2017_RD0827_187_13_20170911_00008.jpg

Updated view of runoff erosion site. LS slope. Fall 2016.

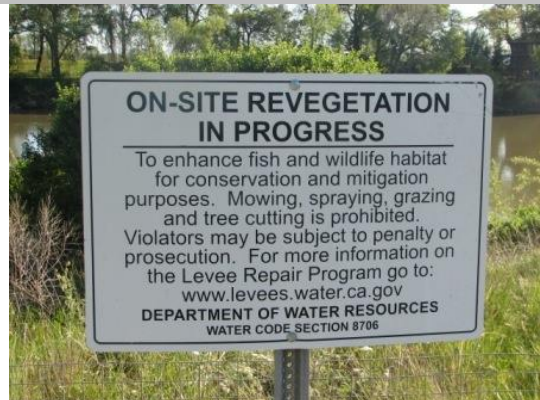
Photo 1 of 2 : FA_2017_RD0827_187_22_20170911_00010.jpg

LM Start	0.61	Rating **	A/W	Issue No.	22
LM End	0.92	Issue Type +	Ma	Location *	WS
Category	Earthen Levee			GPS Latitude/Longitude	
				Start	End
Item	Vegetation			38.668873 °	38.665750 °
				-121.622513 °	-121.618523 °
DWR ID	DWR_RD0827_01_s_2012_22				
Comment Code					
V8 : Environmental Requirements.					
Inspector Comment

Revegetation site spring 2012.

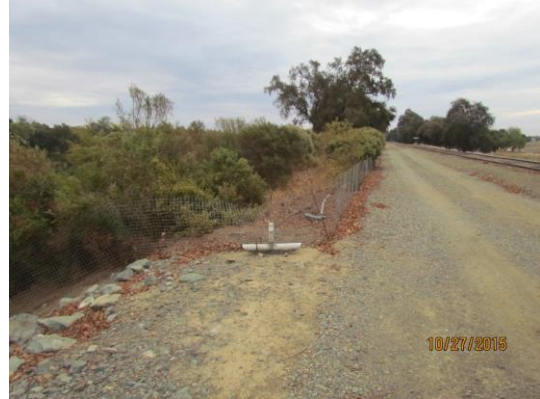
Photo 2 of 2 : FA_2017_RD0827_187_22_20170911_00011.jpg

View of the revegetation site on the waterward side of the levee looking downstream. Fall 2015.

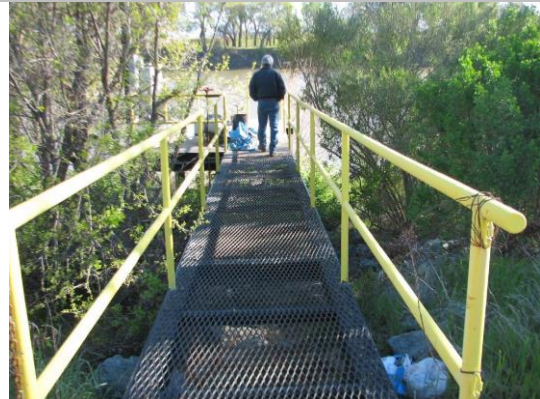
Photo 1 of 3 : UCIP_FA_2017_38983_59737.jpg

Comment Code						
Inspector Comment						
FS_ID:38983						
DS_ID:21147						
EP_NO: N/A						
Repair Type: Non-Urgent						
Crossing Status: Found						
UCIP Comments: Need to contact owner to obtain additional information for this crossing. This crossing does not match original description listed in desk study. Need to coordinate with owner to obtain permit number authorizing modification.						
FIELD_STRUCT_DESC: 14-inch (not 16-inch as listed in desk study) pipe through the levee, 10.3 feet below the crown. 10-inch bypass pipe on waterward side. Siphon breaker on landward (not waterward) shoulder. Pump on platform (not mounted on 48-inch concrete pipe as described in desk study) on waterward bank. Metal (not wooden) walkway to the pump. 3/4-inch conduit through levee at unknown depth.						
FS Date: 3/18/2014

Platform for pump located on waterward side.

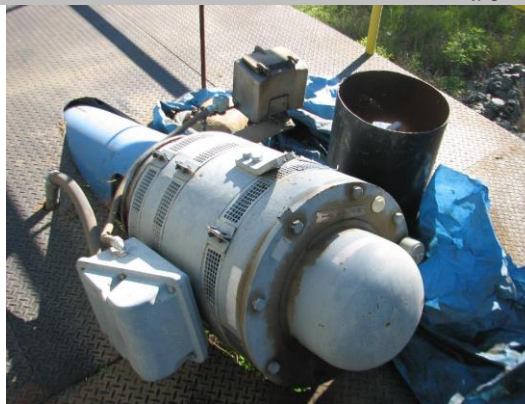
Photo 3 of 3 : UCIP_FA_2017_38983_59735.jpg

Slant pump located on waterward side.

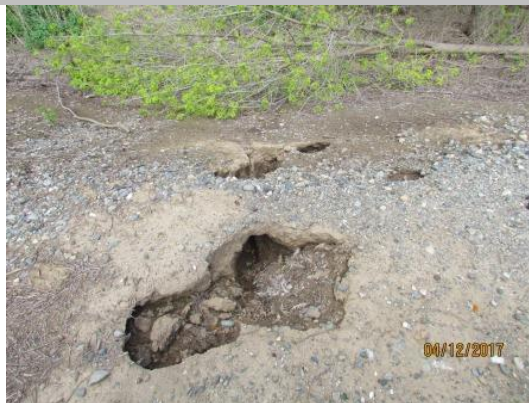
Photo 1 of 3 : FA_2017_RD0827_187_3_20170911_00001.jpg

LM Start	1.12	Rating **	M	Issue No.	3
LM End	1.12	Issue Type +	Ma	Location *	WS
Category	Earthen Levee			GPS Latitude/Longitude	
				Start	End
Item	Erosion / Bank Caving			38.663542 °	38.663542 °
				-121.616056 °	-121.616056 °
DWR ID	DWR_RD0827_01_f_2016_3				
Comment Code					
E2 : Schedule repair of erosion site prior to the next inspection.					
Inspector Comment					
Erosion on the crown and waterside slope from runoff.

Updated view of erosion on waterside levee slope. Spring 2017.

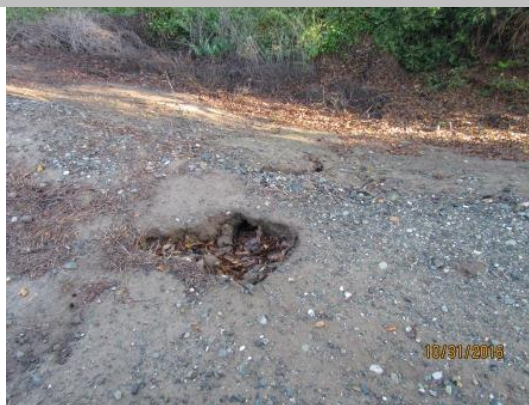
Photo 3 of 3 : FA_2017_RD0827_187_3_20170911_00003.jpg

View of erosion on crown continuing to WS slope. Fall 2016.

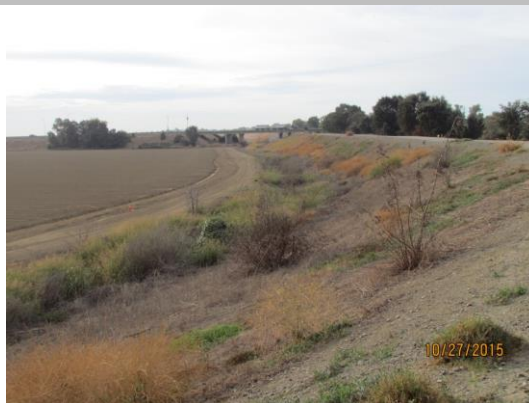
Photo 1 of 1 : FA_2017_RD0827_188_2_20170911_00001.jpg

View of the ditch on the landward side of the levee looking downstream.
Fall 2015.

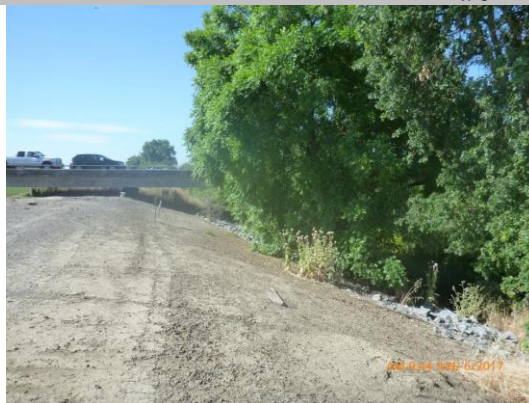
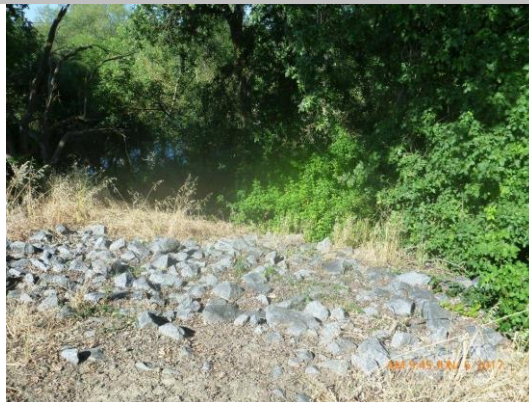
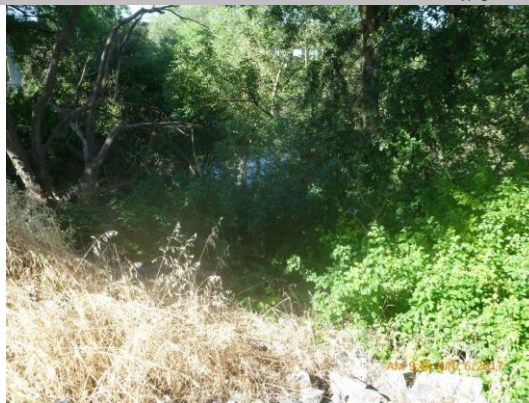
LM Start	0.15	Rating **	A/W	Issue No.	10	
LM End	0.16	Issue Type +	Ma	Location *		
Category	Supplemental			GPS Latitude/Longitude		
				Start	End	
Item	2017 Storm Damage			38.674778 °	38.674583 °	
				-121.642806 °	-121.642722 °	
DWR ID	DWR_RD0827_02_f_2017_10					
Comment Code						
Inspector Comment						
Levee Evaluation Comments						
Description:						
Site ID No:200						
Site Designation:RD 827-02						
Repair Type: Erosion						
Rating:Area of Concern						
Field Date:6/6/2017						
Notes: no damage visible, ws armored with riprap

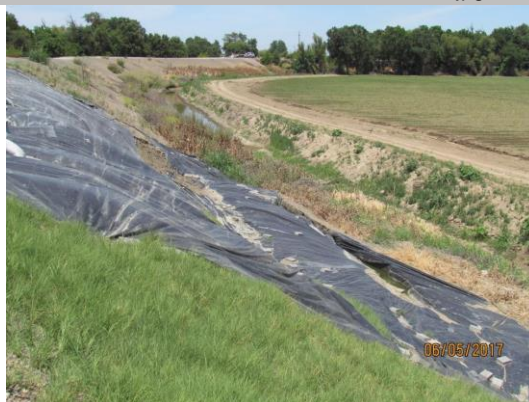
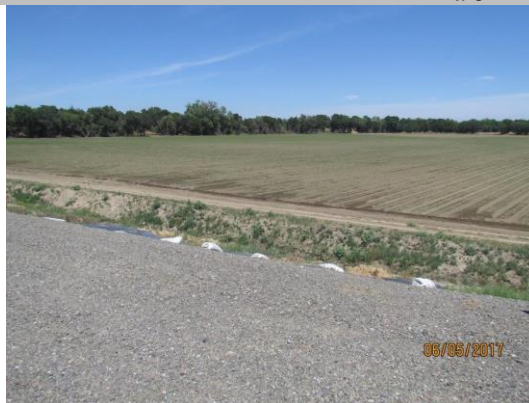
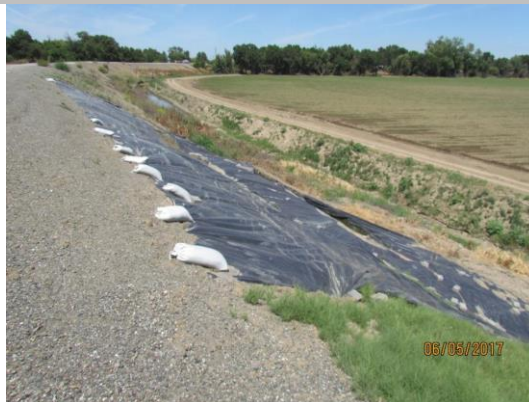
LM Start	0.16	Rating **	A/W	Issue No.	12	
LM End	0.16	Issue Type +	Ma	Location *		
Category	Supplemental			GPS Latitude/Longitude		
				Start		End
Item	2017 Storm Damage			38.674523 °		38.674523 °
				-121.642770 °		-121.642770 °
DWR ID	DWR_RD0827_02_f_2017_12					
Comment Code						
Inspector Comment						
Levee Evaluation Comments						
Description:						
Site ID No:201						
Site Designation:RD 827-03						
Repair Type: Erosion						
Rating:Critical						
Field Date:6/5/2017						
Notes:

LM Start	0.16	Rating **	A/W	Issue No.	12 (cont)	
LM End	0.16	Issue Type +	Ma	Location *		
Category	Supplemental			GPS Latitude/Longitude		
				Start	End	
Item	2017 Storm Damage			38.674523	°	38.674523
				-121.642770	°	-121.642770
DWR ID	DWR_RD0827_02_f_2017_12					
Comment Code						
Inspector Comment						
Levee Evaluation Comments						
Description:						
Site ID No:201						
Site Designation:RD 827-03						
Repair Type: Erosion						
Rating:Critical						
Field Date:6/5/2017						
Notes:

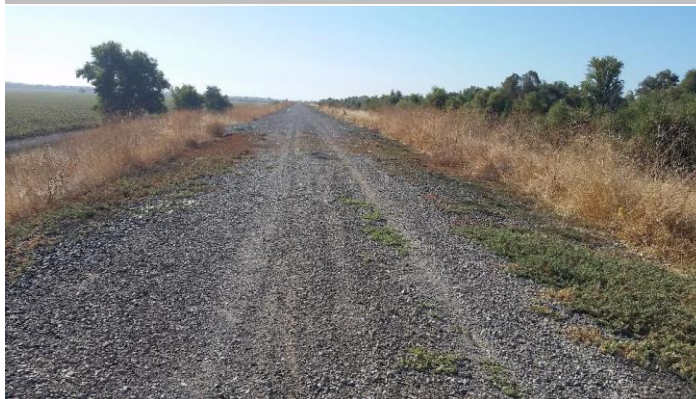
Photo 2 of 3 : UCIP_FA_2017_50065_75672.jpg

View of levee crown at crossing--yellow flag markers visible on both WS and LS shoulder.

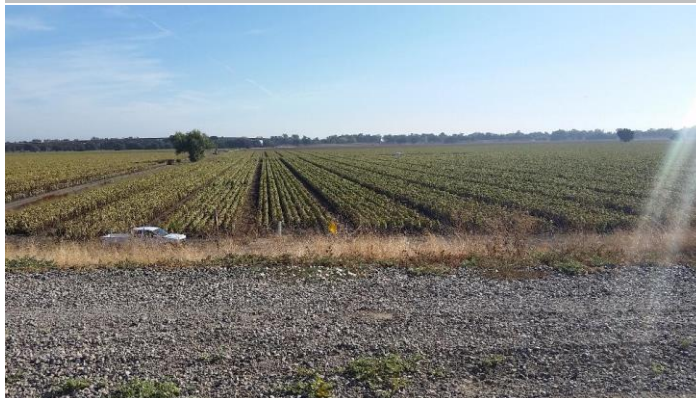
Photo 3 of 3 : UCIP_FA_2017_50065_75671.jpg

View of LS.

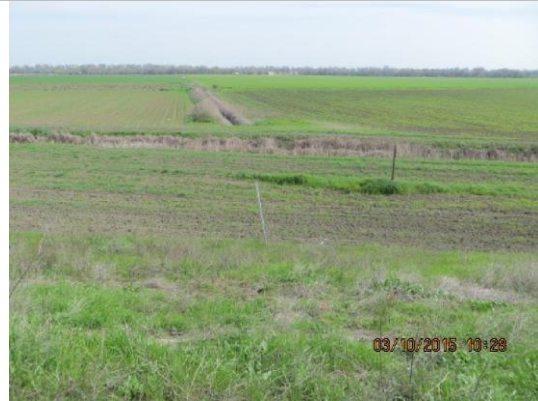
Photo 1 of 3 : UCIP_FA_2017_50030_73360.jpg

Comment Code						
Inspector Comment						
FS_ID:50030 DS_ID:21159 EP_NO: 15904 Repair Type: Urgent Crossing Status: Indicator Found UCIP Comments: 8/31/2016 Meet with Greg Lucas, Assistant Production Coordinator from California Resources Corporation and Steve Steim from Noble Methan, Inc. to discuss the status of a different line upstream. Mr. Steve Steim was aware of the 3-inch line by Two Bay Petroleum as known as a PG&E old pipe at this location. According to Steve Stein the appurtenances previously located on the landside have been removed and the 3-inch line abandoned. Need to contact owner to confirm status of crossing. If crossing is no longer in use the owner will need to coordinate with CVFPB to comply with Title 23. (DWR UCIP - omagana)8/04/2016 No markers found on either WS or LS. Need to coordinate with owner to determine status of crossing. (DWR UCIP - omagana)3/10/2015 Sign missing on WS and LS. Need to confirm status of crossing with permittee. Appears abandoned. (DWR UCIP - wwylie) 03/18/2014 crossing not found. (DWR UCIP - omagana) FIELD_STRUCT_DESC: 3-inch steel pipe through the levee, 20 feet below the crown. Sign on waterside (WS) (not found 2015). Yellow pipe visible east of ditch approximately 150 feet off landside (LS) toe. Contact Number 415-459-3445 for Two Bay Petroleum also referred as Pacific Energetics, Inc. (Permit No. 15904, 1992 - Two Bay Petroleum) FS Date: 8/4/2016

View of LS.

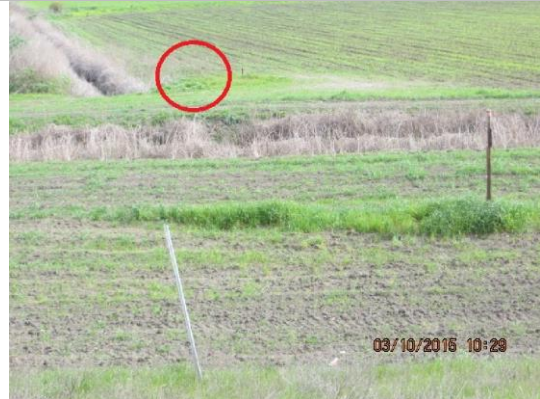
Photo 2 of 3 : UCIP_FA_2017_50030_73361.jpg

03/18/2014 crossing not found. (DWR UCIP - omagana)
FIELD_STRUCT_DESC: 3-inch steel pipe through the levee, 20 feet below the crown. Sign on waterside (WS) (not found 2015). Yellow pipe visible east of ditch approximately 150 feet off landside (LS) toe.
Contact Number 415-459-3445 for Two Bay Petroleum also referred as Pacific Energetics, Inc. (Permit No. 15904, 1992 - Two Bay Petroleum)
FS Date: 8/4/2016

Pipe visible east of ditch approximately 150 ft off LS toe.

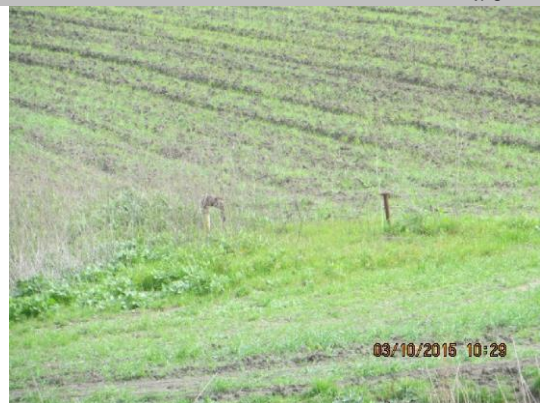
Photo 3 of 3 : UCIP_FA_2017_50030_73362.jpg

Yellow pipe visible off LS toe.

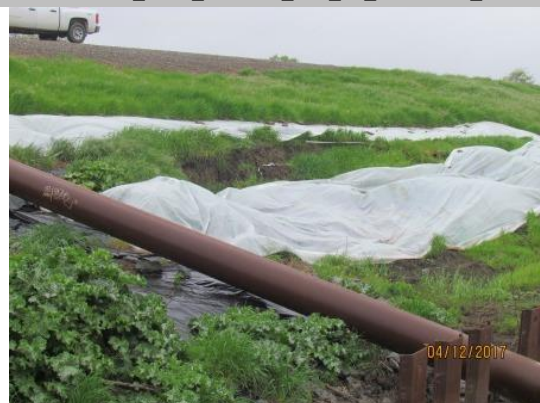
Photo 1 of 4 : FA_2017_RD0827_188_14_20170911_00008.jpg

View of erosion and visqueen on landside levee slope. Spring 2017.

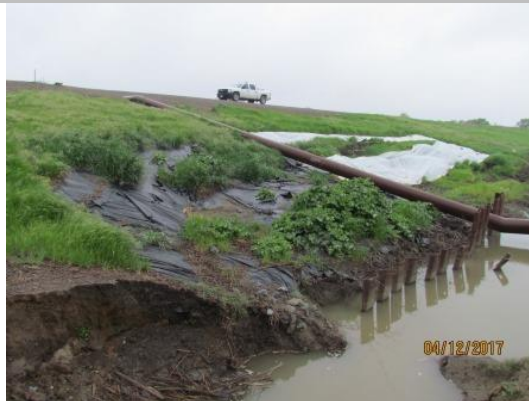
Photo 2 of 4 : FA_2017_RD0827_188_14_20170911_00009.jpg

Additional view of erosion on landside levee slope. Spring 2017.

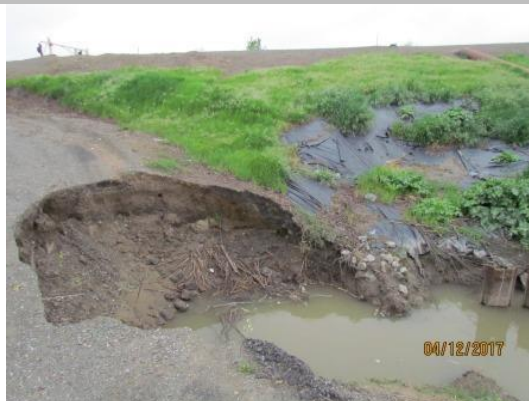
Photo 3 of 4 : FA_2017_RD0827_188_14_20170911_00010.jpg

Another view of erosion on landside levee slope. Spring 2017.

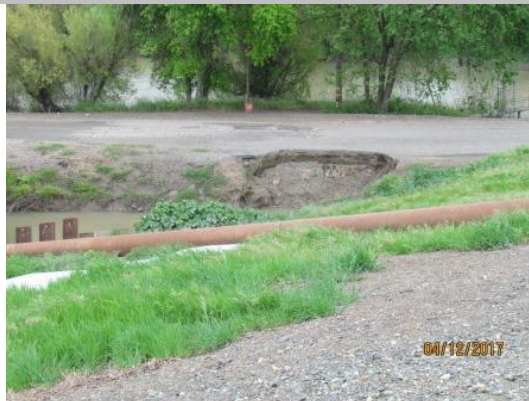
Photo 4 of 4 : FA_2017_RD0827_188_14_20170911_00011.jpg

Looking down levee slope. Spring 2017.

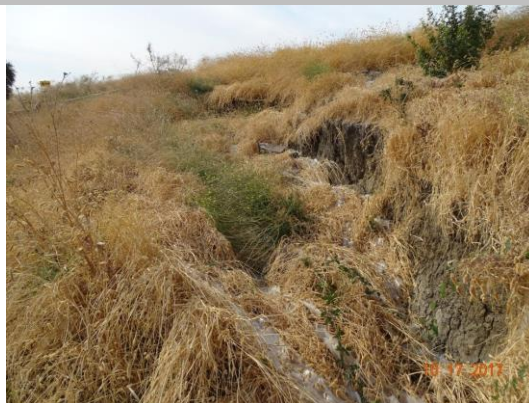
Photo 1 of 4 : FA_2017_RD0827_188_13_20171017_00038.jpg

LM Start	2.72	Rating **	M	Issue No.	13
LM End	2.73	Issue Type +	Ma	Location *	
Category	Supplemental			GPS Latitude/Longitude	
				Start	End
Item	2017 Storm Damage			38.642139°	38.642028°
				-121.620750°	-121.620667°
DWR ID	DWR_RD0827_02_f_2017_13				
Comment Code					
Inspector Comment					
Levee Evaluation Comments					
Description:					
Site ID No:199					
Site Designation:RD 827-01					
Repair Type: Erosion					
Rating:Area of Concern					
Field Date:6/6/2017					
Notes: landside. Visqueen has dried up and is no longer protecting the slope.

Updated view of sloughing on landside slope. Fall 2017.

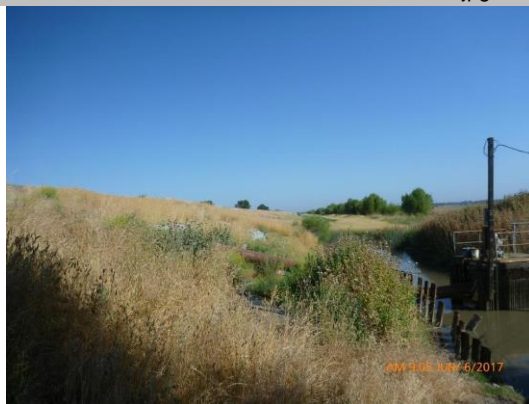
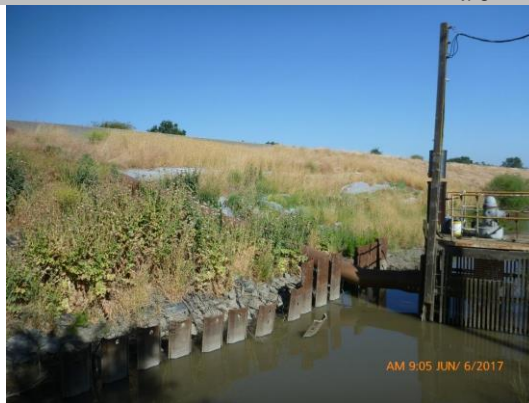
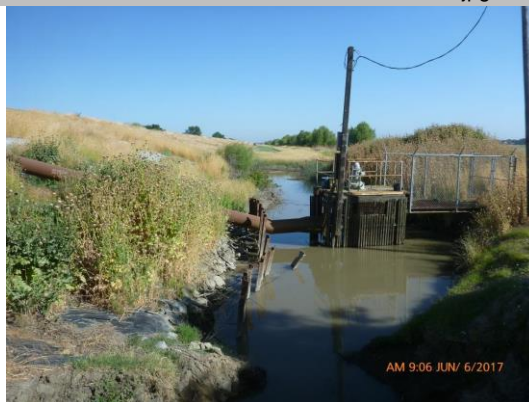
LM Start	2.72	Rating **	M	Issue No.	13 (cont)
LM End	2.73	Issue Type +	Ma	Location *	
Category	Supplemental			GPS Latitude/Longitude	
				Start	End
Item	2017 Storm Damage			38.642139 °	38.642028 °
				-121.620750 °	-121.620667 °
DWR ID	DWR_RD0827_02_f_2017_13				
Comment Code					
Inspector Comment					
Levee Evaluation Comments					
Description:					
Site ID No:199					
Site Designation:RD 827-01					
Repair Type: Erosion					
Rating:Area of Concern					
Field Date:6/6/2017					
Notes: landside. Visqueen has dried up and is no longer protecting the slope.

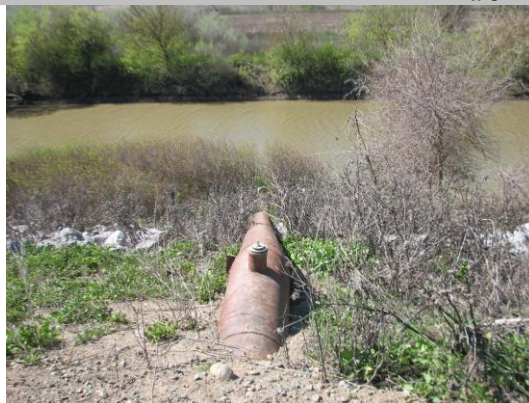
Photo 1 of 3 : UCIP_FA_2017_38984_59769.jpg

Comment Code					
Inspector Comment					
FS_ID:38984 DS_ID:21151 EP_NO: 3277 Repair Type: Non-Urgent Crossing Status: Found UCIP Comments: Crossing appears to have been removed and replaced under maintenance back in 2008. No permit has been found--need to contact owner to obtain additional information about replacement. Landward slope sloughing--does not appear to be associated with crossing. Landward slope is being monitored by LMA. FIELD_STRUCT_DESC: 18-inch (not 20-inch as noted in desk study) steel drainpipe through the levee, 4.0 feet below the crown. Cutoff wall around pipe at center of levee. Siphon breaker on apex of pipe at waterward shoulder. Pump on pipe structure in drainage ditch at landward toe. Rock revetment on waterward slope. Pipe retained through levee and updates required to crossing under Permit No. 3277 (1960). FS Date: 3/18/2014

View of pipe visible on waterward side.

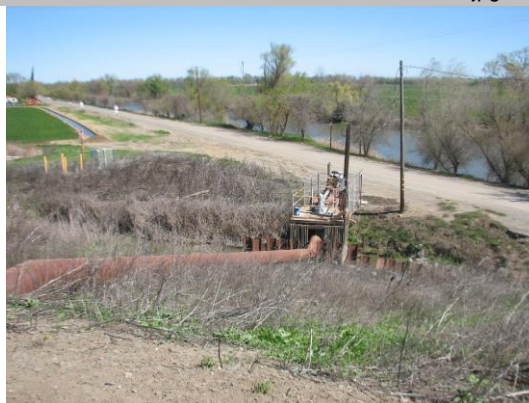
Photo 2 of 3 : UCIP_FA_2017_38984_59768.jpg

View of landward side.

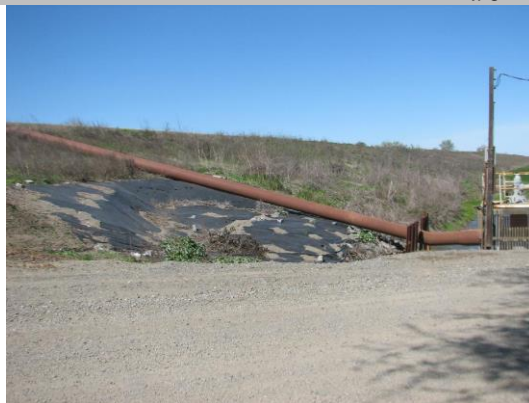
Photo 3 of 3 : UCIP_FA_2017_38984_59767.jpg

Comment Code						
Inspector Comment						
FS_ID:38984 DS_ID:21151 EP_NO: 3277 Repair Type: Non-Urgent Crossing Status: Found UCIP Comments: Crossing appears to have been removed and replaced under maintenance back in 2008. No permit has been found--need to contact owner to obtain additional information about replacement. Landward slope sloughing--does not appear to be associated with crossing. Landward slope is being monitored by LMA. FIELD_STRUCT_DESC: 18-inch (not 20-inch as noted in desk study) steel drainpipe through the levee, 4.0 feet below the crown. Cutoff wall around pipe at center of levee. Siphon breaker on apex of pipe at waterward shoulder. Pump on pipe structure in drainage ditch at landward toe. Rock revetment on waterward slope. Pipe retained through levee and updates required to crossing under Permit No. 3277 (1960). FS Date: 3/18/2014

Pipe exposed on landward side.

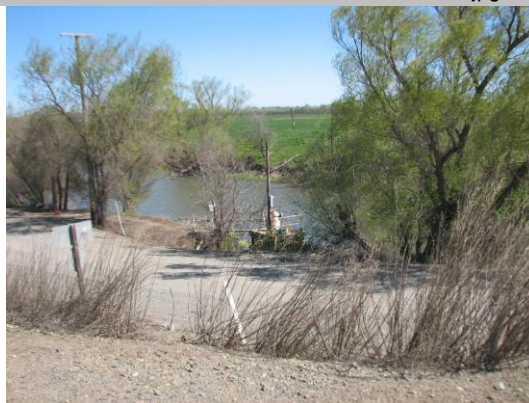
Photo 2 of 3 : UCIP_FA_2017_33032_59777.jpg

Pump station located on landward side.

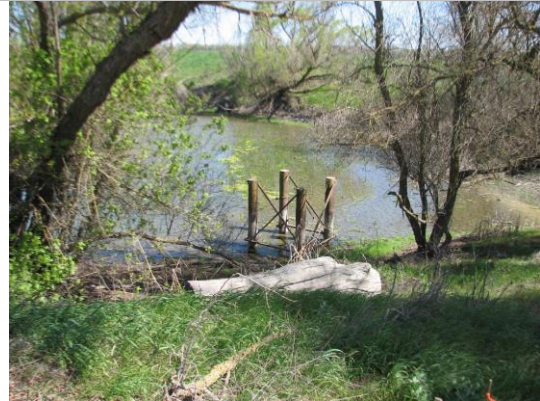
Photo 3 of 3 : UCIP_FA_2017_33032_59776.jpg

Reminise piles located on landward side.
